REPORT OF APOLLO 13 REVIEW BOARD

NATIONAL AERONAUTICS AND SPACE ADMINISTRATION

June 15, 1970

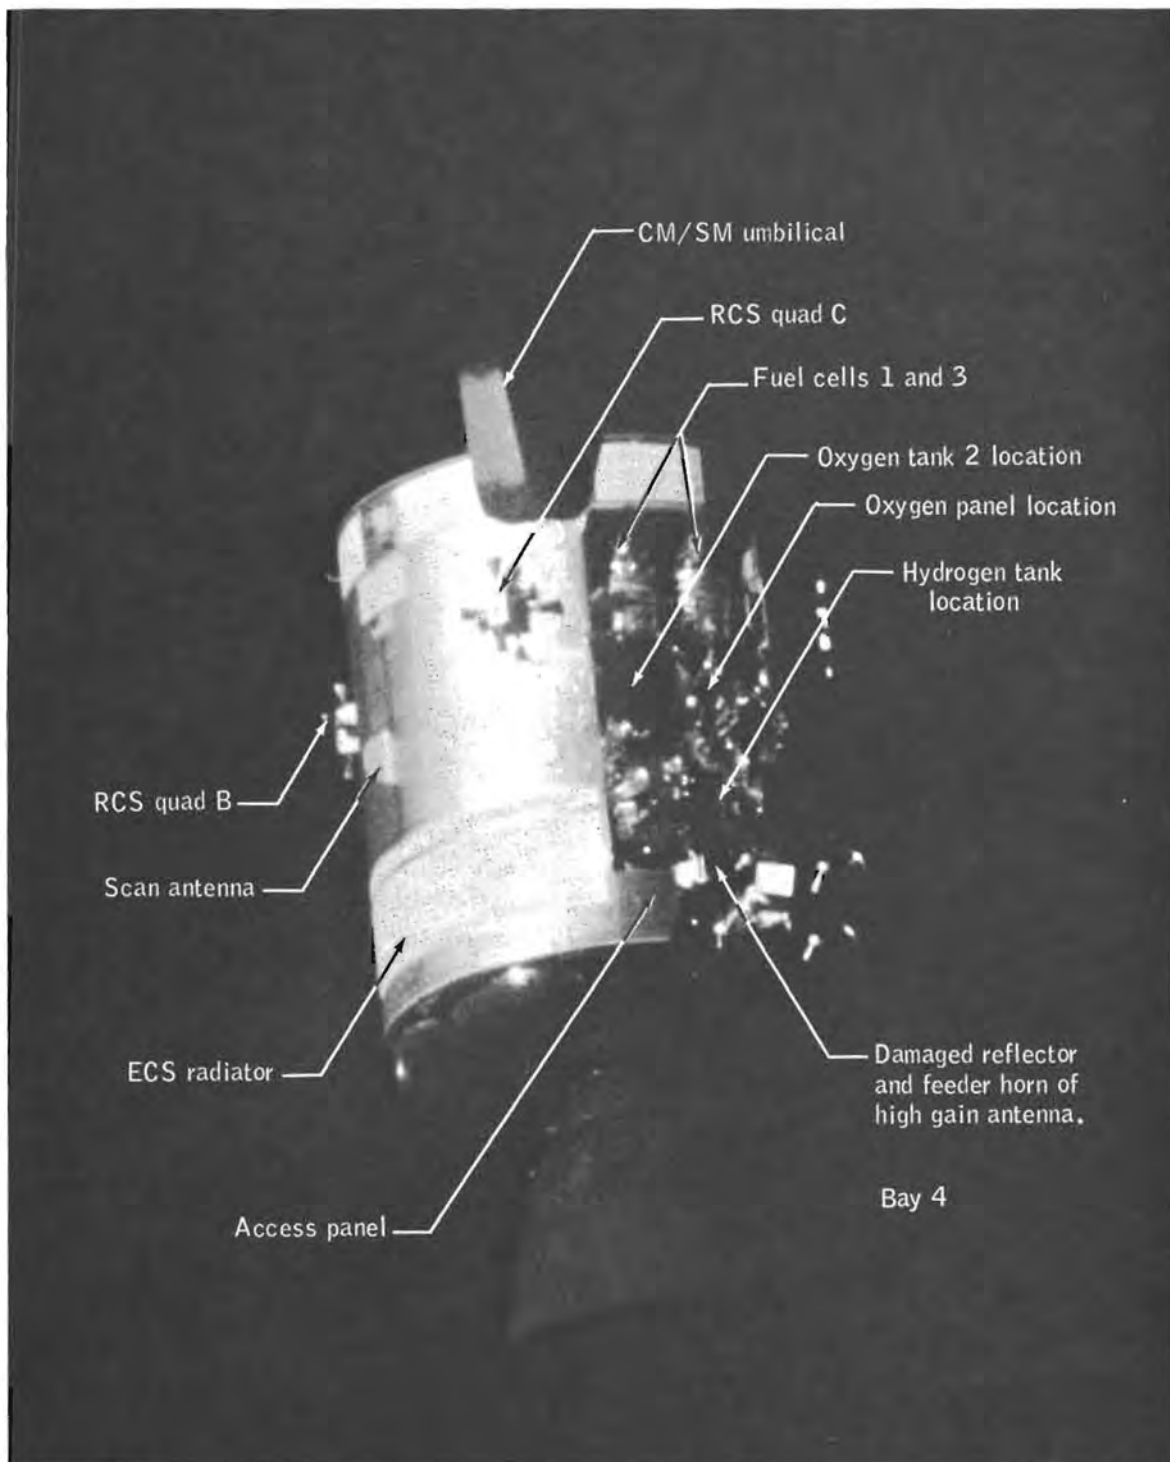
Inflight photograph of service module showing damage to bay 4.

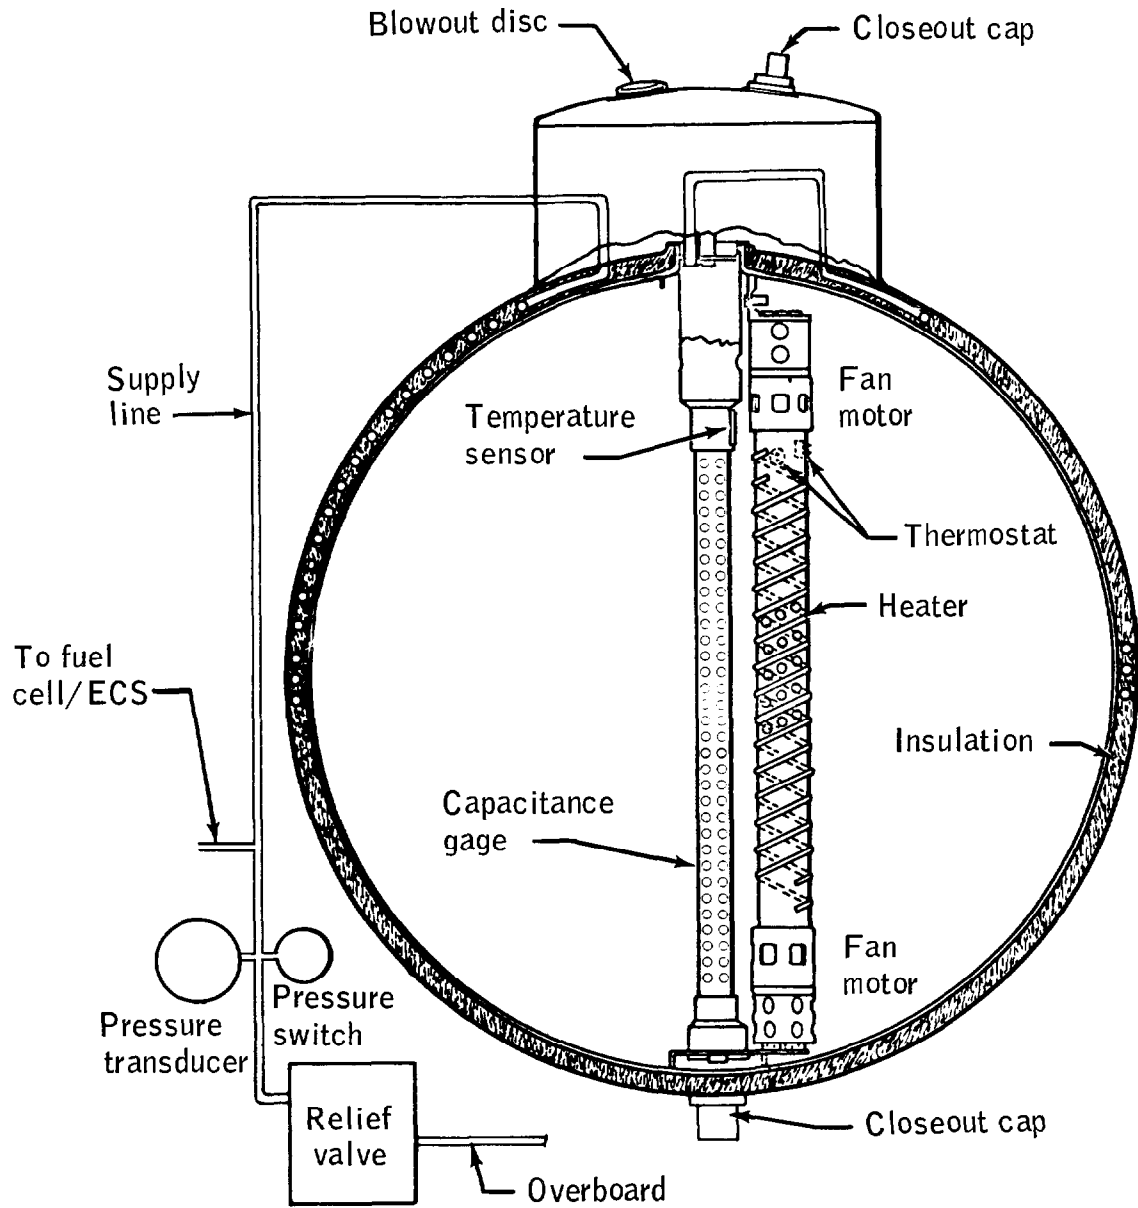
Figure 4-1.- Oxygen tank no. 2 internal components.

As shown in figure 4-2, the fill line from the exterior of the SM enters the oxygen tank and connects to the inner cylinder of the capacitance gage through a coupling of two Teflon adapters or sleeves and a short length of Inconel tubing. The dimensions and tolerances selected are such that if "worst case" variations in an actual system were to occur, the coupling might not reach from the fill line to the gage cylinder (fig. 4-3). Thus, the variations might be such that a very loose fit would result.

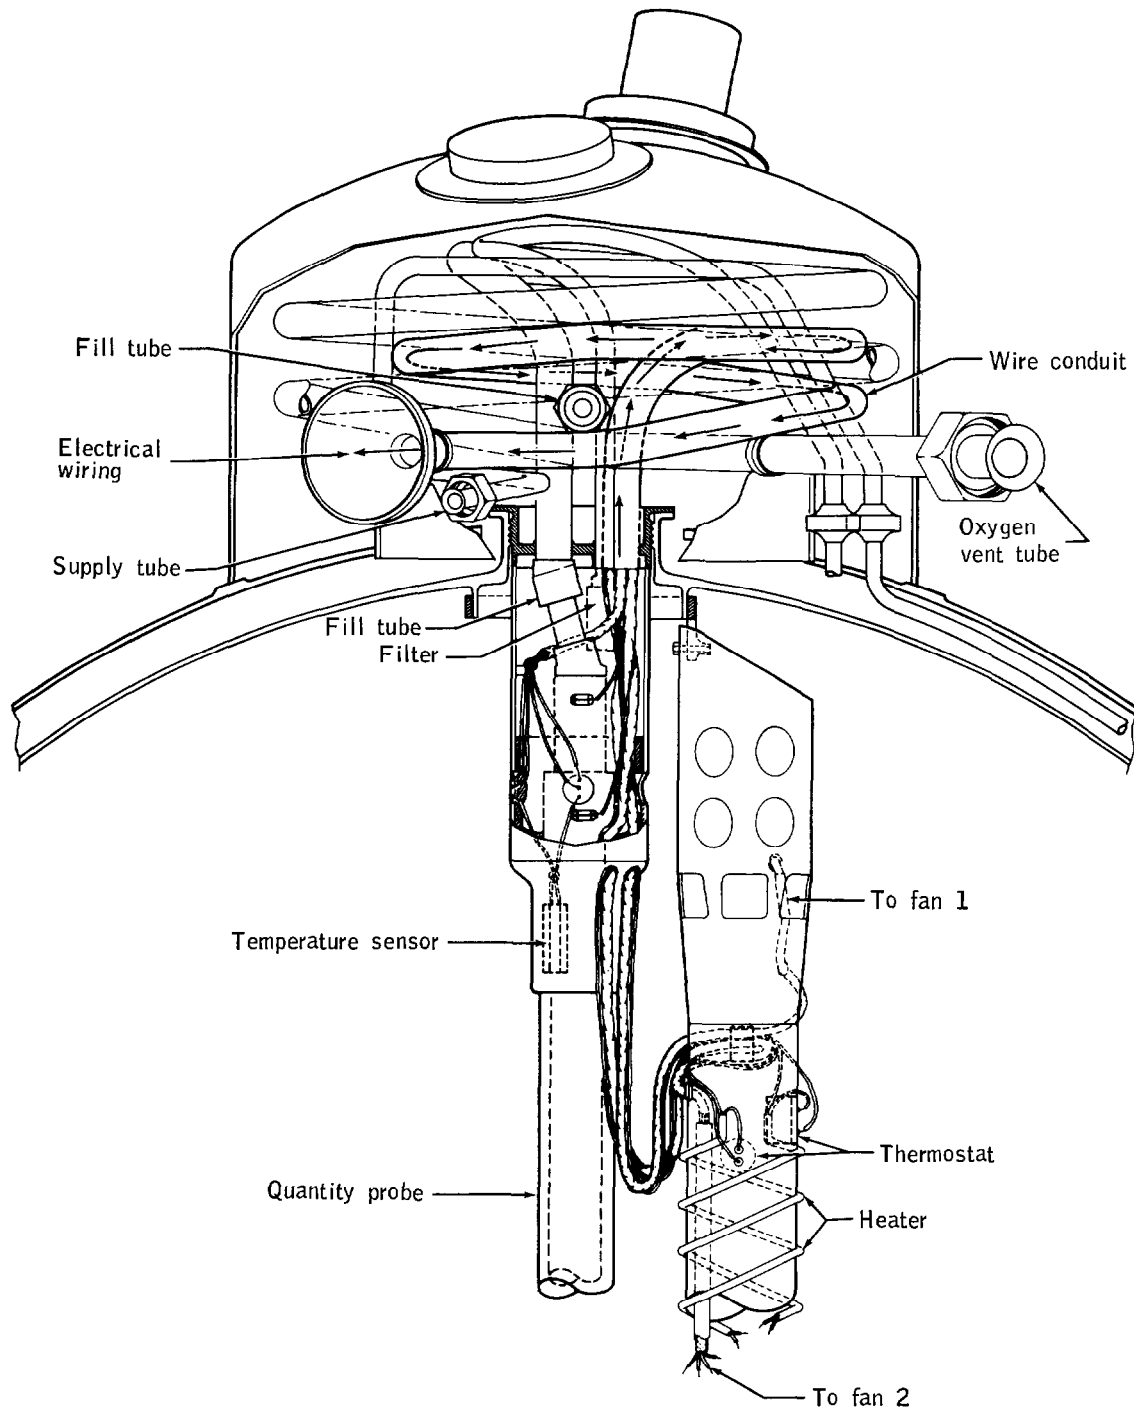
Figure 4-2.- Oxygen tank wiring and lines.

The supply line from the tank leads from the head of the quantity probe to the dome and thence, after passing around the tank between the inner and outer shells, exits through the dome to supply oxygen to the fuel cells in the service module (SM) and the environmental control system (ECS) in the command module (CM). The supply line also connects

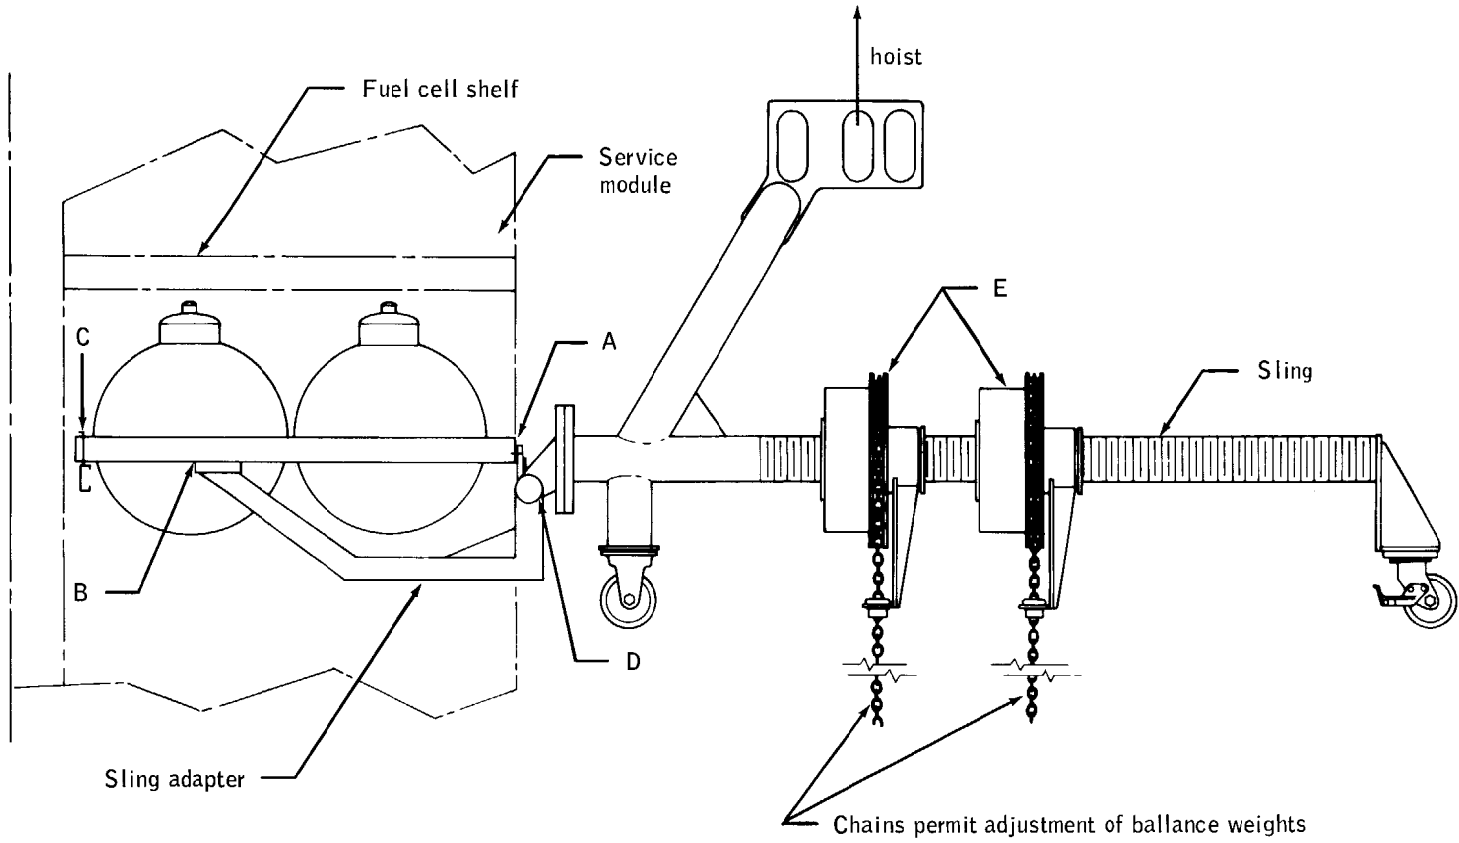
Figure 4-9.- Hoist and sling arrangement - oxygen shelf.

The oxygen shelf was removed in the manner shown in figure 4-9. After various lines and wires were disconnected and bolts which hold the shelf in the SM were removed, a fixture suspended from a crane was placed under the shelf and used to lift the shelf and extract it from bay 4. One shelf bolt was mistakenly left in place during the initial attempt to remove the shelf; and as a consequence, after the front of the shelf was raised about 2 inches, the fixture broke, allowing the shelf to drop back into place. Photographs of the underside of the fuel cell shelf in SM 106 indicate that the closeout cap on the dome of oxygen tank no. 2 may have struck the underside of that shelf during this incident. At the time, however, it was believed that the oxygen shelf had simply dropped back into place and an analysis was performed to calculate the forces resulting from a drop of 2 inches. It now seems likely that the shelf was first accelerated upward and then dropped.

The remaining bolt was then removed, the incident recorded, and the oxygen shelf was removed without further difficulty. Following removal, the oxygen shelf was retested to check shelf integrity, including proof-pressure tests, leak tests, and functional tests of pressure transducers and switches, thermal switches, and vac-ion pumps. No cryogenic testing was conducted. Visual inspection revealed no problem. These tests would have disclosed external leakage or serious internal malfunctions of most types, but would not disclose fill line leakage within oxygen tank no. 2. Further calculations and tests conducted during this investigation, however, have indicated that the forces experienced by the shelf were probably close to those originally

calculated assuming a 2-inch drop only. The probability of tank damage from this incident, therefore, is now considered to be rather low, although it is possible that a loosely fitting fill tube could have been displaced by the event.

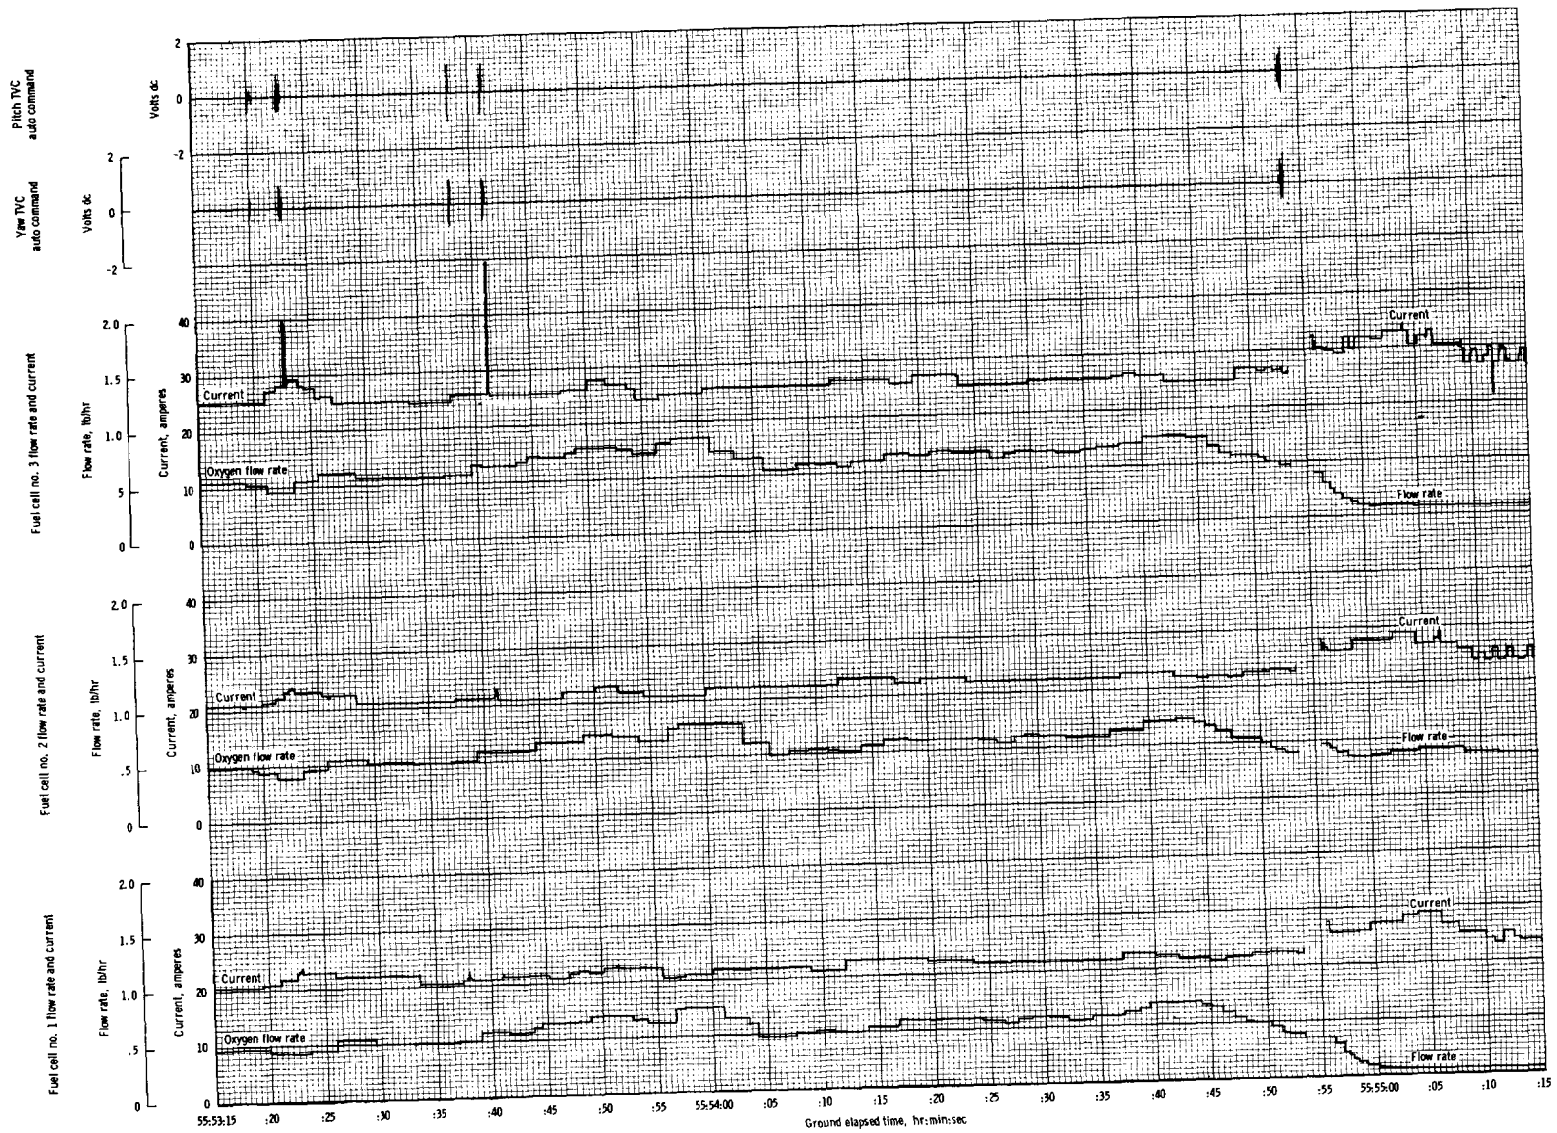
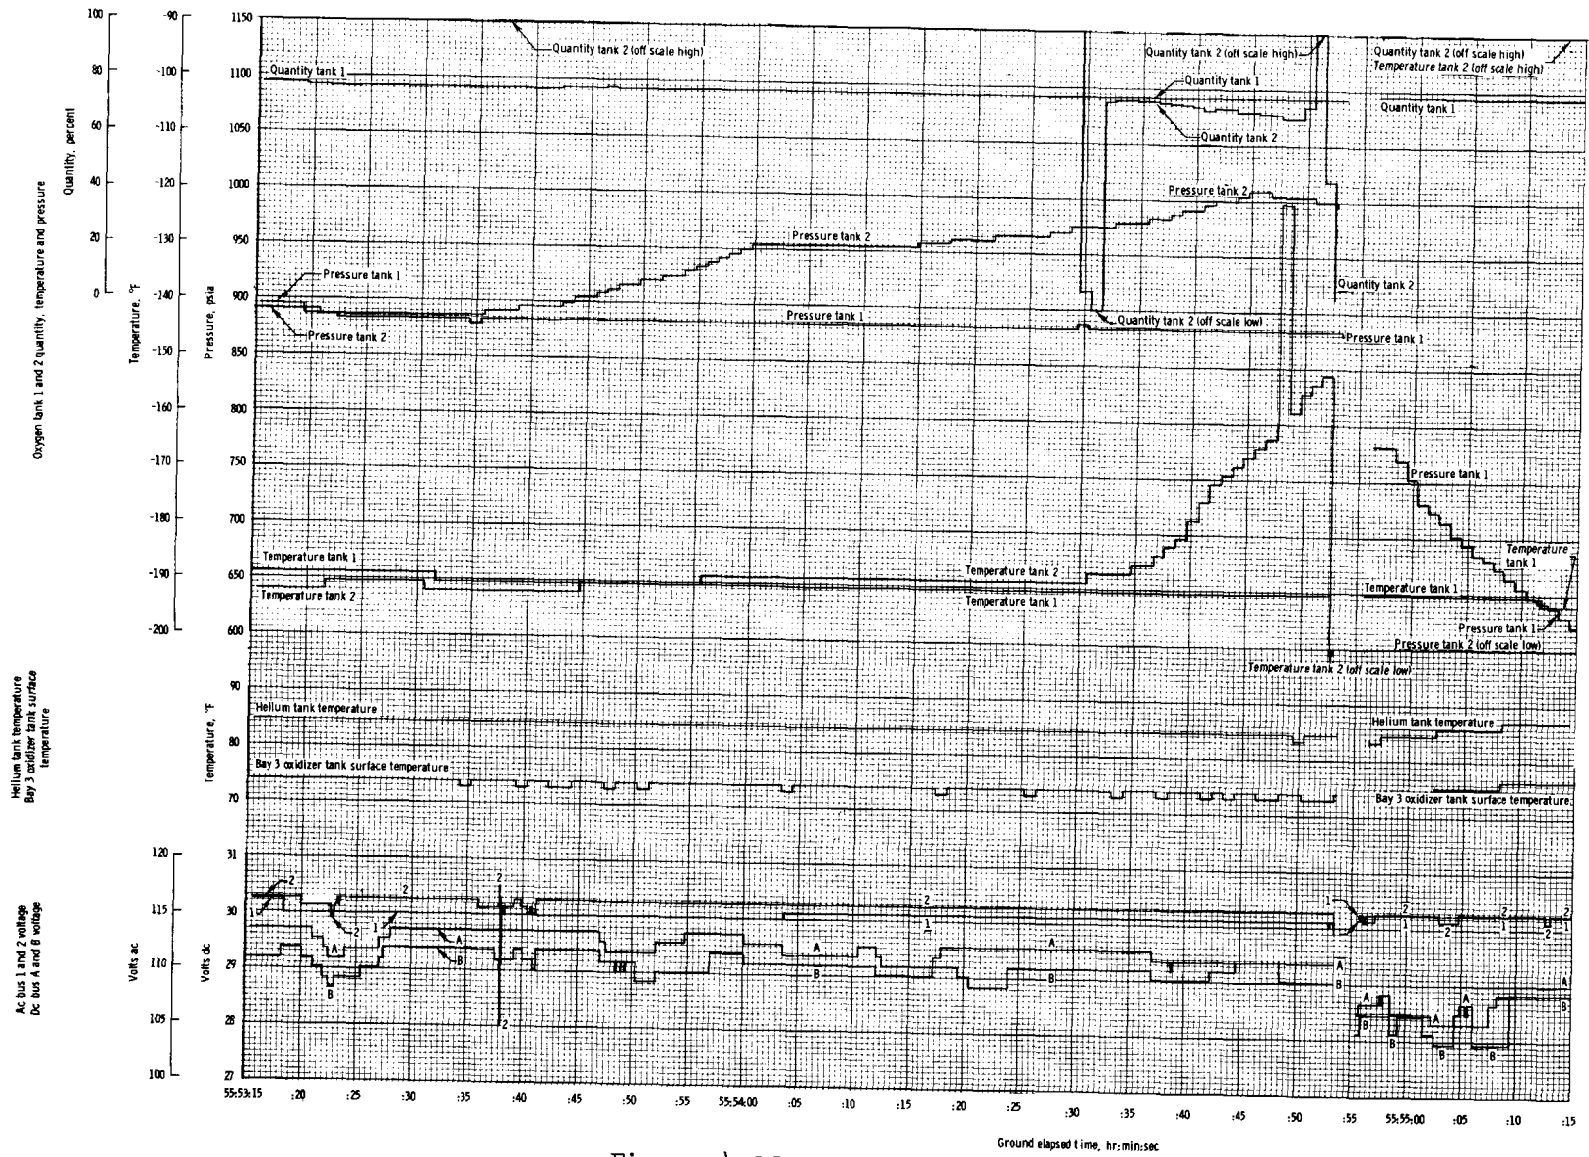
Figure 4-10.- Telemetry record.

The various telemetered parameters of primary interest are shown in figure 4-10 and listed in table 4-11.

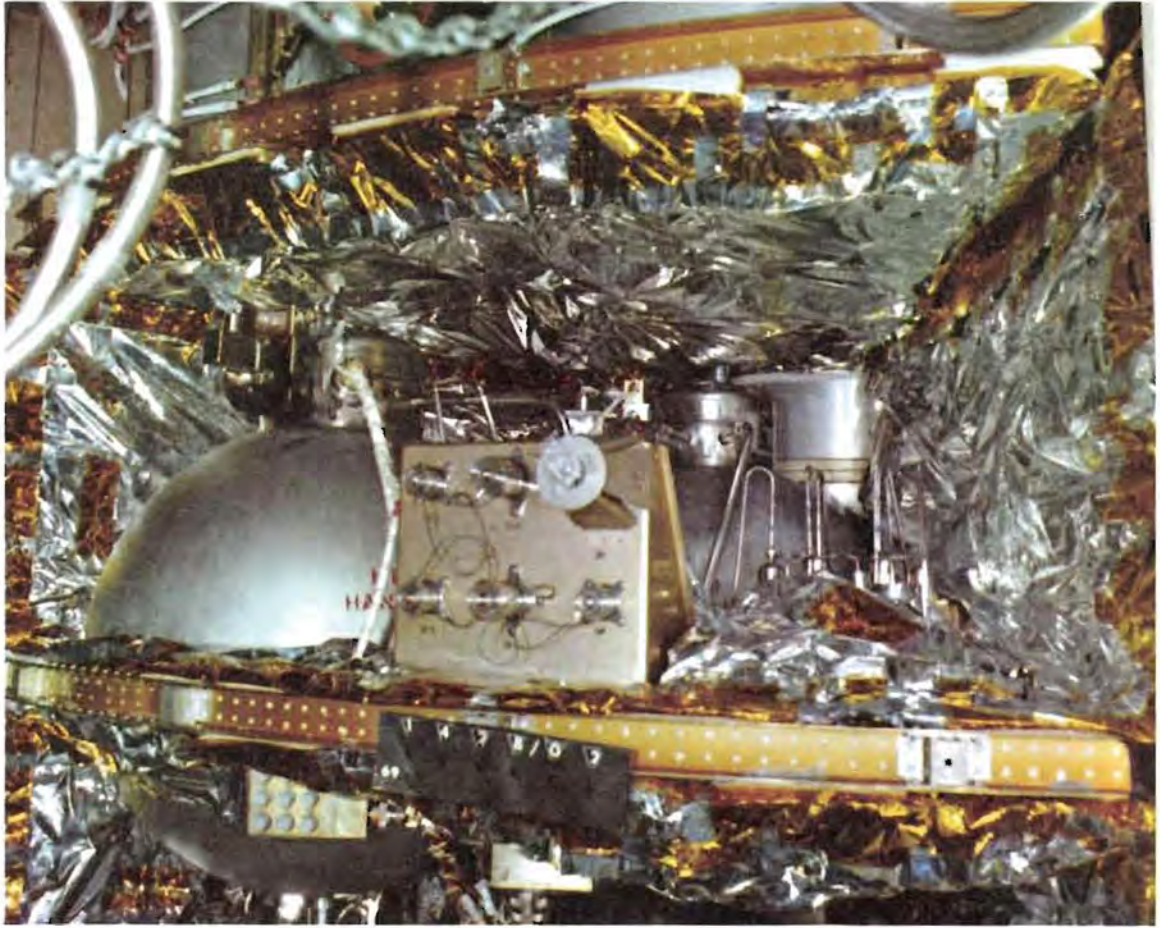
4-11.-
Figure ~~XX-XX~~ Closeup view of oxygen tank shelf.

Failure at this point would lead immediately to pressurization of the tank dome, which is equipped with a rupture disc rated at about 75 psi. Rupture of this disc or of the entire dome would then release oxygen, accompanied by combustion products, into bay 4. The accelerations recorded were probably caused by this release.

Release of the oxygen then began to pressurize the oxygen shelf space of bay 4. If the hole formed in the pressure vessel were large enough and formed rapidly enough, the escaping oxygen alone would be adequate to blow off the bay 4 panel. However, it is also quite possible that the escape of oxygen was accompanied by combustion of Mylar and Kapton (used extensively as thermal insulation in the oxygen shelf compartment, figure 4-11, and in the tank dome) which would augment the

pressure caused by the oxygen itself. The slight temperature increases recorded at various SM locations indicate that combustion external to the tank probably took place. Further testing may shed additional light on the exact mechanism of panel ejection. The ejected panel then struck the high-gain antenna, disrupting communications from the spacecraft for the 1.8 seconds.
