REPORT OF INVESTIGATION

Surface
(Gold Ore)

Fatal Machinery Accident
November 8, 2020

Smoky Valley Common Operations
Round Mountain Gold Corporation
Round Mountain, Nye County, Nevada
ID No. 26-00594

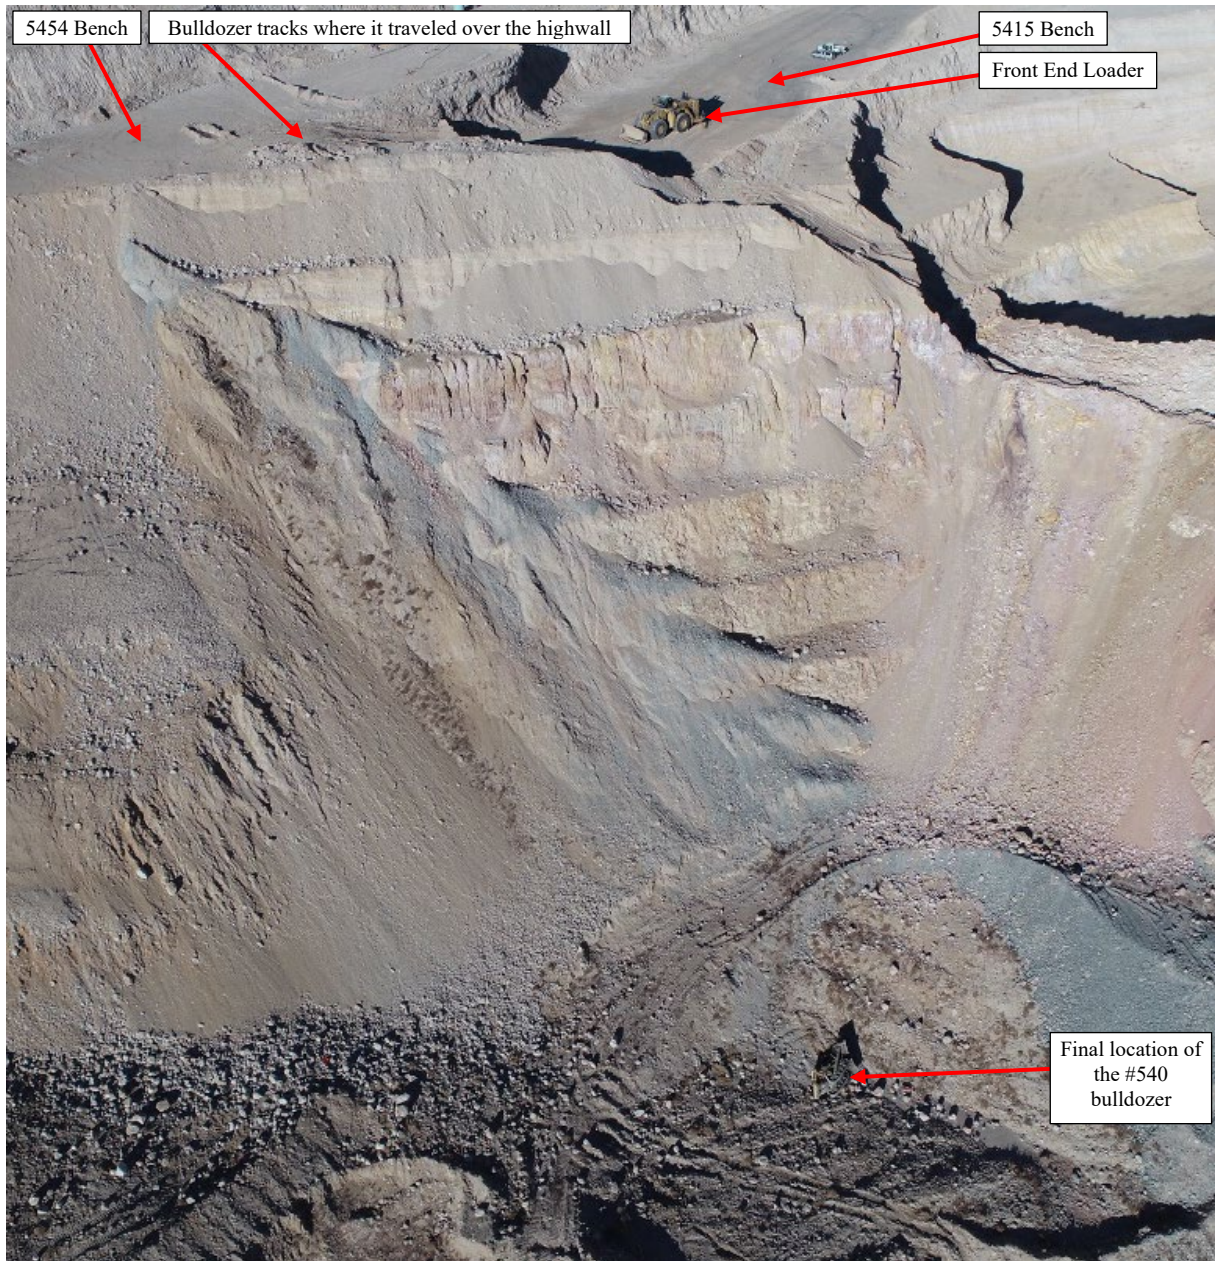
APPENDIX A - Photograph of the Accident Scene

The accident occurred on the 5454 bench of the WA2 phase pit high wall, located in the upper northwest portion of the open pit. Investigators determined there were no barricades or signs to provide a warning of the extreme fall hazard present at the edge of the WA2 phase pit high wall (see Appendix A). This area was blasted on November 4, 2020, and the blast destroyed the berm in that area.

Management did not install barricades and warning signs to demarcate areas of extreme fall hazards at the edge of the pit highwall. Management did not have policies or procedures in place to train their competent persons to install barricades and warning signs demarcating those areas of extreme risk.

4. Root Cause: Mine Management did not provide barricades or warning signs to demarcate the extreme fall potential at the edge at the pit highwall.

The mine operator did not provide barricades or warning signs of the hazardous conditions that were not immediately obvious at the top of the highwall for the 5454 level. The shot material from the 5454 level was being pushed by a Caterpillar D10T2 Bulldozer company #540 to the level below to be loaded into haulage trucks. Barricades or warning signs demarcating the top of the highwall were not in place. The bulldozer operator traveled over the edge of the bench, and the bulldozer fell approximately 300 feet to the bench below, resulting in a fatal injury. The mine operator engaged in aggravated conduct, constituting more than ordinary negligence, in that the edge of the 5454 bench was not barricaded nor were warning signs posted to demarcate the top of the highwall and the extreme fall potential where the victim was working. This is an unwarrantable failure to comply with a mandatory standard.

Corrective Action: Round Mountain Gold Corporation has placed reflective signs and barricades thirty feet from the edge of the pit highwall to demarcate the extreme fall potential. The Company has instituted a written policy to post warning signs and barricades along the edge of the pit highwall. The company has trained their managers, competent persons, examiners and miners in the policy.

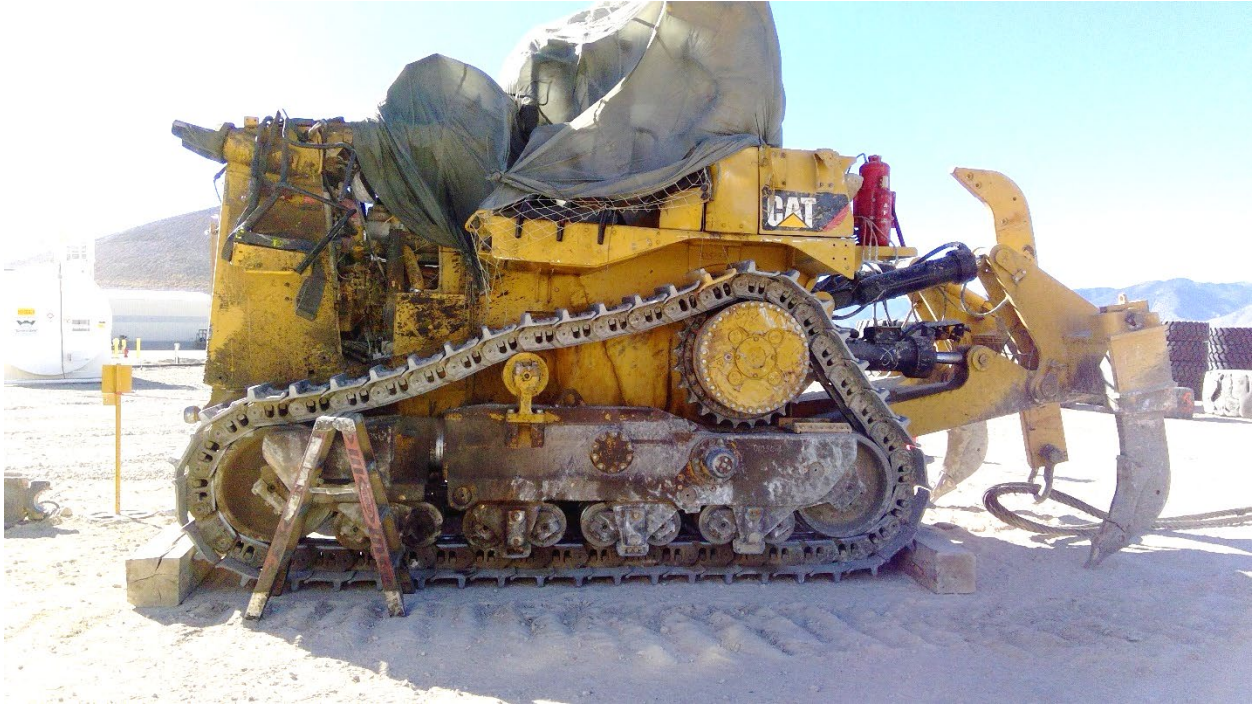
APPENDIX C – Photograph of the Equipment Involved

The Caterpillar D10T2 bulldozer (company number #540) involved in the accident is a track-mounted earth moving piece of equipment (see Appendix C). The company retrieved data from the electronic control modules (ECM) on the bulldozer and found no faults in the ECM data prior to the time of the accident. Investigators did not find preoperational examination records for the bulldozer. The records were kept on the bulldozer and investigators believe the records were lost when the bulldozer fell.
