Resolving Vibration Issues of Diesel Engine Driven Fire Water Pumps in QP Offshore

Case Study

Isham Sudardjat
Reliability Engineer
QP Offshore Operation

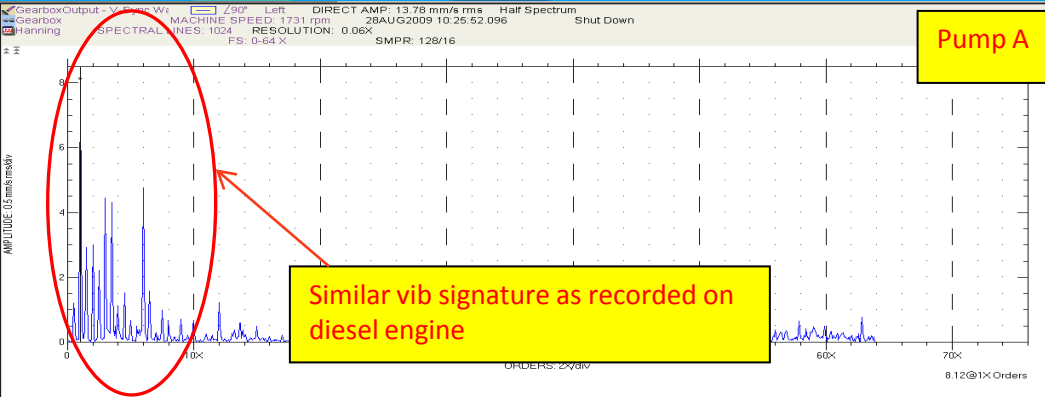
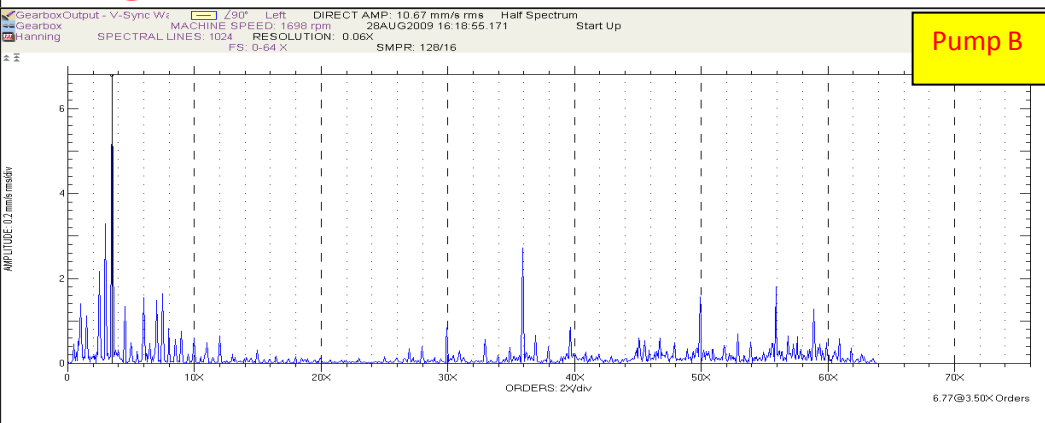
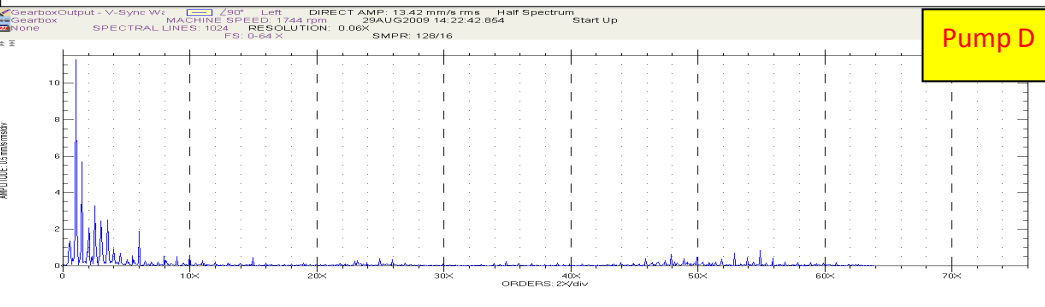
Comparison of vibration signatures of Pumps A, B & D for the GB output Vertical location

Observation-1: Vibration signature on Gearbox indicated that a significant energy getting transmitted from the Diesel Engine components of 3X, 3.5X and 6X other than the dominant 1X

Reason could be: vibration isolators are not installed either under the engine feet nor under the frame on which the engine is mounted.

Action-2: The engine stand was replaced with a new stand with vibration isolators

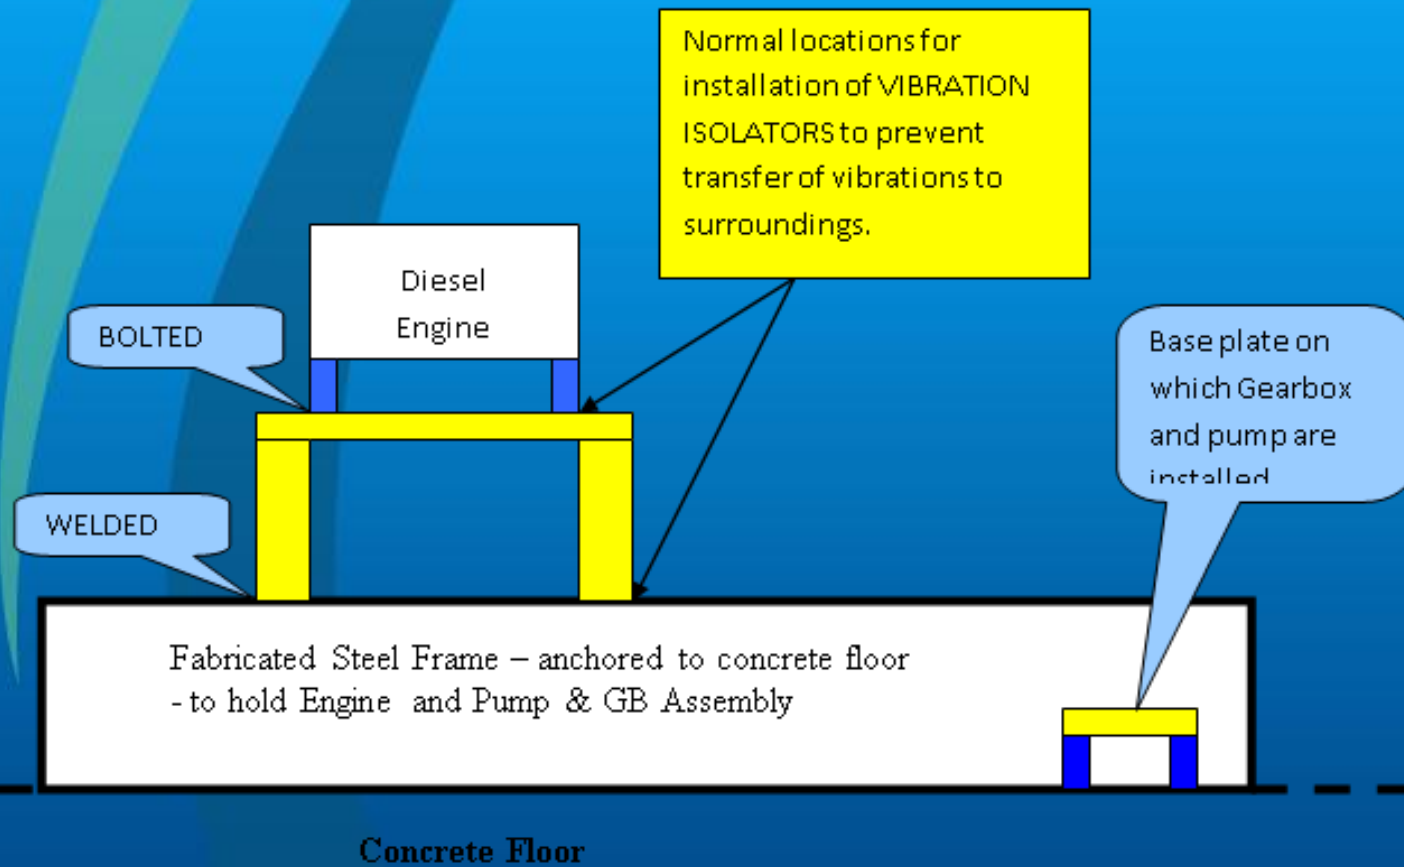
Foundation/supporting arrangement for Diesel Engine, Gearbox and Pump.

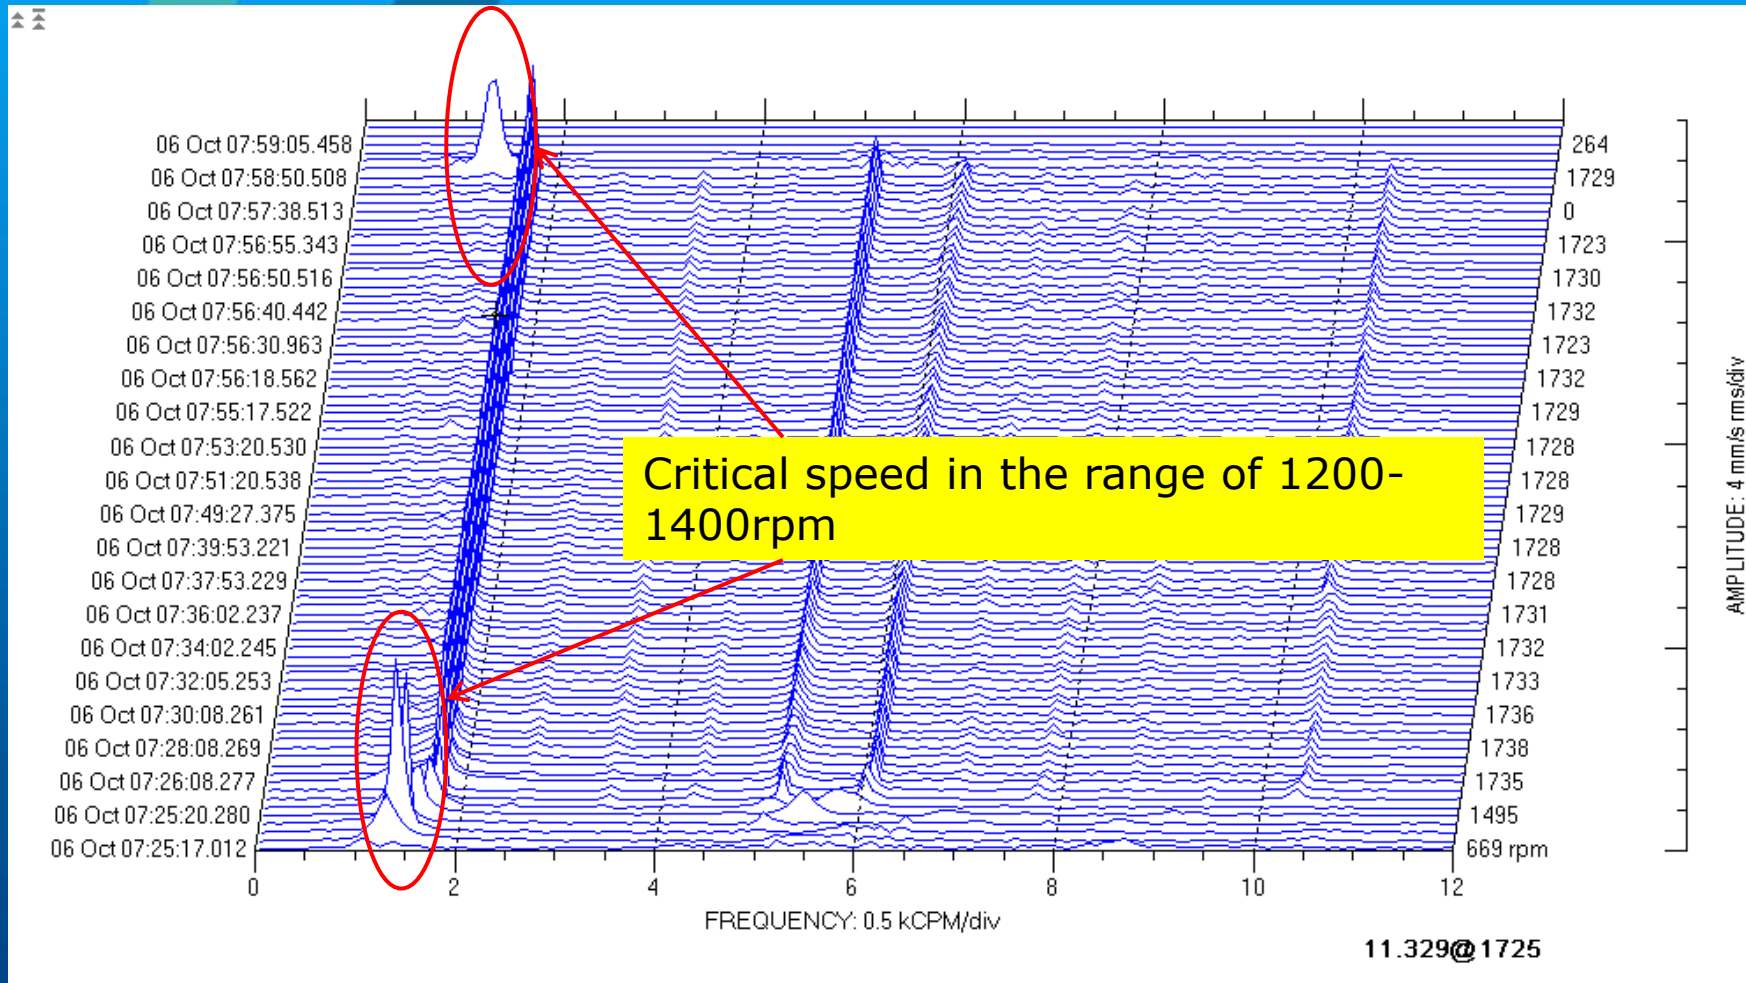
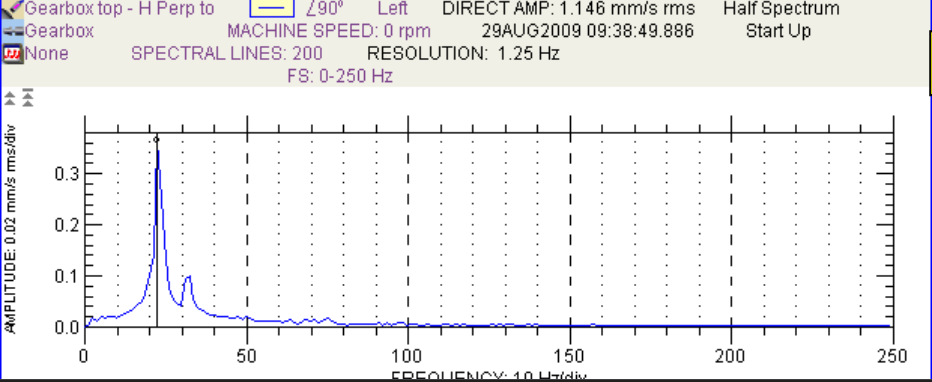
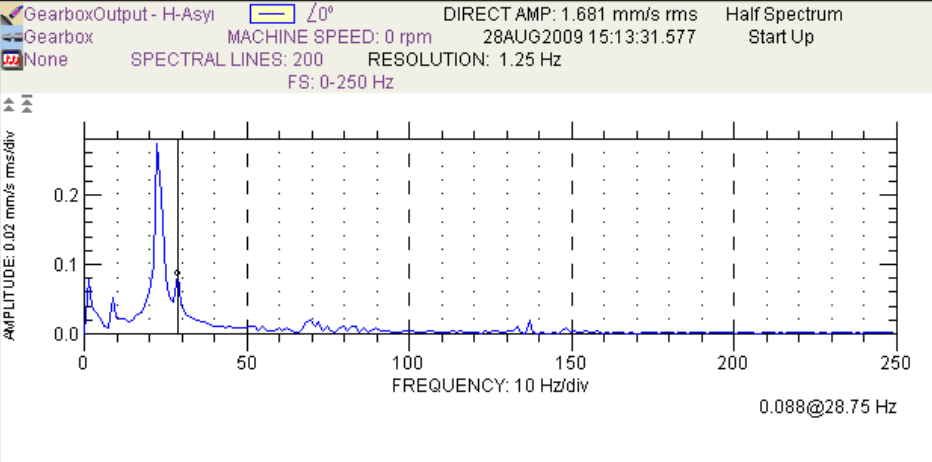
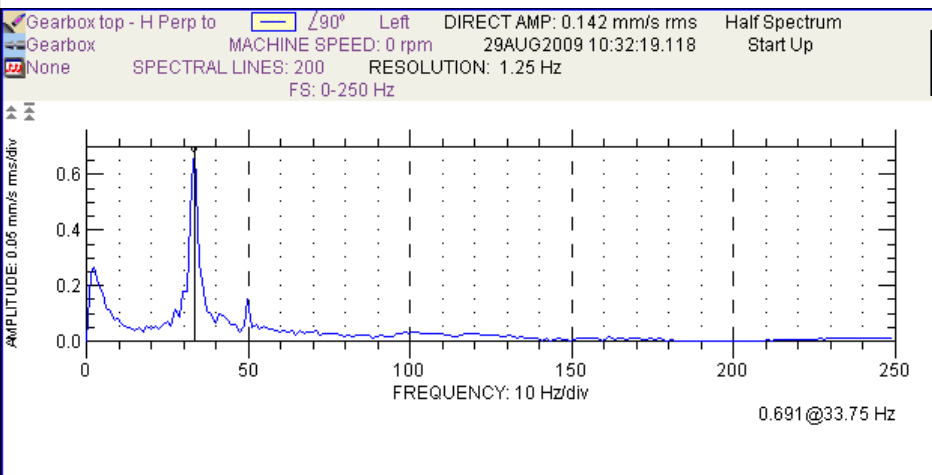
Observation: 2 Startup/coast down waterfall indicated resonance in the speed range 1200 to 1400 rpm – Most likely from the cordon shaft or coupling hub

Action-1: Balancing attempted on GB I/P and GB O/P shaft to reduce unbalance on cordon shaft and to reduce excitation on the GB structure respectively. (coupling between Engine and GB used to balance the GB I/P shaft. GB fan at the top used to balance the GB O/P shaft).

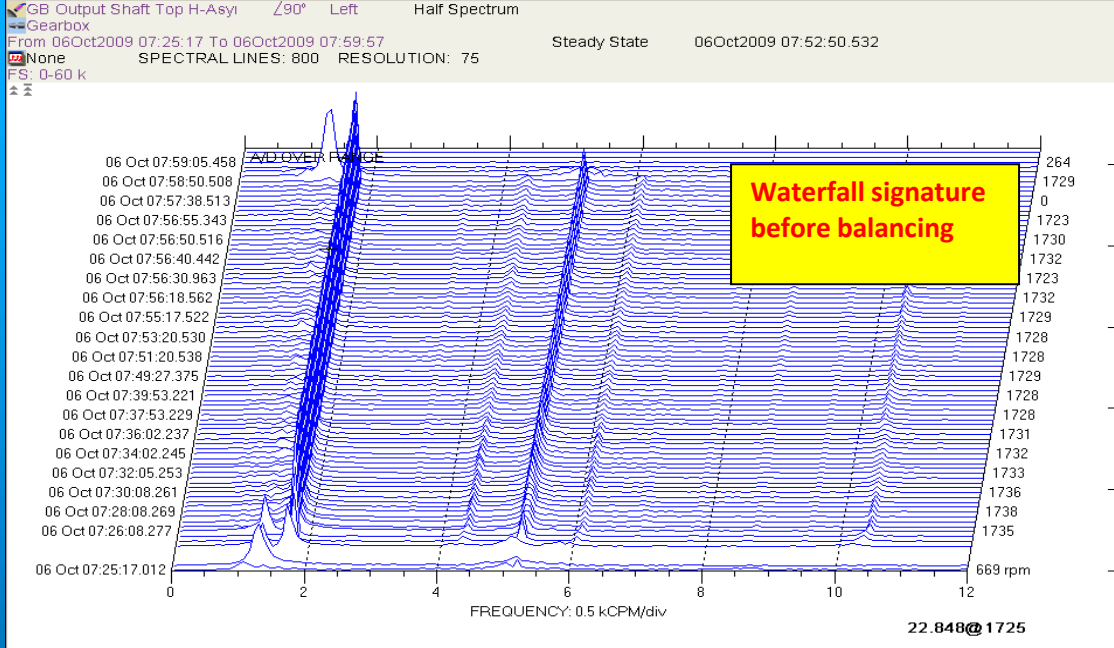
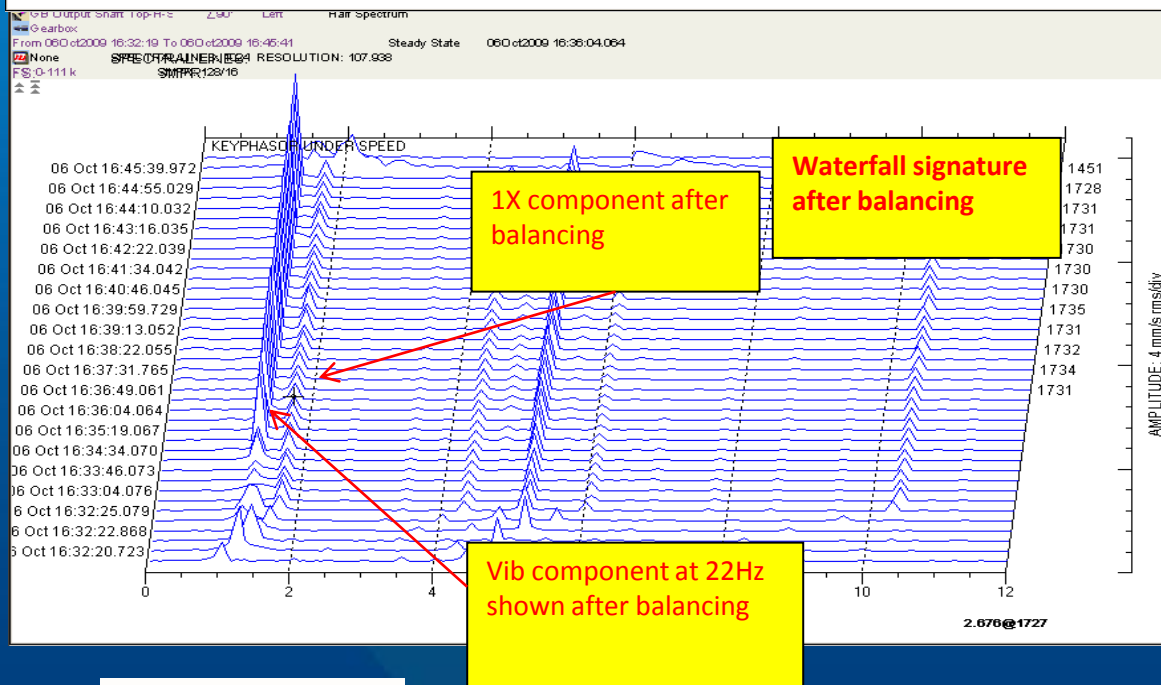
Action-1 (contd): In-situ balancing resulted in reduction of 1X. However the amplitude shifted to the frequency of 22 Hz (0.8X).

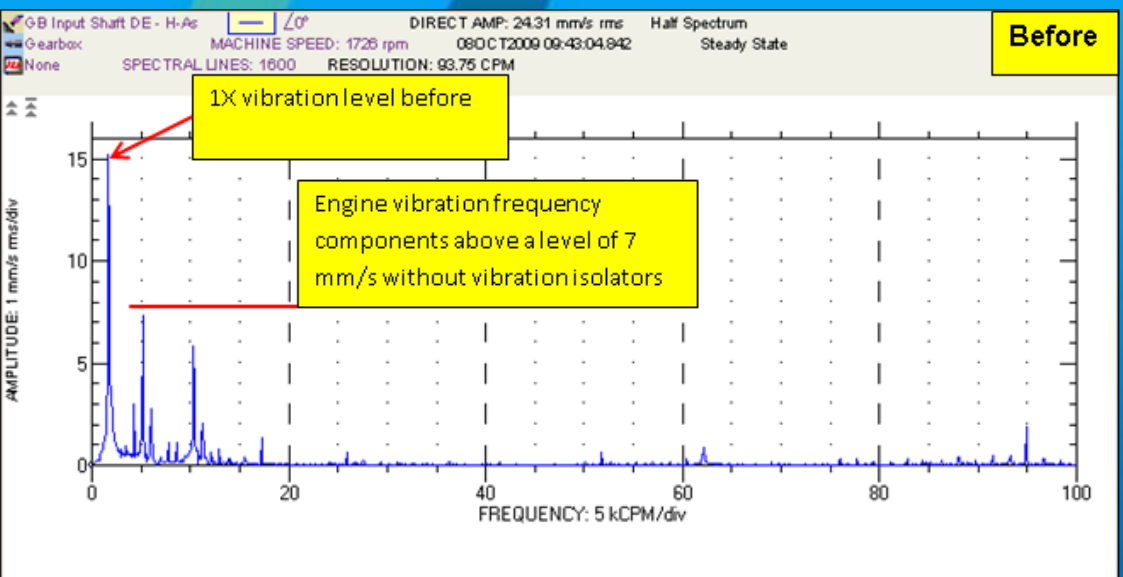
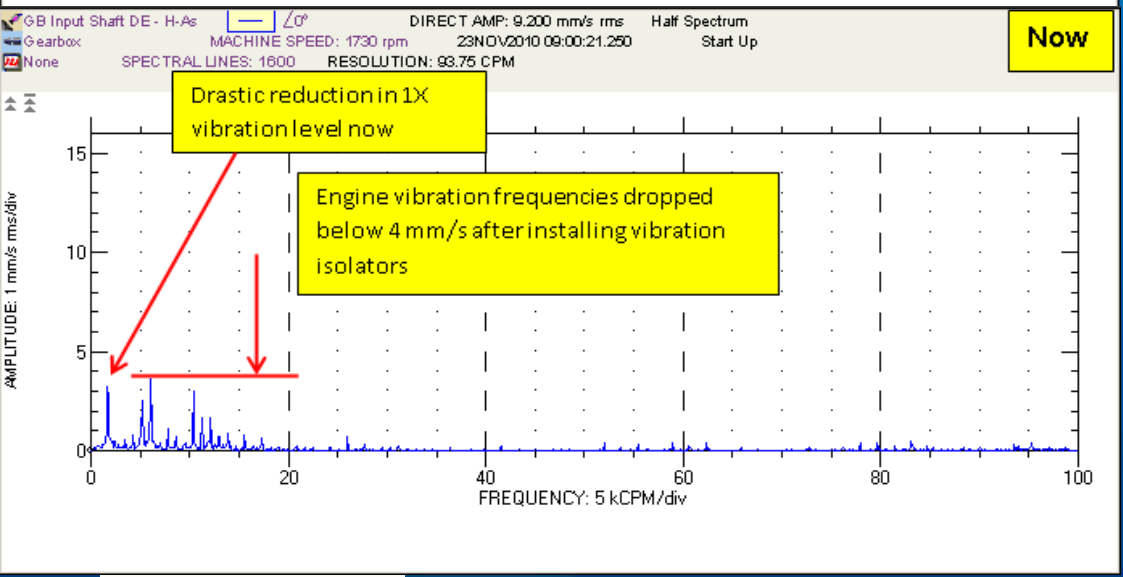
Comparison of vibration spectrum before and after the modification of engine base frame with vibration isolators

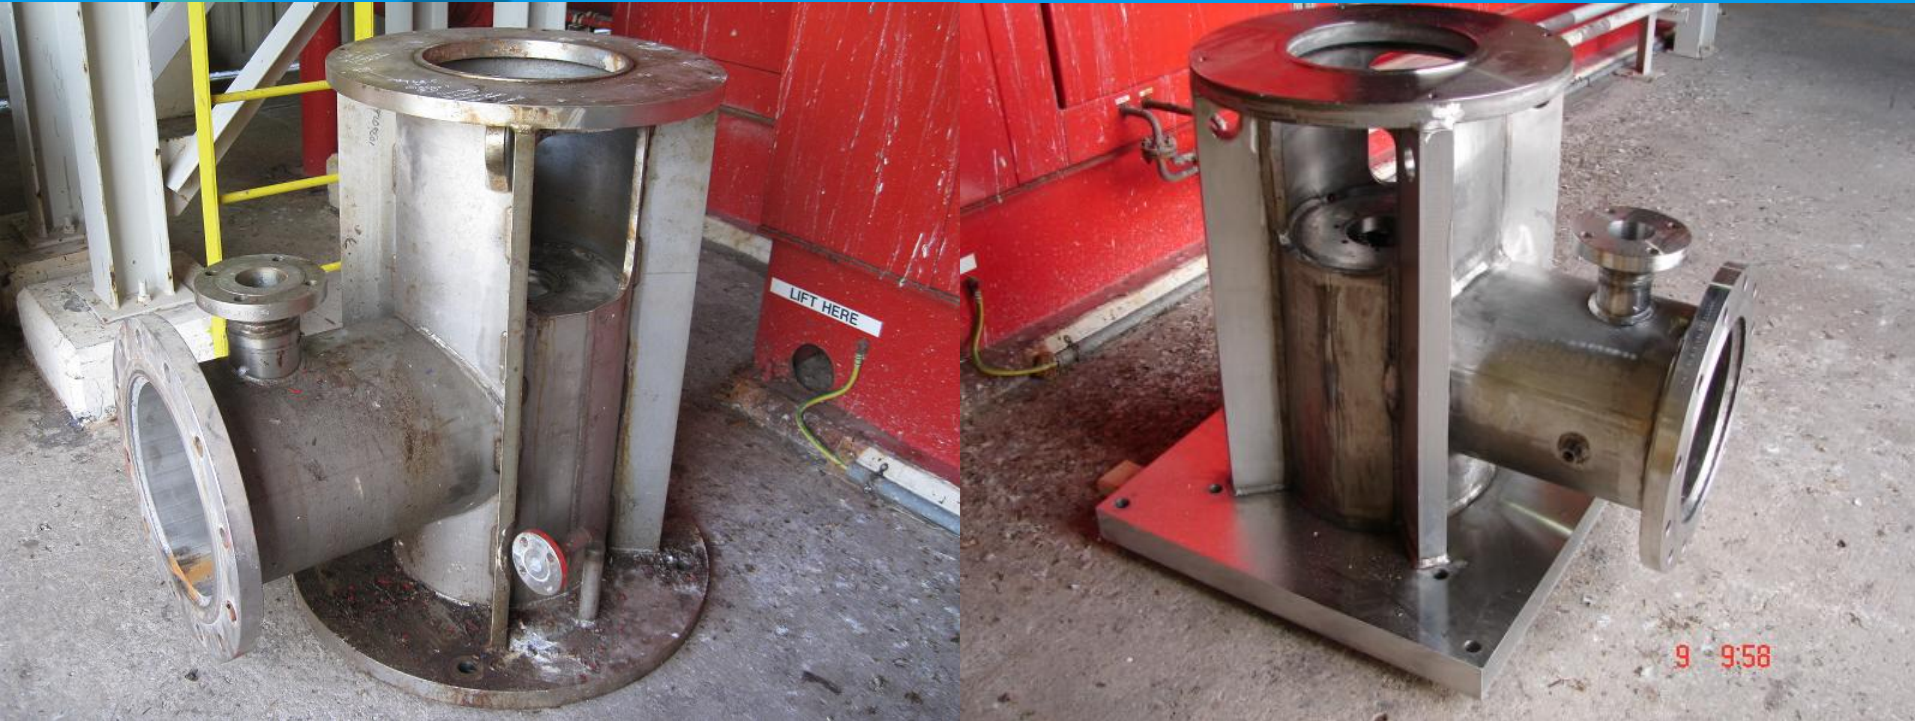
Old Pump head

New Pump head

Action-3: Pump Head/Gearbox structure modified

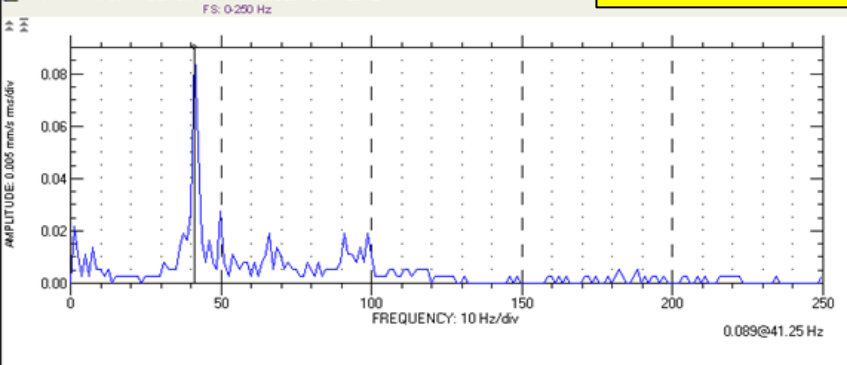
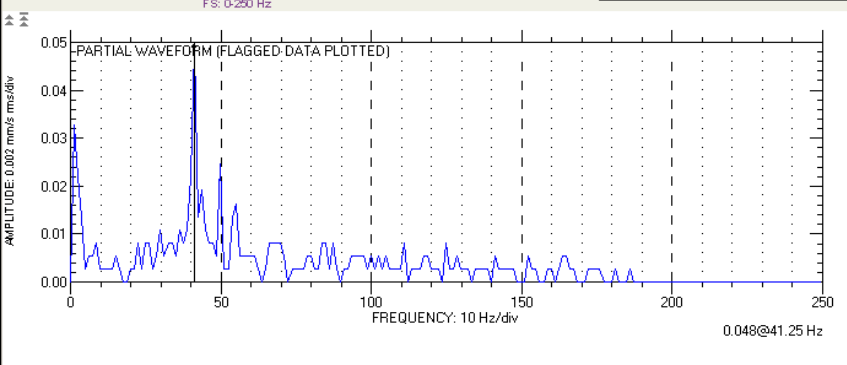
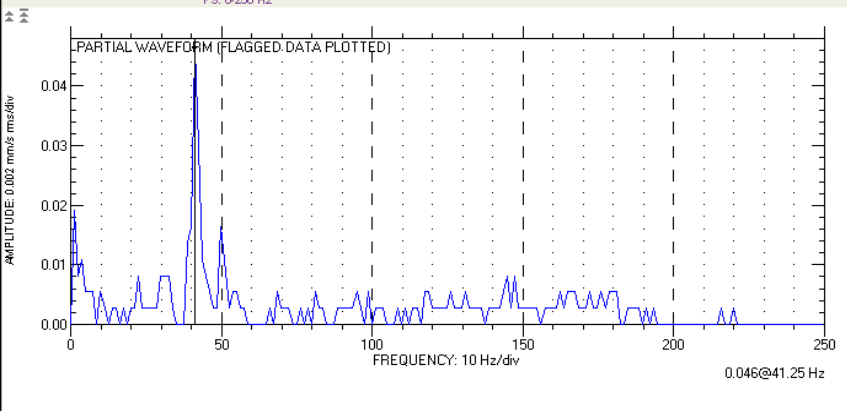
Bump test on the GB and pump head (with modified head) showed natural frequency at 41.25 Hz (achieved 41% separation margin)

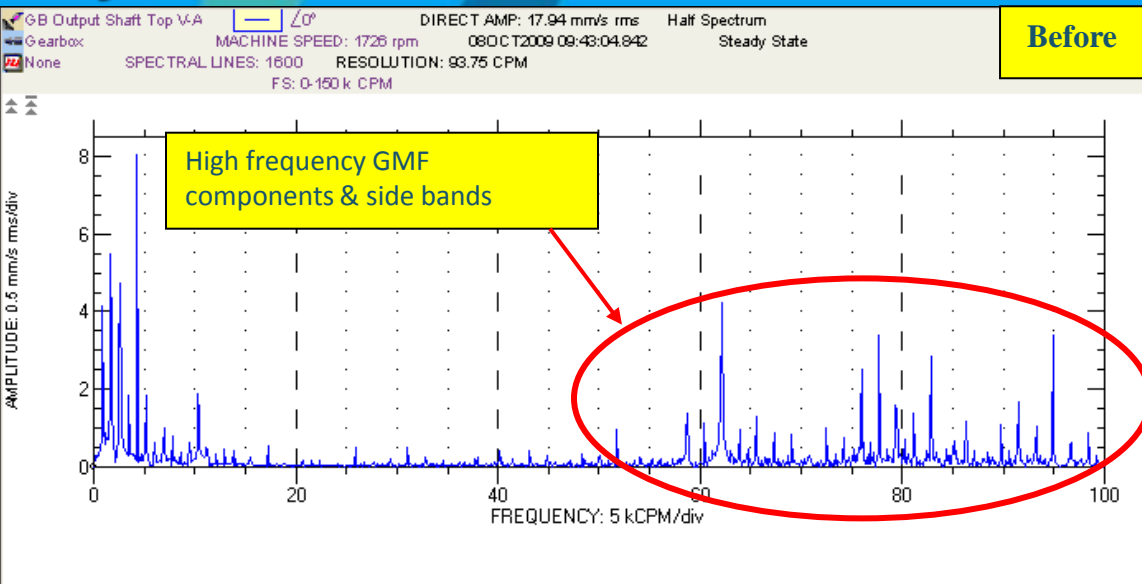
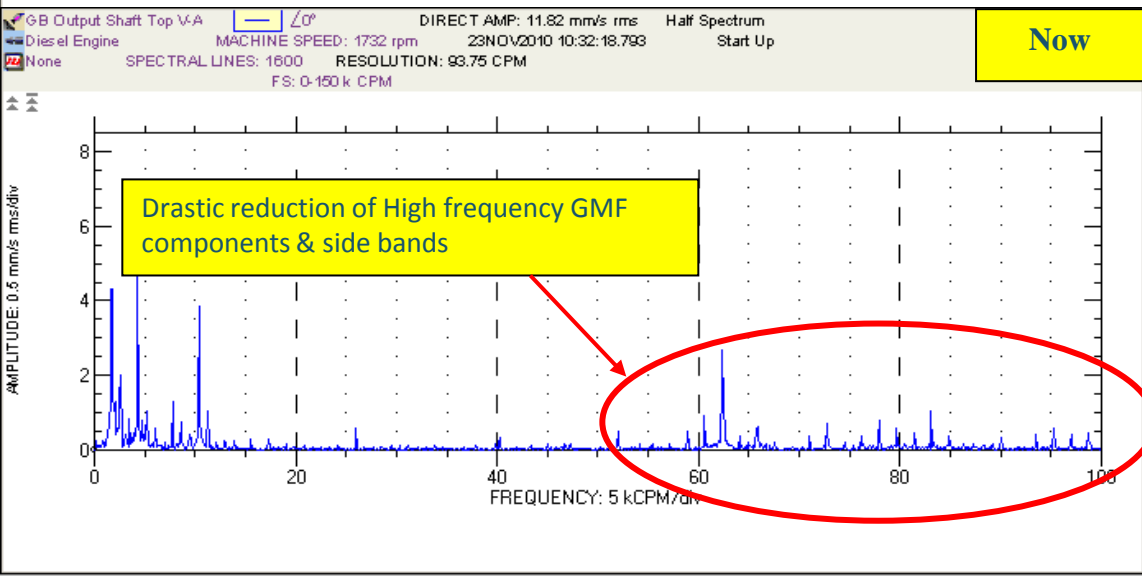
Comparison of vibration spectrum before and after the backlash adjustment on the Gearbox
