**Roof Survey**

**13-31 Elm Street  
Springfield, MA**

Prepared for: Mr. Dan Dodge & Mr. Brian Connors  
Prepared by: Mr. Chuck Gray  
September 28, 2011

**Inspection Date:** September 27, 2011

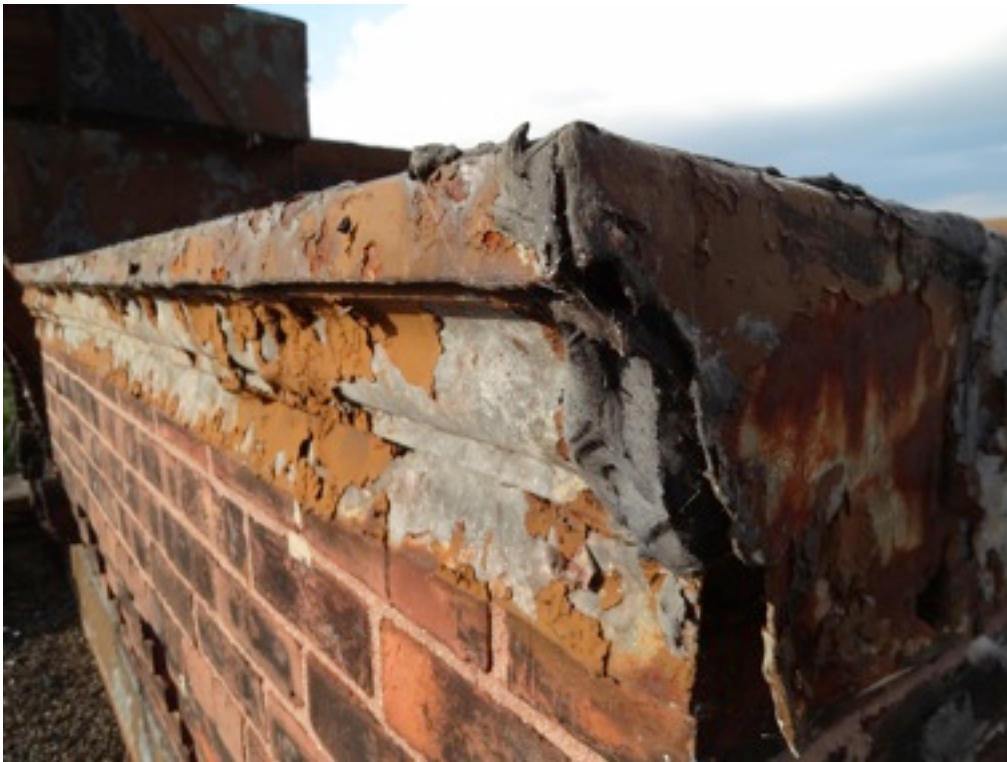
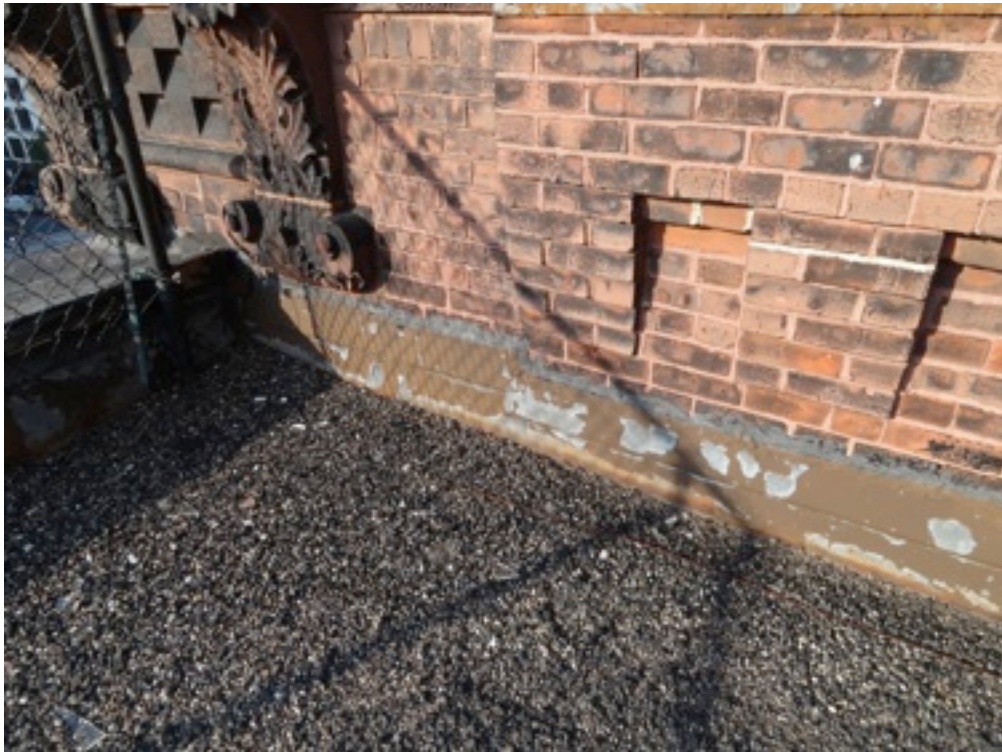
The photos on the left show the condition of the metal coping and the base flashing for detail A.

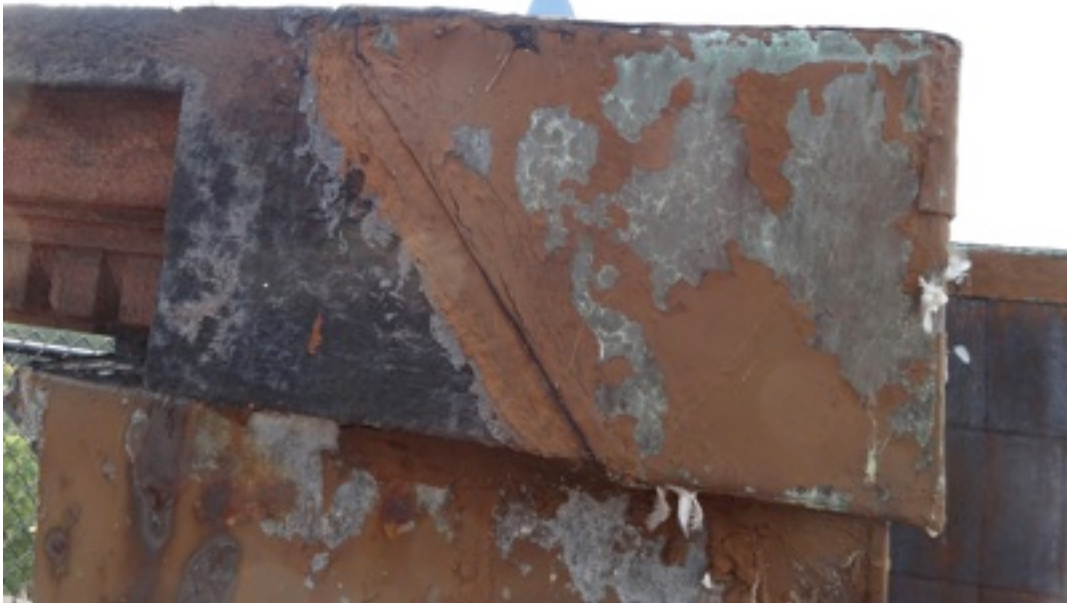
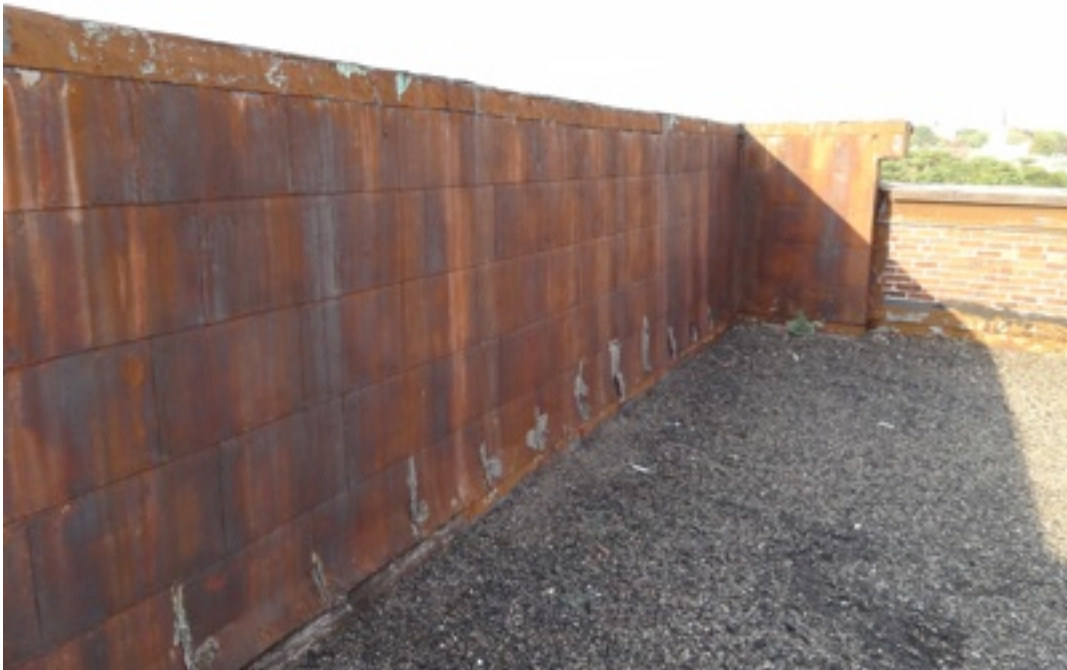
**Detail B:**

The existing coping is a stone cap and metal was installed over the back side of the stone and the top of the cap was sealed with an asphalt base sealant. The back wall has a metal siding that has rusted and will need to be replaced. When using a single ply roofing membrane, the material can be ran completely up the wall thereby eliminating the need to install a similar metal siding product.

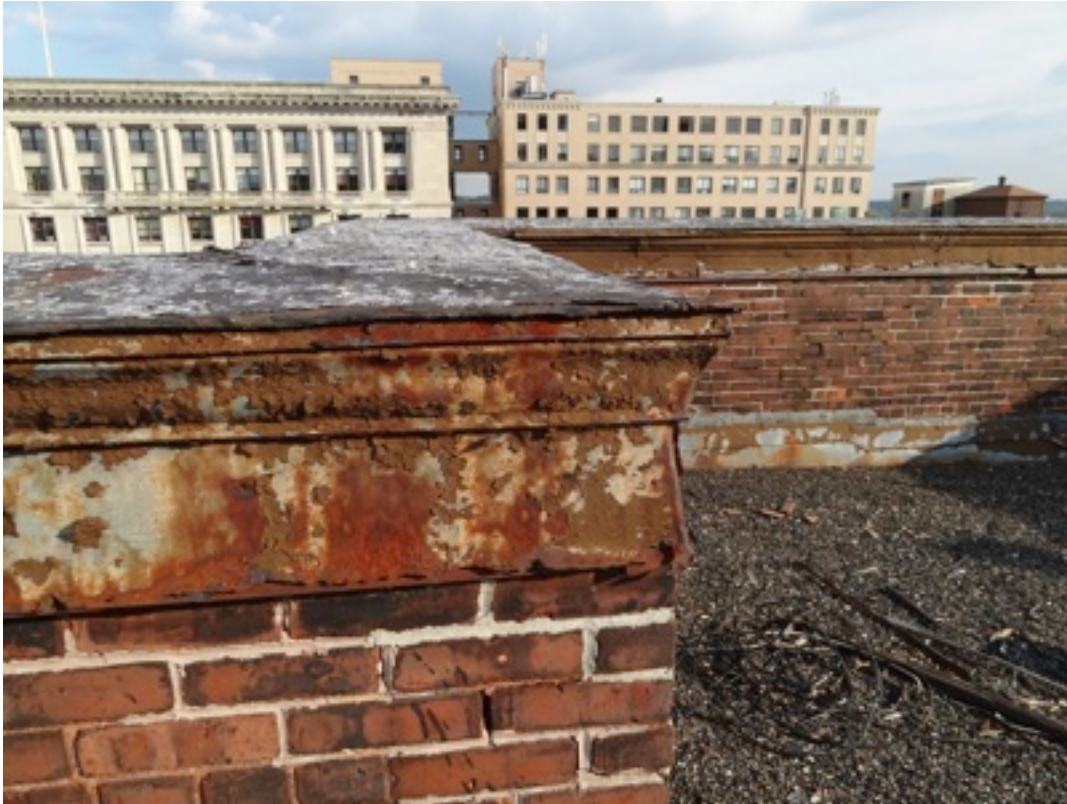
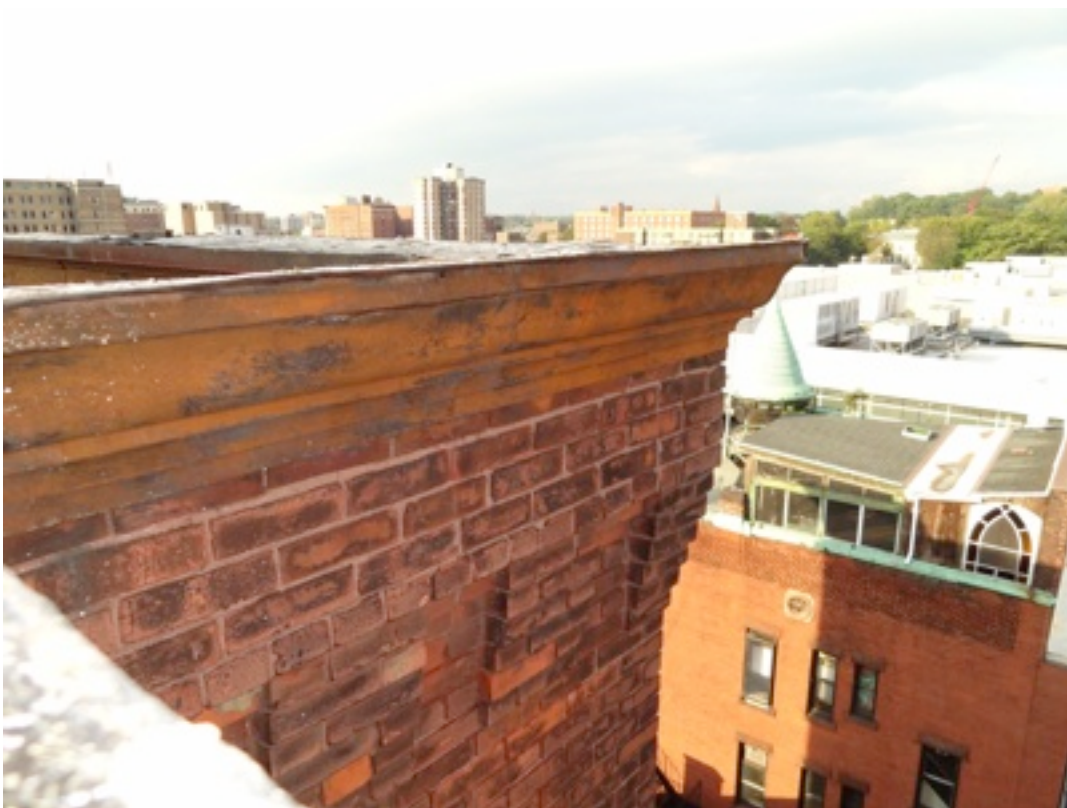
**Detail D:**  
The existing metals are in disrepair. The mortar in the brick wall has deteriorated completely in areas. This wall section may be able to be addressed in a similar fashion to detail B. As opposed to utilizing a base flashing along with the coping detail, a single ply membrane can totally encapsulate the brick wall and seal the top of the wall below the new coping.

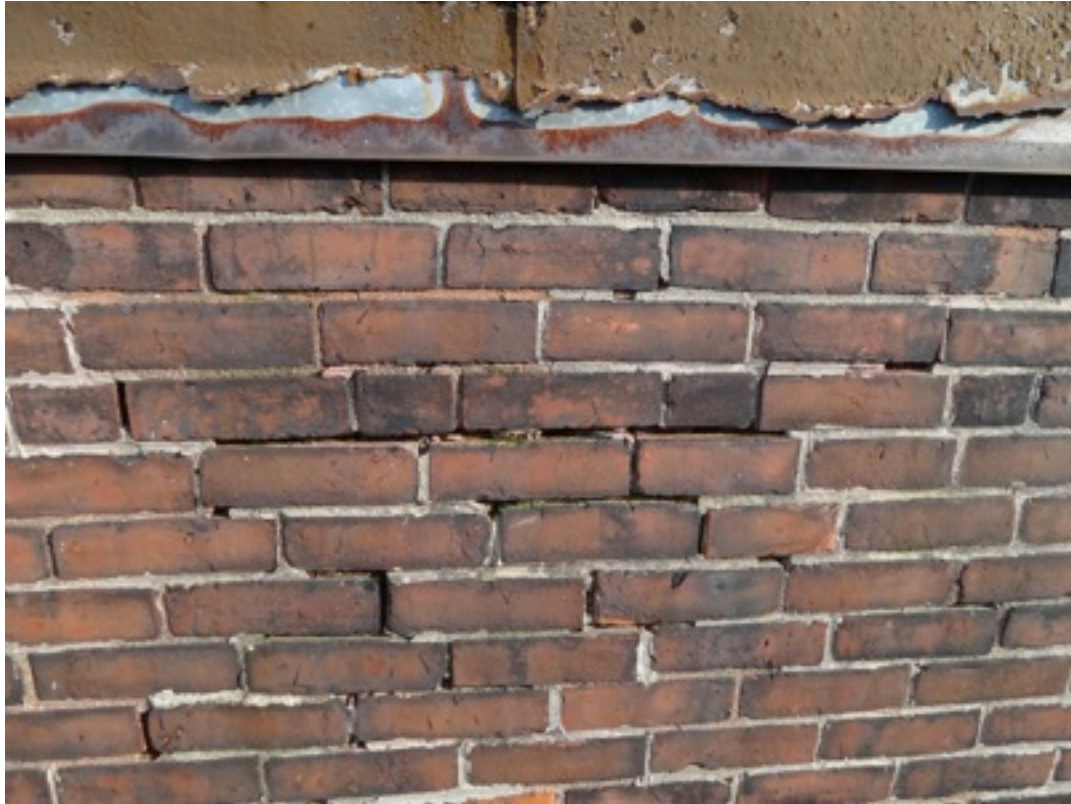
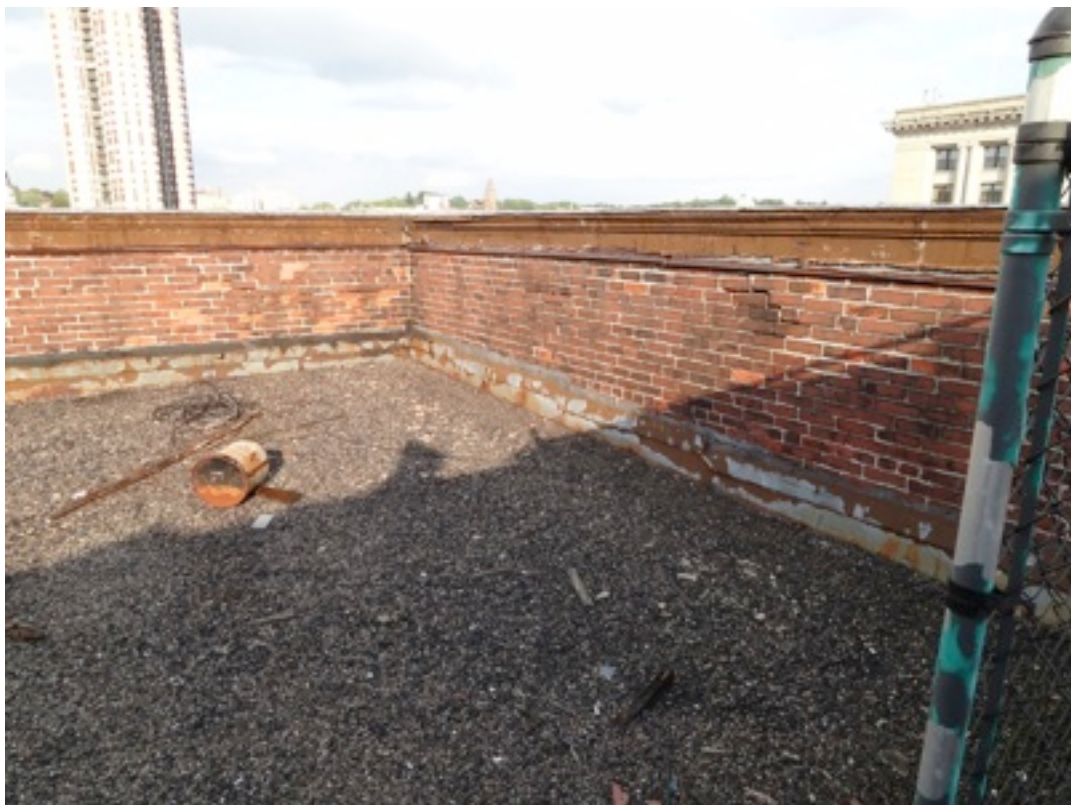
More photos of detail C  
showing the breakdown of  
the mortar.

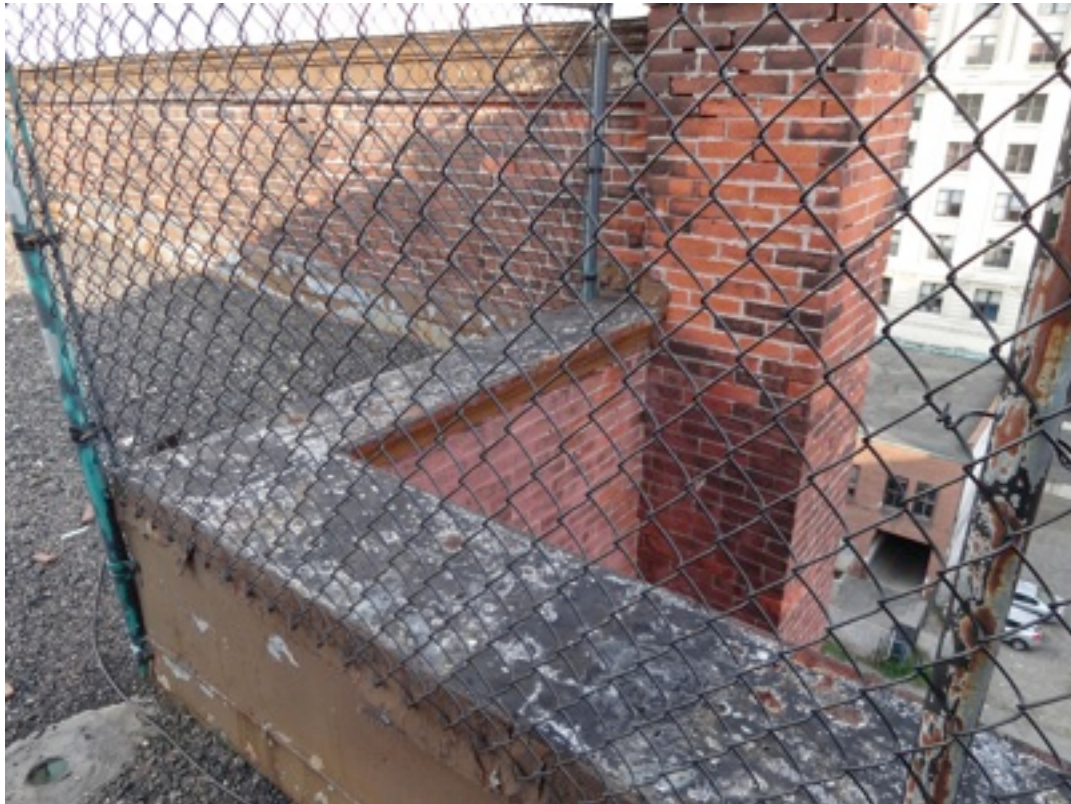
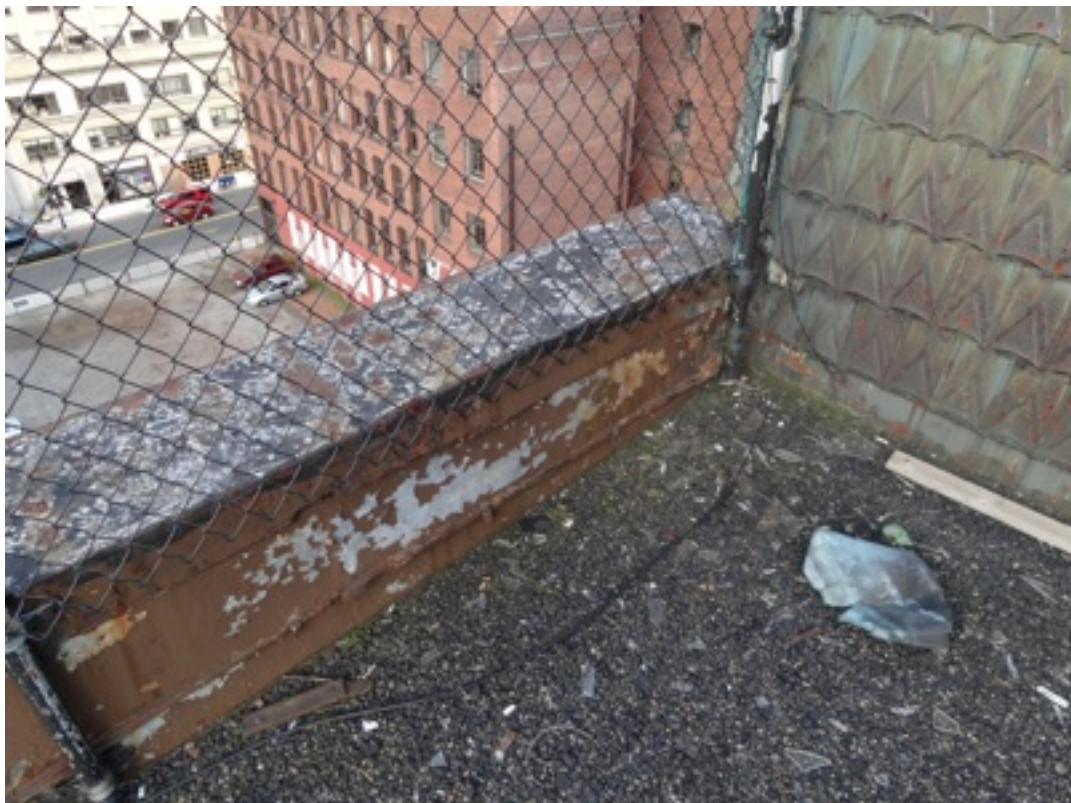
Detail D:  
Showing the existing  
condition of the coping,  
holes in mortar beyond,  
chain link fence.

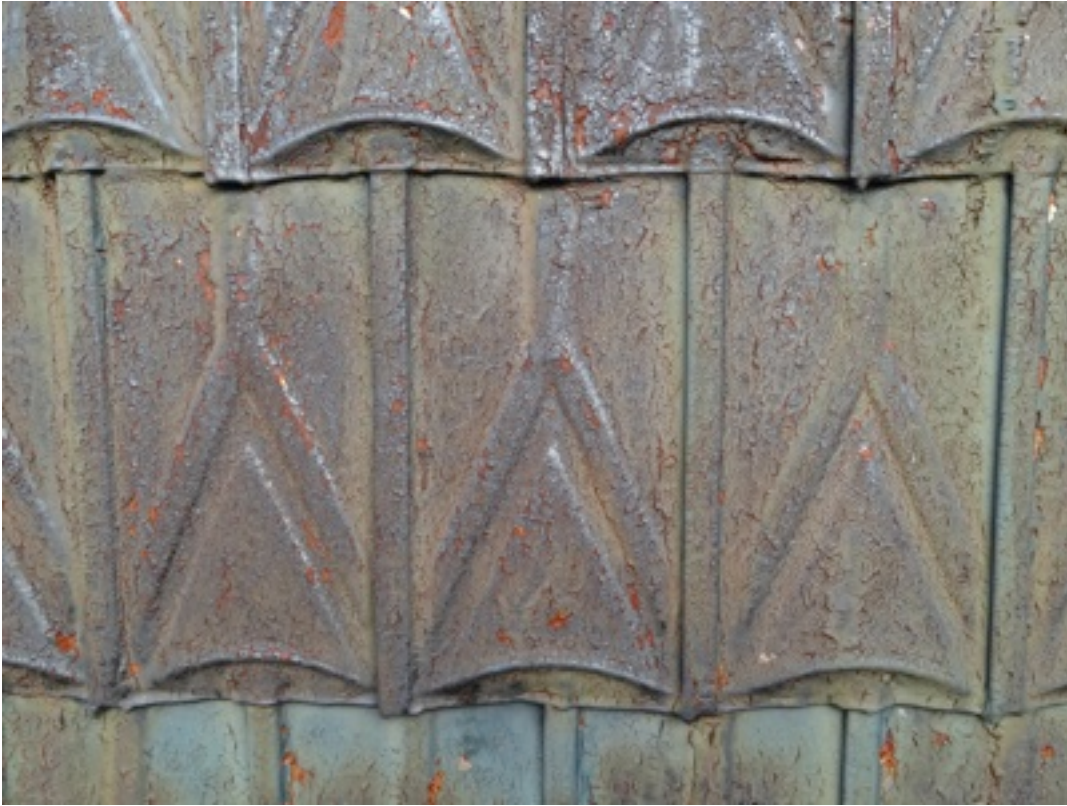
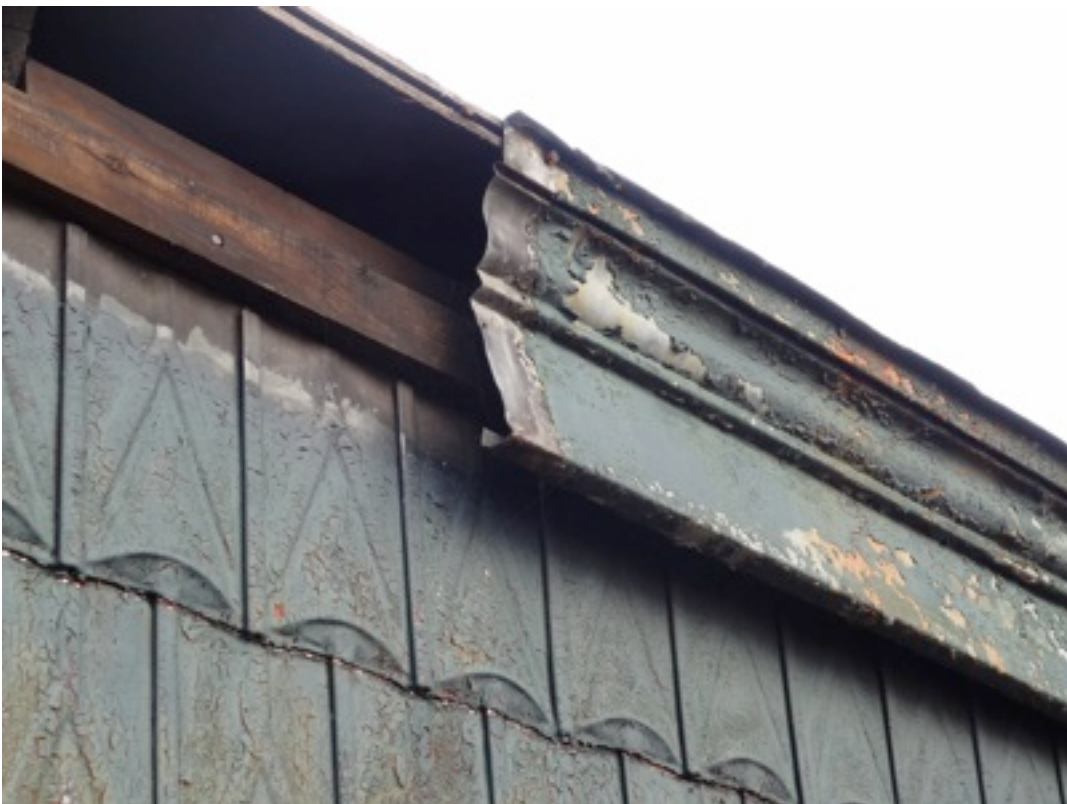
Existing siding on roof top buildings. The existing exposure on these panels are approximately 5 1/2"x8 1/2". Berridge makes a matching prefinished panel that has an exposure of 8"x12"

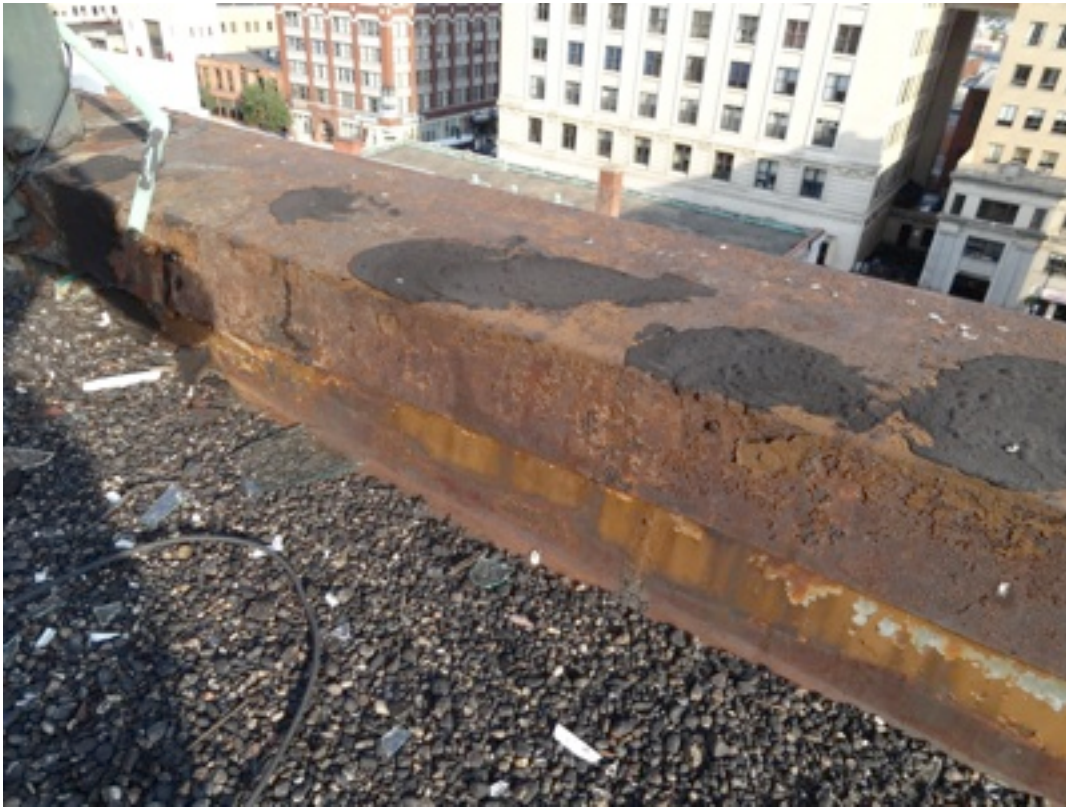
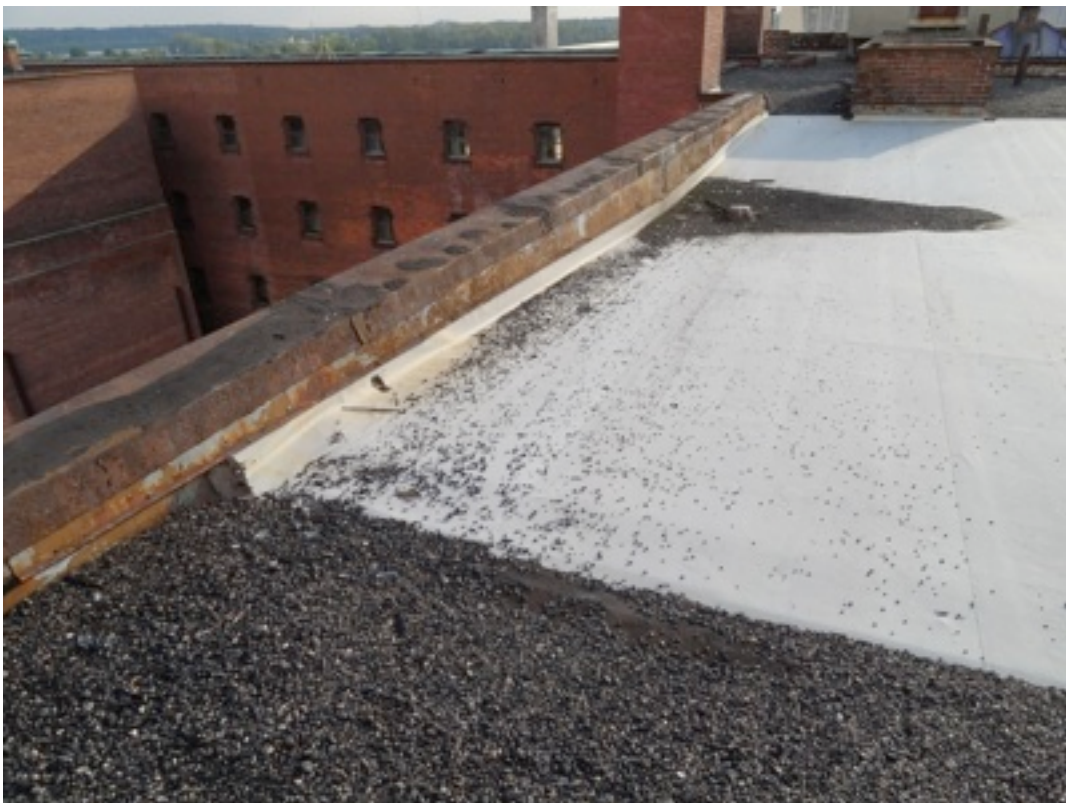
Metal roof edge that blew off. Most likely attributed to the tornado.

Detail D:  
Showing the condition of  
the coping along with the  
repair that was made to the  
roof. Broken glass and  
debris is scattered all over  
this roof.

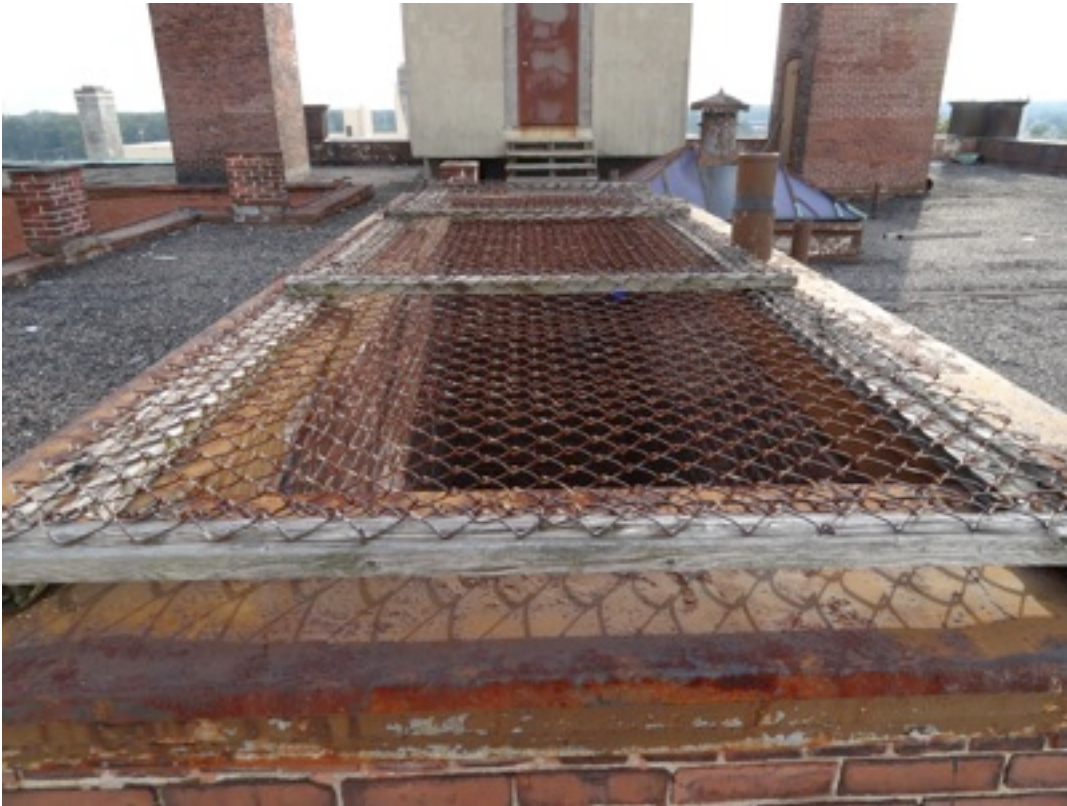
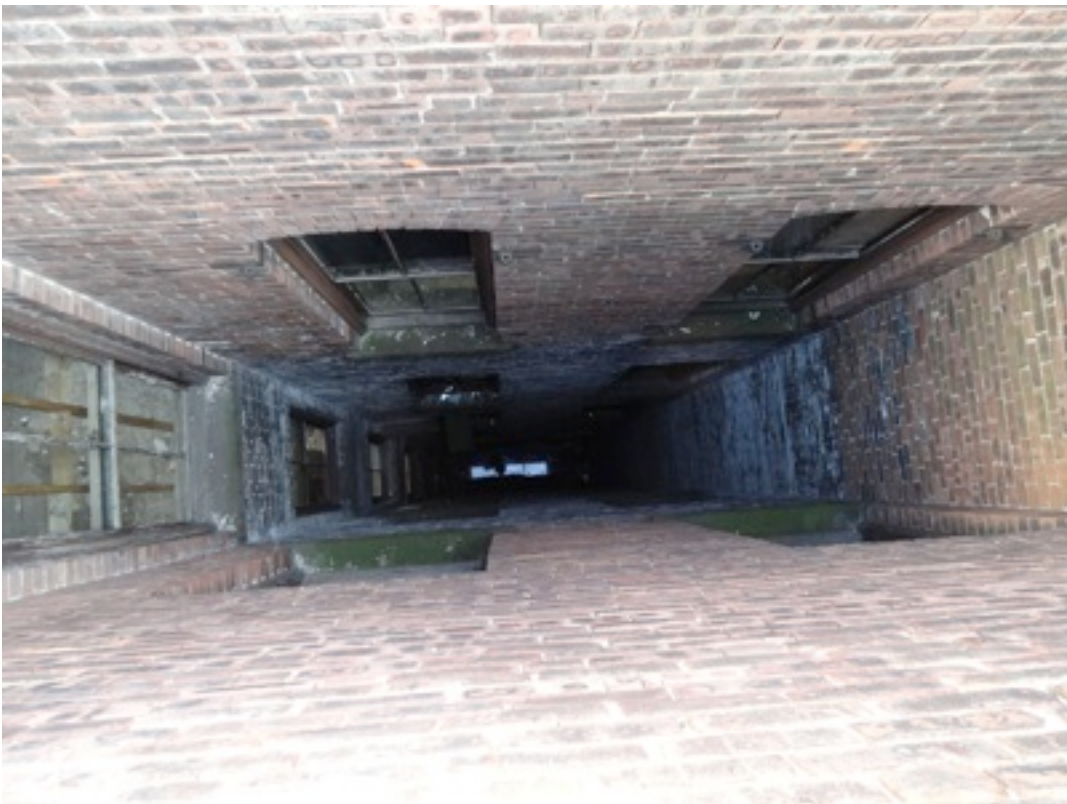
This is an open skylight that goes to a roof section several stories below. The roof section below was not accessible at the time of the survey but the condition of this roof is assumed to be in the same condition as the rest of the roof and will need to be addressed in a similar manner. The drainage of this roof will need to be addressed to make sure that there is not any ponding water.

A decision needs to be made whether a new fall protection needs to be installed over the open skylight.

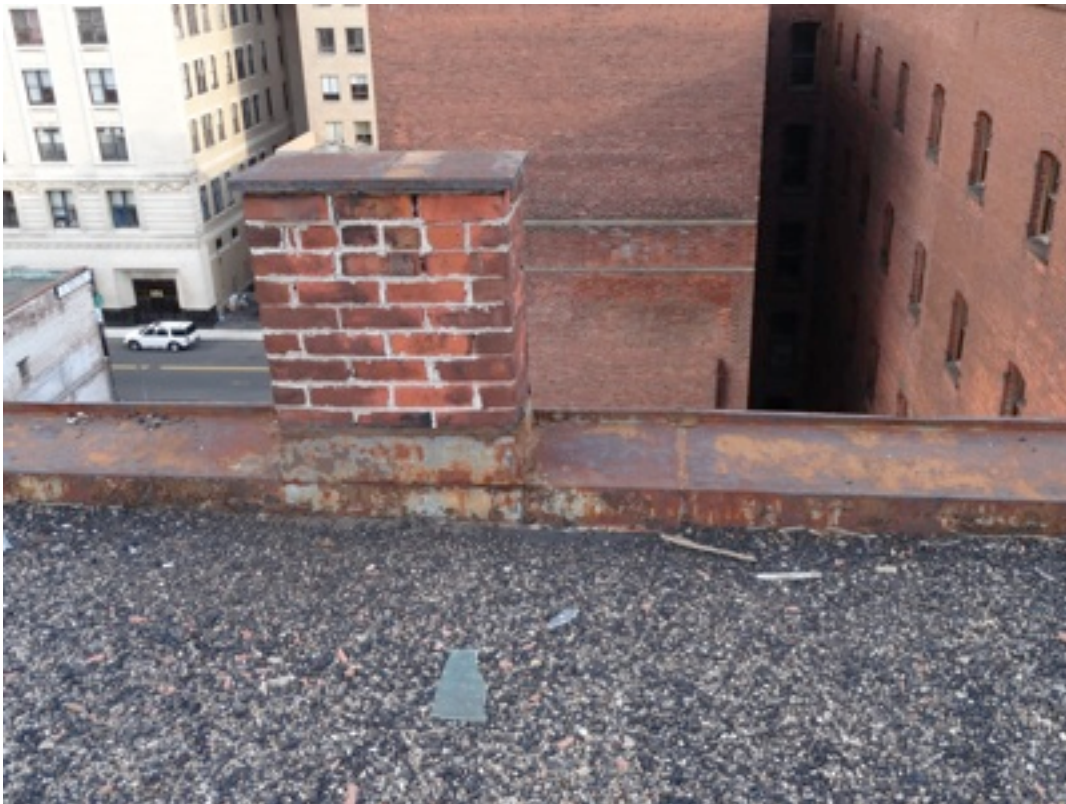
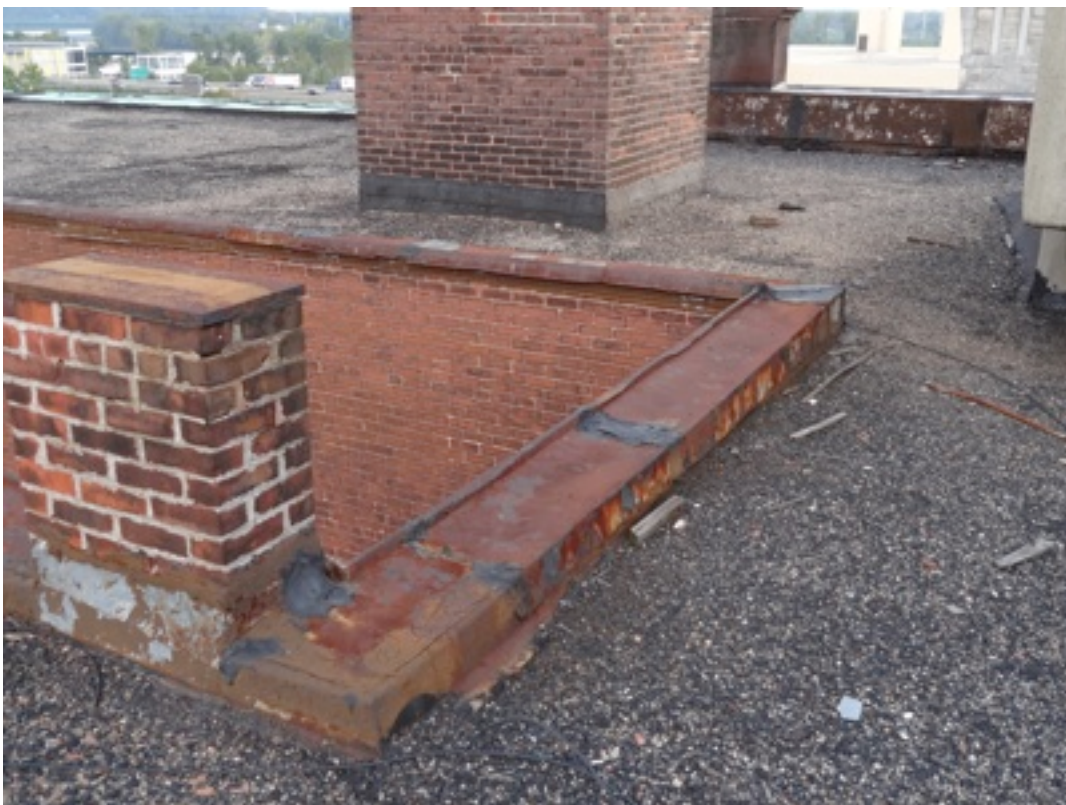
Detail G1:  
Showing the distressed  
coping details along with  
debris on the roof.

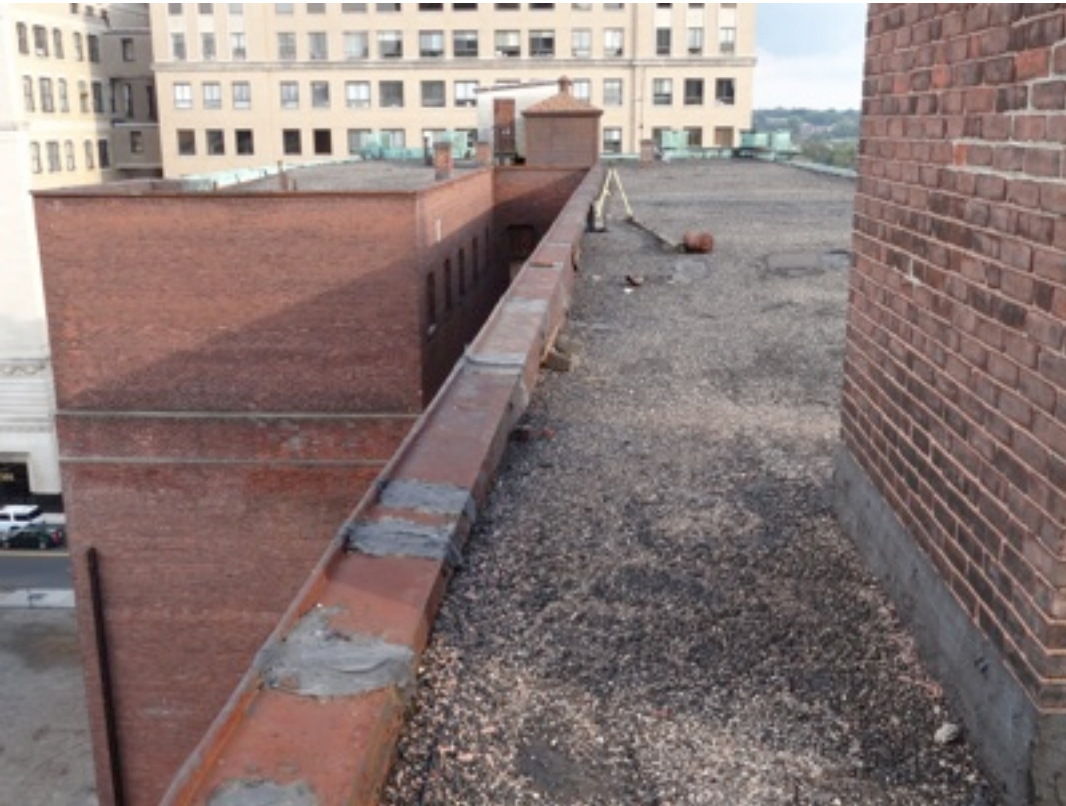
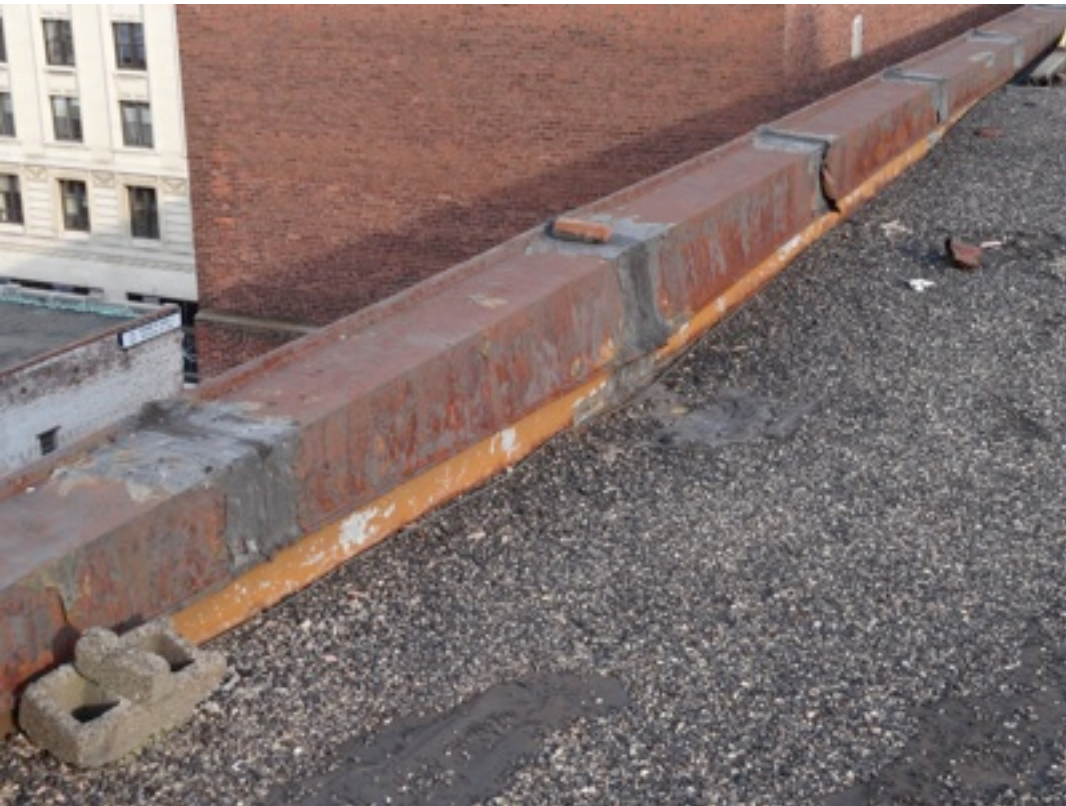
All of the roof drains are missing clamp rings and strainers, allowing for any roof top debris to fall into the drain pipes.

Detail G2:  
Showing the distressed  
perimeter detail along with the  
roof drain that is missing  
clamps and strainer.

Install new drain clamps, bolts and strainers.

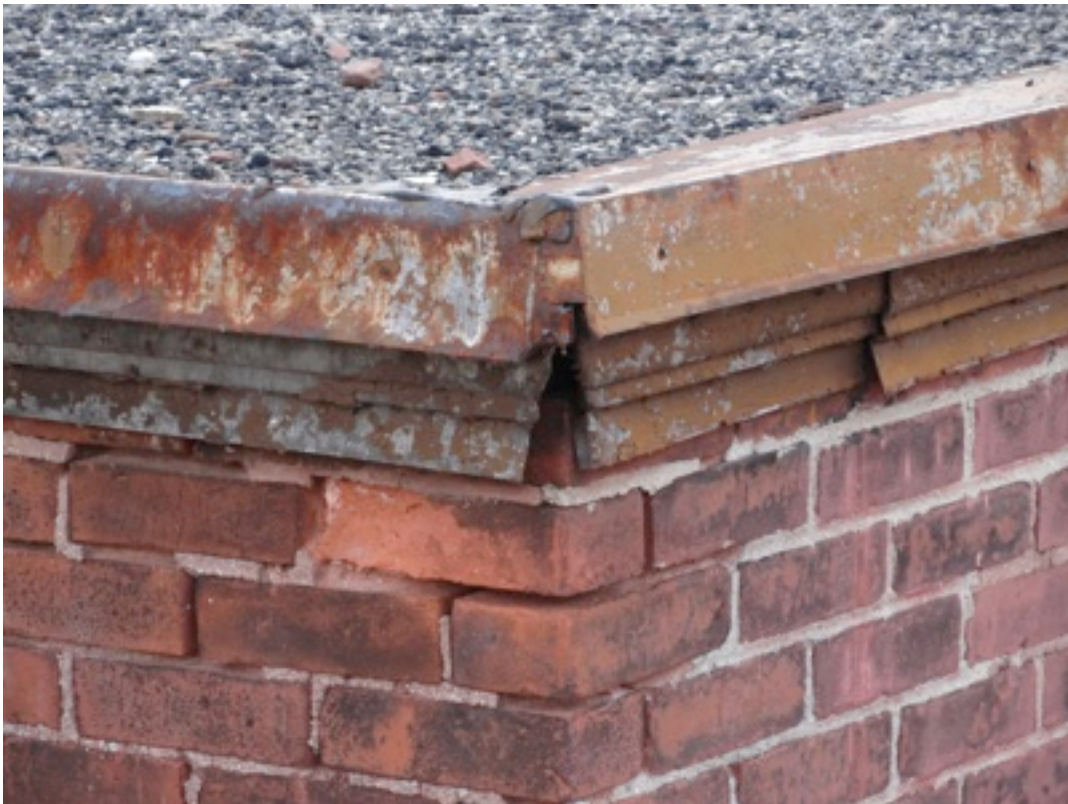
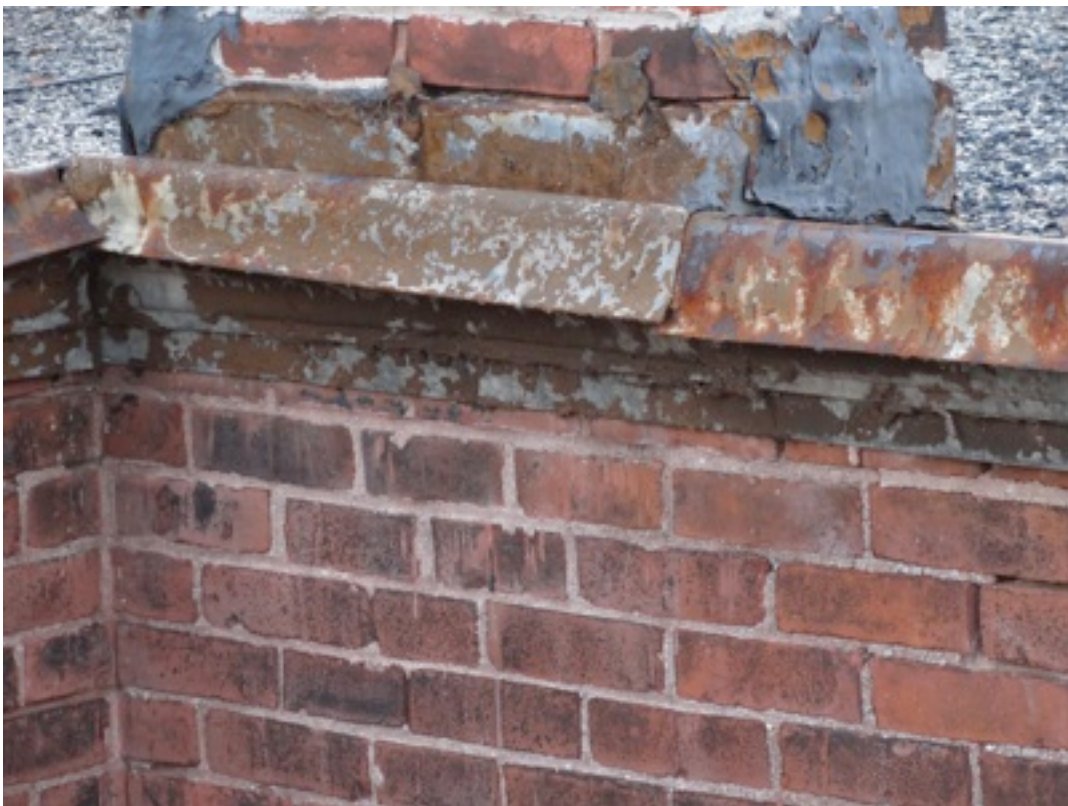
View of the exterior portion of the building showing the distressed coping details and the tuck pointing issues.

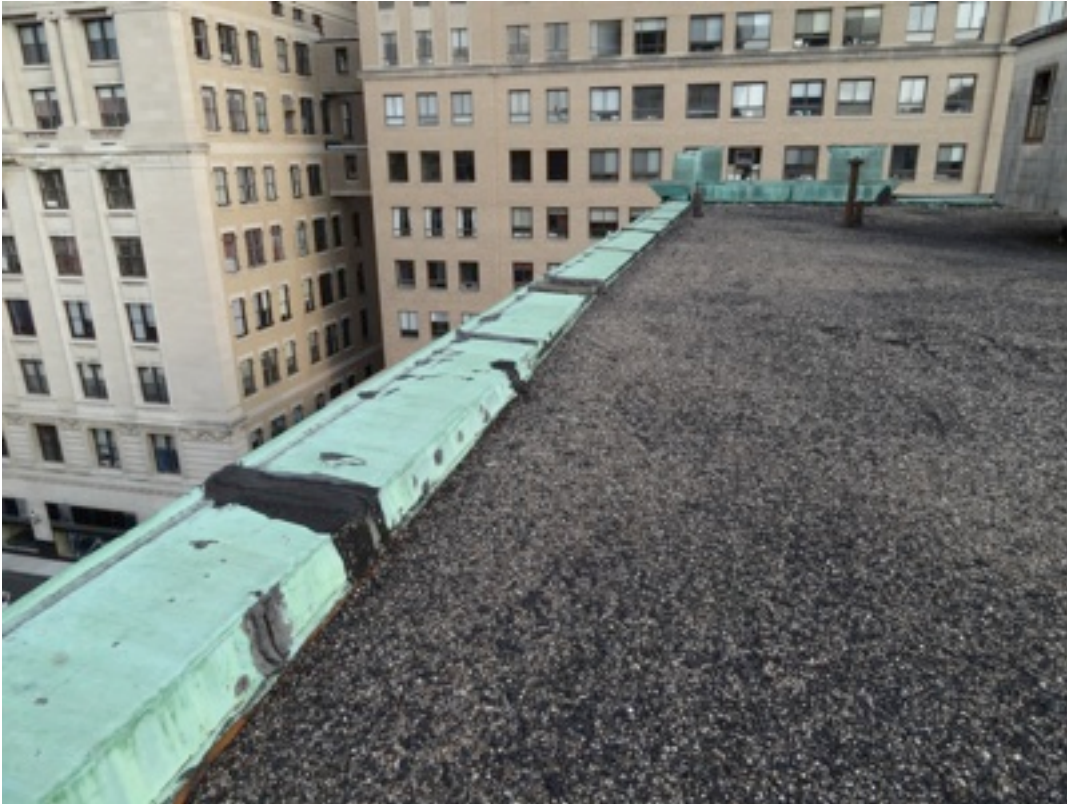
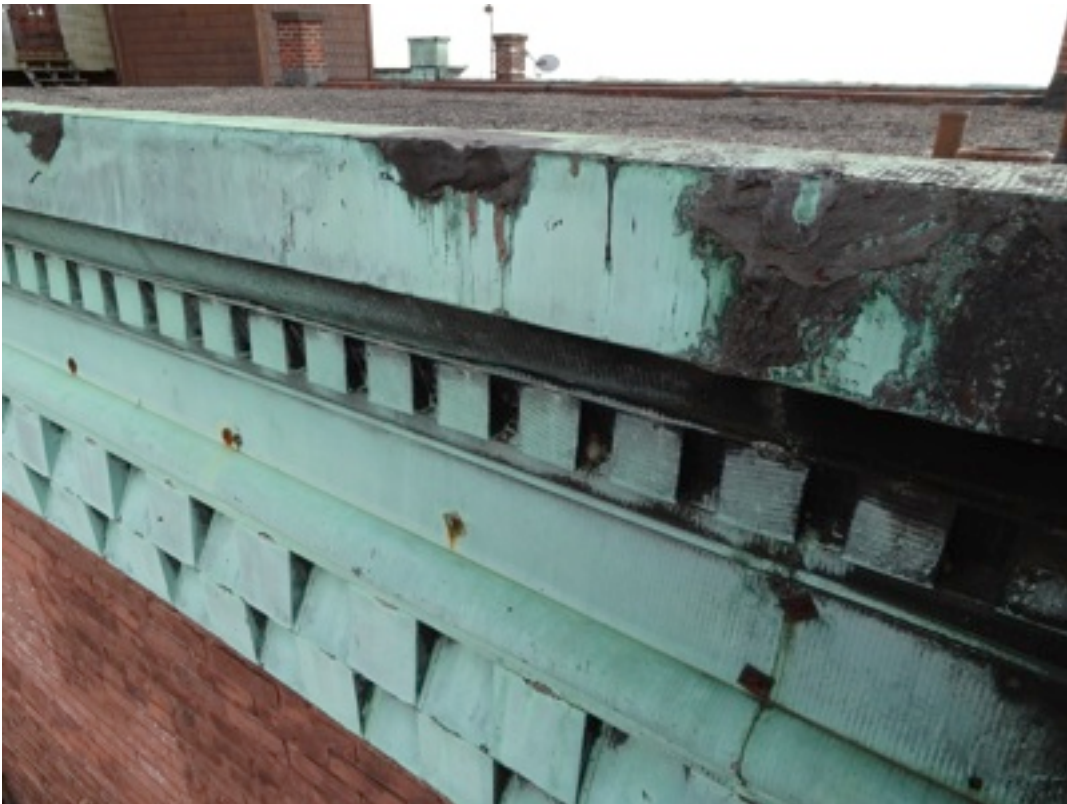
Detail H1:  
Photos on the left show  
the interior and exterior  
views of the copper  
coping and exterior  
dental detail.

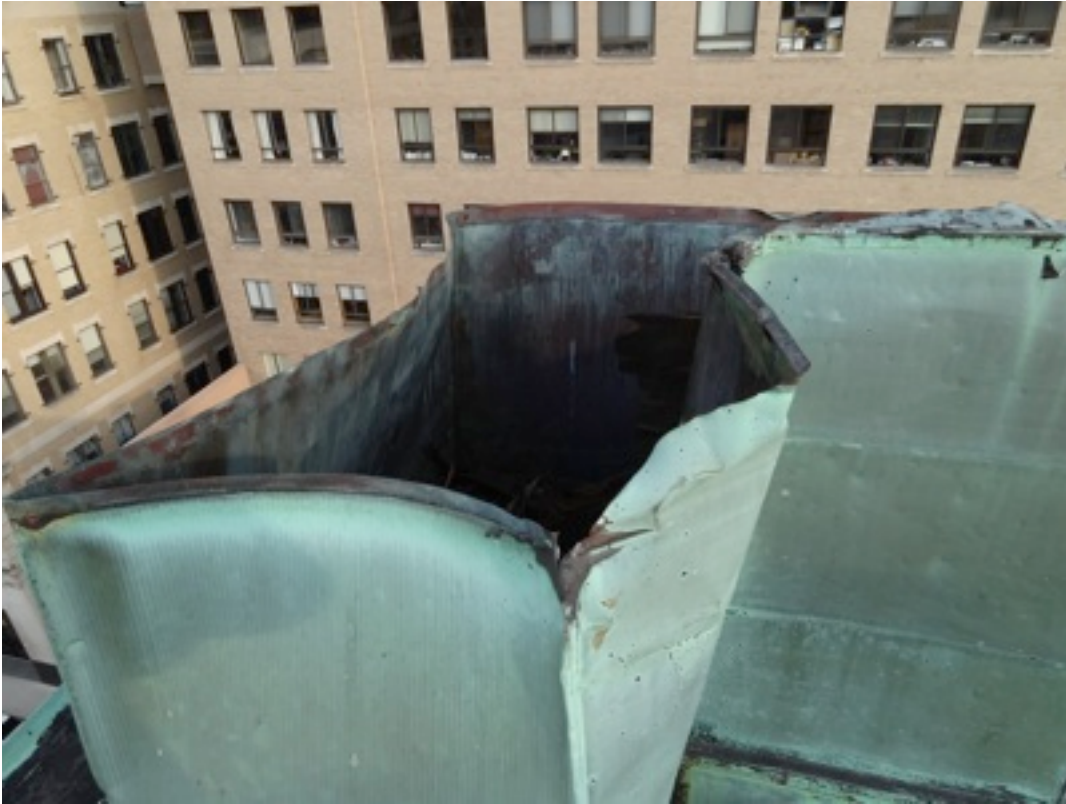
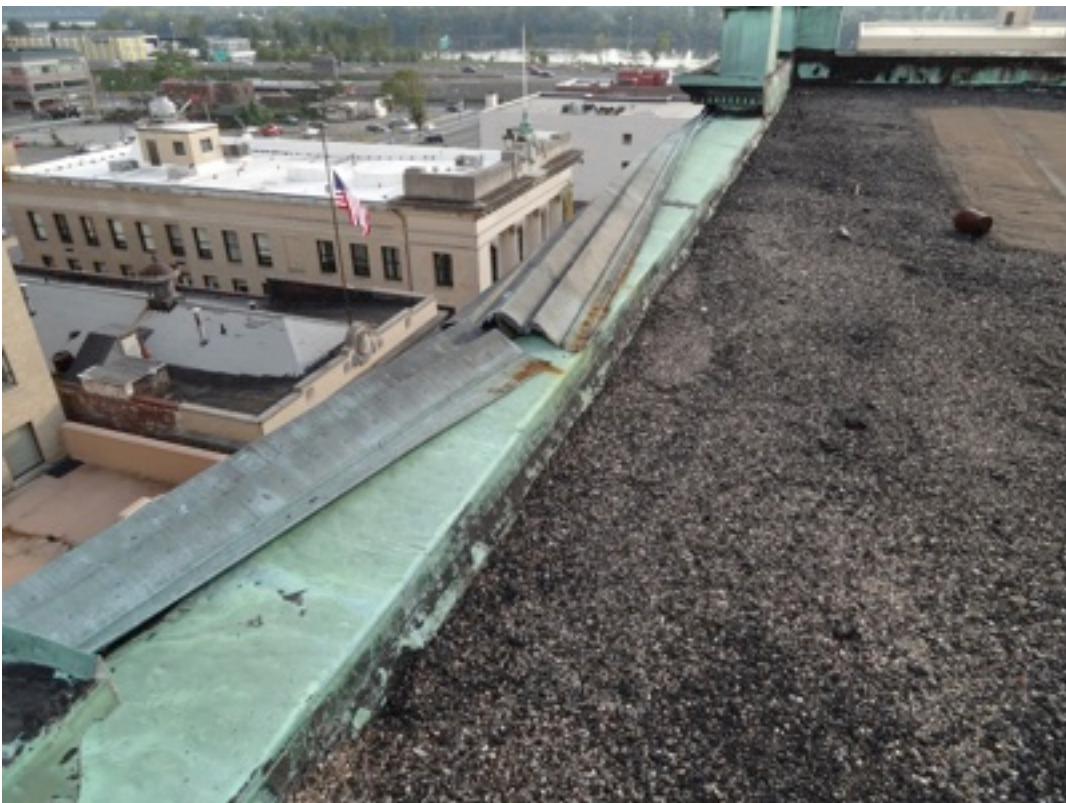
The photos on the left show the damage to the copper copings on the south side of the building that were most likely damaged during the tornado.

Some of the damage to the copper copings and the copper roof may be attributed to the tornado and it is worth investigating whether the insurance company may share some of the cost of replacing these areas. The vacuum that a tornado cause sometimes will cause roof uplift which will separate the roof from the deck and in some cases can pull the decking up from the supports.
