**Roof Survey**

**13-31 Elm Street  
Springfield, MA**

Prepared for: Mr. Dan Dodge & Mr. Brian Connors  
Prepared by: Mr. Chuck Gray  
September 28, 2011

**Inspection Date:** September 27, 2011

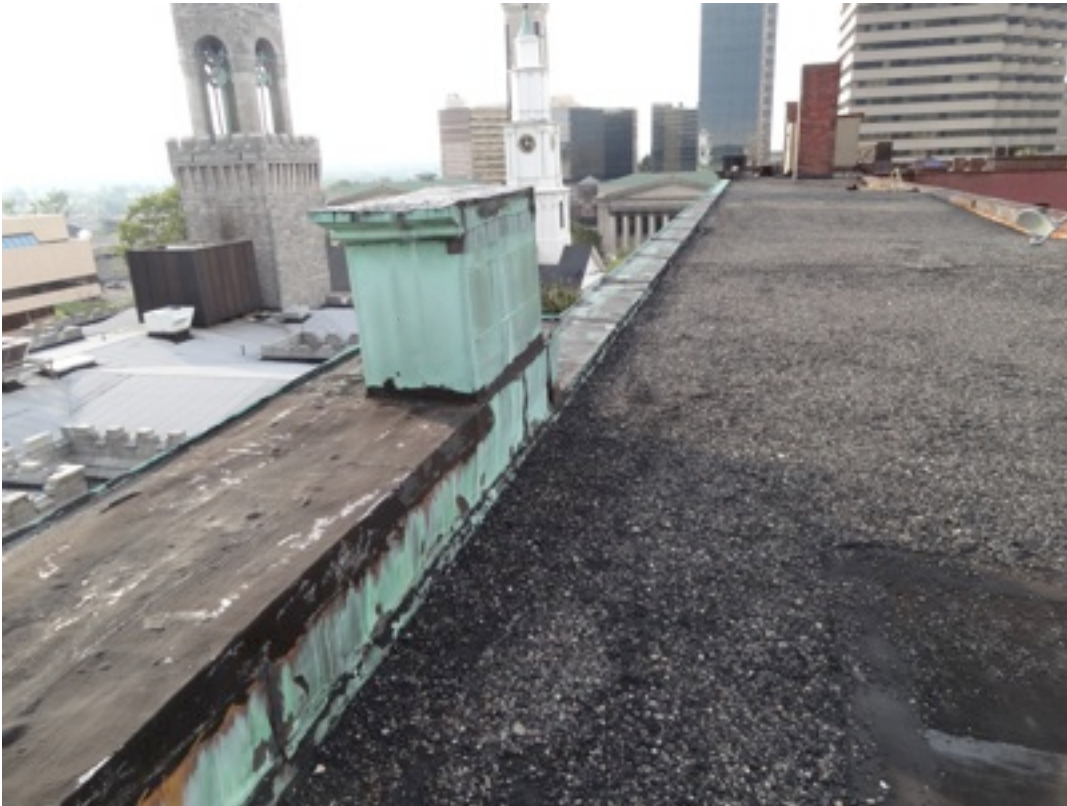
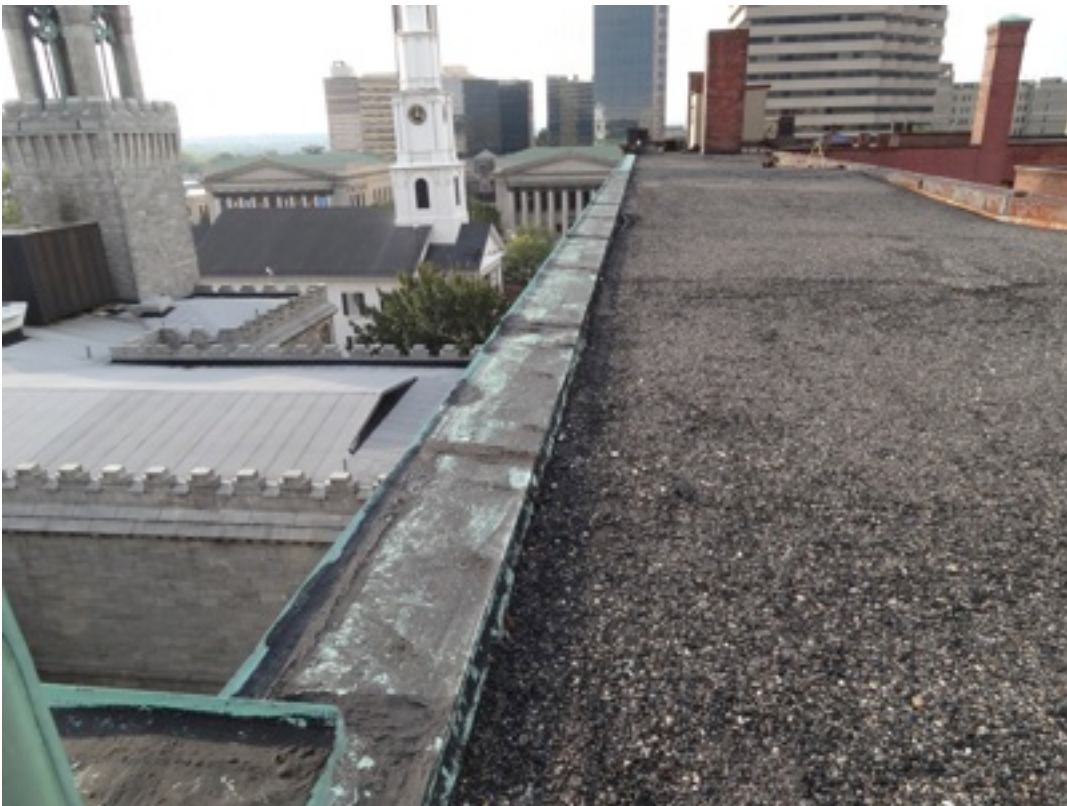
Detail H2:  
Copper copings looking  
from the south to the north.  
The copings have had  
repair attempts made by  
smearing asphalt .

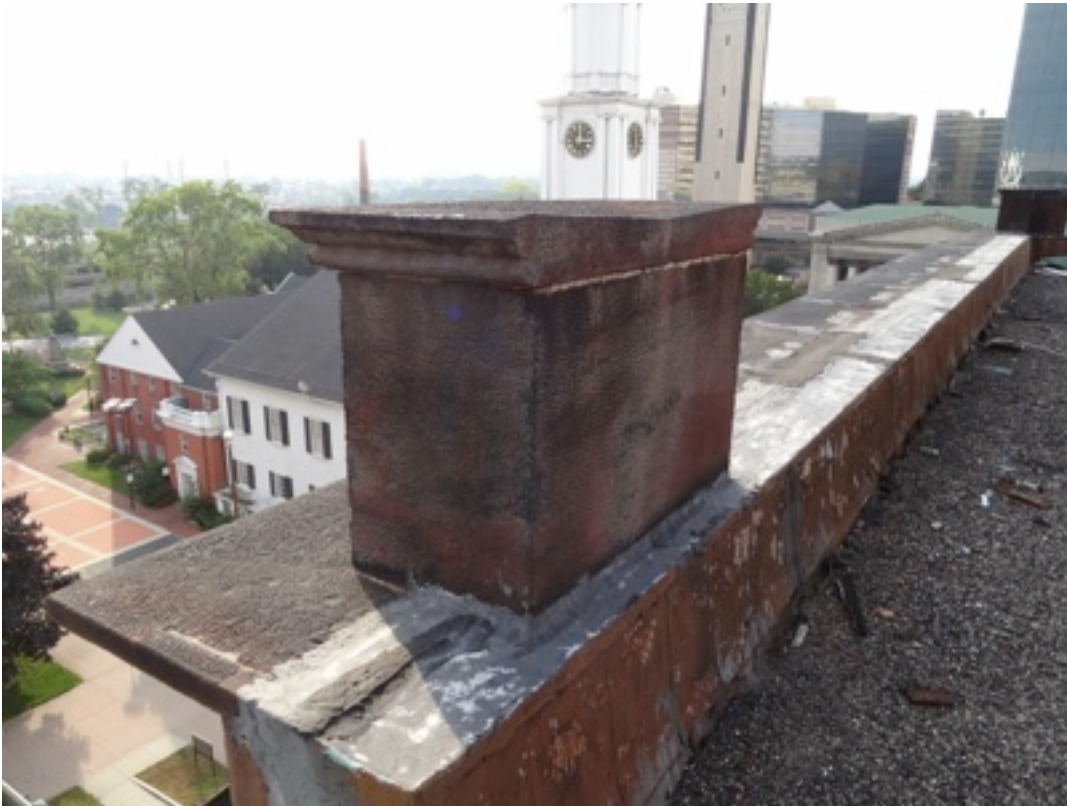
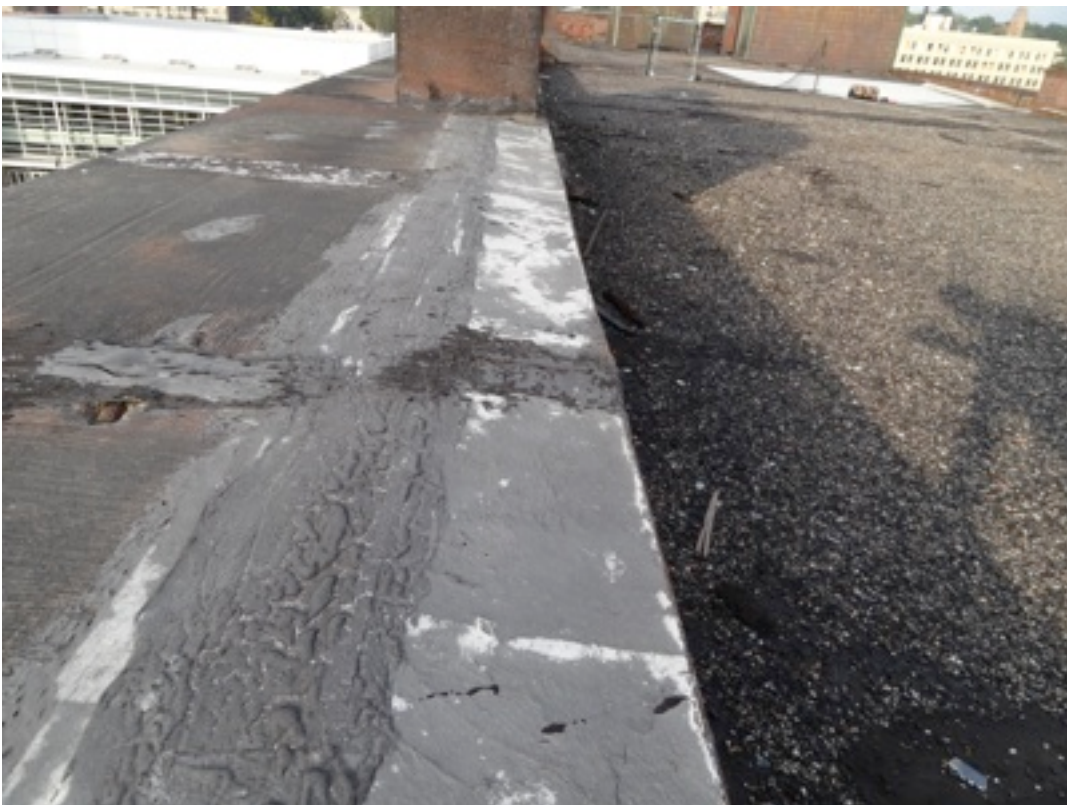
Detail I:  
Showing the stone cap  
and the termination  
attempt of the metal on  
the back side.

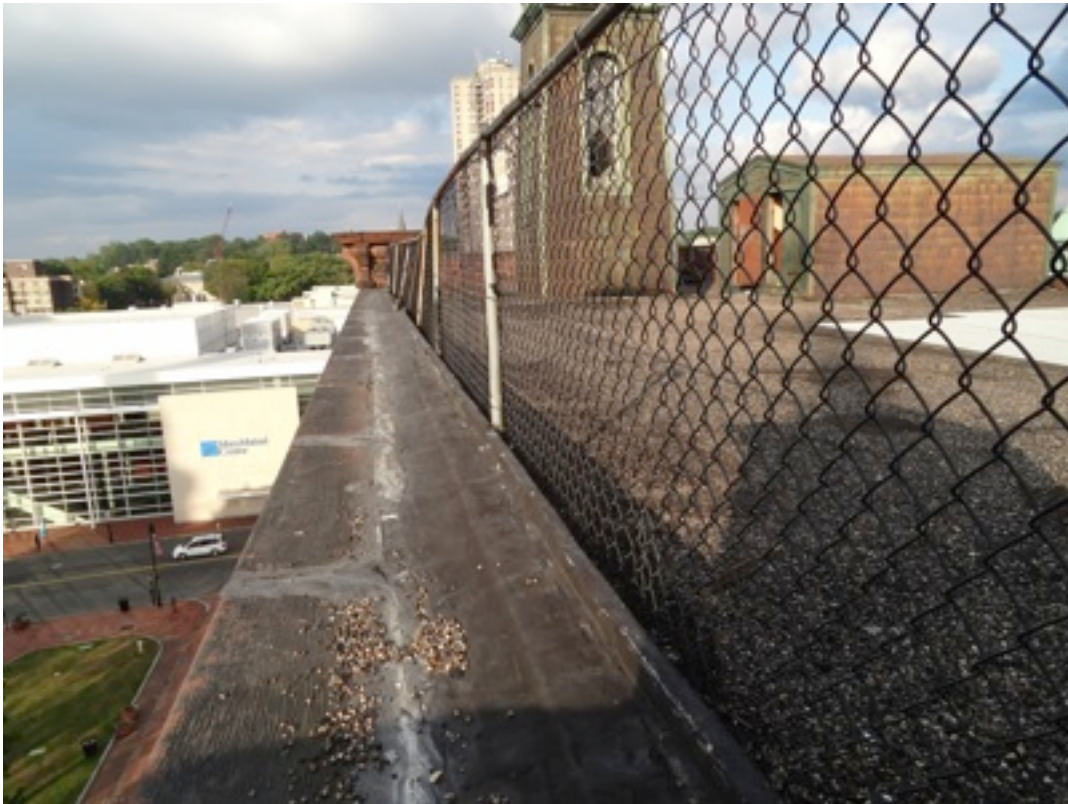
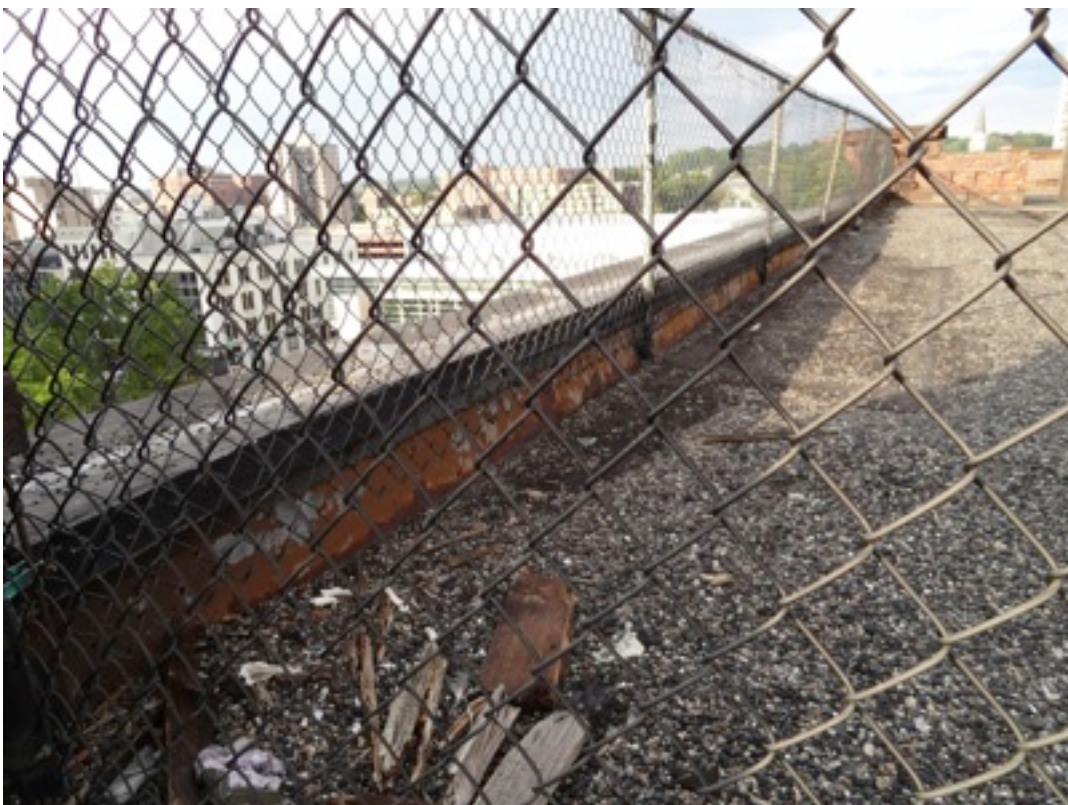
Detail J:  
Showing the chain link fence  
and the coping detail.

A decision needs to be made as to whether the chain link fence along some of the parapet walls will need to be replaced with new.

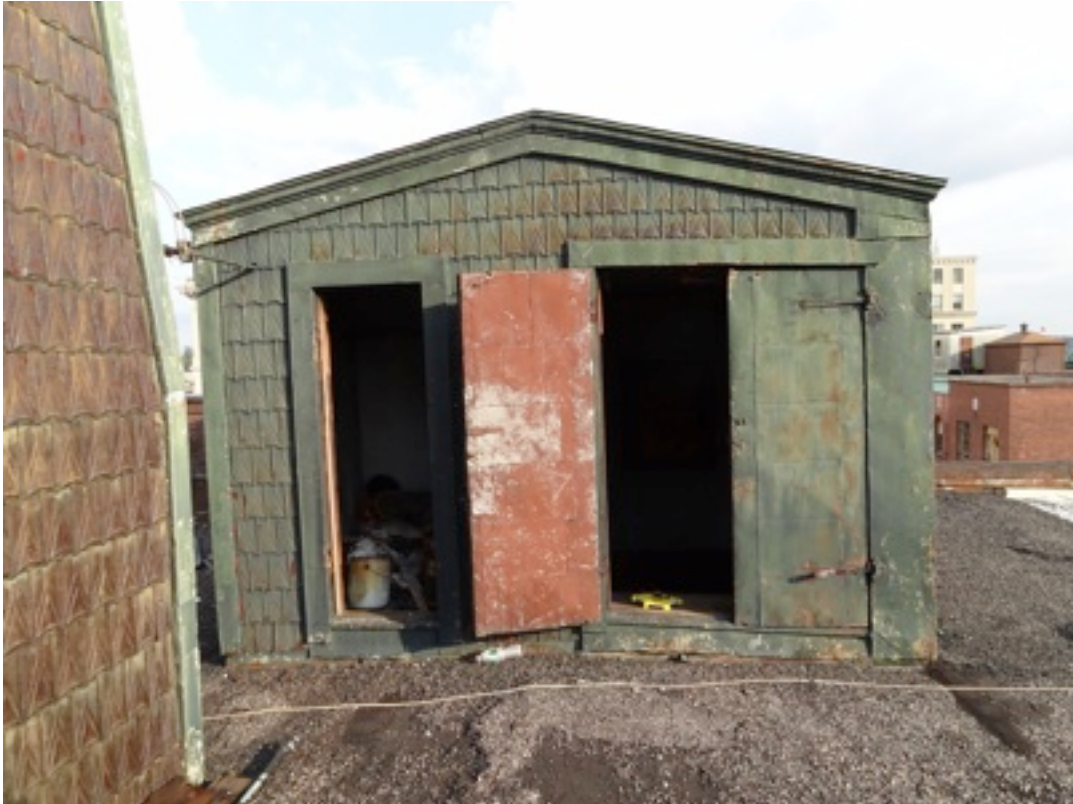
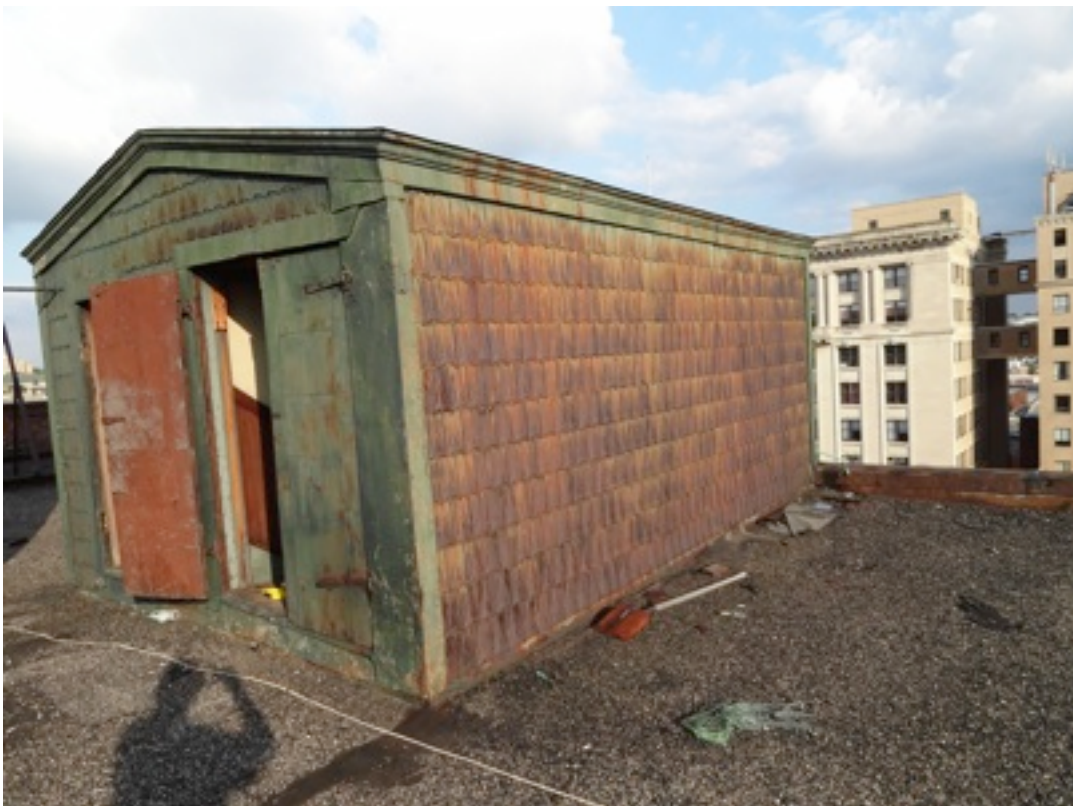
Building #3:  
The siding on this building  
has severe rust and the  
edge metal has partially  
blown off on the east side.

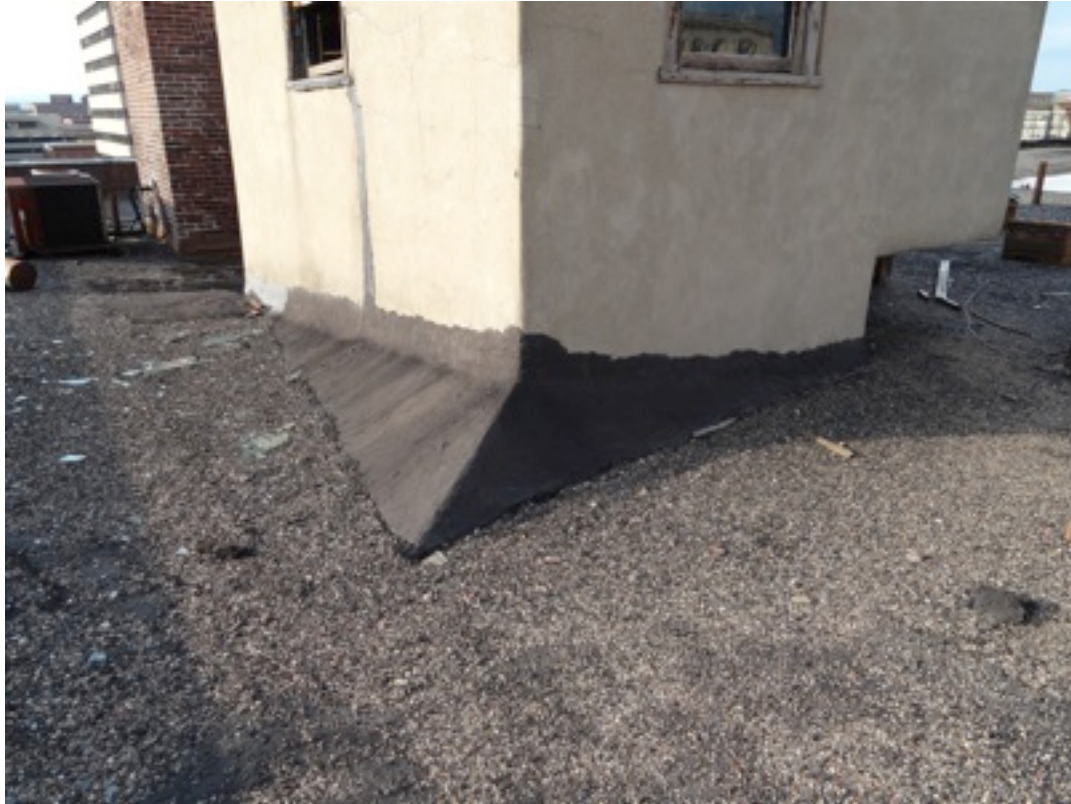
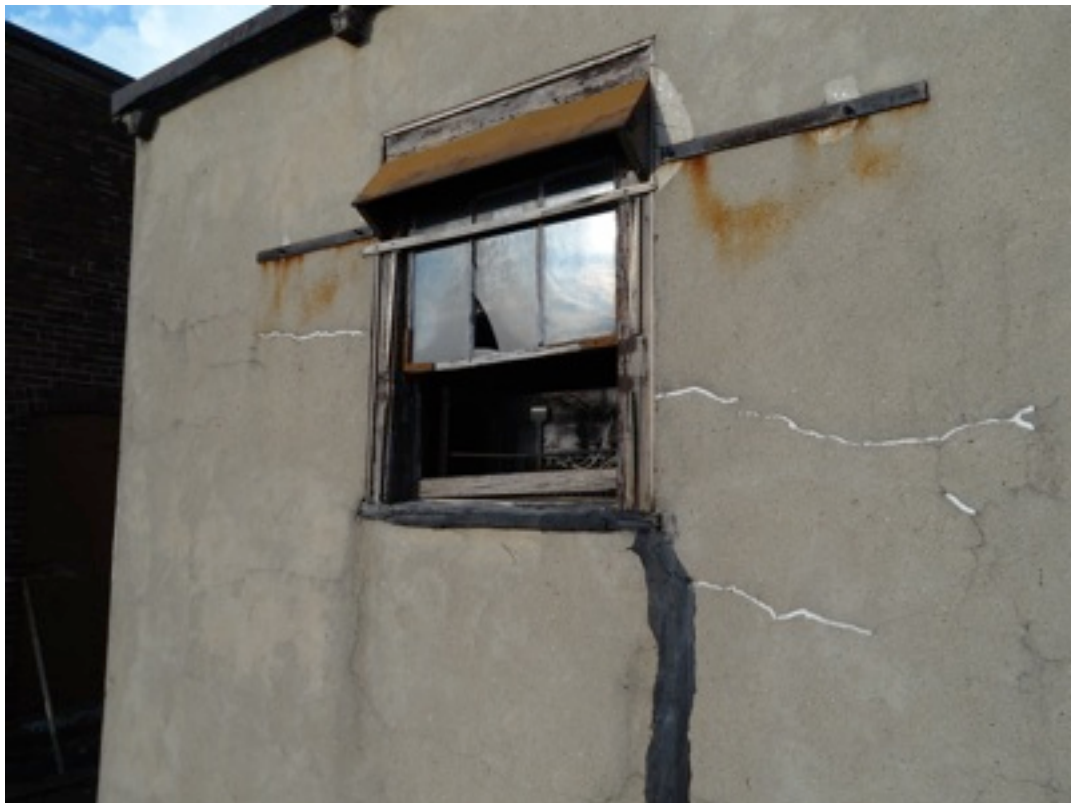
Building #4:  
Appears to have a concrete  
roof deck. The roof on this  
building was not accessed at  
the time of the inspection.  
The concrete walls have  
several cracks and repairs  
have been attempted

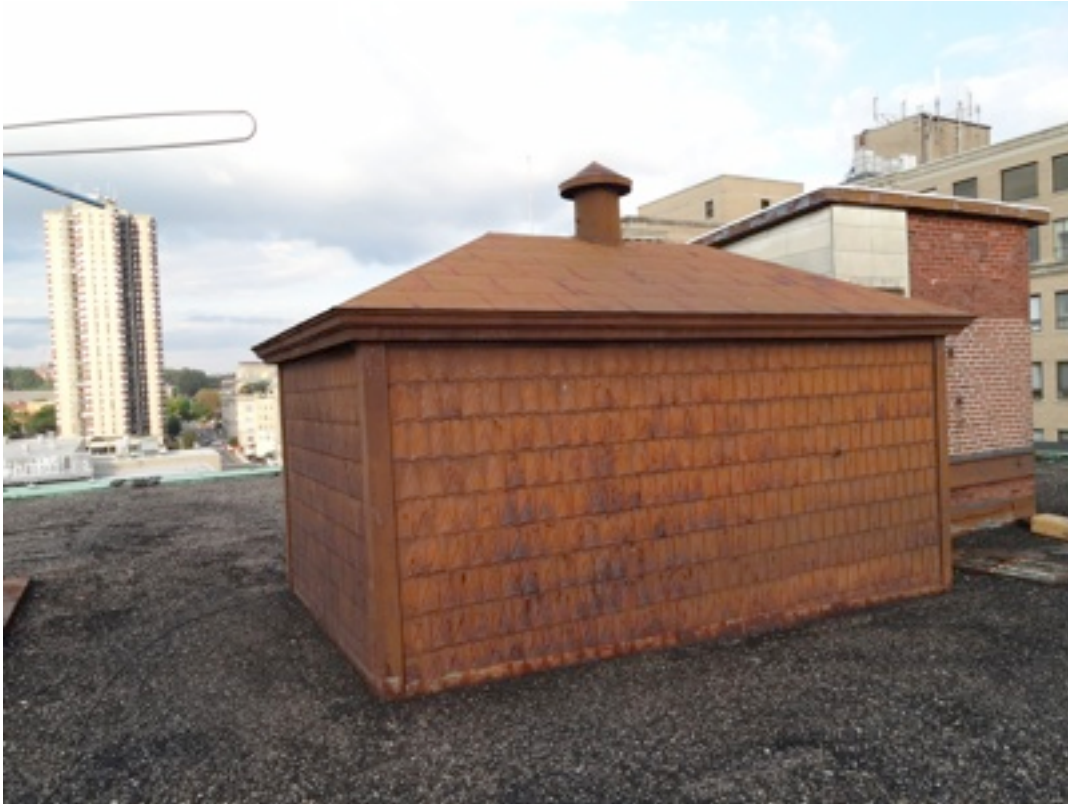
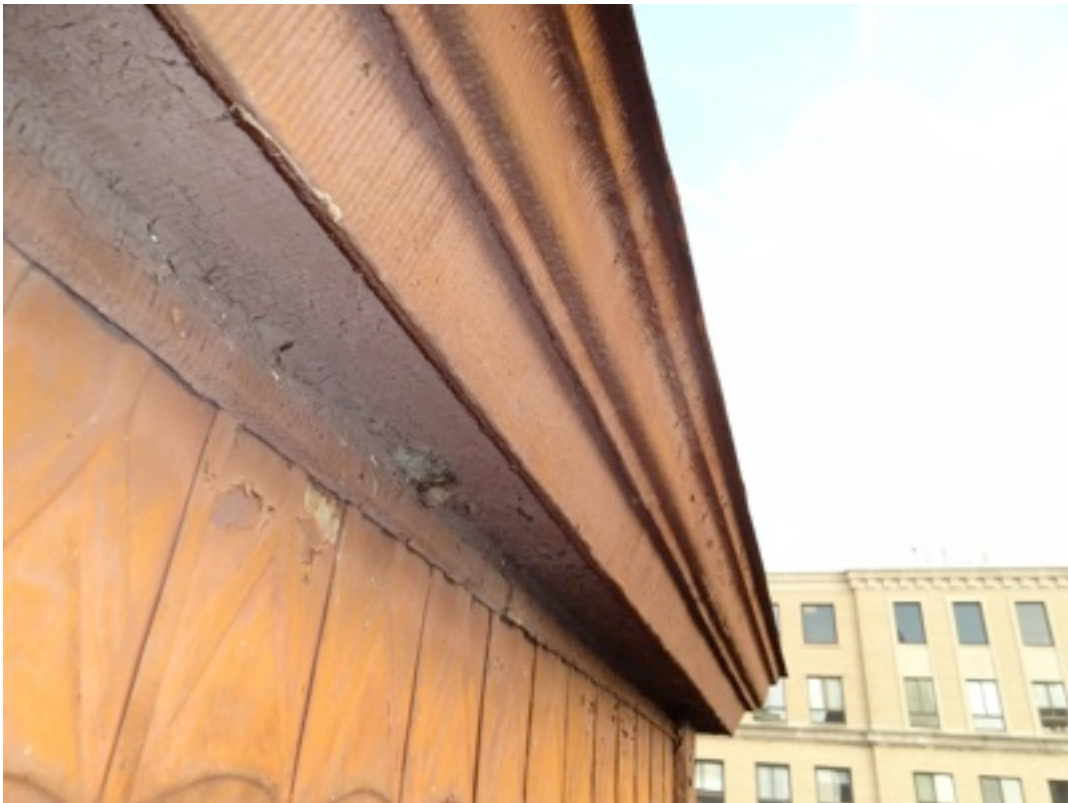
Building #5:  
Has a metal hip roof and  
siding similar to building #3

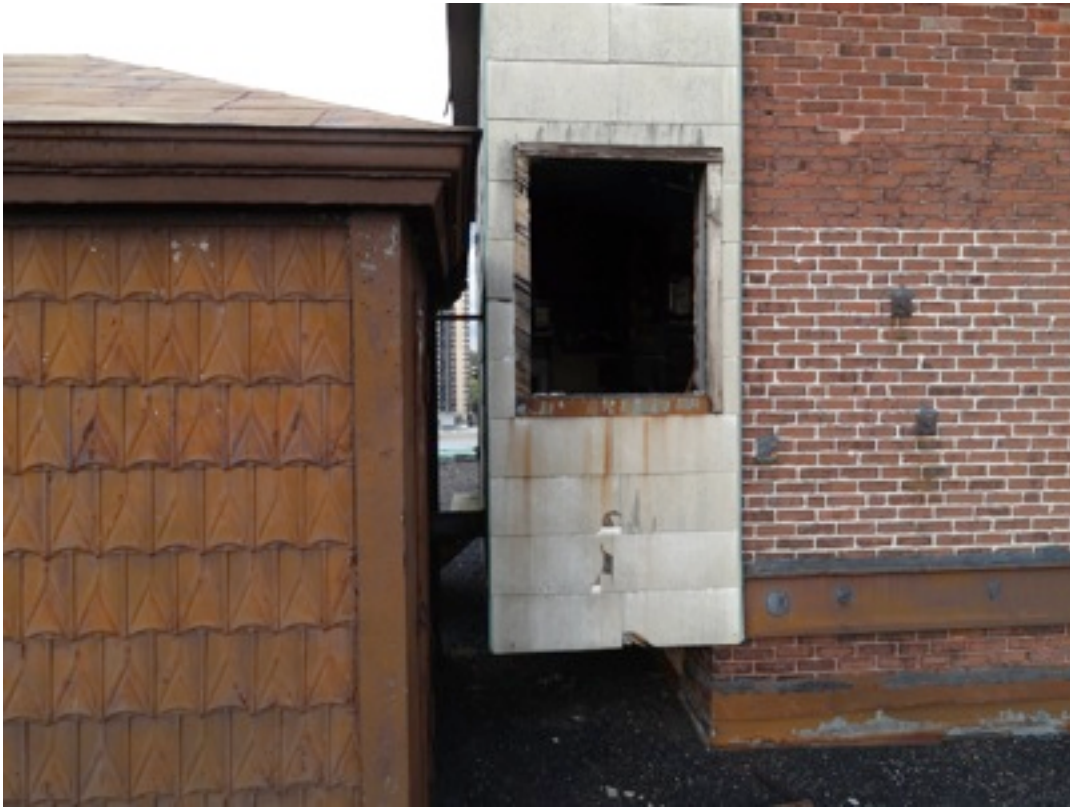
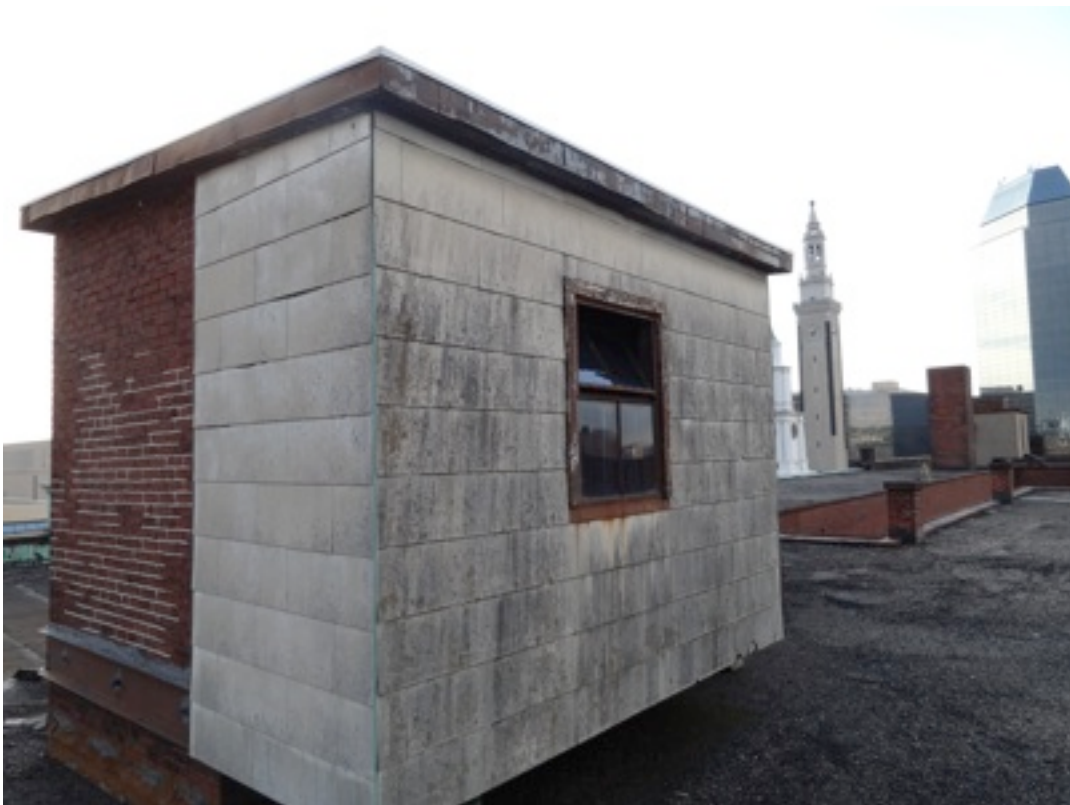
Building #6:  
This building has a sloped  
roof and is partially brick  
and has an addition that has  
broken windows and  
appears to have asbestos  
siding.

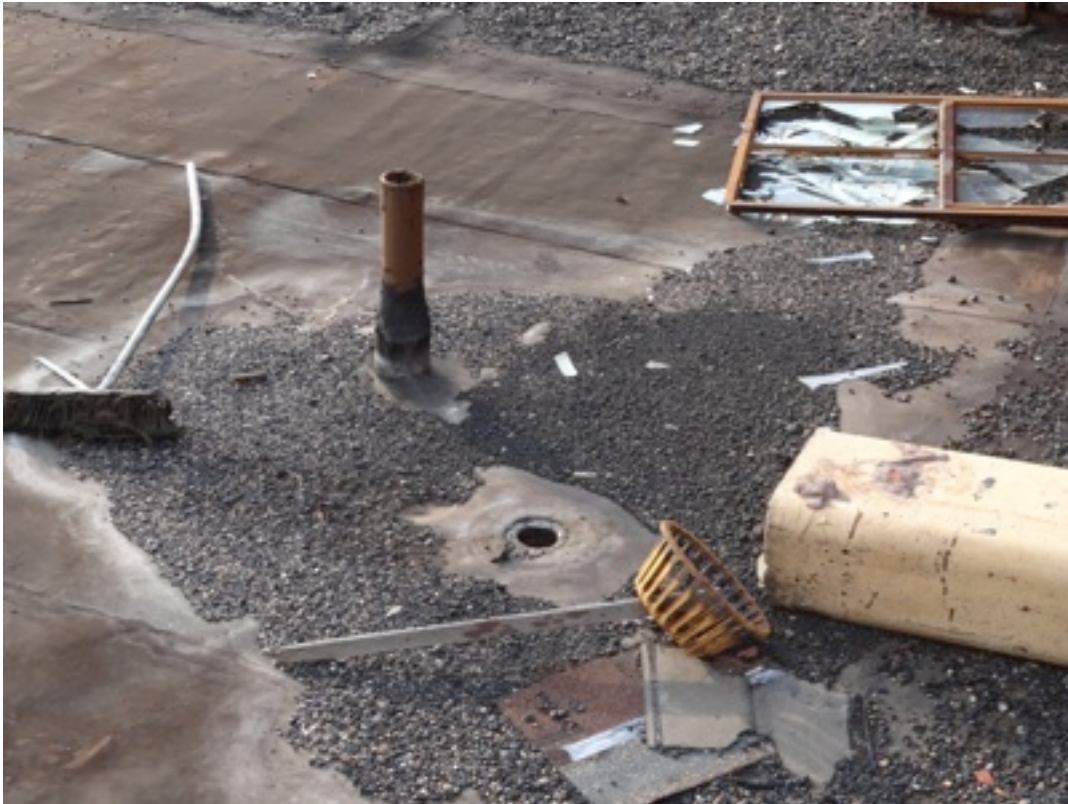
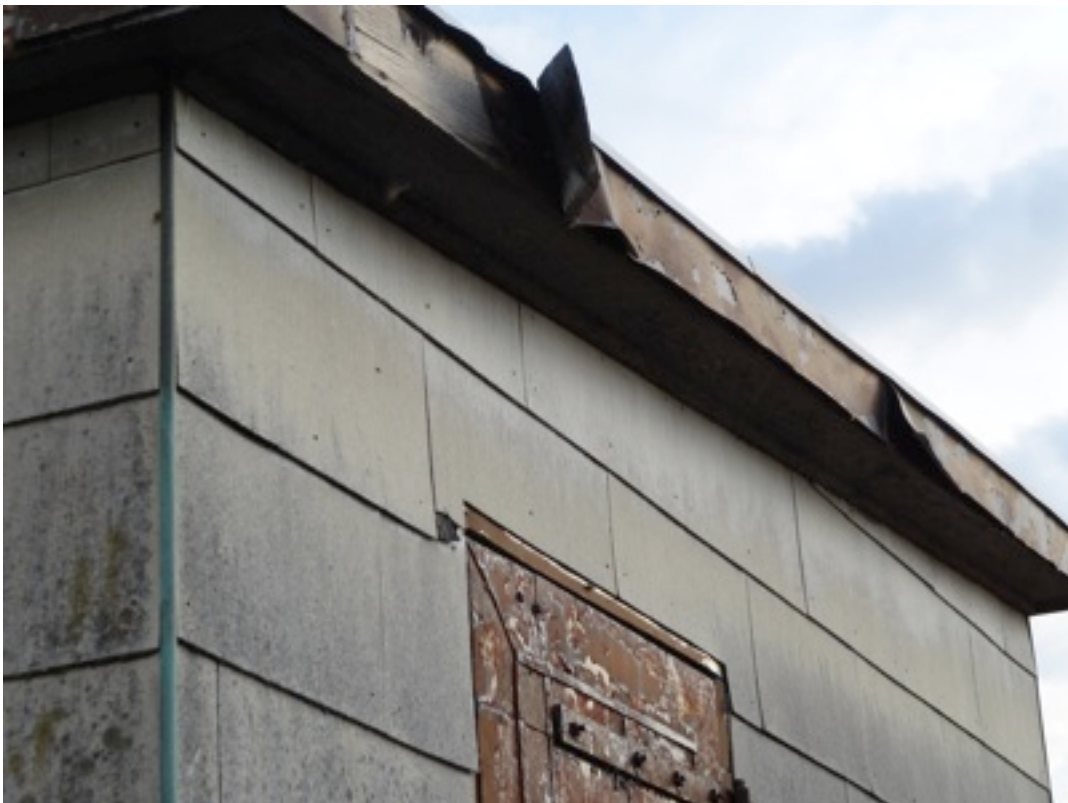
The photos on the left show more of the damage caused by the tornado. A window was blown out, shingles laying on the roof and fascia metal has been blown off.
