Runaway of Suburban Electric Passenger Train 5264 and collision with Diesel Locomotive Hauled Passenger Train 8141

Spencer Street Station, Victoria,
3 February 2003

RAIL INVESTIGATION REPORT

No. 2003/0001

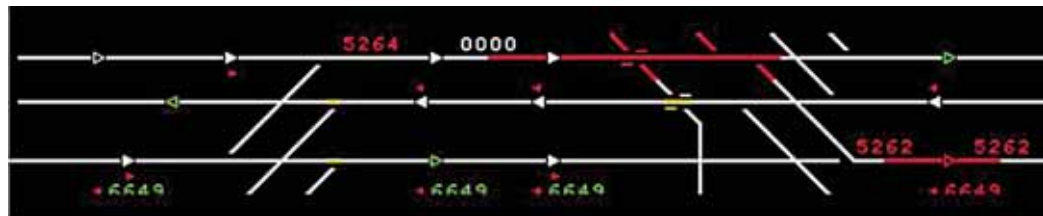
FIGURE 4:
Signallers VDU screen indicating possible collision

The signaller at Metrol then reversed the points immediately beyond signal NME 566 the moment train 5262 cleared the relevant track circuitry. At this time the signaller's VDU screen showed all routes occupied in red and the train radio was crackling, indicating that a collision may have occurred. Metrol staff urgently tried to contact the driver, without immediate success. After a short period they received an answer from the driver of 5262 (at about 2131:20) telling them that the runaway train had passed his train on the east suburban line and was proceeding through platform one North Melbourne at speed (figure 6 event 26).

Metrol signal logging revealed that the leading bogie of train 5262 occupied the first track circuit immediately beyond signal NME 566 at 2130:29 and that train 5264 passed signal NME 566 in the stop position, thereby occupying the same track circuit, 33 seconds later at 2131:02 (figure 6 event 24). Points NME 464 are 158 metres beyond signal NME 566 and are the points that set the route for either the Up east or Up main suburban lines. Metrol signal logging revealed that these points reset to the east suburban route and detected normal²³ at 2131:09. If the runaway train was travelling at 80 km/h it would take about seven seconds to traverse the 158 metres from signal NME 566 to points NME 464. The runaway train therefore traversed these points as they were detecting normal (figure 6 event 25). The runaway train then proceeded along the east suburban route. There is therefore no doubt that runaway train 5264 came within a second of being placed on a collision course with train 5262.

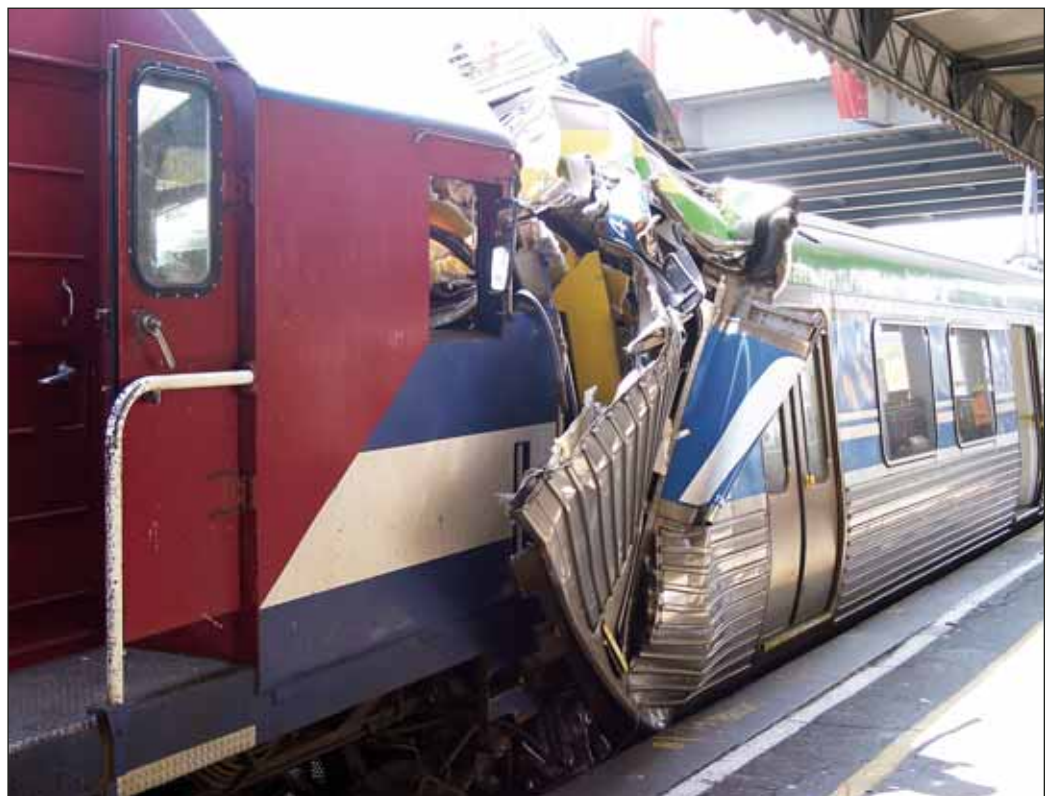
FIGURE 5:
Collision between trains 5264 and 8141

At about 2133 runaway electric suburban train number 5264 collided with the stationary Bacchus Marsh train at platform 2 at an estimated speed of 75 km/h (figure 6 event 28). Emergency services had already been contacted shortly before the collision and were on the scene within minutes. When the collision occurred it was still unknown by all involved whether or not there were passengers on board the runaway electric suburban train.

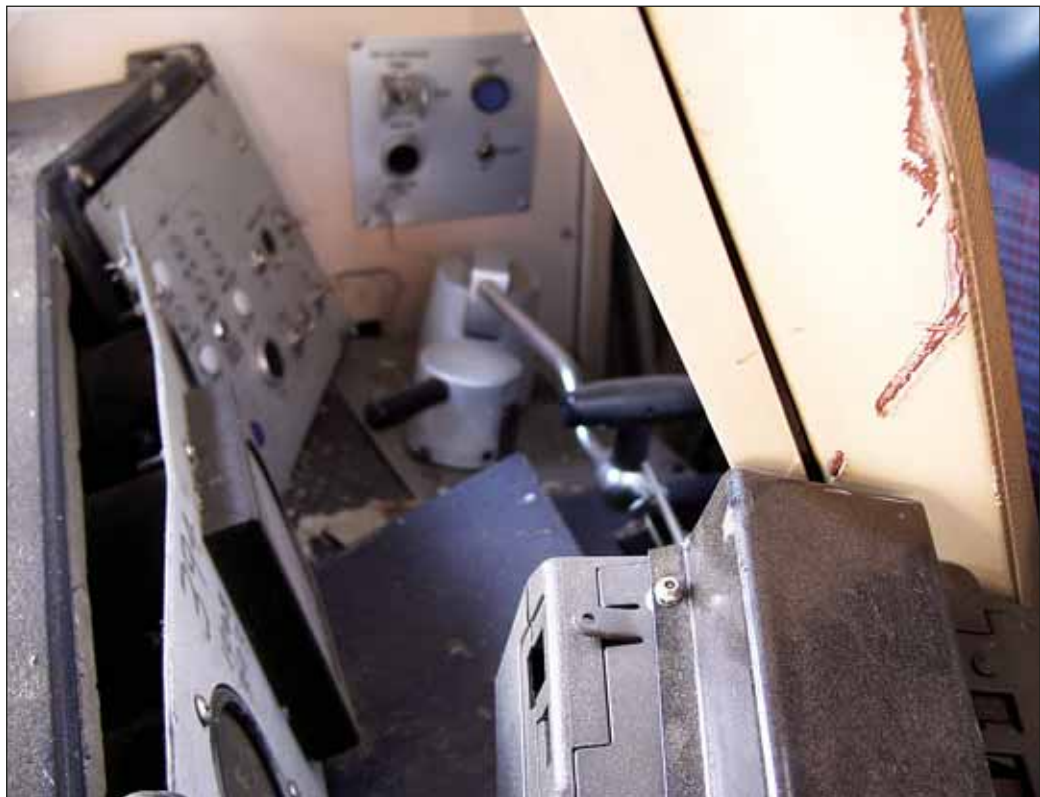
FIGURE 7:
Damage to drivers cabin, car 394

Damage sustained to the lead car of train 5264 (car 394) was severe. The driver's compartment and passenger vestibule immediately behind the driver's compartment bore the brunt of this damage. See Appendix 8.1 for more detailed description of the damage to train 5264.

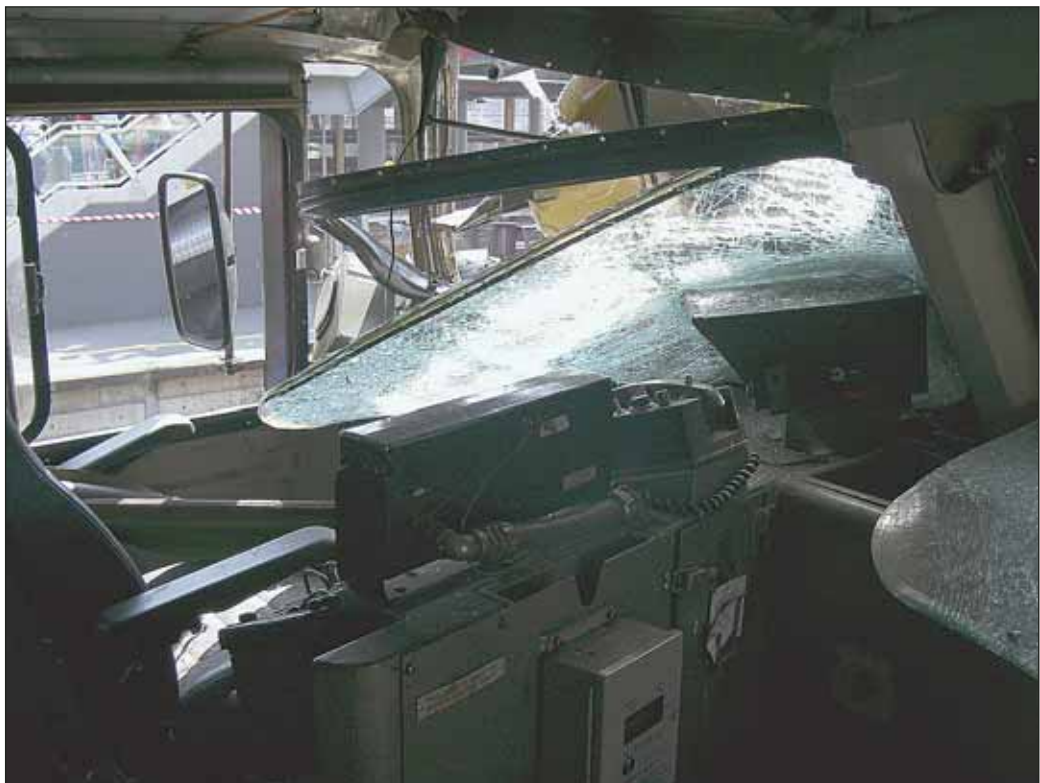
FIGURE 9:
Damage to driver's cabin, N463

The damage to train 8141 was primarily confined to locomotive N463, the leading driver's cab in particular. A detailed description of the damage sustained to train 8141 is contained at appendix 8.1.

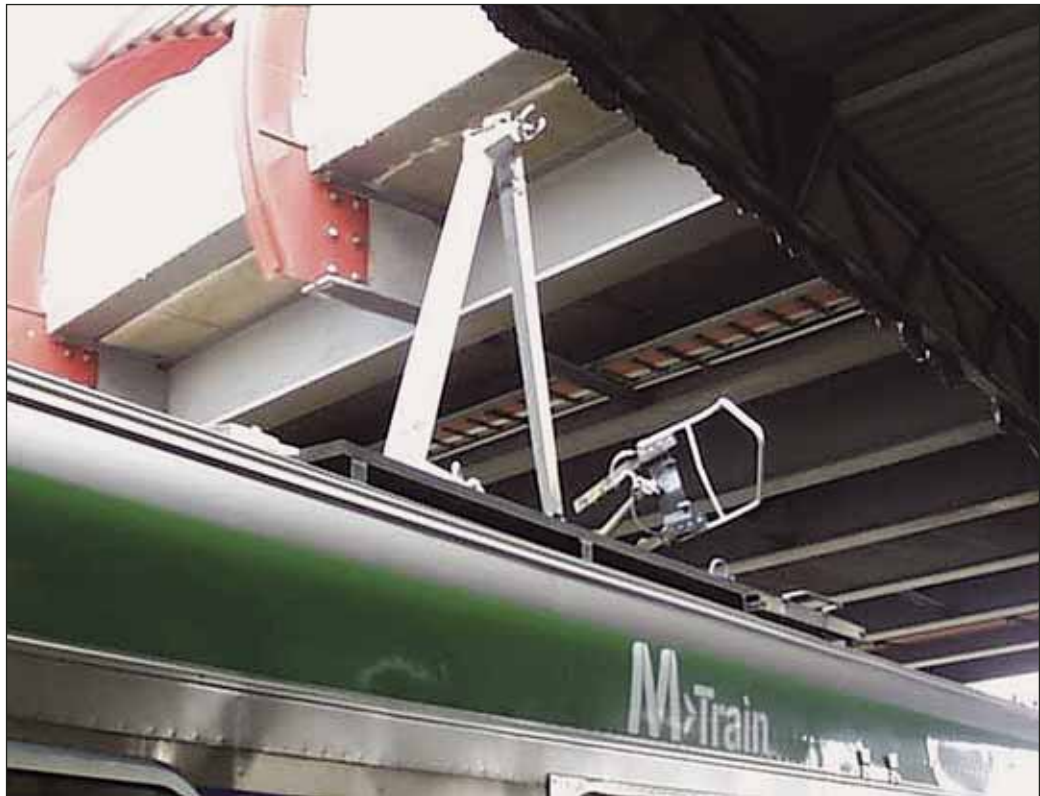
FIGURE 10:
Damaged fully extended pantograph

In an attempt to stop runaway electric train 5264 the power was isolated on the Up line between Newmarket and Glenroy at 2127 on 3 February 2003. This action caused the rear pantograph (on car 393) to drop and the lead pantograph (on car 394) to remain in the raised position. This was due to a feature fitted to all Melbourne suburban electric trains that was designed to alleviate a major power drain on the system in the event of overhead power being restored after an unplanned shut down.

On the approach to Spencer Street Station the east, main and through suburban lines are all wired for the passage of electric suburban trains. The approach to Spencer Street Station platforms one to seven is not. When electric suburban train 5264 was diverted from the east suburban line towards platforms one to seven the overhead wire ran out and the front pantograph fully extended vertically, subsequently becoming 'out of gauge'. As a consequence, the pantograph struck various infrastructure items and sustained damage.

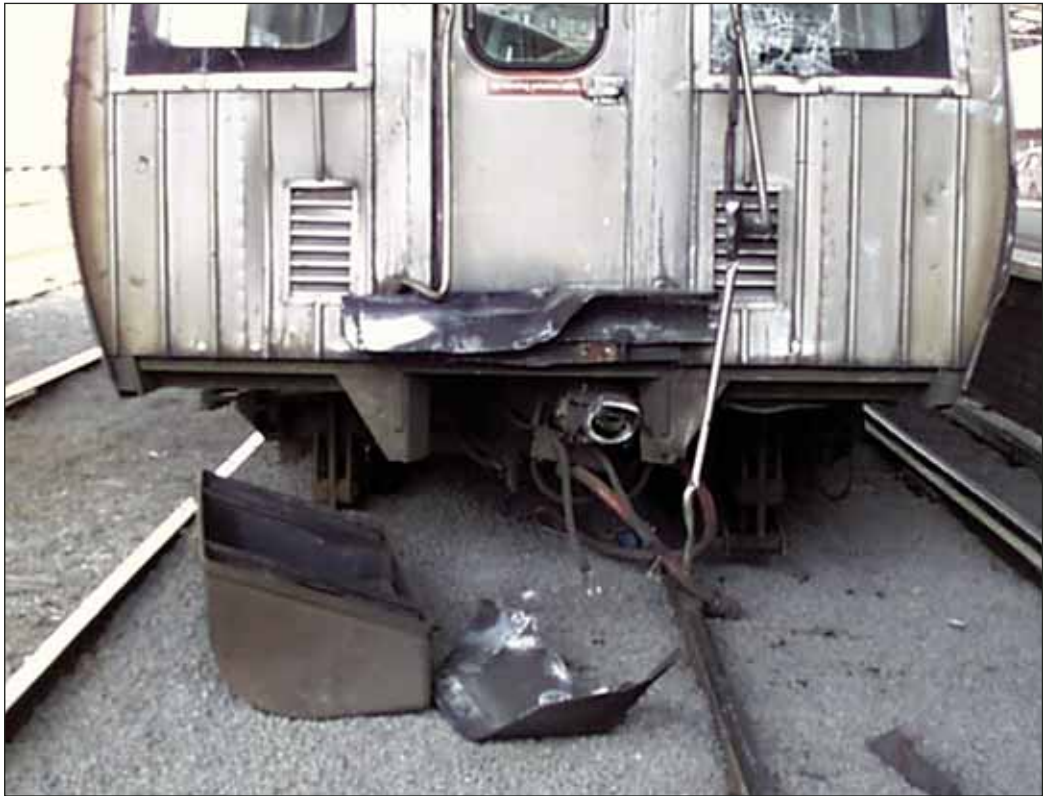
FIGURE 12:
End of car 1048

The intermediate coupler three phase and control wiring between car 394 and 1048 were torn apart as a result of trailer car 1048 derailing and slowing dramatically while the motor car continued forward.

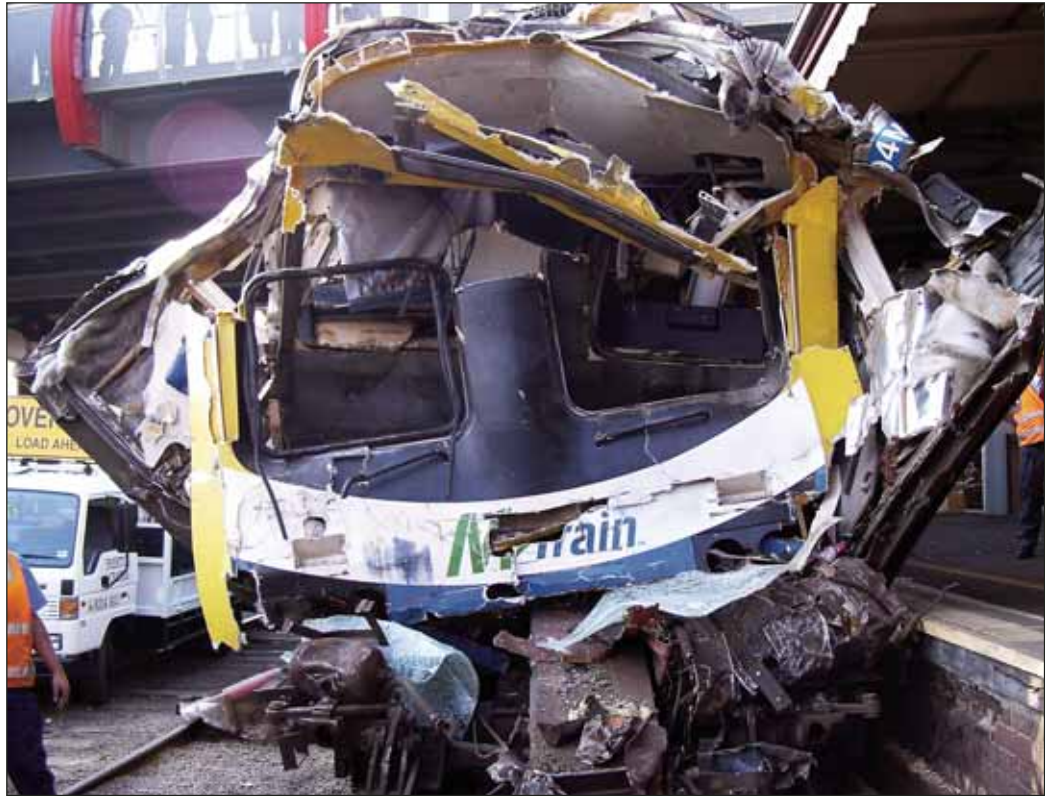
FIGURE 13:
Damage to car 394

All doors were damaged and some were jammed in the open position. This was due to the deformation of the upper brackets secured to the door carrier bar and possible broken chains. Several seat back pads were found dislodged on the floor. The bulk head wall was forced into the saloon area resulting in the flip seats punching the number one and 12 weather shields out of their mountings. The number one weather shield was completely dislodged although the toughened glass in both weather shields remained intact. There appeared to be no damage sustained to the internal ceiling and the floor from the first set of saloon doorways behind the driver's cabin to the number two end. The floor within the saloon showed no signs of buckling and the seat frames appeared to be sound with no visible damage to where they were secured to the floor tapping plates. The number two end wall windows, walkway plates, handrails, external end wall and ducts were damaged.

The 'B' side of the external sidewall stainless steel lower corrugation towards the number two end was deformed, most likely due to scraping number two platform at Spencer Street Station. Number two and nine saloon windows were cracked. The top external stainless steel corners of the windows and the doorframe showed signs of buckling from the middle doorway towards the driver's cabin. The external sidewalls including the driver's cabin sliding doors and roof of the cabin were splayed outwards. These were later cut off with plasma cutting equipment. The headstock was also cut in this manner as it was found to be preventing the bogie from steering. This resulted in a minor derailment while moving the crippled unit to a siding at Spencer Street. The air conditioner had to be removed to bring the height of car 394 within the loading gauge. The pantograph arm had over extended once it left the overhead wire shortly before Spencer Street Station. This resulted in damage to the pantograph head as well as the arm.

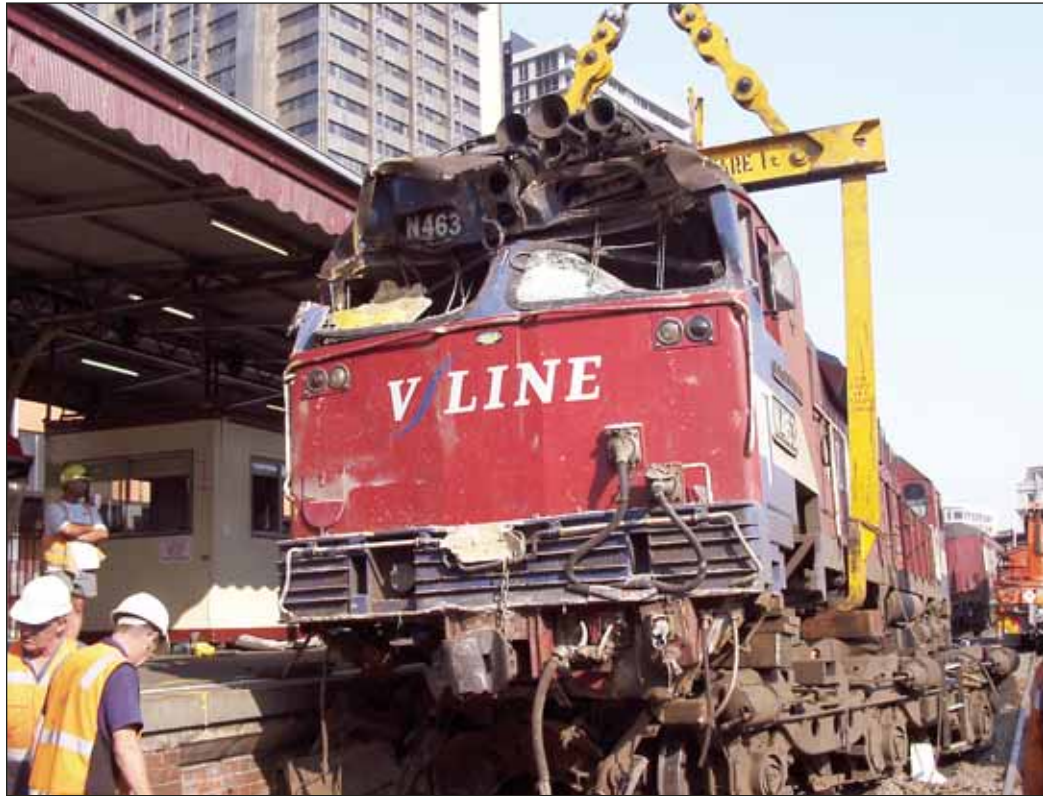
FIGURE 14:
Recovery of locomotive N 463

25 mm. The antiriders²⁸, main reservoir, brake pipe, jumper cable plugs and receptacles, handrails and so on were all damaged. The rear automatic coupler had fully compressed the attached draft gear²⁹ as evidenced by the marks on the pocket.
