Runway Overrun During Rejected Takeoff  
Global Exec Aviation  
Bombardier Learjet 60, N999LJ  
Columbia, South Carolina  
September 19, 2008

**Accident Report**

NTSB/AAR-10/02  
PB2010-910402

The National Transportation Safety Board determines that the probable cause of this accident was the operator's inadequate maintenance of the airplane's tires, which resulted in multiple tire failures during takeoff roll due to severe underinflation, and the captain's execution of a rejected takeoff (RTO) after  $V_1$ , which was inconsistent with her training and standard operating procedures.

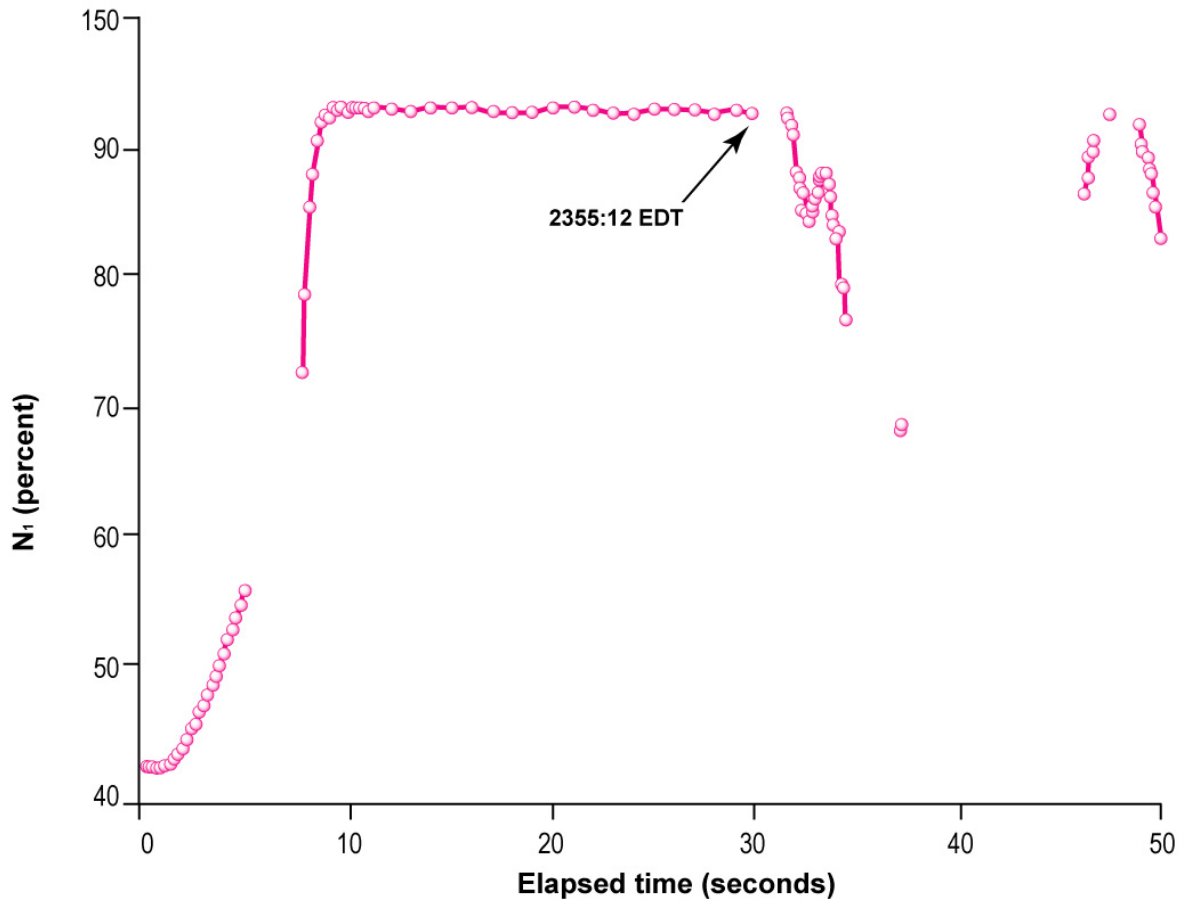
**Figure 4.** Engine N<sub>1</sub> calculated as a function of elapsed time into the takeoff roll (time of the start of the loud rumbling sound is shown).

As shown in figure 4, from 2354:42, the calculated engine N<sub>1</sub> increased to a peak within 10 seconds and then remained constant near that peak level (about 93 percent) for the next 20 seconds until 2355:12, when a distinct noise burst (corresponding with the beginning of a loud rumbling sound) was recorded. After the noise burst, from 2355:14 to 2355:16, there was noticeable wavering of engine N<sub>1</sub>; during this 2-second period, N<sub>1</sub> decreased from about 93 percent to about 84 percent and then increased back up to about 88 percent before finally decreasing below about 76 percent, at which point engine noises became only intermittently discernible. At 2355:19, engine N<sub>1</sub> was about 68 percent. In the final 4 seconds of analyzed audio (beginning at 2355:28), discernible engine noises corresponded with an N<sub>1</sub> rising through about 86 percent to about 93 percent before decreasing again to about 83 percent.

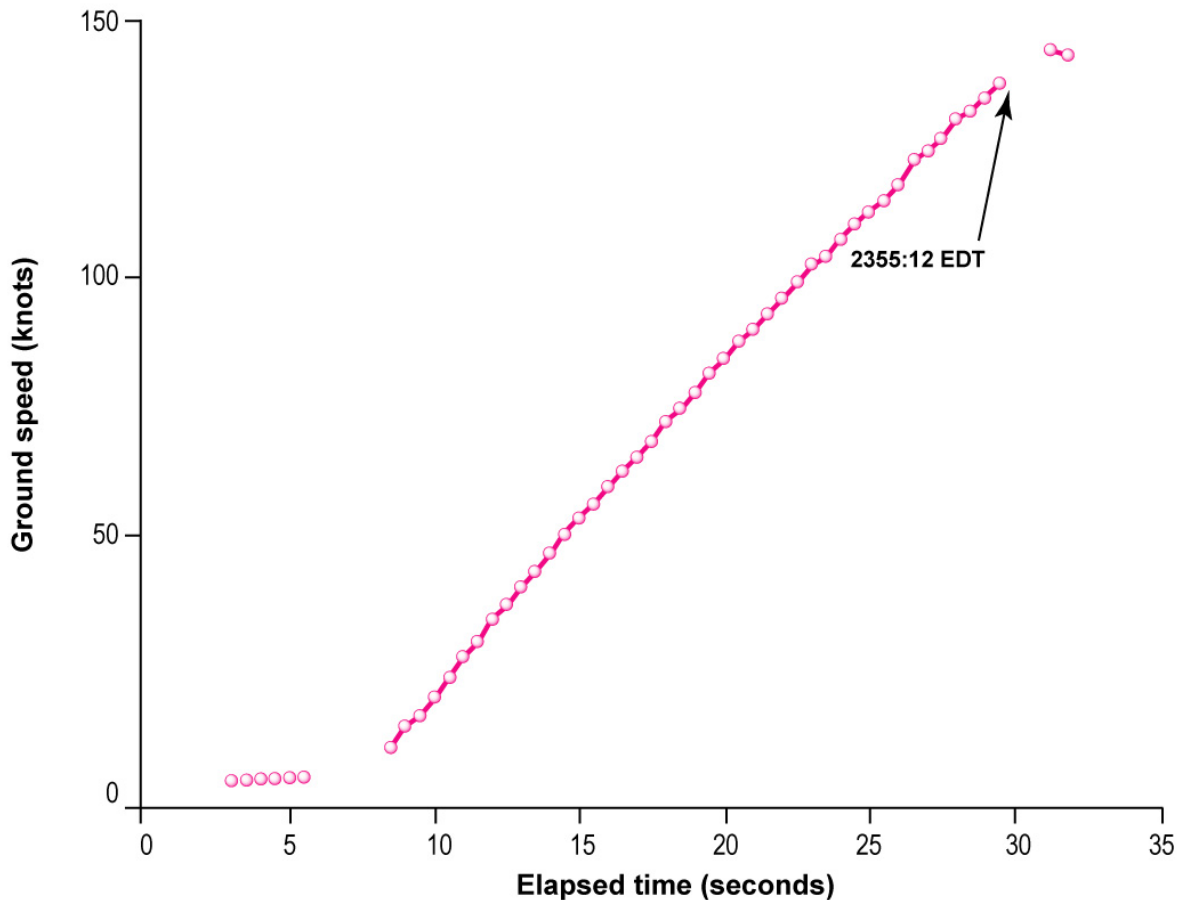
**Figure 5.** Airplane ground speed calculated as a function of elapsed time into the takeoff roll (time of the start of the loud rumbling sound is shown).

As shown in figure 5, the airplane's ground speed increased from about 5 kts about 8 seconds into the recording (at 2454:50) to about 138 kts at the time that the rumbling sound began at 2355:12. The sound spectrum analysis of airplane ground speed ends a few seconds later; tire-rolling sounds beyond that time were not clearly discernible. The analysis indicated a peak ground speed of about 144 kts.

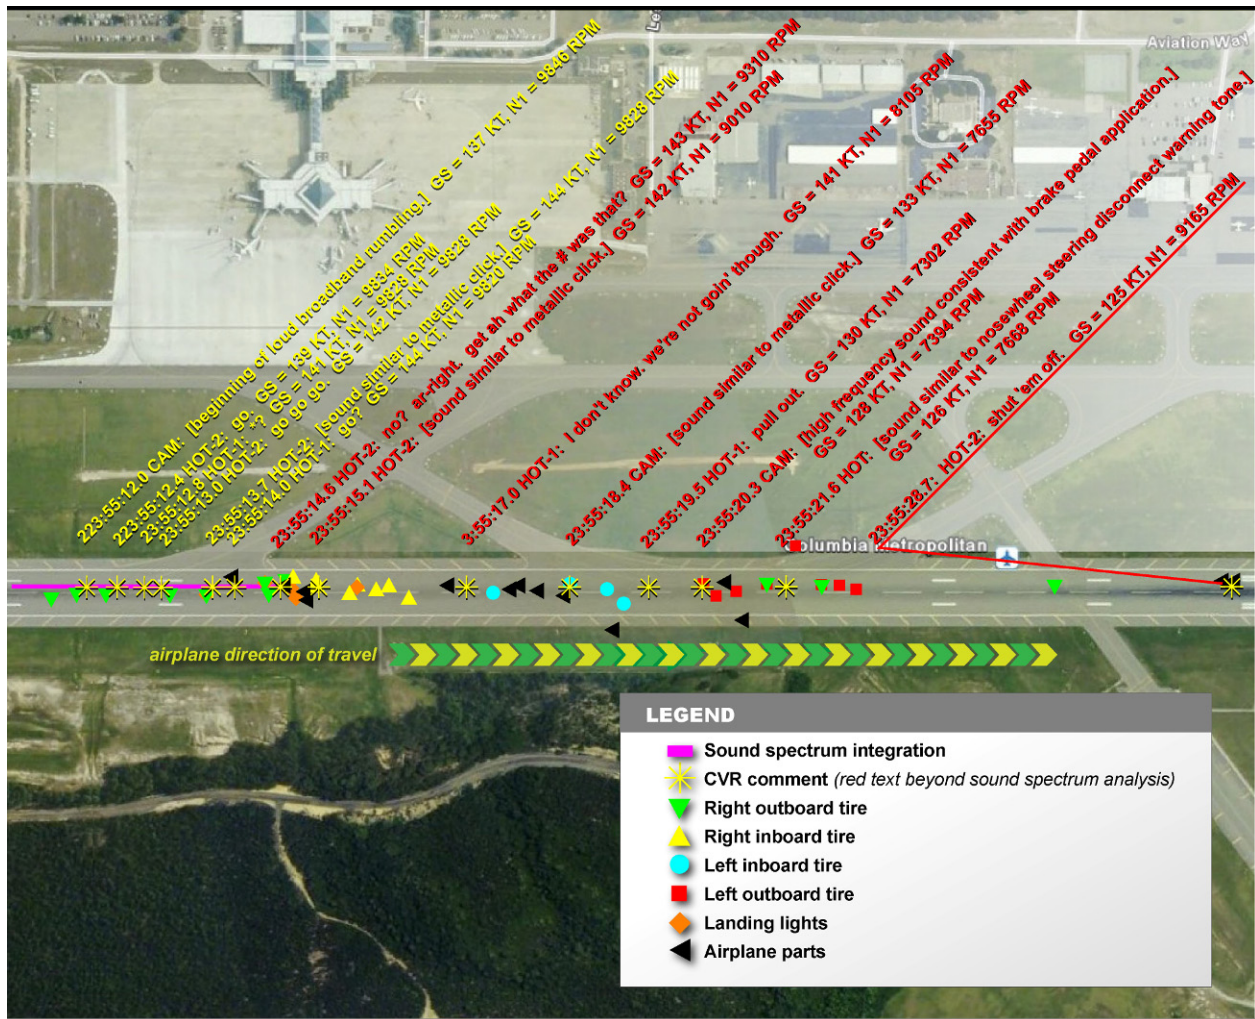
**Figure 6.** Map of Columbia Metropolitan Airport showing integrated sound spectrum data, cockpit voice recorder comments, and wreckage locations plotted.

The sound spectrum study speed analysis ends at 2355:14 (when sound signatures are no longer clearly discernible); information derived from the integration of that portion of the sound spectrum is shown in pink. CVR comments, engine N<sub>1</sub>, and ground speed from the same timeframe are shown in yellow text. For the purpose of positioning the remaining CVR comments in the approximate locations where they occurred, the airplane performance study further extrapolated the airplane's ground speed to 2255:31 through a visual examination of the sound spectrum illustration. This extrapolated information is shown in red text. Wreckage and tire debris found on the runway are also shown as marked.

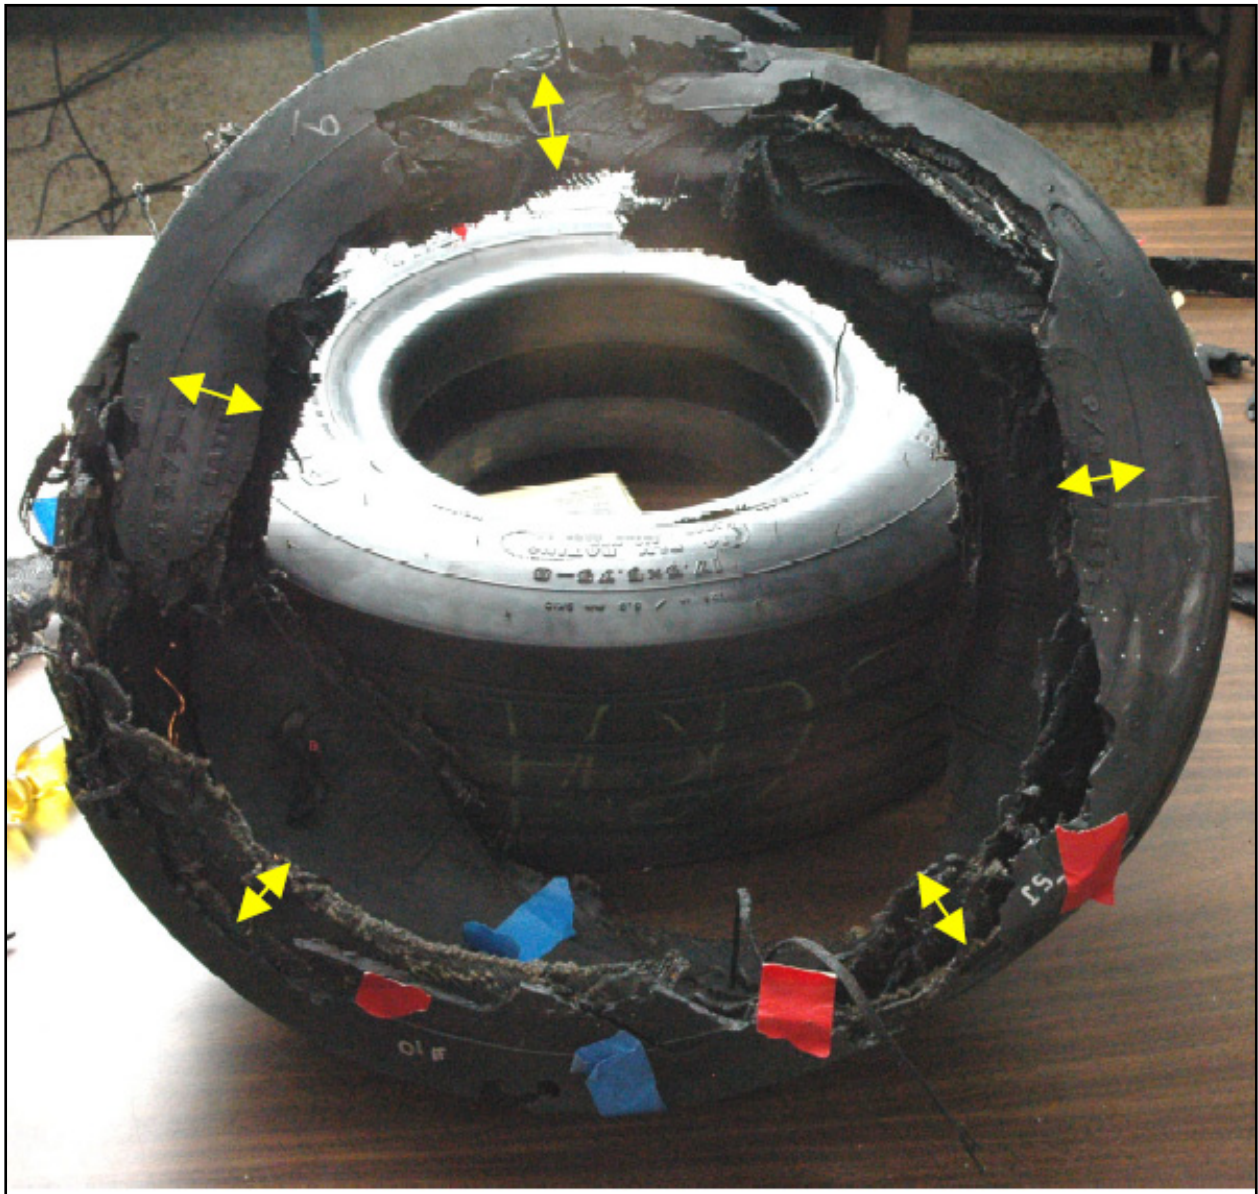
Pieces of the right outboard tire, which were the first debris found on the runway, were identified as fragments of the tire's sidewall. About 80 percent of the tire was reconstructed. Both sidewalls showed damage around the entire circumference of the tire; the damage had a ragged appearance and was located at a generally uniform distance from the wheel rim, as shown in figure 7 on the following page.

**Figure 7.** Reconstruction of the right outboard main landing gear tire showing outboard sidewall damage. Arrows depict the generally uniform location of the damage.

The characteristics of the sidewall damage observed on all four of the accident airplane's tires were consistent with a photograph in a Goodyear publication showing typical heat damage sustained from sidewall overdeflection and flexing fatigue.<sup>38</sup> Goodyear engineers and the Goodyear publication noted that previous tire testing found that aircraft tire sidewall damage from flexing fatigue is predominantly consistent with taxi-cycle operations while the tire is

Because either underinflation or overloading can result in tire sidewall overdeflection, tire testing data for both scenarios were reviewed. According to estimated static load deflection charts created during the investigation for the accident tires, the amount of underinflation needed for a loaded tire to produce the type of overdeflection damage observed on the accident airplane's tires (specifically, the damage location on the sidewall) would be about 36-percent underinflation. Alternatively, testing data showed that the amount of overload needed for a properly inflated tire to produce the amount of overdeflection consistent with the sidewall damage observed on each of the accident airplane's tires would be about 12,200 pounds.

Other damage observed on fragments from each of the accident airplane's tires included blue to purple heat discoloration indicative of moderate to severe heat damage. According to the Goodyear publication, blue tinting appears at temperatures from 210° to 230° F. Microscopic examination of fragments from all four tires revealed that the tires' nylon fibers (which are generally soft and fabric-like when undamaged) had melted and resolidified into single strands that had a stiffness resembling that of broom bristles. The Goodyear publication noted that the melting point of nylon is greater than 400° F. Rubber reverts to an uncured state and loses strength and adhesion at temperatures from 280° to 320° F, then becomes hard and dry at temperatures from 355° to 390° F.

Fragments from all four tires showed abrasion and rub marks on the inner liner and heat damage to the rubber and nylon fibrous cord materials. Goodyear engineering personnel and investigators experienced in tire failure examinations noted that, although heat and rolling distance could affect the start of wrinkling, they were not aware of wrinkling or liner damage ever occurring in aircraft tires that had been properly inflated.

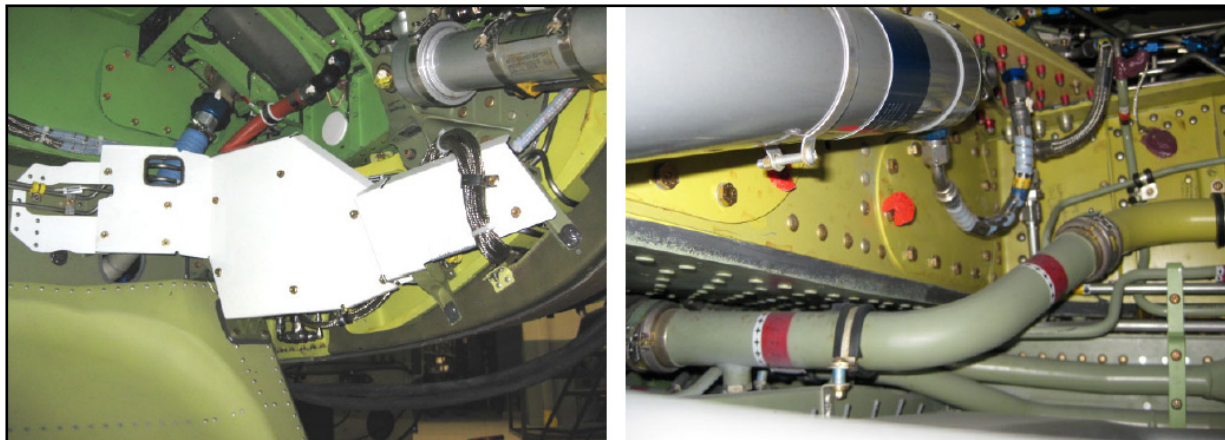
With the exception of the Learjet 45, the MLG is similar throughout the series of Learjet airplane models and is based on similarities to the initial 1960s models that had been certificated before more stringent regulatory requirements existed. Components in the wheel wells of the Learjet 45 have protective plating and revised routing that provide more protection. Differences in the Learjet 45's and the Learjet 60's protection of system components in the MLG well, for which 14 CFR 25.1309 applies, are illustrated in figure 8 below, which shows protection in the inboard aft corner of the MLG wheel well for each airplane. Notable is the white shield that protects the Learjet 45's hydraulic and electrical system components, whereas components in the Learjet 60 are more exposed.

**Figure 8.** Inboard aft corner of the left main landing gear wheel well for the Learjet 45 (left) and the inboard after corner of the right main landing gear wheel well for the Learjet 60 (right).
