**HEAVY MOVABLE STRUCTURES, INC.
SIXTEENTH BIENNIAL SYMPOSIUM**

**Safeco Field Movable Stadium Roof
Bogie System Repair**
Frank Marzella, PE
Hardesty & Hanover, LLC

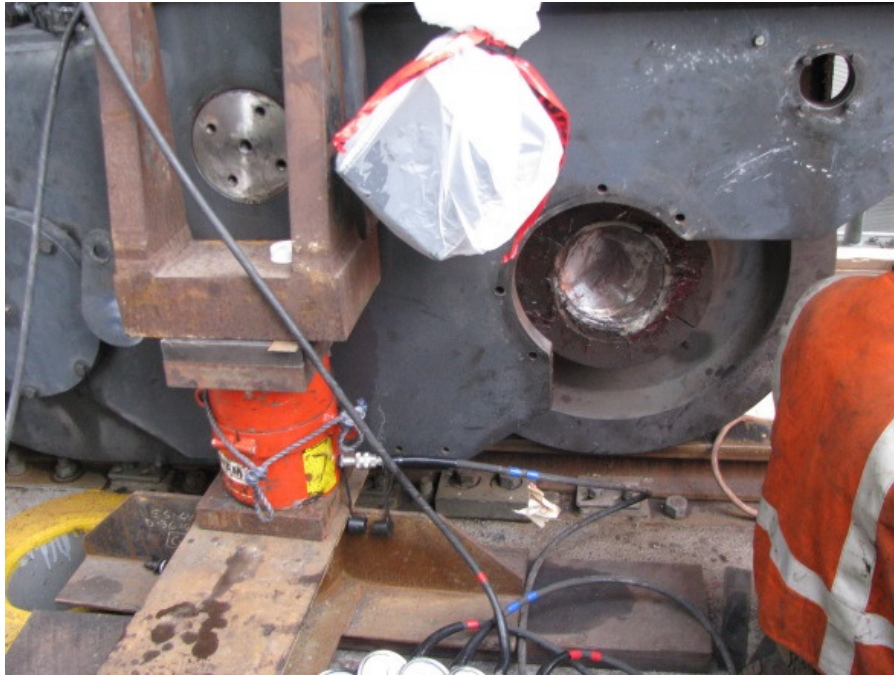
On January 26, 2012, the 3rd wheel axle of the Panel 1 North Northwest Bogie # 1 (designation PIN-B1-W3) experienced a catastrophic axle failure during a routine maintenance roof move. The failed axle is pictured below.

Fortunately for the Mariner's, the axle failure happened during the off-season of baseball. After an emergency repair construction contract was issued, the failed wheel assembly was replaced with one of the two spare wheel assemblies.

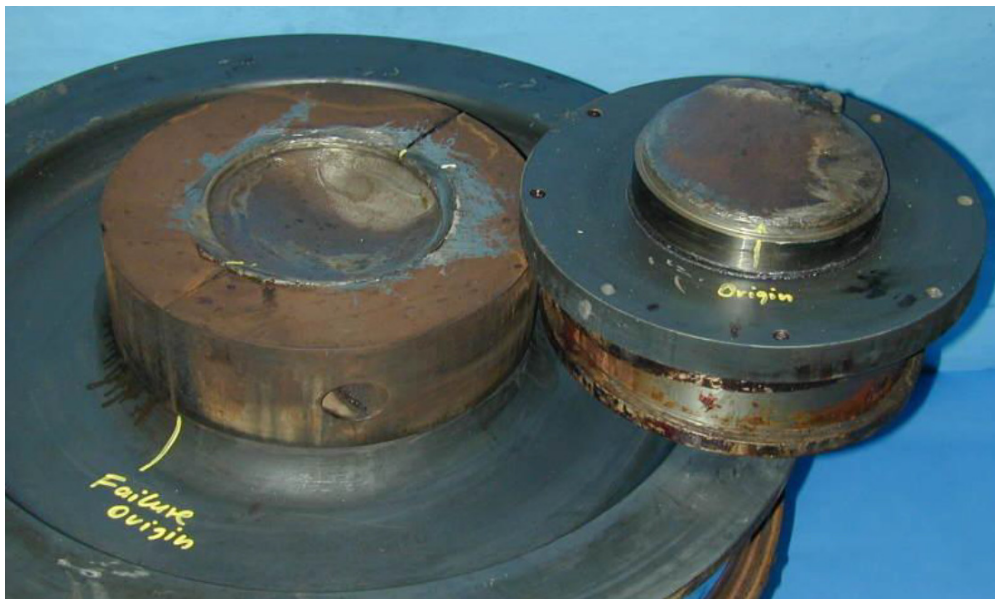
- The axle failure was the result of *low-stress/high-cycle fatigue*, (i.e., the axle failure was progressive in nature and occurred over a period of time).
- *The fatigue failure originated at the toe of the locking collar groove* and then progressed across the shaft thickness until crack instability resulted in final failure.
- Approximately 95% of the fracture face was covered by fatigue, suggesting that a *relatively low nominal stress had propagated the failure (Stage II of fatigue)*.

Initial Axle Failure at Locking Collar Groove

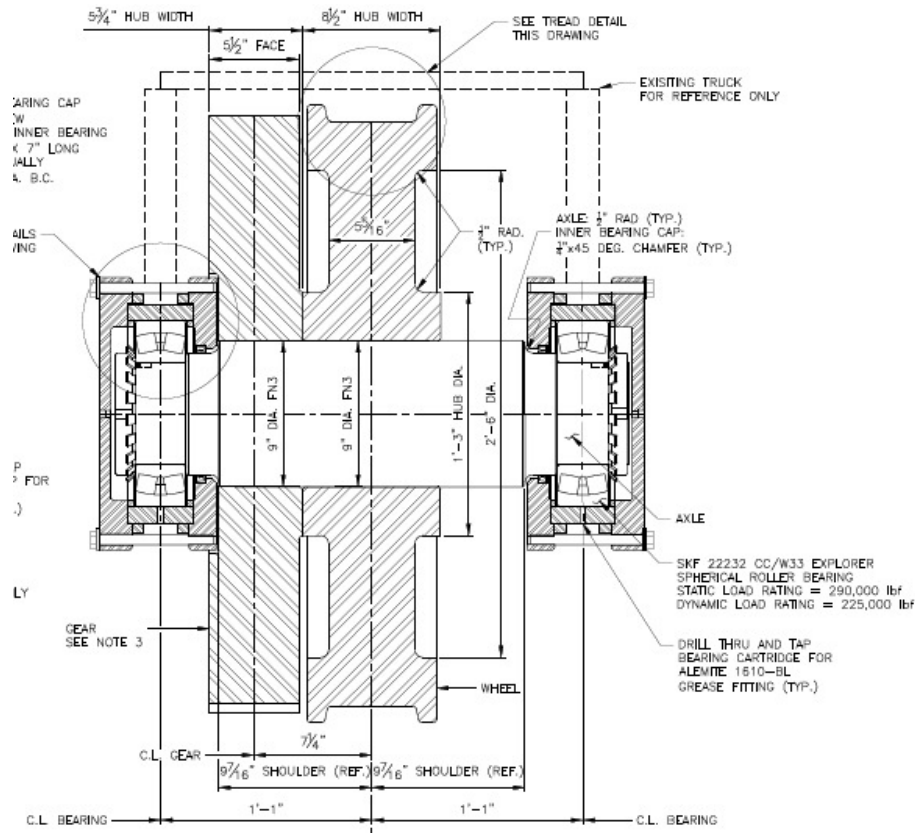
Interim Wheel/Axle Assembly with Improved Details

Hardesty & Hanover developed a “drop in” replacement wheel assembly design with the following improvements:

- Eliminated the 1-1/2 x 3/4 inch key between the axle and wheel/gear
- Eliminated the locking collar and snap rings as a axial wheel restraint
- Utilized a “**Heavy Drive FN3**” force fit between the axle and wheel/gear to provide lateral wheel restraint and transmit driving torque

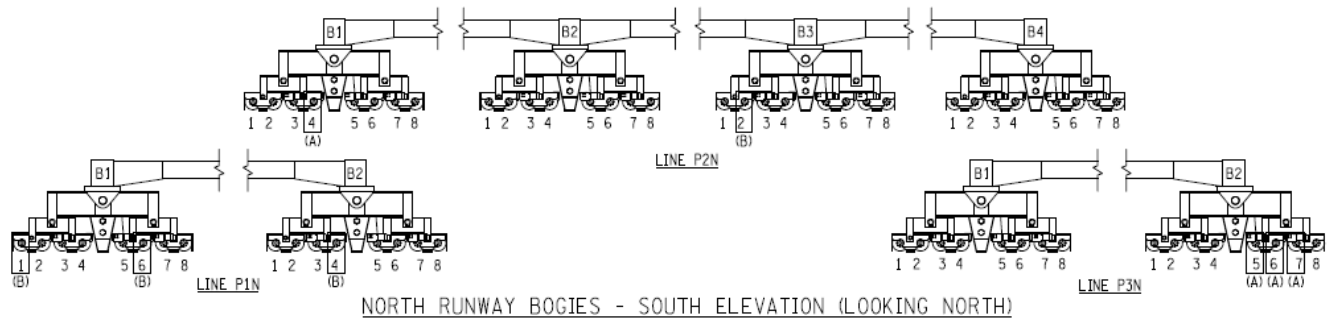
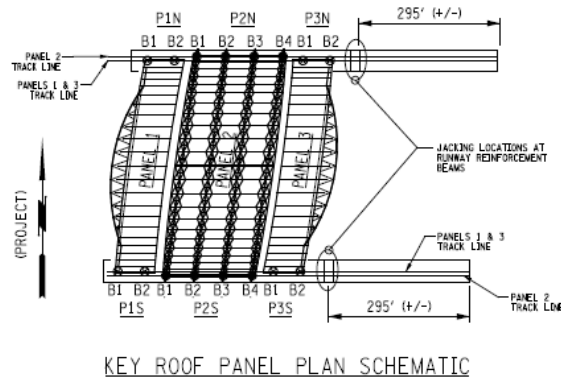
The following is a partial schematic plan of the roof layout and the location of the 15 wheel that required replacement.

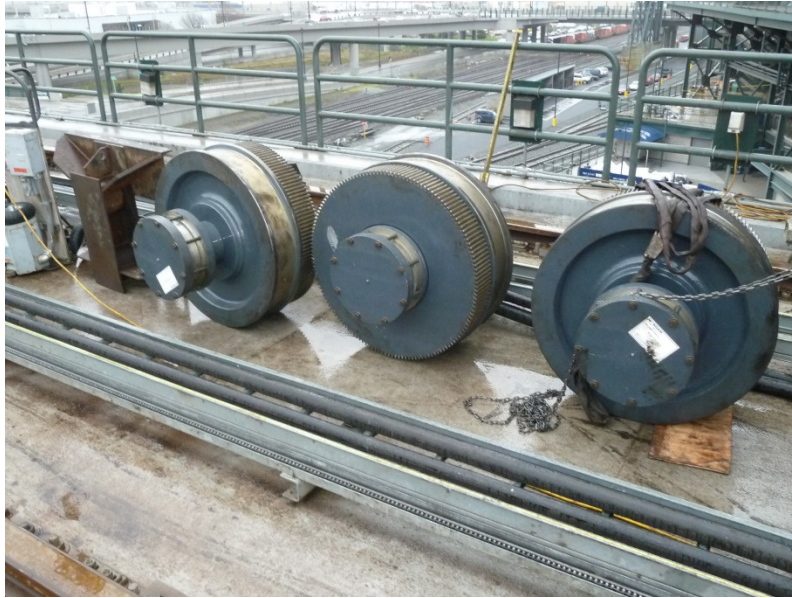
Interim Wheel Assemblies Ready for Installation

In January 2013, the Interim 15 wheel change out was implemented.

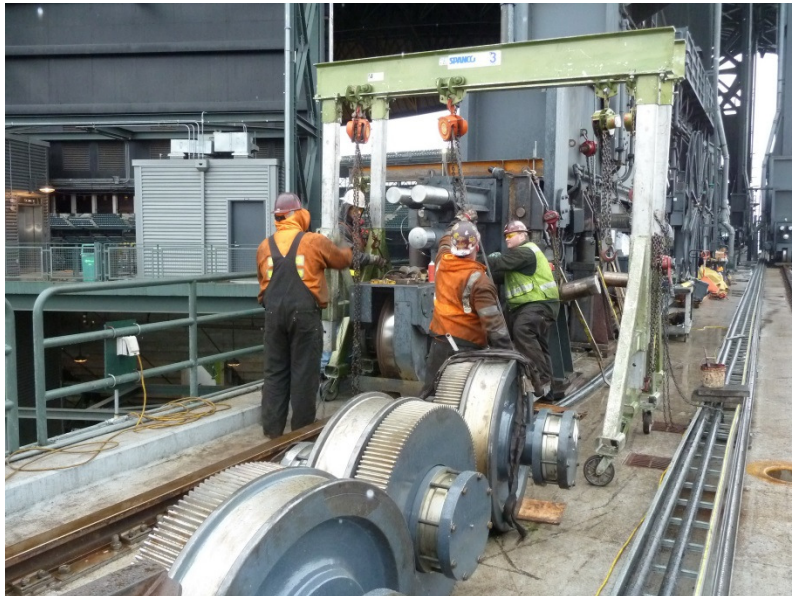
Interim Wheel Assembly Installation

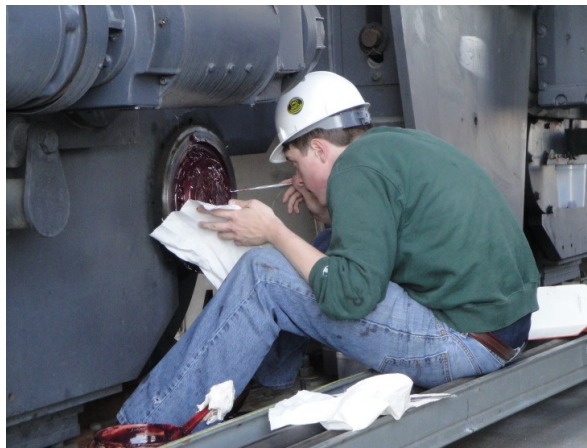
Since being put into operation, the retractable roof system experienced multiple wheel bearing failures. Safeco's maintenance forces were spending considerable effort on wheel bearing inspection efforts as well as general maintenance and replacement of failed bearings.

Annual Bogie Wheel Bearing Inspection

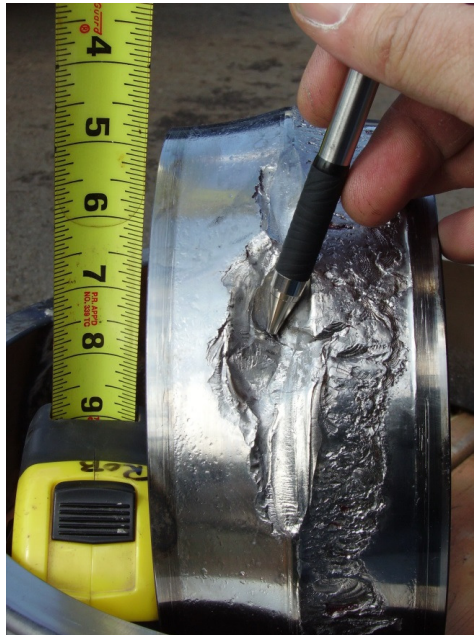
Failed Rollers and Inner Bearing Race
