Date	Group.	No.	Page
04.14	SC0375		1(17)

Electrical Power Distribution Module
(EPDM)
CHU, CXU, GU, TD

SAFETY RECALL INFORMATION:

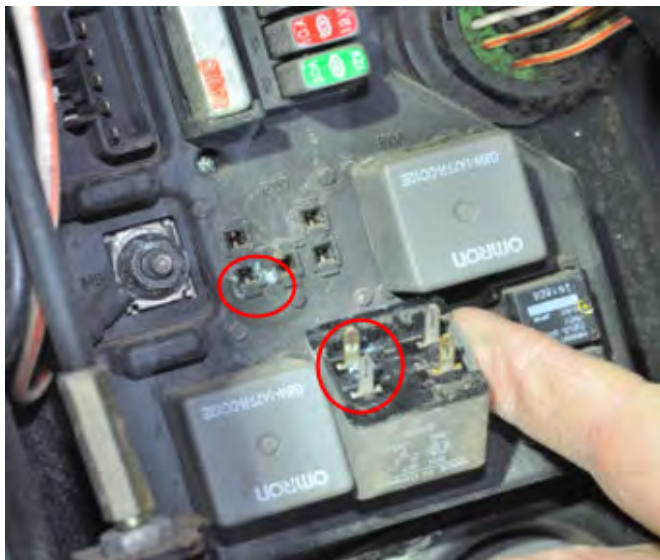
10. Inspect the removed EPDM for signs of water damage. Pull each component from the EPDM and inspect both the component and the EPDM at that location for traces of water. Inspect both sides of the EPDM. If traces of water are found on the EPDM or any component go to step 11a and replace the EPDM and all components. If no signs of water are evident, go to step 11b.

NOTE: This photograph is an example only. Traces of water may be found at various locations on the EPDM, and to varying degrees of contamination.

11. A) If it is determined that a new EPDM is required, using new EPDM 85142790, install 2 x sealed relay 21595026 in positions R01 and R02. Install 3 x sealed relay 25110754 in positions R07, R08, and R09. Populate or remove any other fuses/circuit breakers/relays (using old EPDM as a guide), with new parts.

B) If it is determined that a new EPDM is not required, using the existing EPDM, install 2 x sealed relay 21595026 in positions R01 and R02. Install 3 x sealed relay 25110754 in positions R07, R08, and R09.

NOTE: Any old parts must not be reused if any one component shows sign of water damage. Any part not reused must destroyed.
