Safety Recall P36 / NHTSA 14V-391

Sun Visor Wiring

2011 – 2014 (WD) Dodge Durango

(WK) Jeep® Grand Cherokee

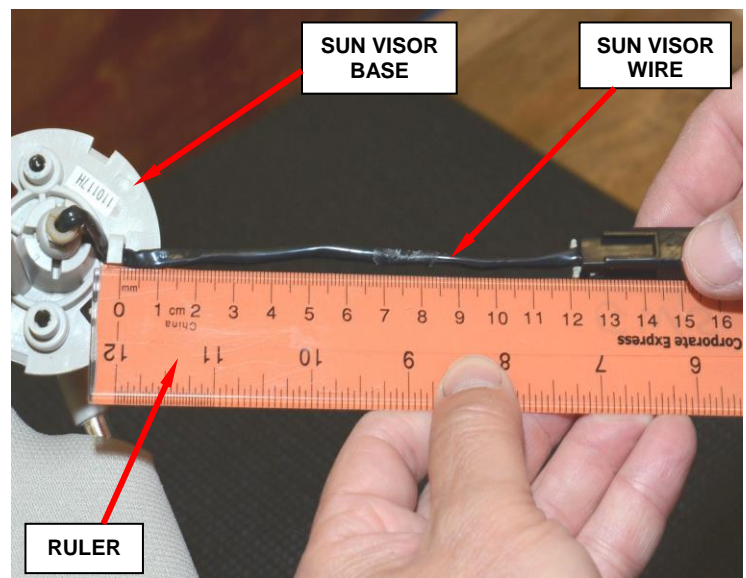
Figure 11 – Measure Wire Length

26. Inspect the right and left side sun visor wiring for broken or bare wires. Repair wires if required.
27. Remove and discard the original right and left side sun visor wire guides.
28. Measure the length of the sun visor wire to determine the correct wire routing (Figure 11).

NOTE: The majority of the vehicles built before September 01, 2012 will have a 4 ¾ inch (120 mm) long sun visor wire. The majority of the vehicles built after September 01, 2012 will have a 2 ¾ inch (70 mm) long sun visor wire.
