Safety Recall

Code: 69L2

Subject	Steering Wheel Clock Spring
Release Date	December 10, 2015
Affected Vehicles	U.S.A. & CANADA: Certain 2010-2014 Model Year Volkswagen vehicles <i>Check Campaigns/Actions screen in Elsa on the day of repair to verify that a VIN qualifies for repair under this action. Elsa is the <u>only</u> valid campaign inquiry & verification source.</i> <ul style="list-style-type: none">✓ Campaign status must show "open."✓ If Elsa shows other open action(s), inform your customer so that the work can also be completed at the same time the vehicle is in the workshop for this campaign.
Problem Description	Hair or other fibers may contaminate the airbag clock spring (a spiral wound, flat cable that keeps the airbag powered while the steering wheel is being turned). This contamination may tear the cable and result in a loss of electrical connection to the driver's frontal airbag. A loss of electrical connection to the driver's frontal airbag will prevent the airbag from deploying in the event of a vehicle crash, increasing the risk of injury.

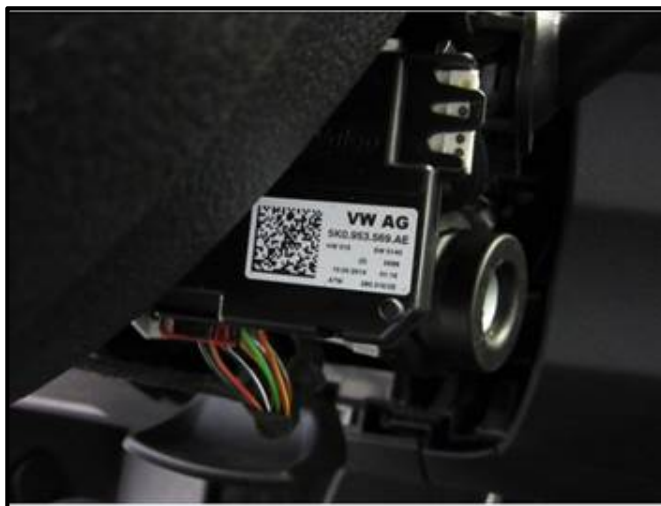
- <Position A> indicates the 8 o'clock position.
- <Position B> indicates the 4 o'clock position.
- Inspect the part number on the clock spring label <as shown>.
- If the part number suffix is "AL, AK, AS, or AR", the clock spring cover MUST NOT be installed. Reassemble the steering column trim and **Proceed to Section E**
- If the part number suffix is **NOT** "AL, AK, AS, or AR" – **proceed to the next step.**
