SERVICE BULLETIN

Beechcraft

TITLE: PROPELLERS - PROPELLER SLIP RING MOUNTING PLATE INSPECTION AND REPAIR

Beechcraft Model 58 Baron, Serials TH-1889 through TH-2093.

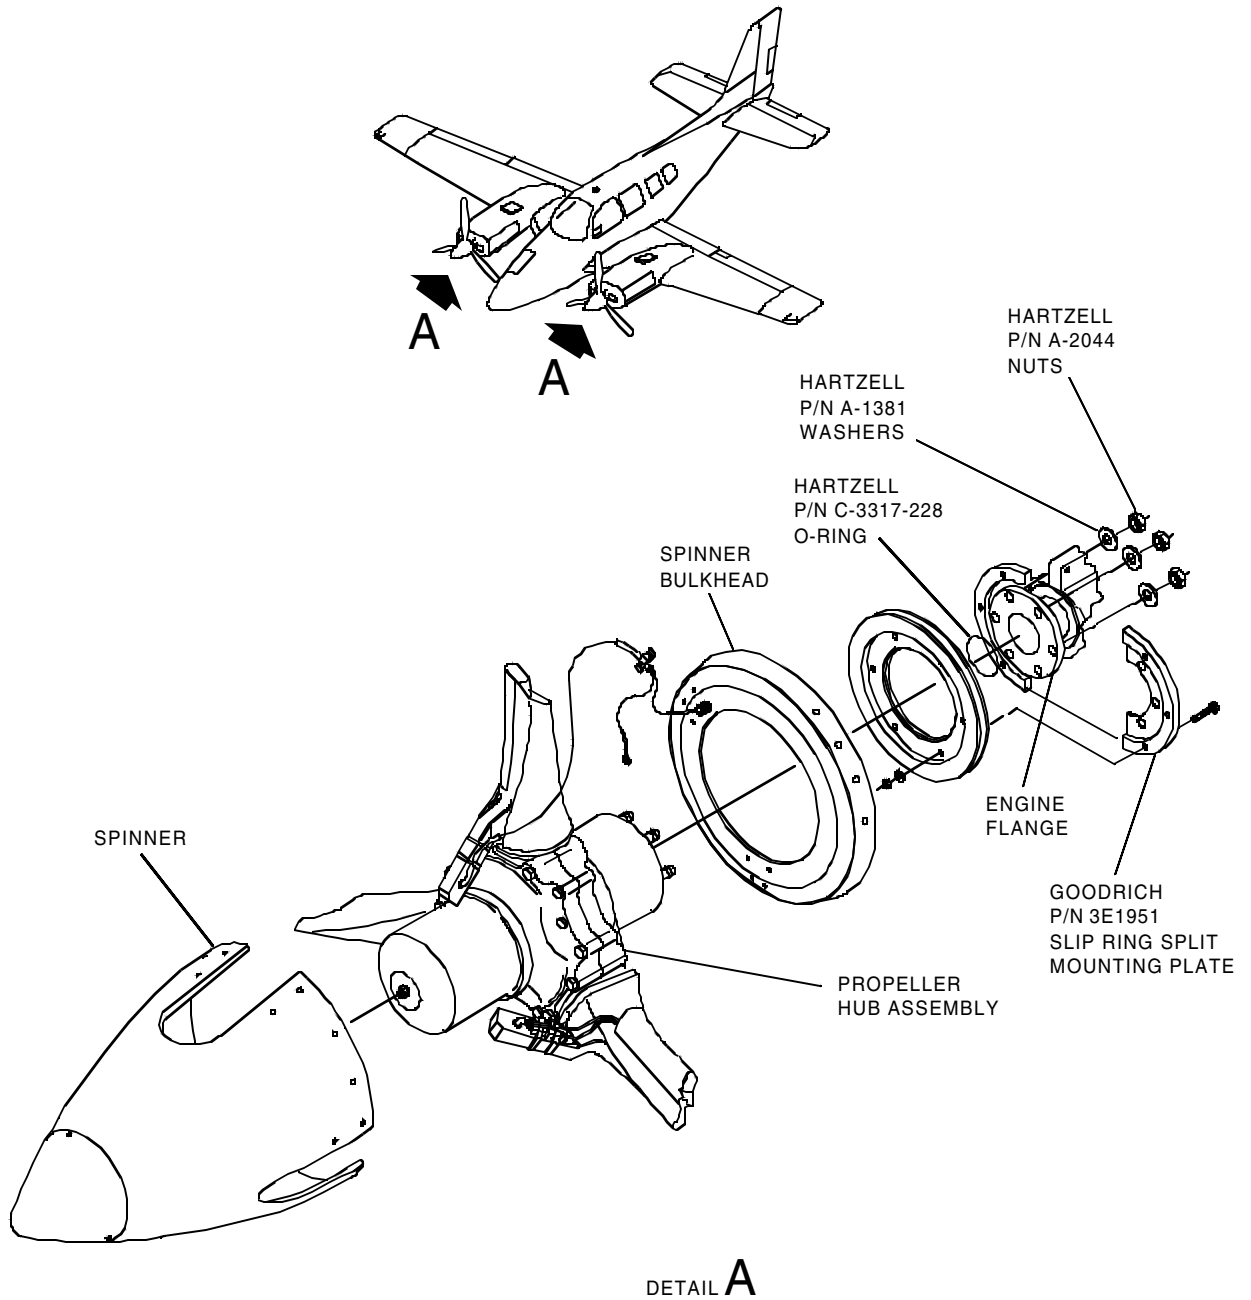
**Installation of Hartzell 3 Blade Propeller with Goodrich Electrical Propeller Deicing
Figure 1**

Part I of this Service Bulletin provides an initial torque inspection which checks the torque on the propeller mounting nuts to ensure that the mounting nuts are properly torqued on each propeller installation (both the left and right engines of the airplane). Refer to Figure 1. Part I of this Service Bulletin also requires the replacement of propeller hub assembly on any propeller installation that has two or more propeller mounting nuts that do not pass the initial torque inspection. Part I of this Service Bulletin must be accomplished in accordance with Hartzell Service Bulletin No. HC-SB-61-272 on each propeller installation (both the left and right engines of the airplane). After ensuring that the propeller mounting nuts are properly torqued and accomplishing the propeller hub assembly replacement (as applicable), the airplane may be returned to service until accomplishment of Part II of this Service Bulletin is required by the time limits specified under COMPLIANCE.

- (1) On each propeller installation (both the left and right engines of the airplane), accomplish Hartzell Service Bulletin No. HC-SB-61-272 to: 1) inspect the torque of the propeller mounting nuts and 2) replace the propeller hub assembly as applicable. Refer to Figure 1.
- (2) After accomplishing Hartzell Service Bulletin No. HC-SB-61-272 on each propeller installation (both the left and right engines of the airplane), make a logbook entry noting compliance with Part I of this Service Bulletin.
- (3) The airplane may be returned to service until accomplishment of Part II of this Service Bulletin is required by the time limits specified under COMPLIANCE. If Part II of this Service Bulletin is to be accomplished at a later date, proceed to COMPLETION OF INSPECTION/MODIFICATION. If Part II of this Service Bulletin is to be accomplished at this time, proceed to PART II.

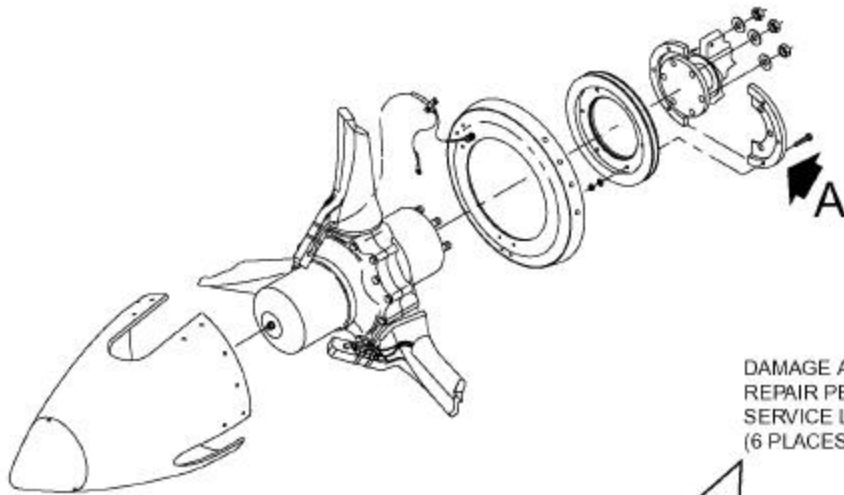
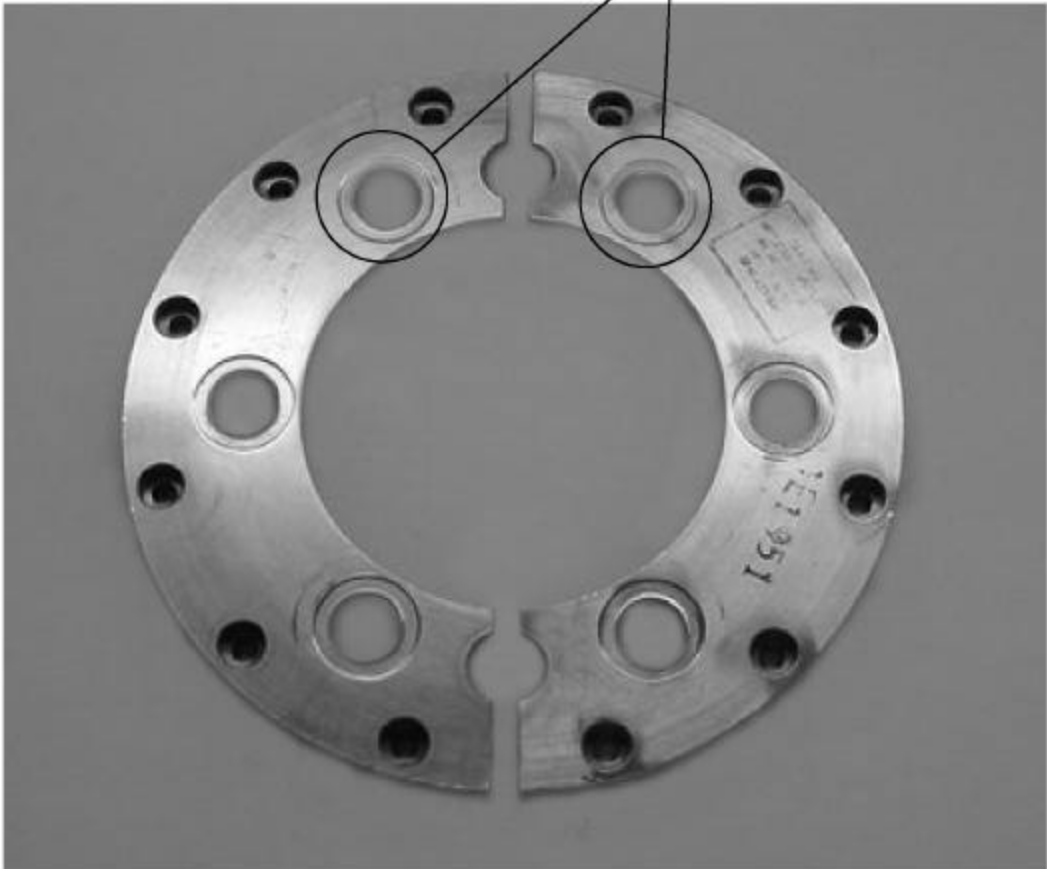
Goodrich Electrical Propeller Deicing Slip Ring Split Mounting Plate
Figure 2 (Sheet 1 of 2)

- Hartzell Service Letter No. HC-SL-61-239 inspects the area around the mounting holes in the propeller slip ring split mounting plate for any scoring, gouging or other damage that could be caused by the propeller mounting nuts when securing the slip ring split mounting plate without the propeller mounting washers being installed. In addition, the Hartzell Service Letter accomplishes any applicable repairs to the propeller slip ring split mounting plate and installs a Hartzell P/N A-1381 propeller mounting washer between each propeller mounting nut and the propeller slip ring split mounting plate.

Any propeller slip ring split mounting plate that has surface damage around a mounting hole may permit the applicable propeller mounting nut to lose torque

DAMAGED MOUNTING PLATE

and must be repaired. Remove any surface damage using a Bridgeport, or equivalent, (recommended) with a 15/16 inch counterbore piloting tool with a 0.005 inch maximum corner radius. Removal and installation of the propeller slip ring split mounting plate must be accomplished in accordance with Section 11 of the Beechcraft Baron 55 and 58 Shop Manual and the applicable Hartzell Propeller Manual(s).

- (1) On each propeller installation (both the left and right engines of the airplane), accomplish Hartzell Service Letter No. HC-SL-61-239 to: 1) inspect the area around the mounting holes in the propeller slip ring split mounting plate for any scoring, gouging or other damage that could have been caused by the propeller mounting nuts, 2) accomplish any applicable repairs to the propeller slip ring split mounting plate and 3) install a Hartzell P/N A-1381 propeller mounting washer between each propeller mounting nut and the propeller slip ring split mounting plate. Refer to Figures 1 and 2.

DAMAGE AREA
REPAIR PER HARTEZLL
SERVICE LETTER HC-SL-61-239
(6 PLACES)

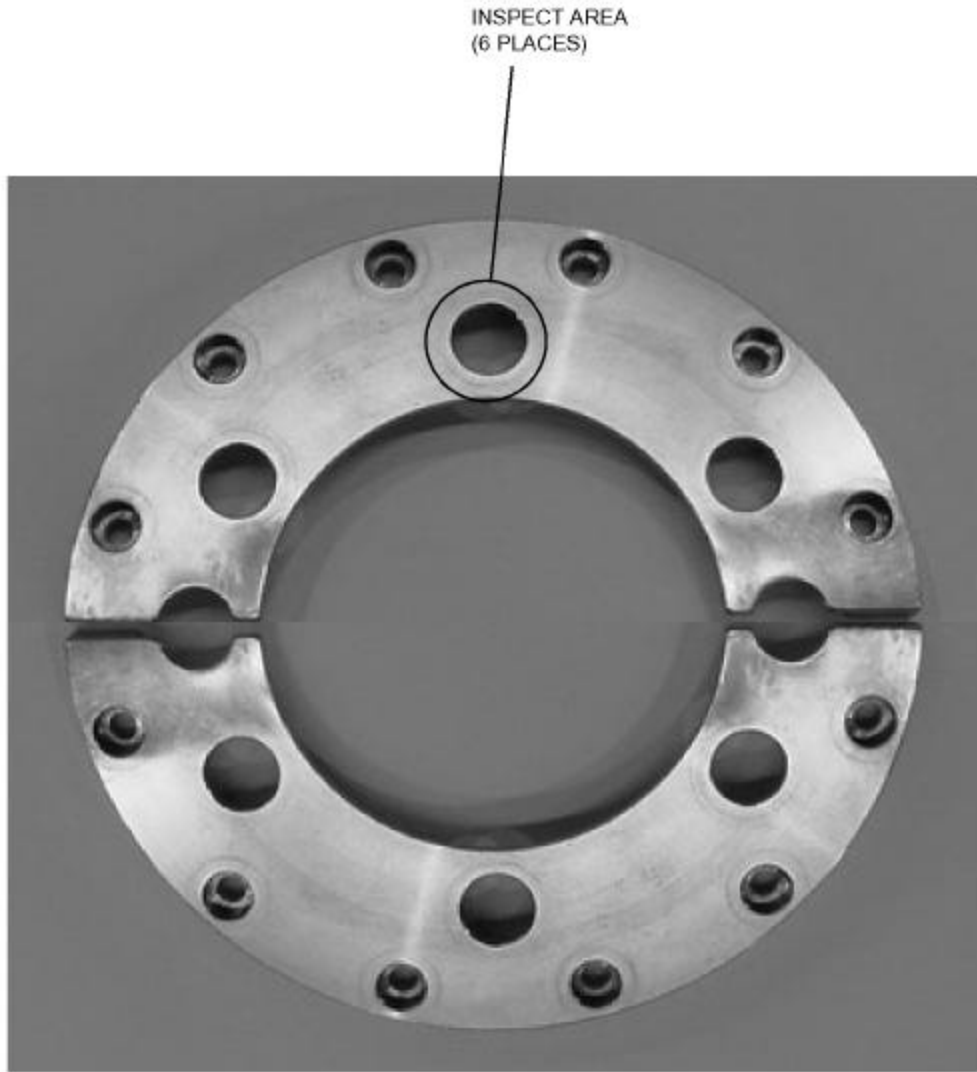
Goodrich Electrical Propeller Deicing Slip Ring Split Mounting Plate
Figure 2 (Sheet 2 of 2)

UNDAMAGED MOUNTING PLATE

The propeller slip ring split mounting plate is installed on the aft side of the engine mounting flange and should be secured with a Hartzell P/N A-1381 propeller mounting washer installed between each propeller mounting nut and the propeller slip ring split mounting plate.
