SERVICE CAMPAIGN BULLETIN

SUBJECT:			No: SC-15-003REV
POTENTIAL TRANSMISSION SHUDDER/SURGE – SERVICE CAMPAIGN – REVISED			DATE: October, 2016
			MODEL: 2015 Outlander Sport/ RVR
CIRCULATE TO:	<input checked="" type="checkbox"/> GENERAL MANAGER	<input checked="" type="checkbox"/> PARTS MANAGER	<input checked="" type="checkbox"/> TECHNICIAN
<input checked="" type="checkbox"/> SERVICE ADVISOR	<input checked="" type="checkbox"/> SERVICE MANAGER	<input checked="" type="checkbox"/> WARRANTY PROCESSOR	<input checked="" type="checkbox"/> SALES MANAGER

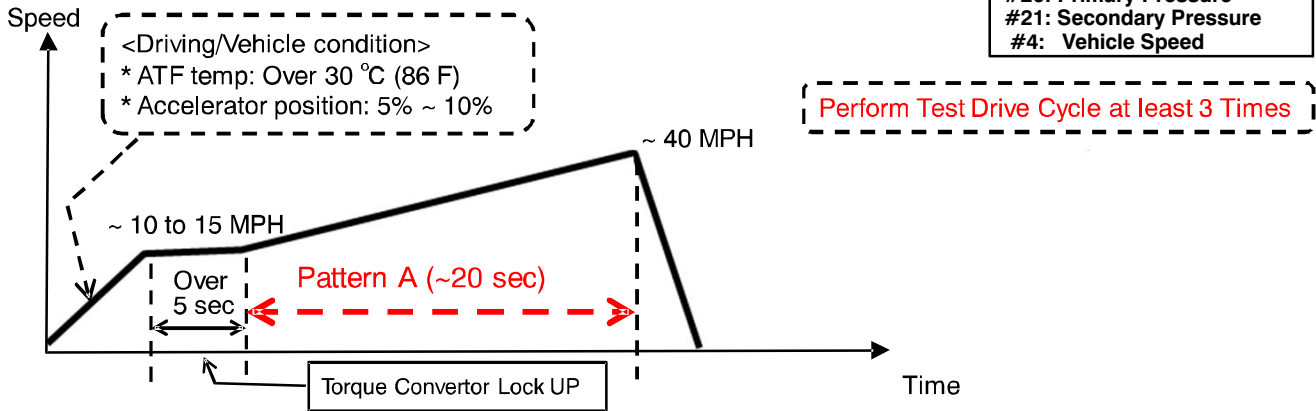
FIGURE 1. Test Drive Procedure for Duplicating CVT-8 Shudder

Drive Record Items:
 #15: Accelerator Position
 #20: Primary Pressure
 #21: Secondary Pressure
 #4: Vehicle Speed

Condition	Driving Criteria	Judgment Criteria
Pattern A (Slow acceleration)	Shudder	<ul style="list-style-type: none"> Slow & gentle acceleration 10 to 40 MPH Constant acceleration Approximately 10% throttle angle Slight uphill grade or flat road 	<ul style="list-style-type: none"> Vehicle shuddering is felt Can be described also as a "bucking" Can also be described as a "judder" or repeated "jerking"

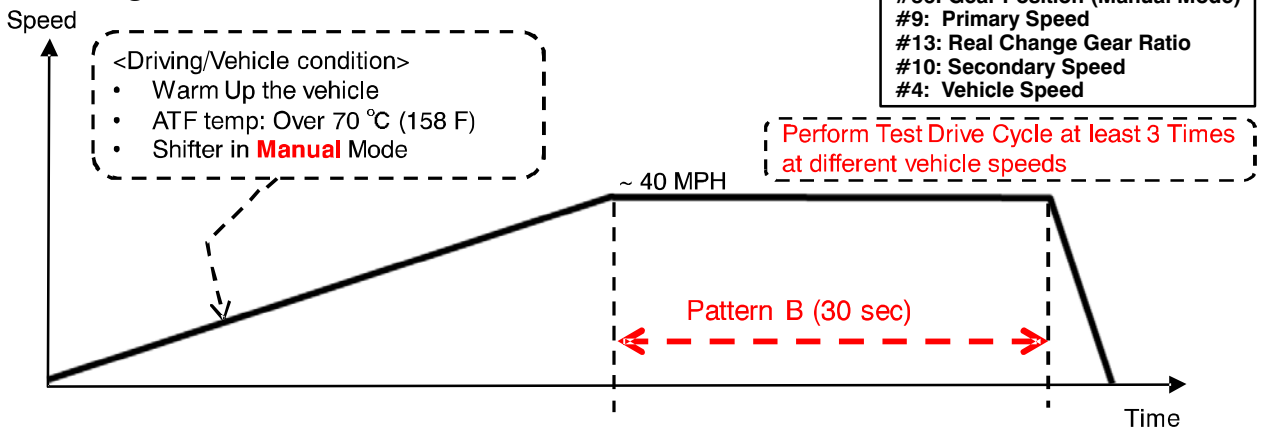
FIGURE 2. Test Drive Procedure for Duplicating CVT-8 Surge/Flare

Drive Record Items:
 #11: Engine Revolution
 #56: Gear Position (Manual Mode)
 #9: Primary Speed
 #13: Real Change Gear Ratio
 #10: Secondary Speed
 #4: Vehicle Speed

Condition	Driving Criteria	Judgment Criteria
Pattern B (Constant Vehicle Speed)	Surge/Flare	<ul style="list-style-type: none"> Steady speed highway driving (follow all applicable laws) <ul style="list-style-type: none"> ~ 40 MPH ~ 50 MPH ~ 65 MPH ATF Temp > 158 F (warmed up) Shifter in Manual Mode 	<ul style="list-style-type: none"> Engine RPM surging or flaring (more than 200 RPM from base) at steady state vehicle condition
