SEISMIC EVALUATION OF HOSPITAL PIPING SYSTEMS

SUMMARY

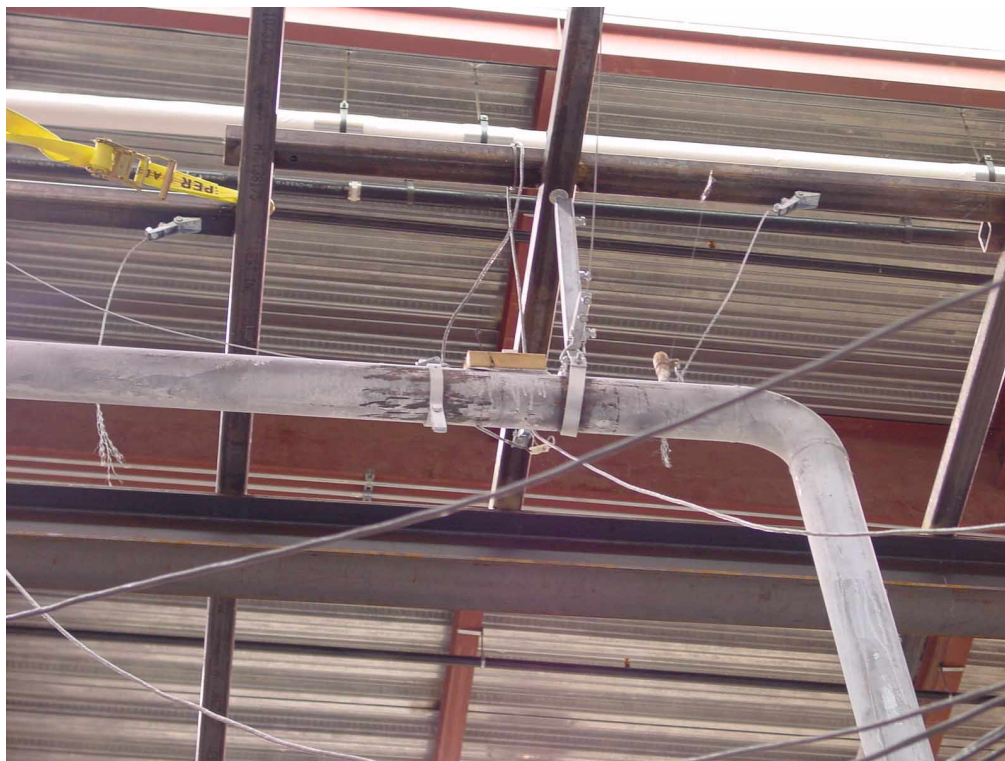
Figure 10. Brace #B11 Failure

During the braced E-W 100% SIMQKE input motion two braces failed. The cable portion of both longitudinal brace #B11 and the transverse brace #B10 (see Figure 5 for brace positions) failed. Figure 10 illustrates the failure at the longitudinal portion of brace #B11. The flanged connection joining the heat exchanger to the pipe began to leak, as shown in Figure 11, during the 10" dynamic pushover.

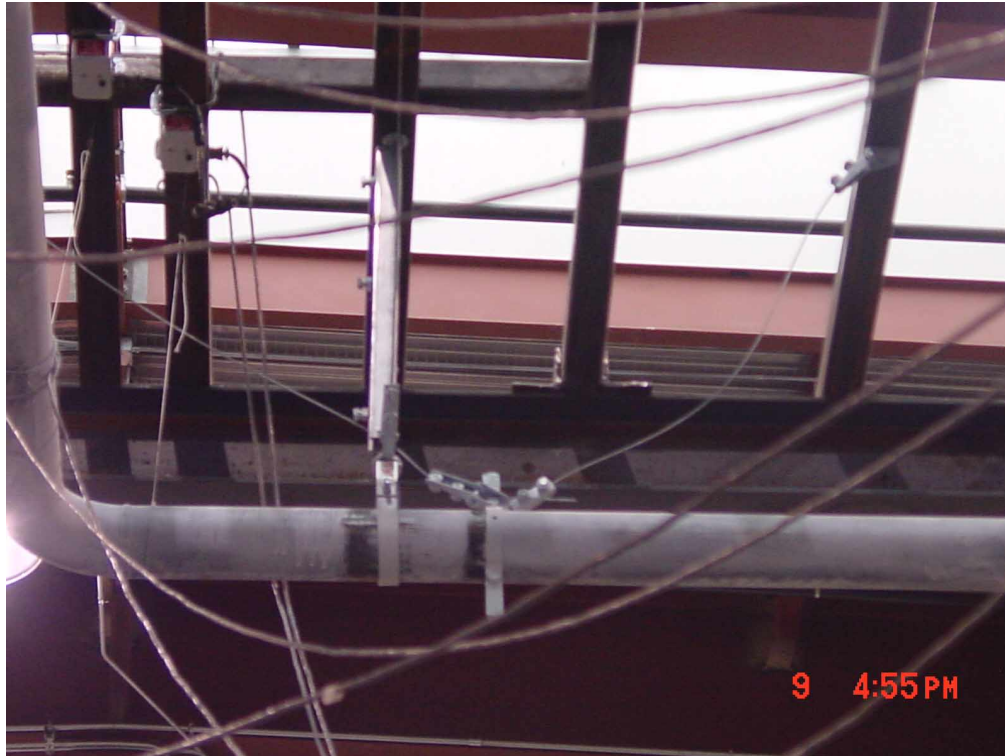
Figure 12. Permanent Displacement of Brace #B7

White washing the surface of the pipes not only aided in identifying leaks, but also illustrated the permanent relative displacement of the braces to the piping system. Figure 12 shows that brace #B7's clevis scraped off the whitewash in the places it had touched the pipe during the excitation. Every brace point had at least 1" of permanent displacement after the testing of the braced system and brace #B2 moved permanently 4".
