SEISMIC PERFORMANCE OF MASONRY BUILDINGS DURING RECENT EARTHQUAKES IN TURKEY

A. Doğangün¹, A. Ural² and R. Livaoglu³

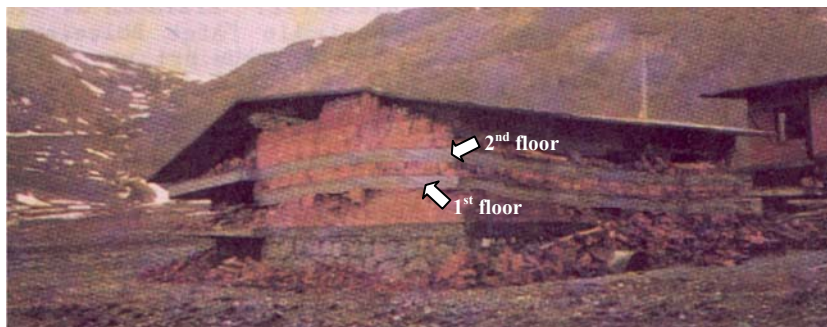
structures whereas they are not classified as masonry structures technically due to exceeded void ratio for brick. Although the usage of them is improper in a bearing wall application, even such a slight variation in shape had repercussions on seismic behavior (Bruneau & Saatçioğlu, 1994). Observed heavy damages and collapses of the buildings in the earthquake regions are generally associated with hollow clay tiles used instead of solid brick units. Fig. 6 shows a collapsed two-storey unreinforced masonry building in which load-bearing walls with hollow clay tiles were cut laterally.

Figure 6 Two-storey building collapsed during Erzincan Earthquake (Bayülke & Doğan, 1993)

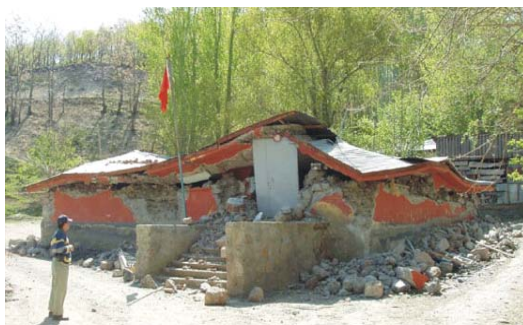
Mortars to be used in load-bearing walls shall be lime mortar enhanced with cement (cement/lime/sand volumetric ratio=1/2/9) or cement mortar (cement/sand volumetric ratio=1/4) according to TEC (2007). But it is not generally observed that mortar quality was the same one defined in the codes. Poor quality mud or cement mortar caused in the disintegration of masonry units and loss of support to floors as shown in Fig. 7. Especially, mud-stone masonry structures collapsed or were heavily damaged even in small earthquakes due to poor mud mortar and insufficient anchorage between mud and stone. Many people and animals have lost their lives under debris of these structures. So, this structural system should not be constructed in the earthquake zones or some wood structural elements should be inserted in this system adequately to prevent total collapse.

(a) Poor cement mortar in the elementary school building (Emre et al, 2003)

Figure 7 Collapsed and damaged masonry units due to poor mortar during Bingöl Earthquake

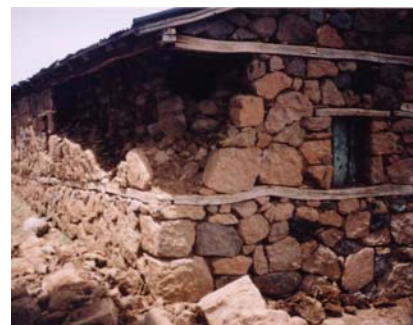
(b) Poor mud mortar

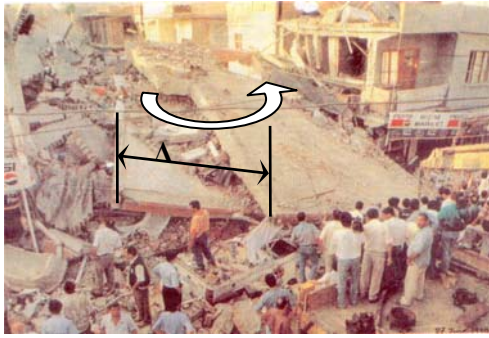
Load-bearing walls of masonry buildings must be arranged in plan, as much as possible, regularly and symmetrically in respect of the two main axes. Fig. 8a shows a collapsed three-storey masonry building subjected to torsion opposite of clockwise.

(a) Damaged during Ceyhan Earthquake (Tezcan & Boduroğlu, 1998)

Figure 8 Collapsed three-storey masonry building and RC storey resting on stone masonry storey

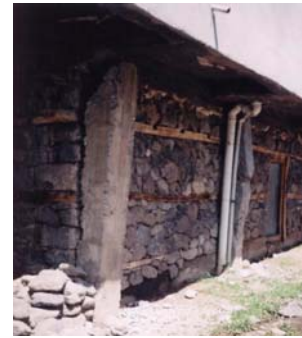
(b) Damaged during Bingöl Earthquake

It may be seen in Turkey that some masonry buildings in which different types of masonry units (stone, solid brick and hollow clay tiles) used for every different storeys exist. In these cases, lateral rigidities of every storey were very different from each other. The worse, it is still possible to see a reinforced concrete storey is resting on a stone masonry ground storey (columns are located only in sides of the building) as shown in Fig. 8b or a masonry storey constructed on the reinforced concrete storey. The different stiffness and weight of these upper storeys increase the risk of failure.

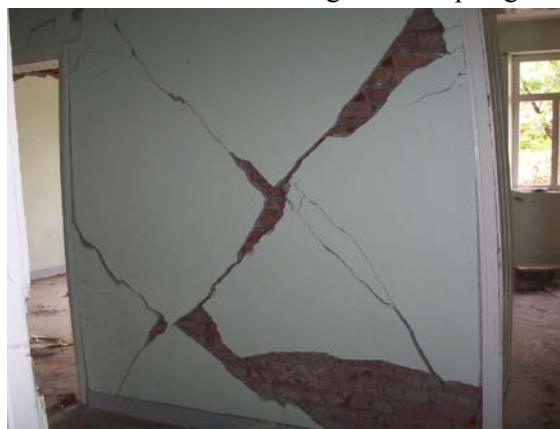
According to TEC, the ratio of the total length of masonry load-bearing walls in each of the orthogonal directions in plan (excluding window and door openings), to gross floor area (excluding cantilever floors) shall not be less than $0.25 I$ (m/m^2) where I represents Building Importance Factor changing between 1.0 and 1.5. Total length of the load-bearing walls is the main important factor for masonry building damages occurring during the earthquakes. Excessive bending and shear may produce in-plane failures, depending on the aspect ratios of the unreinforced masonry elements. Many masonry buildings had sustained very significant damage to walls, in the form of X (double-diagonal shear) cracking, typical of weak unreinforced masonry walls in shear as shown in Fig. 9. However, this cracking seldom reaches total collapse. But the triangular sections of the X crack can become unstable leading to collapse when a full X crack occurs during an earthquake (Decanini et al, 2004). This cracking was not only apparent to masonry buildings but also the most commonly observed damage in reinforced concrete structures was in the form of cracking and collapsing of infill walls.

Figure 9 Typical X cracks occurred in the load-bearing inner walls during Bingöl Earthquake

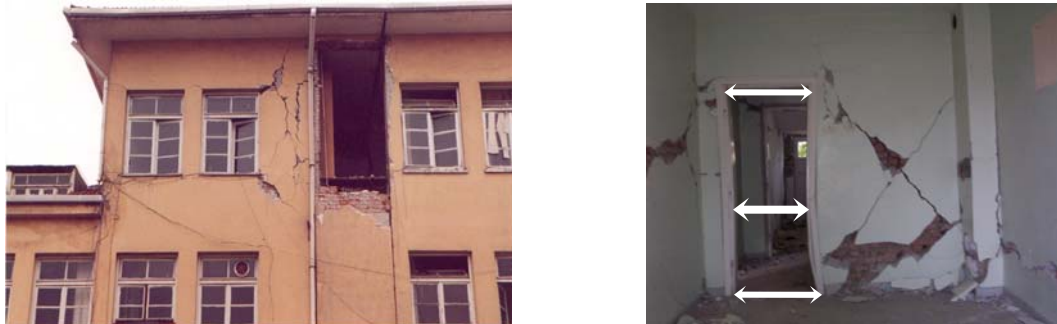
Vertical confining elements (see Fig.2) should be located at the end of the load-bearing walls, at the both sides of the doors and windows opening. Fig. 10 shows two damaged masonry buildings due to the lack of vertical confining elements. Side of load-bearing wall next to joint space failed as shown in Fig. 10a and the door opening was extremely narrowed around the middle of the door height as shown in Fig. 10b due to the lack of vertical confining elements.

(a) Damage during Kocaeli Earthquake

(b) Damage during Bingöl Earthquake

Figure 10 Damaged masonry buildings due to lack of vertical confining elements.

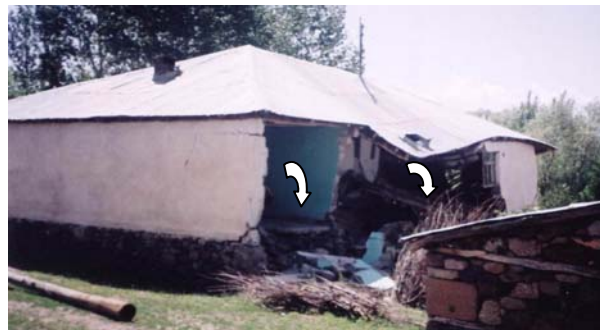
Unreinforced masonry buildings are the most vulnerable to flexural out-of-plane failure. If the connection between the walls and floors is not adequately restrained, the whole wall panel or of a significant portion of it will overturn due to seismic excitation in the perpendicular direction to the wall plane. Fig. 11 shows a view of out-of-plane collapse of load bearing walls. Added vertical R/C confining elements contribute to earthquake resistance of the wall; in this manner, out-of-plane failure does not easily occur.

Figure 11 A view of load bearing walls collapsed in the out-of-plane direction during Bingöl Earthquake

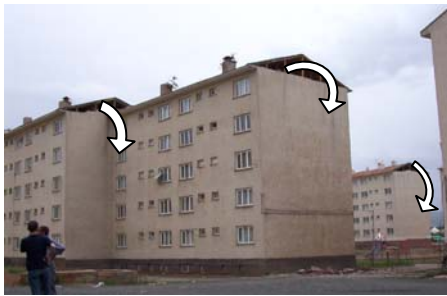
Parapet and gable wall failures fall into this category. If unrestrained these non-structural unreinforced masonry elements behaves as a cantilever wall extending beyond the roof line (Bruneau, 1994). Gable walls located at the top of the buildings are subjected to the greatest amplification of the ground motions, and are consequently prone to flexural failures under the roofs. The falling of gable walls of lodgings for security personals as shown in Fig. 12a caused broking about 20 cars and the falling of gable wall as shown in Fig. 12b caused death of a child during Bingöl Earthquake. Authors also observed many building damages and vulnerability of people and cars due to falling of gable walls during Erzincan, Kocaeli and Düzce Earthquakes. It is stated in the masonry buildings section of TEC that in the case where the height of the end wall resting on the horizontal bond beam at the top storey exceeds 2m, vertical and inclined bond beams shall be constructed. But almost all the buildings which have large gable walls in the earthquake region did not satisfy this requirement.

(a) Falling of gable walls caused broking about 20 cars

Figure 12 Typical out-of-plane failure of unanchored gable walls during the Bingöl earthquake

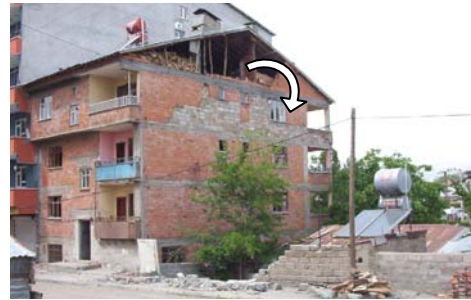
(b) Falling of gable wall caused death of a child

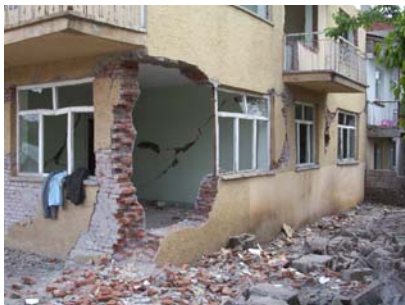
Another failure can be the formation of vertical cracks at the corners of an unconfined masonry building in which the wall begins to form a hinge from the swaying. Failures and cracks at the corners occurred because of the insufficient connections between the walls and floors (Fig. 13). As seen in Fig. 13a, the failure occurred in the bearing wall between the window and the corner. If there were vertical confining elements at the corners, these elements would have contributed to the earthquake resistance of the wall. Fig. 13b shows separation of adjacent walls due to connection of stresses at the building corners and poor connection between walls. Likewise, for all types of masonry buildings, this has been playing a vital role in the damage. According to TEC, plan length of the load-bearing wall segment between the corner of a building and the nearest window or door opening to the corner shall not be less than 1.5 m in the first and second seismic zones (maximum ground accelerations are assumed in these zones as 0.4g and 0.3g, respectively). Again, vertical confining elements are recommended for confined masonry buildings to prevent this type of failure occurred around the corner.

(a) Damaged during Bingöl Earthquake

Figure 13 Collapse of a corner and vertical cracks near the corner for masonry buildings

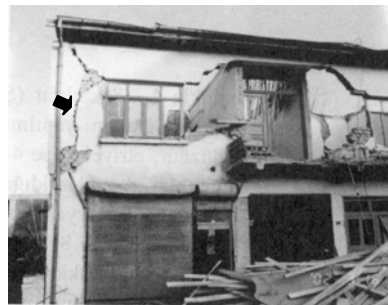
(b) Damaged during Sultandağı Earthquake (Ulusay et al, 2002)

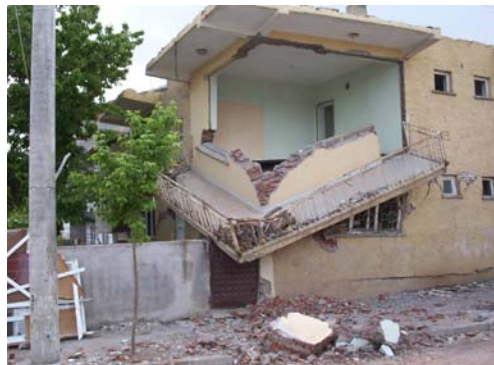
According to the TEC, the free cantilever length should not be more than 1.5 meters. This requirement is not enough to describe inadequate cantilever elements for masonry buildings. If vertical component of the ground acceleration is large and cantilever is a heavy one, the mass of cantilever can be a very important parameter for seismic behaviour. As seen from Fig.15, the balcony is weakly supported due to window openings in the bearing wall and lack of R/C vertical and horizontal elements. In addition, corner walls constructed inadequately at the upper storey collapsed and applied a force to the end point of the balcony span. As a result, heavily damage was occurred on this part of the masonry building. The upper storey balcony did not collapse due to smaller dead loads, continuous horizontal bond beams and absence of walls fallen on it during the earthquake. If this unreinforced masonry structures were confined, this damage would almost prevented.

Figure 15 A failure occurred around the balcony of a masonry building during Bingöl Earthquake
