**SERIOUS INCIDENT**

<b>Aircraft Type and Registration:</b>	ATR 72-212 A, G-COBO	
<b>No &amp; Type of Engines:</b>	2 Pratt & Whitney Canada PW127M turboprop engines	
<b>Year of Manufacture:</b>	2009 (Serial no: 852)	
<b>Date &amp; Time (UTC):</b>	4 March 2016 at 09:15 hrs	
<b>Location:</b>	On departure from Manchester Airport	
<b>Type of Flight:</b>	Commercial Air Transport (Passenger)	
<b>Persons on Board:</b>	Crew - 4	Passengers - 27
<b>Injuries:</b>	Crew - None	Passengers - None
<b>Nature of Damage:</b>	None	
<b>Commander's Licence:</b>	Airline Transport Pilot's Licence	
<b>Commander's Age:</b>	58 years	
<b>Commander's Flying Experience:</b>	8,276 hours (of which 928 were on type) Last 90 days - 113 hours Last 28 days - 49 hours	
<b>Information Source:</b>	AAIB Field Investigation

**Synopsis**

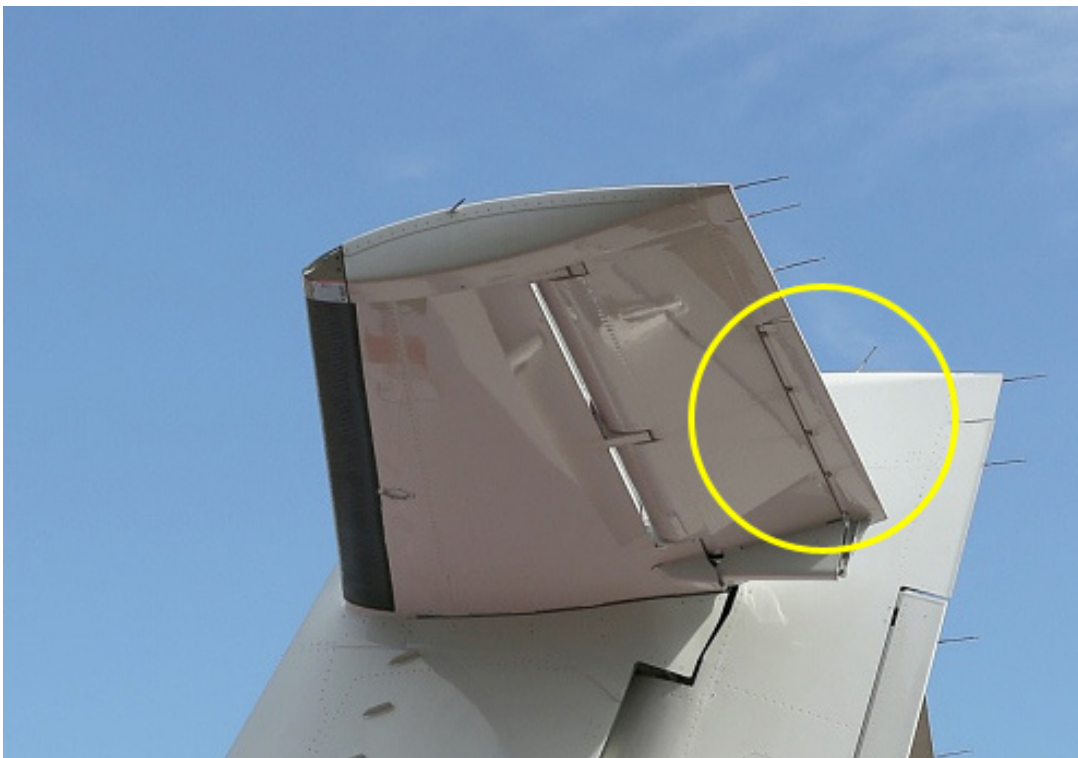
**Figure 2**

Two elevators provide pitch control and both have associated trim tabs. The left horizontal tailplane assembly is shown at Figure 2 with the trim tab visible towards the rear of the elevator.

Left side of tailplane assembly showing trim tab (circled) on left elevator

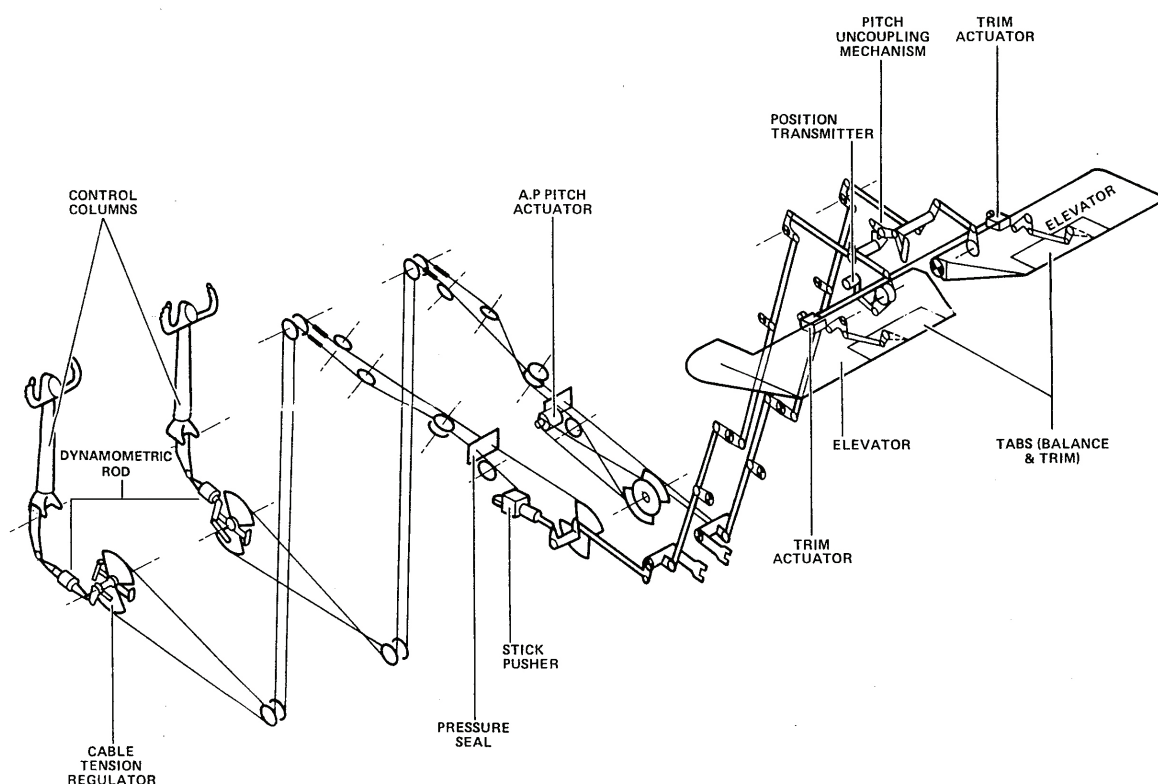
**Figure 3**

Each control column mechanically drives the elevator on the associated side. The elevators are linked by an uncoupling mechanism, so that movement of one elevator moves the other and this causes the control column on the other side to move. In the event of a control jam, applying a force of approximately 50 daN<sup>5</sup> on the free control column will trigger the uncoupling mechanism, leaving each column only linked to its associated elevator (Figure 3).

Schematic diagram of elevator control system

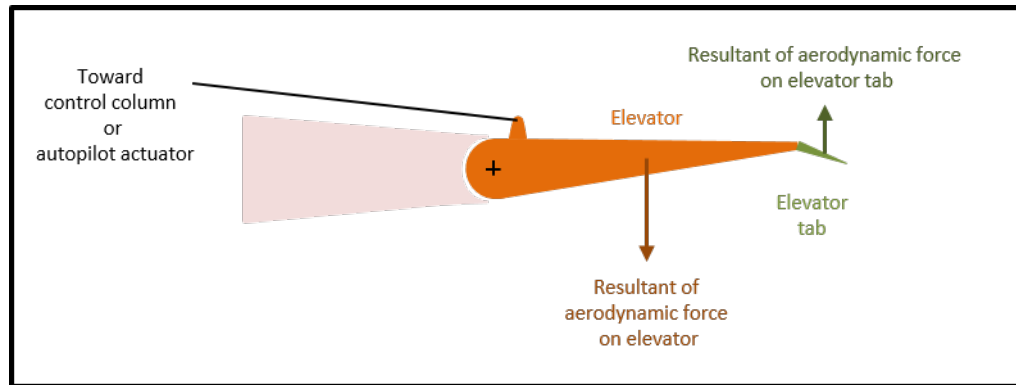
**Figure 4**

If a downward aerodynamic force is applied to the elevator, the elevator deflection can be maintained by applying effort through the control column or through the autopilot pitch actuator. This effort can be cancelled through a pitch trim input which deflects the elevator trim tab downwards and creates an upward aerodynamic moment of equal magnitude to the downward moment on the elevator. In this condition, the elevator hinge moment resulting from elevator and tab aerodynamic forces is null and there is no residual effort on the control column or on the autopilot actuator (Figure 4).

Manufacturer's diagram to illustrate aerodynamic forces in normal flight with pitch trim set

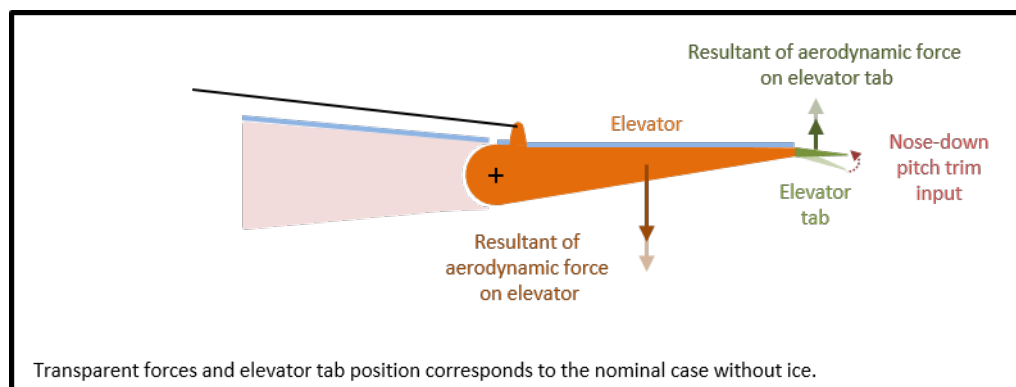
**Figure 5**

Comparison was made with a similar flight condition, with the elevator deflected the same way, but with ice contamination to the upper surface of the horizontal tailplane, which may also extend over the upper surface of the elevator (and possibly over the elevator tab as well). Numerical aerodynamic simulation, using a two-dimensional cross-section of the horizontal tailplane and elevator assembly, showed that a 5 mm layer of ice on the upper surface thickens the airflow boundary layer. The pressure distribution on the lower surface is virtually unaffected by this but the pressure on the upper surface is reduced. Thus, for a given deflection of the elevator, less downward aerodynamic force will result (Figure 5).

Manufacturer's diagram to illustrate aerodynamic forces with an ice-contaminated upper surface and the pitch trim set to compensate

The evidence indicated the horizontal tailplane was affected by ice which formed while the aircraft was on the ground in freezing conditions and was not de-iced/anti-iced. The outcome was uneventful but there is evidence that failure to de-ice/anti-ice adequately could lead to a more serious outcome in certain conditions.
