Applies To: **See VEHICLES AFFECTED**
February 5, 2008

Warranty Extension: Audio-HVAC Display Is Dim or Dark

(Supersedes 04-027, dated November 27, 2007 to update the information marked by the black bar)

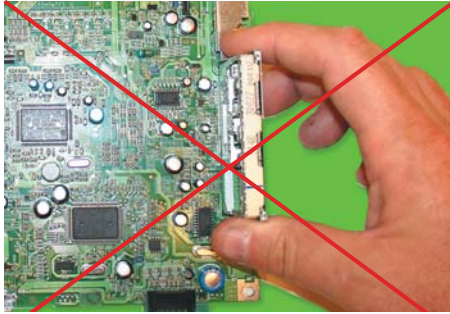
- Handle the PCB only by the edges of the board.
- Always use the anti-static mat and wrist strap when doing this repair.
- Never lift the PCB by the component parts.

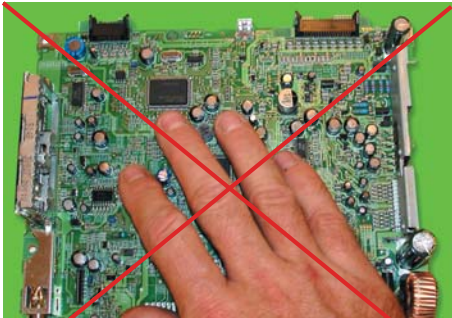
- Never touch the electrical components of the PCB.

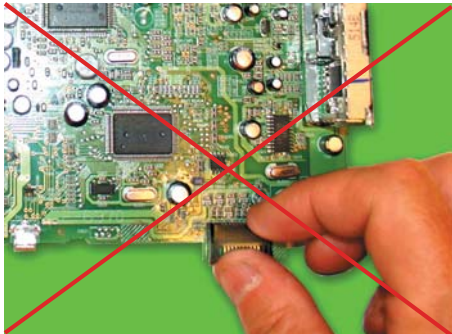
- Never lift or hold the PCB by its connectors.

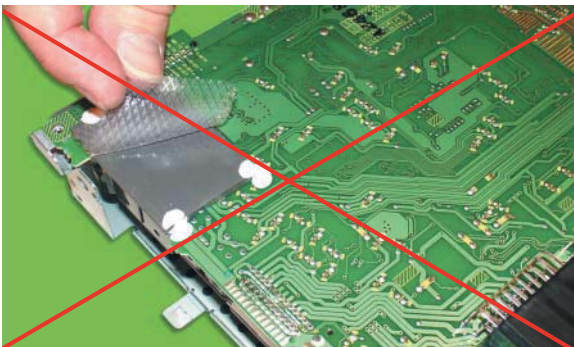
- To prevent damage to the thermal pad, don't remove the protective cover until step 15.
