Service Bulletin

Bulletin No.: 18-NA-020

Subject: Malfunction Indicator Lamp Illuminated with DTC P0300 and/or P0299/P2227 Set

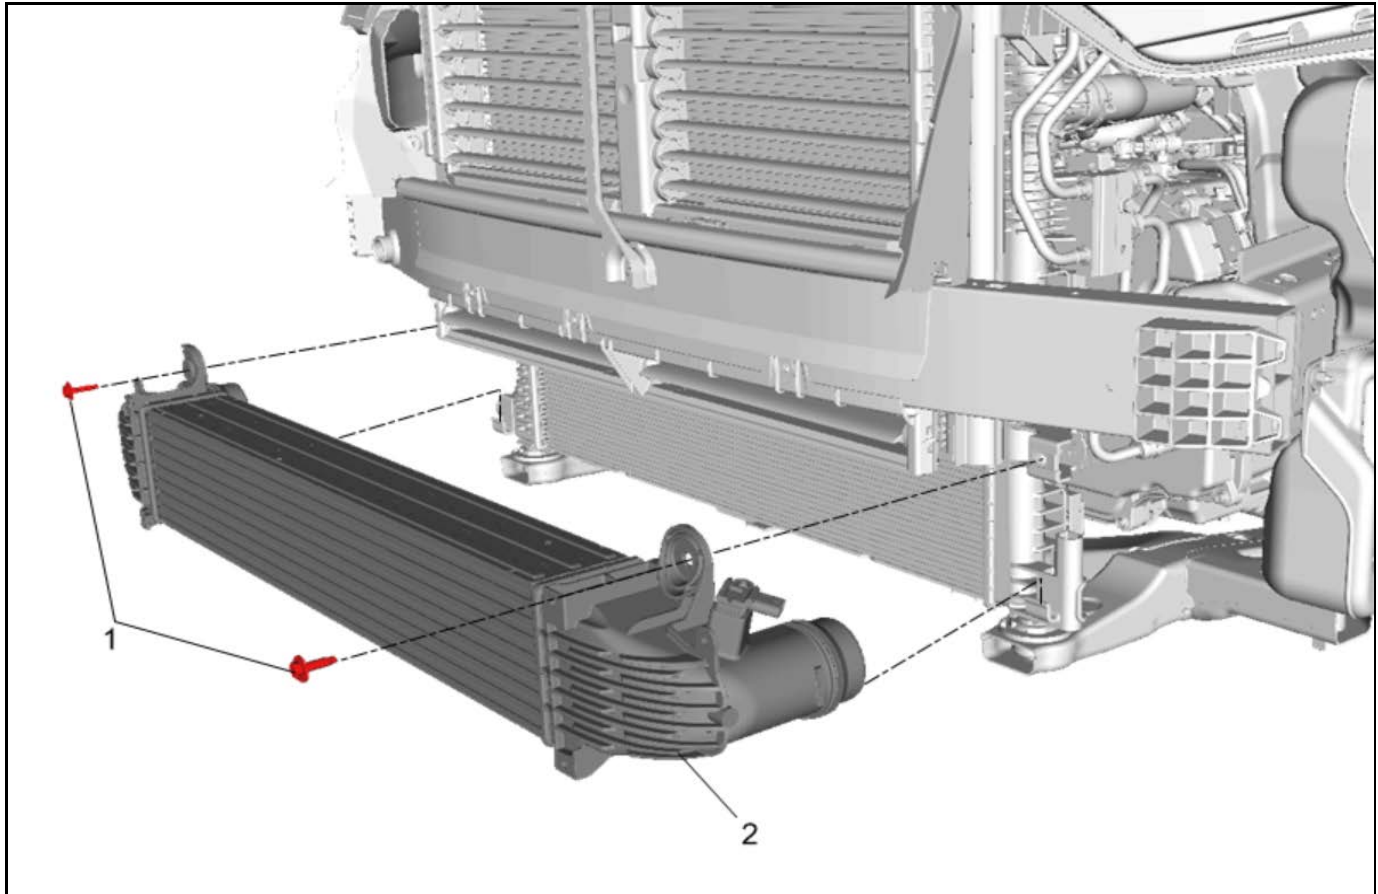
4597334

1. Perform a smoke leak test of the charge air cooler.

- If a leak is determined, replace the charge air cooler with the newly designed part. Refer to *Charge Air Cooler Replacement* in SI.
- If there is NO leak, but a P0300, P0299 and/or P2227 are present, **AND the vehicle was built ON or BEFORE March 1, 2018**, then replace the charge air cooler with the newly designed part. Refer to *Charge Air Cooler Replacement* in SI.
- If there is NO leak, but a P0300, P0299 and/or P2227 are present, **AND the vehicle was built AFTER March 1, 2018**, refer to SI for further diagnosis.
