# Service Bulletin

Bulletin No.: 18-NA-199

**Subject: Sunroof Inoperative After Cycling, and/or Sunroof Window Function Slow**

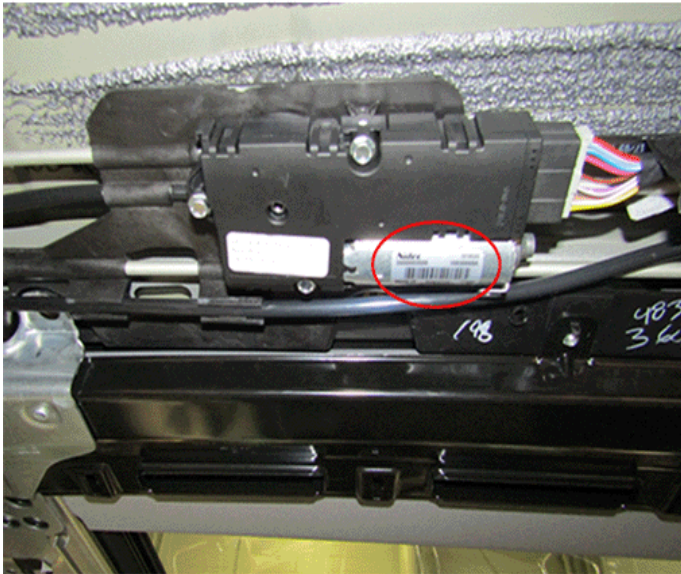
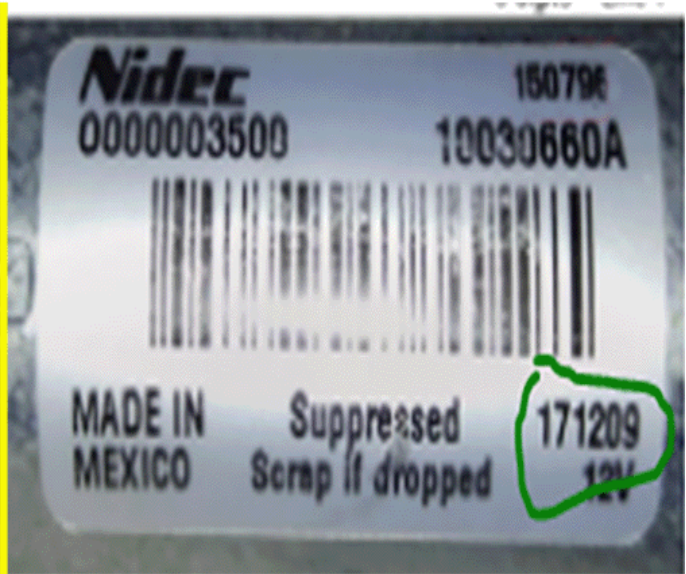
5096958

2. Inspect the supplier's part label on BOTH sunroof motors for the Julian build date, shown circled in green in the graphic above.

**Important:** The Julian date is formatted Year/Month/Day, so the example above would have been manufactured December 9, 2017. Therefore any motor before 180201 (February 1, 2018) is suspect.

3. Any motor manufactured prior to February 1, 2018 is in the suspect range, and will need replacement. Refer to *Sunroof Window Motor Replacement* and/or *Sunroof Sunshade Motor Replacement*, in SI.
  - **For vehicles with the new motors installed,** cycle the sunroof 2 complete cycles. If condition is no longer present, no further repairs are necessary and the headliner can be reinstalled. Refer to *Headlining Trim Panel Replacement*, in SI.

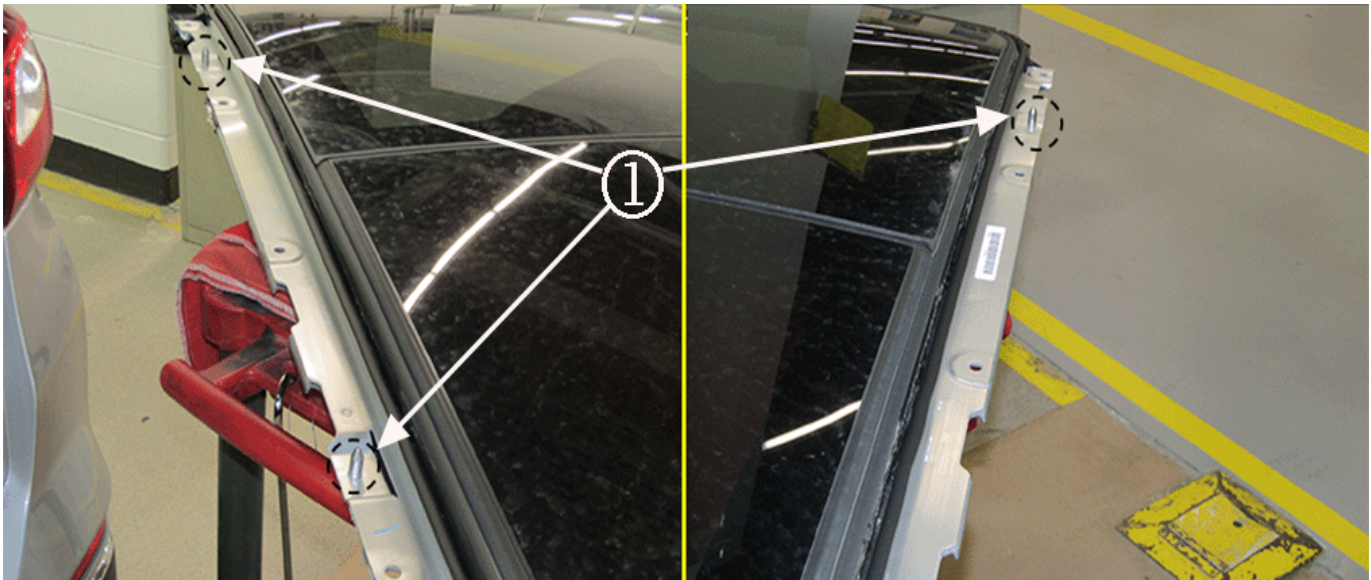
5096967

**Note:** The graphic above, and one following, shows the sunroof housing removed for clarification purposes only. It is not necessary to remove the housing from the vehicle.

7. Locate the 3 sunroof housing locator pins (1); 2 on the left side and 1 on the right.

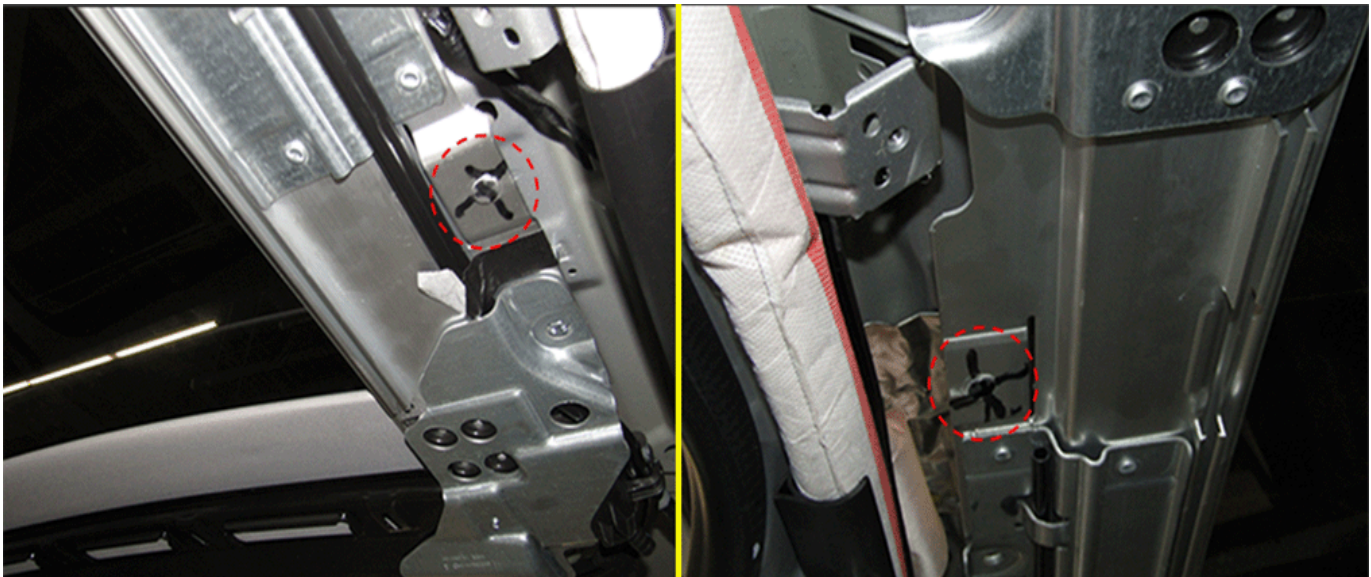
5096975

**Note:** The graphic below shows an underside view of the locator pins, in vehicle.
