SERVICE BULLETIN

Inspection of turbocharger assy. for ROTAX® Engine Type 915 i A and 915 i B (Series)

ATA System: 78-10-00 Exhaust system

MANDATORY

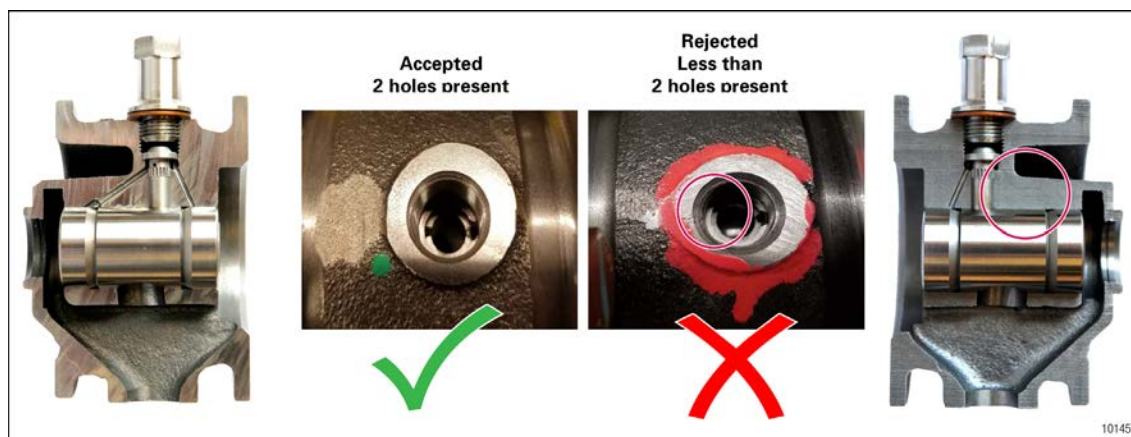
Fig. 7

Internal quality checks have shown that in isolated cases, an oil supply gallery within the turbocharger Center Housing Rotating Assembly (CHRA) may not be present. In rare cases, this may lead to inadequate lubrication causing turbocharger damage and subsequently loss of engine power.

| Step | Procedure |
|---|--|
| 1 | With good lighting, inspect the CHRA oil inlet for lubrication bores. 2 drilled oil bores must be present on turbine and compressor side of CHRA. NOTE: If possible or necessary record your findings by means of a camera from a smart device (e.g. cell phone). |

| Step | Procedure |
|---|--|
| 2 | If both drilled lubrication bores are present, the turbocharger is not affected per section 3.2. NOTE: If both bores are present, mark the center housing with a green dot near the oil inlet. |
| 3 | If one of the 2 oil bores is missing, the turbocharger must be replaced by following the instructions of the latest Maintenance Manual Heavy for the respective engine type. This turbocharger is defective and must be removed and quarantined. Circle the oil inlet with red marker. NOTE: Contact your nearest ROTAX® Authorized Distributor or their independent Service Centers for required parts and next steps. |

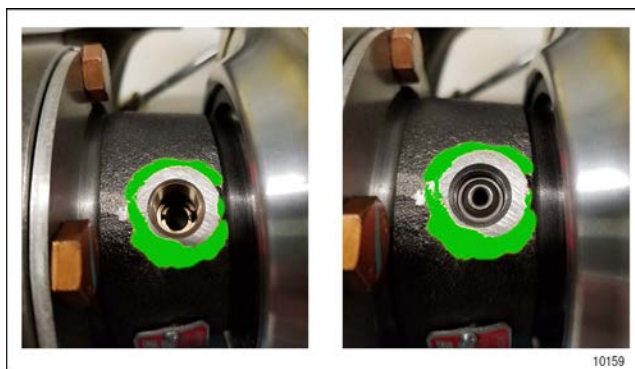
Fig. 8

| Step | Procedure |
|---|--|
| 4 | Check to make sure the bearing has not been disturbed and the bearing hole is in line with the pin hole. NOTE: The bearing must be rotated with a pick, if the holes are not in line. |

NOTICE Failure to check for that and to do so may result in damage when installing the pin.
