SERVICE UPDATE SEMINAR

2017-2018

Proper Preparation and Diagnosis of Subsequent Valve Cover Failures with RTV Sealant

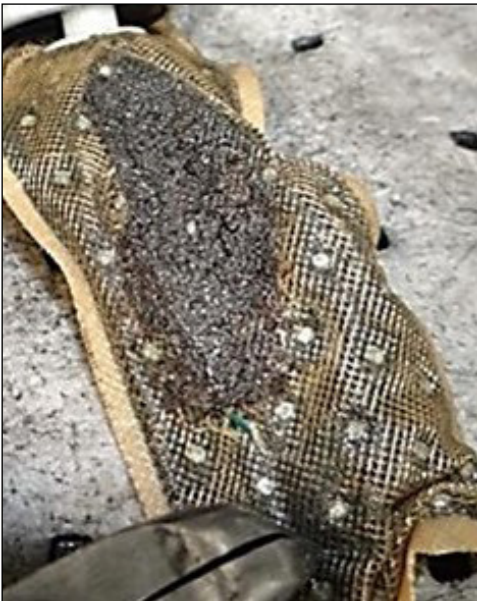
There have been fuel pump modules being returned to the factory with no defects found and testing operationally good, many are being returned with significant amounts of internal debris which is an indication of improper fuel filter usage. We want to discuss proper testing procedures and fuel pump module information to assist with proper diagnosis and servicing of fuel pump modules and help you educate your large fleet customers that may be performing their own preventative maintenance.

The micron ratings used in different fuel filters and applications is important to maintain through the regular service procedures. Micron ratings before the lift pump will be relatively standard (51-75 micron) and the filter used after the lift pump between the fuel pump module needs to be a 10-micron filter. It is imperative that an approved 10-micron filter is used and replaced following the maintenance schedule indicated in the service manual. Many cross-referenced filters do not meet specification with micron ratings up to 80 or beyond.

**Filter Inside Fuel Pump Module when
Incorrect Micron Fuel Filter is Used**

If you service customers that perform regular/general maintenance on their equipment, work to educate them on the difference in filters. Be sure the unit you are repairing/troubleshooting has the proper filter installed before the fuel pump module. Kohler has been requesting back fuel filters and lines for returned fuel pump modules. If an improper fuel filter is found this is considered a non-warrantable defect. If it is found to not be using the proper filter it may be denied warranty. Claims may be denied if requested components are not returned.

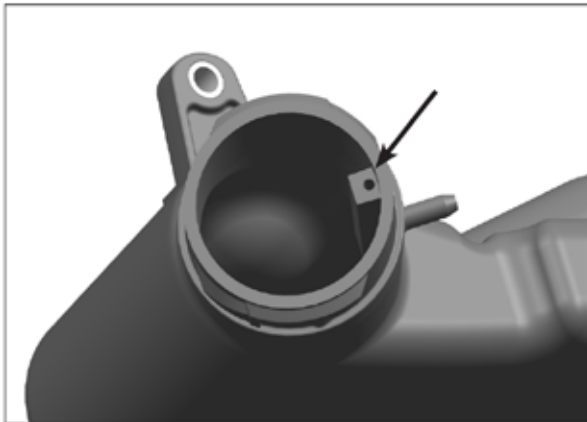
The new 14 065 63-S fuel tank utilizes a material that addresses isolated incidents of nylon leaching into the fuel system (previously covered in the 2013-2014 Service Update Book), as well as improved cap installation and fit.

Figure 1. Old Tank 14 065 56-S.

This new tank should be used as the replacement for any such reports and can be identified visually by the round shape of the internal tank neck feature shown below.

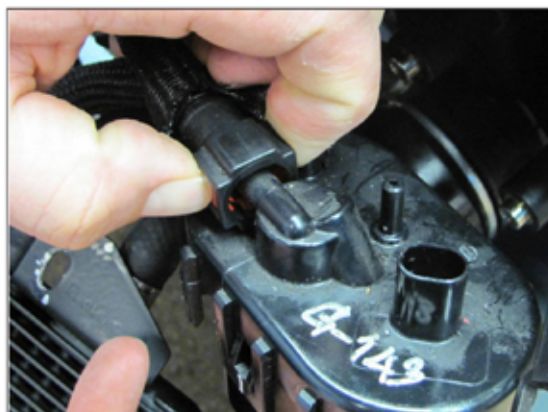
- Broken high pressure hose assembly connector to the FPM:** Remove and/or back out FPM fasteners before attempting to remove the high pressure hose from the FPM. Both the red and white button connectors operate by pressing to unhook from the barbed male fitting on the FPM. See Figure 1.

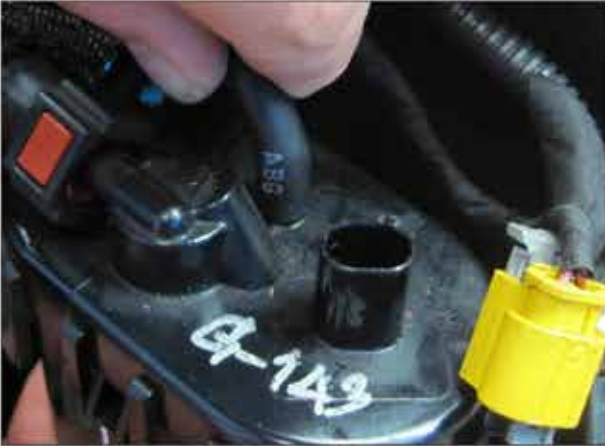
Figure 2.

2. **Broken FPM vent nipple:** Prying on the FPM to remove the vent hose can result in breaking off the vent nipple. If the hose cannot be removed from the FPM by hand (see Figure 2), remove from the vent tee fitting (see Figure 3). It may be possible to twist the hose free once removed from the vent tee fitting. If risk of damaging the FPM is probable, cut and replace the hose.
3. **Damaged engine wiring harness terminals at the FPM connector:** Forcing a test probe into the electrical connector results in terminal damage and potential intermittent connections. Use a probe with a diameter of 0.032 in. (0.8128 mm) or smaller.
4. **Broken high pressure fuel hose fittings at the #2 injector:** Remove and/or back out FPM fasteners before attempting to remove the high pressure hose from the FPM.

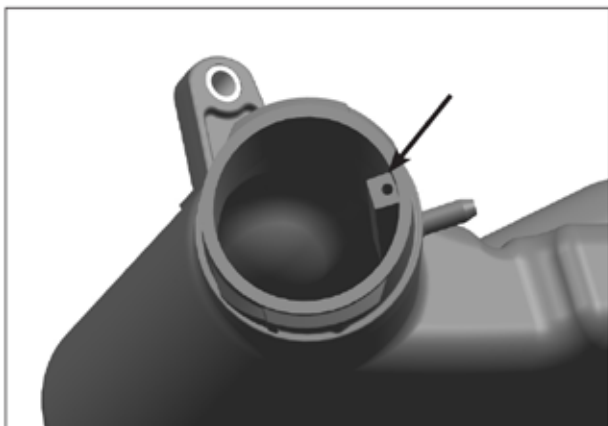
A new 14 065 63-S fuel tank has been implemented with a material that addresses isolated incidents of nylon leaching into the fuel system (previously covered in the 2013-2014 Service Update Book), as well as poor fuel cap installation and fit.

Figure 1. Old Tank 14 065 56-S.

This new tank should be used as the replacement for any such reports and can be identified visually by the round shape of the internal tank neck feature shown below.

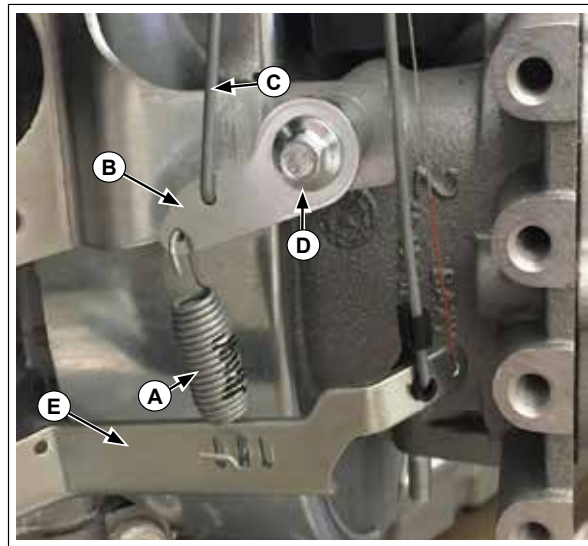
Figure 1. Original Governor Linkage Lever and Governor Spring.

1. Remove the M6 screw (D) securing the governor linkage lever (B). Unhook the speed control linkage (C) and governor spring (A) from the governor linkage lever (B). Save the screw (D) and spacer behind the governor linkage lever (B); discard the governor linkage lever (B). Remove the governor spring (A) from the governor lever (E); discard the governor spring (A). See Figure 1.

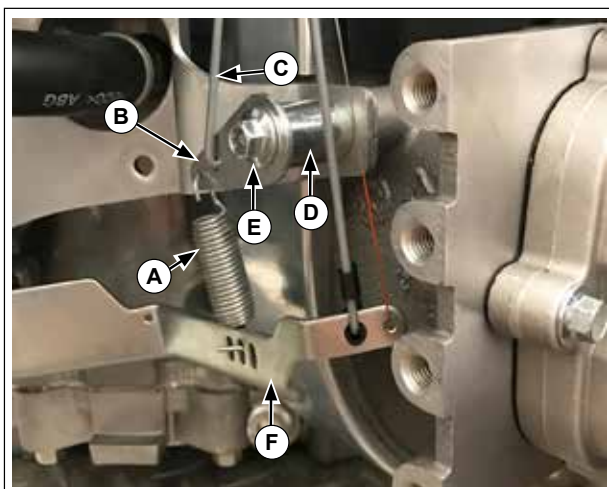
Figure 2. New Governor Linkage Lever and Governor Spring.

2. Hook the speed control linkage (C) and the new governor spring (A) into the new governor linkage lever (B). See Figure 2.
3. Hook the new governor spring (A) into the middle slot of the governor lever (F). Orient spring ends as shown in Figure 2. Secure the new governor linkage lever (B) and the spacer (D) with the M6 screw (E). Torque screw (E) to 10.2 N·m (90 in. lb.). See Figure 2.
