'caught in
the net'

Ship particulars

Name: Abit Beser

M/V Abit Beser arrives in Catania (Italy) on the 20th of march 2009 with her holds full of grain. According to the new inspection regime she is a standard risk ship already inspected in previous 10 months and marked in thetis information system as a 'no priority' ship, no liable to inspection under Paris MoU region.

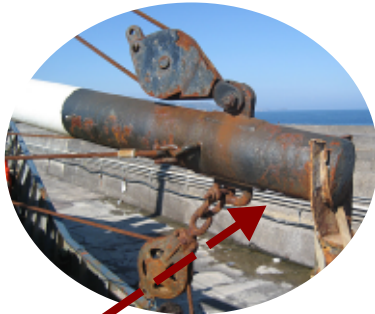
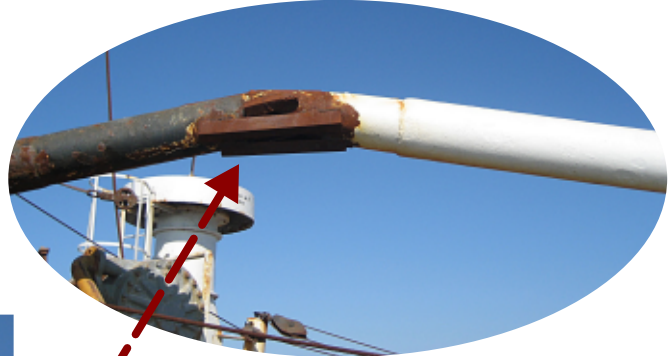
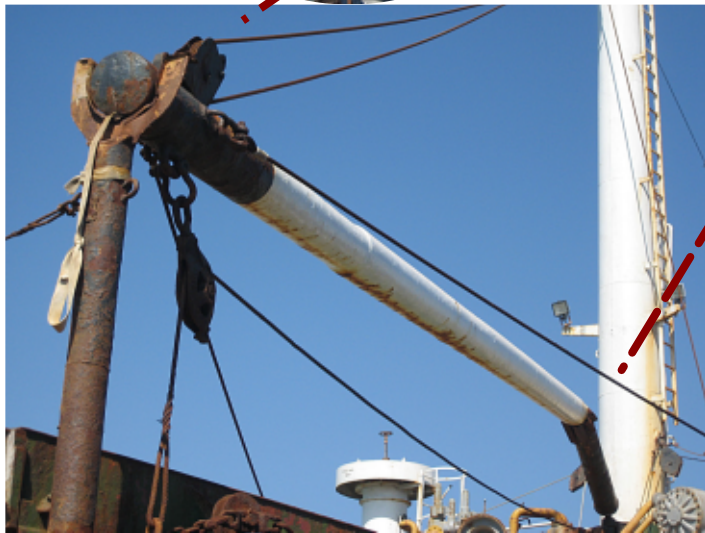
The rustbucket ship, berthed in a solitary quay, is waiting inspectors in the early morning showing her worn out ropes and her deformed, bumped hull. No safety net is positioned under the gangway and the ugly foremost boom, broken in two pieces and temporary welded with iron bars, seems to be falling out from its position to the ground.

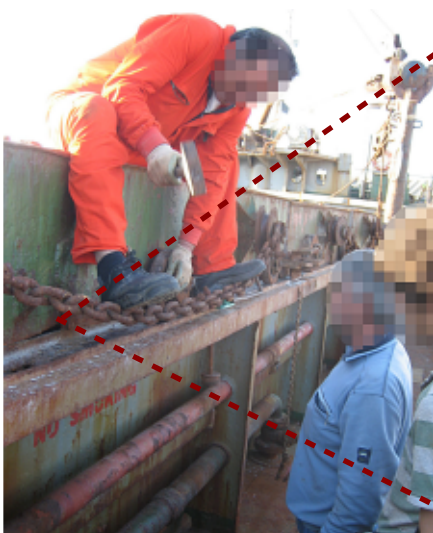
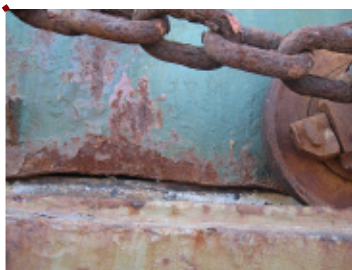
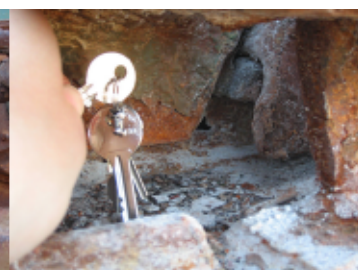
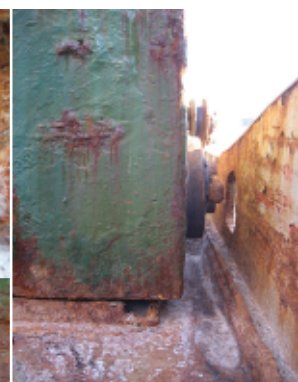
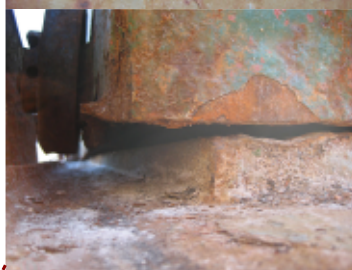
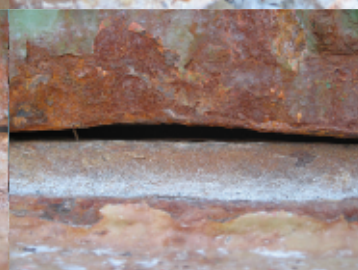
- Steering gear is not properly maintained and emergency steering gear test is unsuccessful;
- Pilot transfer arrangements are unsafe (ladder and stanchions) or missing at all (lifebuoy with light);
- Hatchcovers are heavily corroded, deformed and not properly closing.

Hatchcovers heavily corroded and deformed. Clearly not weathertight

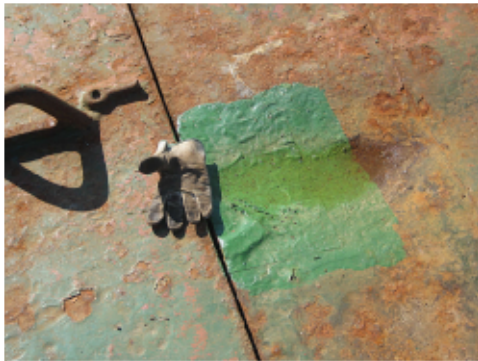
Temporary repair (tar carpet) hatchcover no. 2

- The cover of the hold no. 2 is holed and a temporary repair by tar carpet is observed upon it;
- All lifejackets onboard are missing or lights are provided with expired batteries;
- All flammable liquids tanks' quick closing valves are inoperative;
- Emergency generator is inoperative;
- Fire pump is inoperative;
- Emergency fire pump is inoperative;

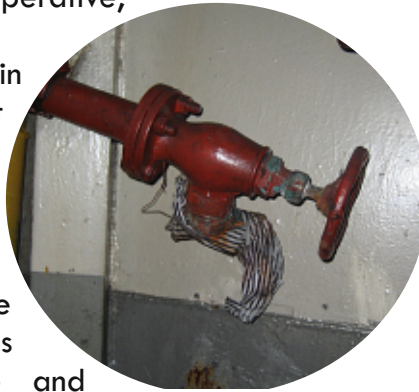
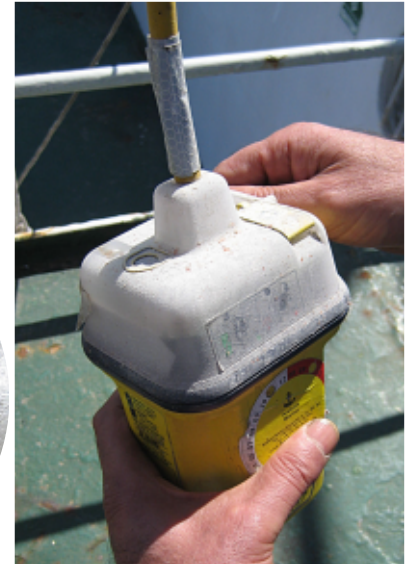
- Gyro compass is inoperative;
- The EPIRB is not annually tested, in very poor conditions and not properly marked. Its battery and hydrostatic release unit are both expired. It's inoperative;
- All ship's air compressors are inoperative (temporary repairs are carried out: a compressor's head is temporary fixed by rubber tube and a gear puller!);

EPIRB in poor maintenance conditions and inoperative

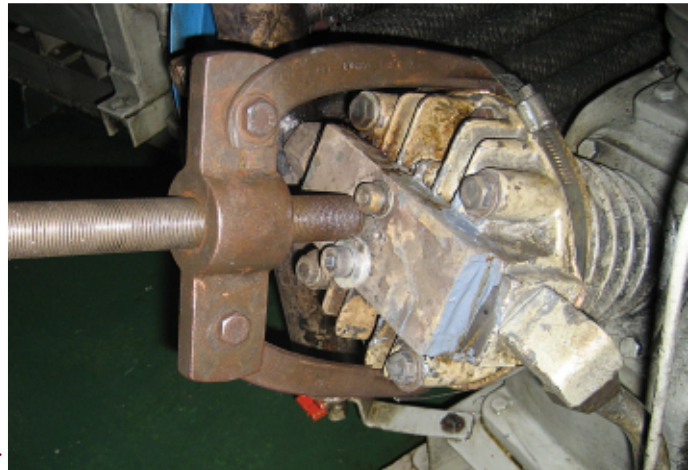
Air compressor no. 1: out of service. On the right a particular of its head temporary fixed by a gear puller

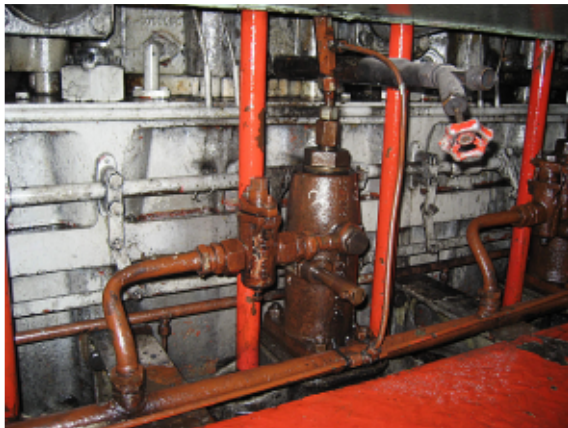
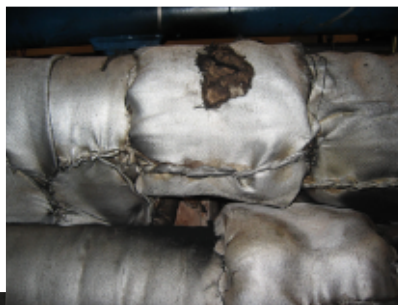
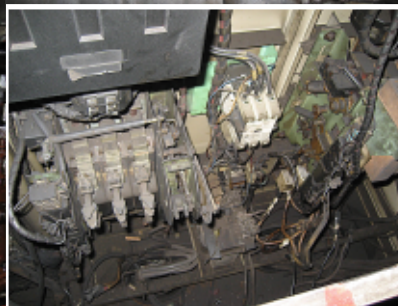
- The engine room is very dirty: oil leakages are everywhere and a thick layer of soot coming out from the damaged exhaust pipe of main engine covers everything.

On the left: main engine oil leakages near an injection pump

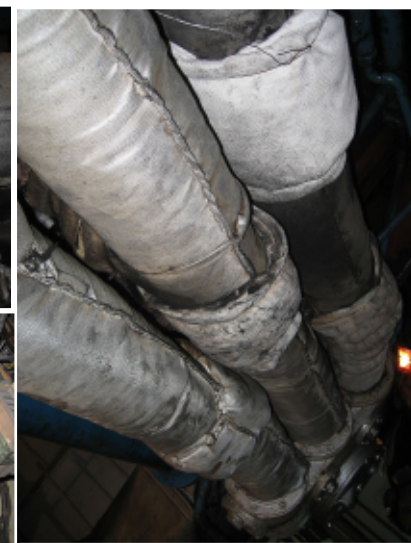
Damaged insulation in E/R and soot inside electrical panel

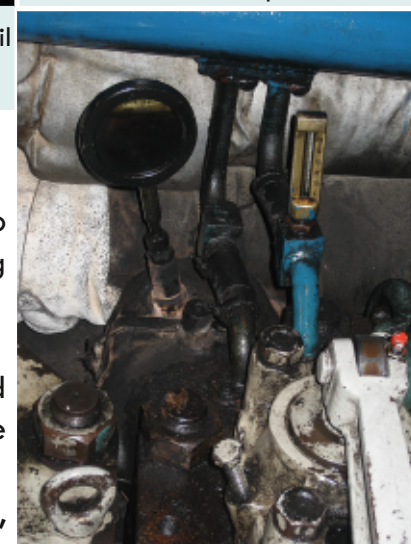
Unreadable temperature gauge in main engine cylinder no. 3

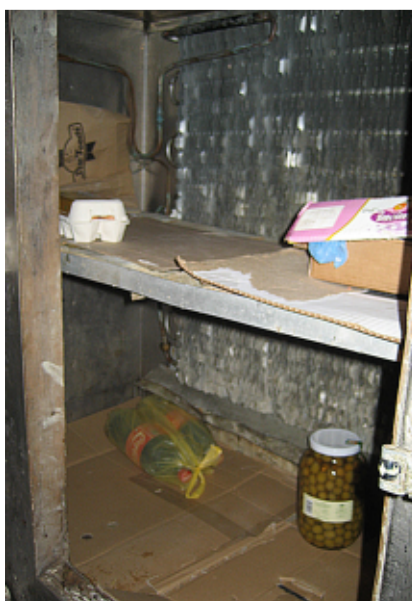
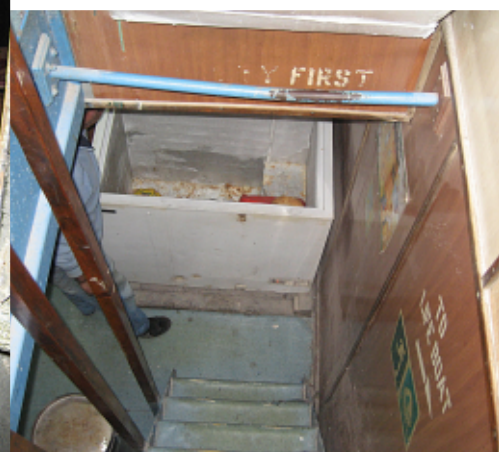
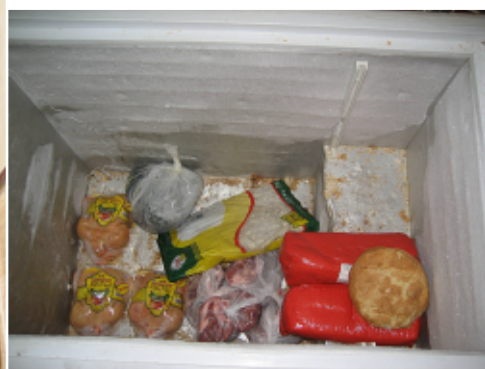
- Cold room is inoperative;
- Provision quantity is insufficient: no milk, no eggs, no bread, no flour, no fruit, no vegetables, very few frozen meat and fish (fishing rod and lines are everywhere onboard);
- Big quantity of food provisions are expired or rotten;
- The few provisions onboard are not properly segregated and stored in not hygienic containers (mainly garbage plastic-made black bags);
- Floor, linings and furnishings in galley, handlingroom, messroom, coldroom are dirty and damaged, some cockroach is noted during inspection in cutlery and tableware;

On the left: inside the dirty, empty and inoperative cold room. A refrigerator placed near engine entrance and its poor content. Meat, cheese, frozen potatoes are all expired. Inside the white plastic bag fish caught by crew

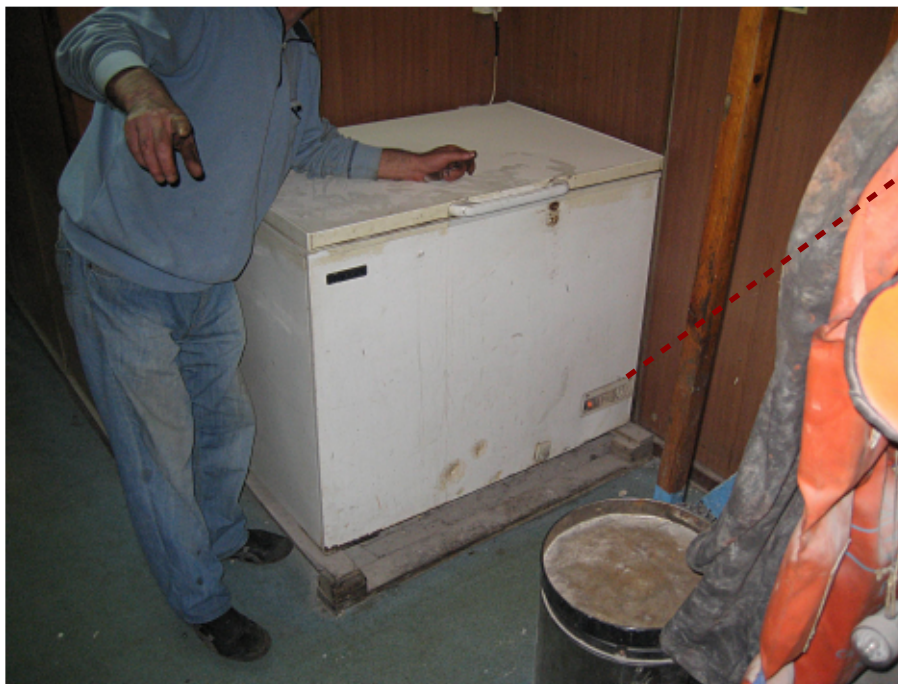
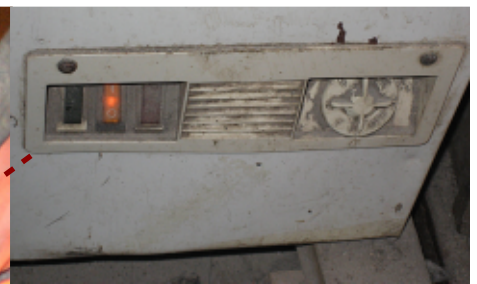
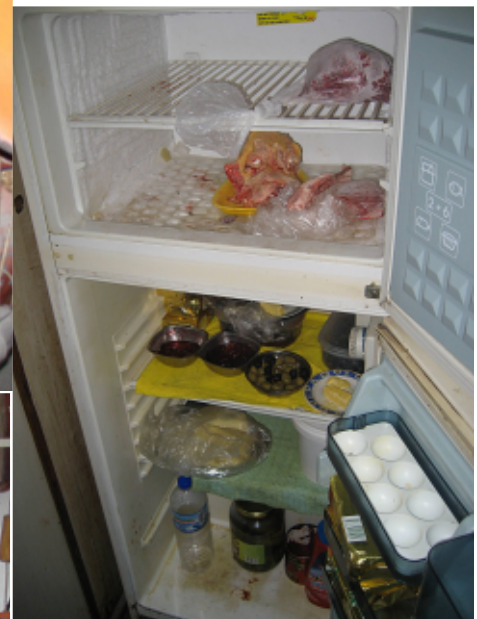
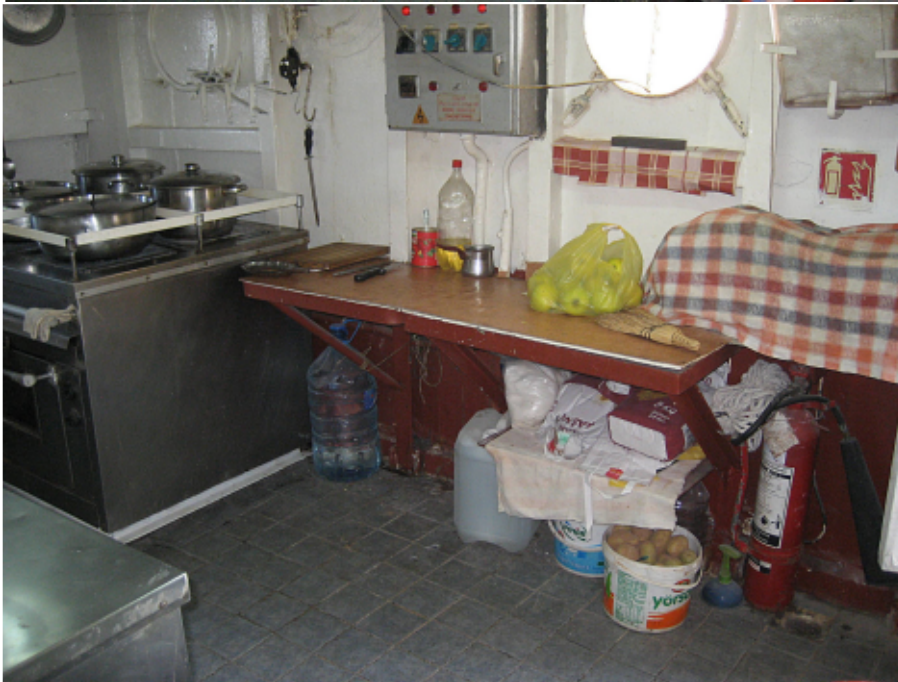
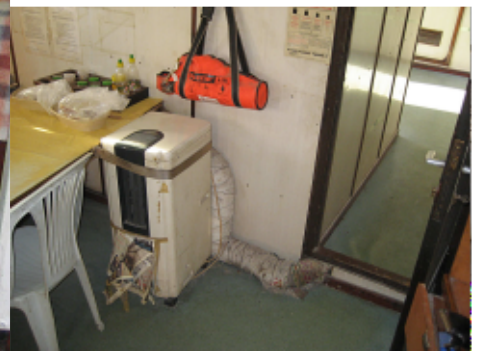
Refrigerators, galley and crew mess: poor hygienic conditions
