SB-10046779-4871

SI M17 06 12
Cooling SystemsOctober 2012
Technical Service

SUBJECT**Service Action: Retrofit of the Engine Coolant Temperature Sensor****MODEL**

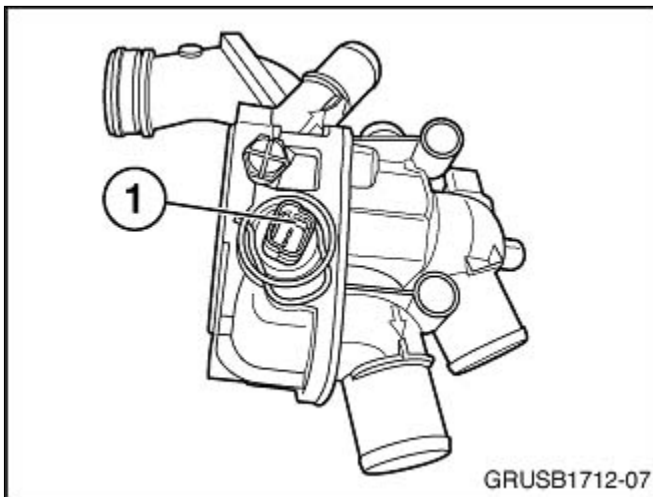
NEW Checking for the updated thermostat: The 11 53 7 534 521 thermostat has a replaceable engine temperature sensor (1).
