DEPARTMENT OF DISASTER MANAGEMENT

SITUATION REPORT 002

Event: Hurricane Irma
Date of Event: September 6, 2017
Issue Date: September 16, 2017
Issue Time: 10:00 pm
Report Number: 002

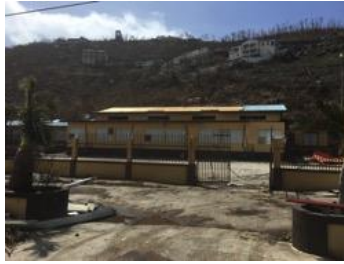
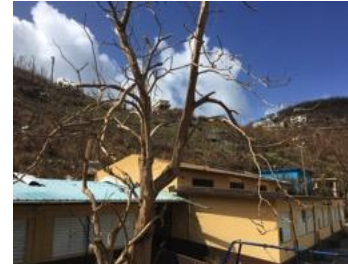
4.15.1 Leonora Delville Primary

The structural integrity does appear to be compromised, however, it is not weather tight. The building can be reinstated in the long term but not in the immediate future as the remedial work entails immediately unavailable resources.

- Approximately 20% of the plywood sheathing needs replacing.
- 75% of the roof cladding (zinc sheets) needs reinstating.
- Mass debris needs clearing
- No mobile signal on site
- No Power on site

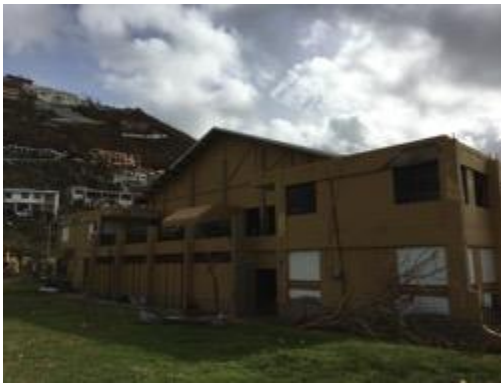
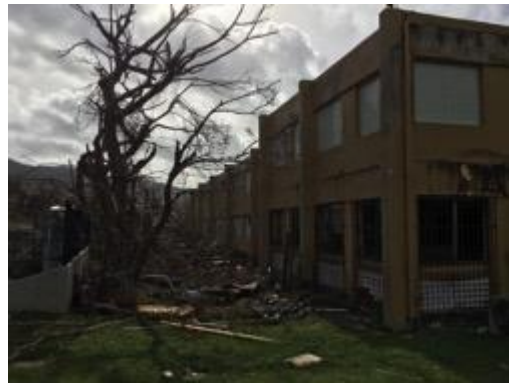
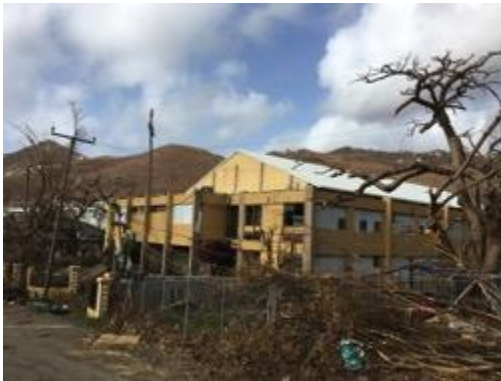
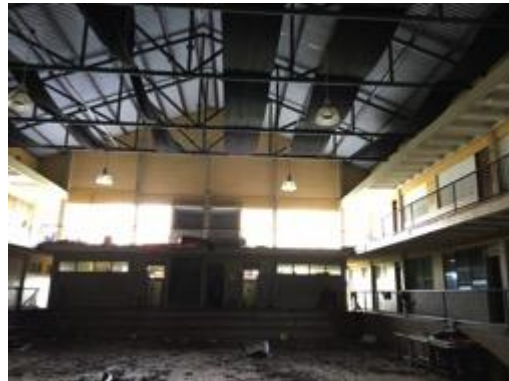
a) Block A (Main Building)

- No visible compromising damage to superstructure or roof
- Roof assumed to be weather tight.
- Building is habitable following window repairs or temporary shuttering
- Minor cosmetic damage to external façade.
- No confirmed generator
- No confirmed water storage tank

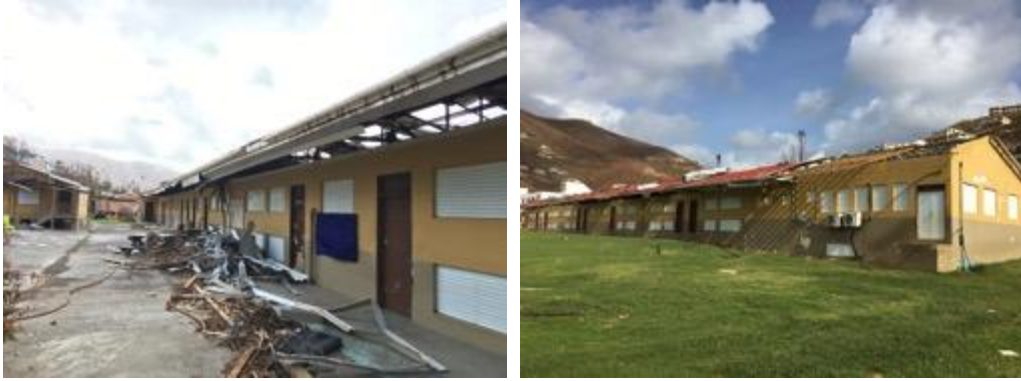
b) Block B

- Structural integrity has not been compromised
- 10% of rafters need replacing
- 50% of roof sheets need replacing
- All eave boards gone and need replacing to reinstate water tightness

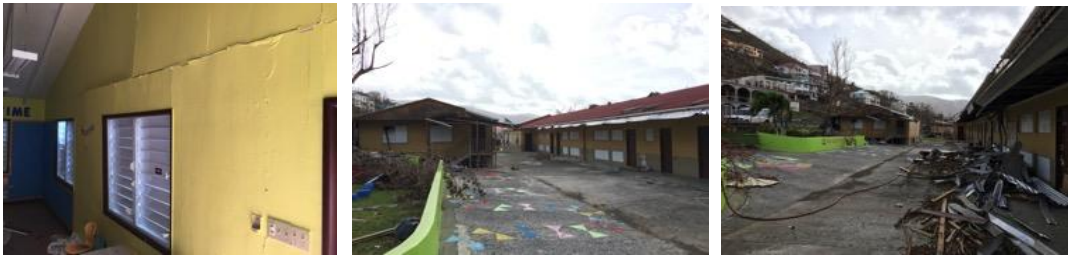
c) Block C (Nursery)

- No major structural damage
- Eastern wall has been affected by wind (excessive deflection). Internal studwork needs to be realigned and secured.
- Minor damages to eastern lean-to roof

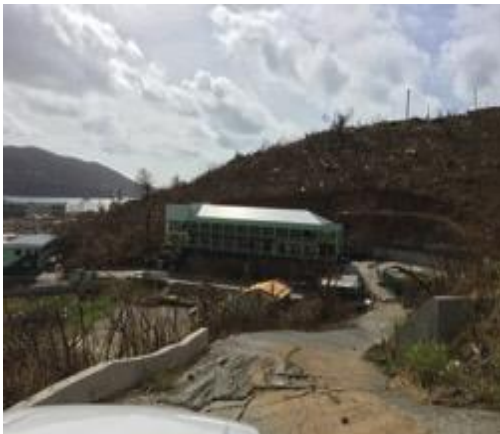
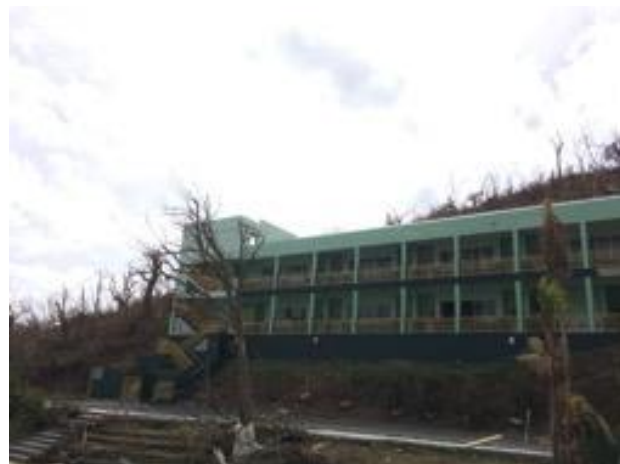
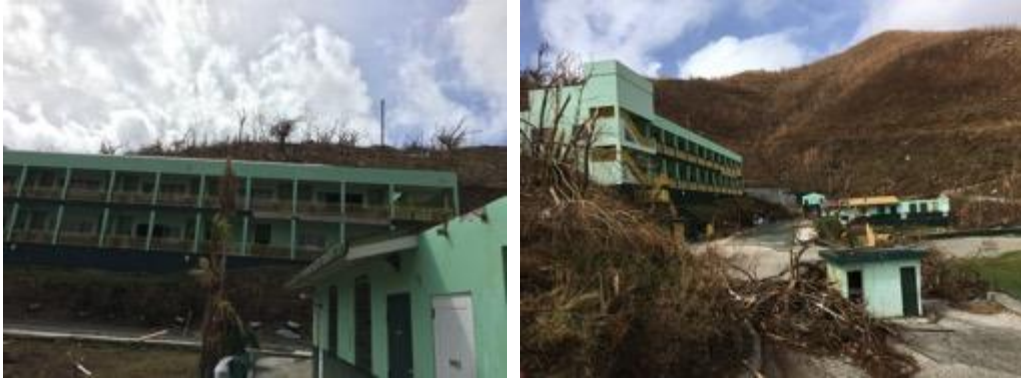
a) Block A (Main Building)

- No compromise to structural integrity
- Building is habitable following window repairs or temporary shuttering
- Minor cosmetic damage to external façade.

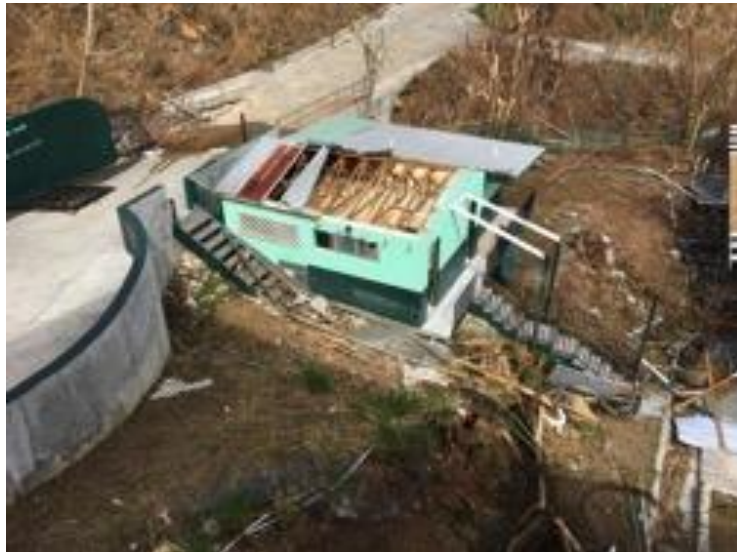
b) Block B (Bathroom Block)

- Structural integrity has not been compromised
- Rafters and roof sheathing need replacing (50%)

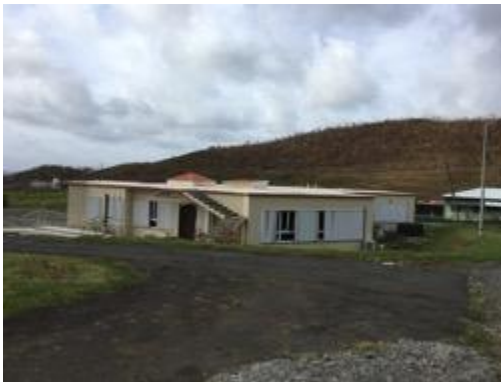
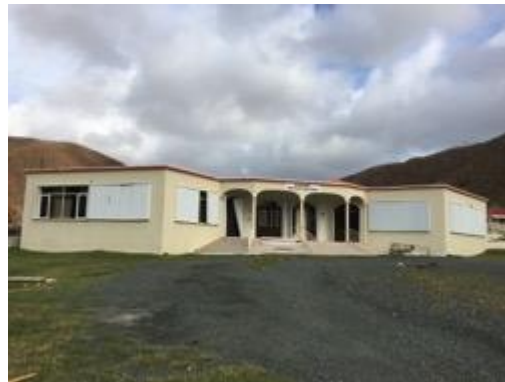
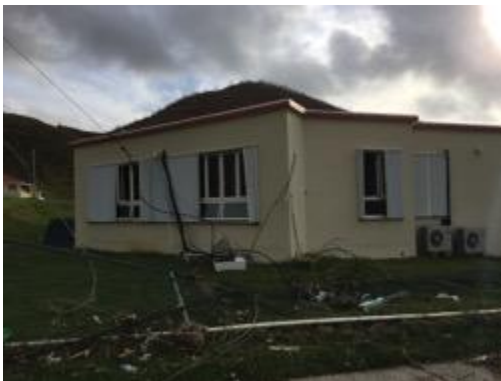
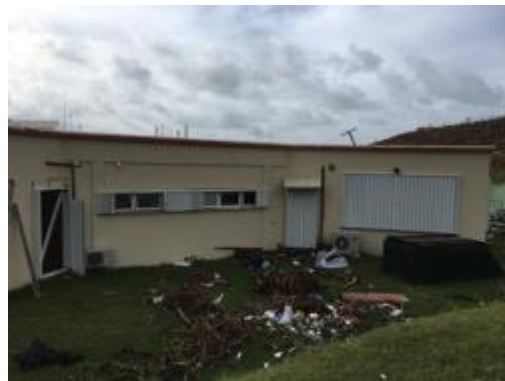
a) Block A (Academic Services Building)

- No compromise to structural integrity
- Building is habitable following minor repairs or temporary shuttering to windows
- Concrete flat roof
- Water appears to be water tight (concrete flat roof)

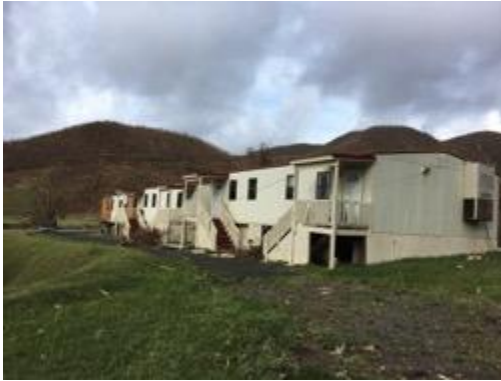
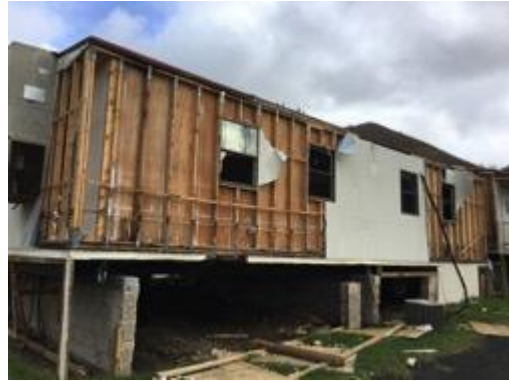
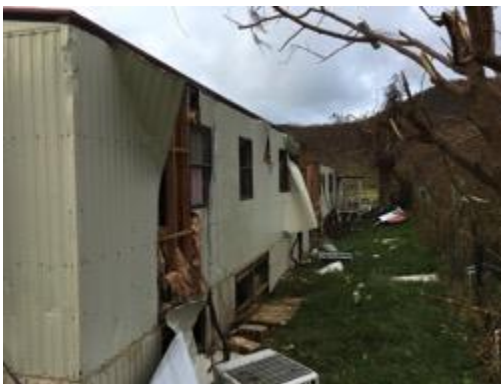
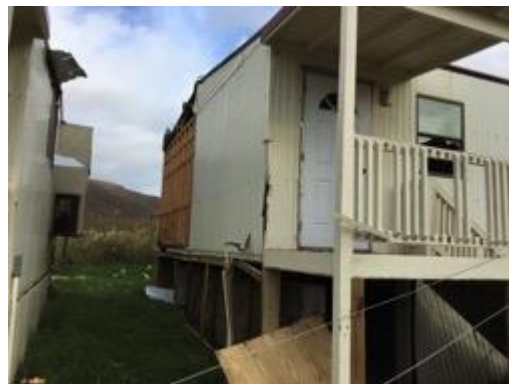
b) Block B (Northern Lecture Rooms)

- Made up of 3No. temporary structures (retrofit trailers)
- Structural integrity has not been compromised
- Rafters and roof sheathing need replacing (50%)
- Wall cladding needs replacing (50%)
- Buildings not habitable

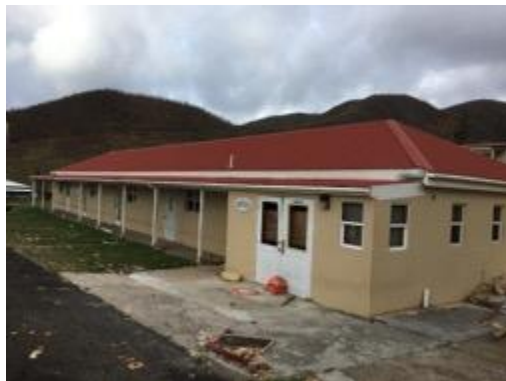
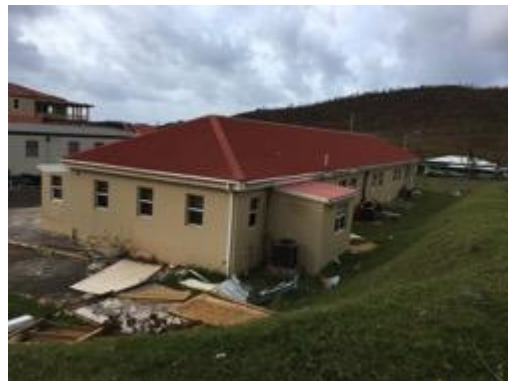
c) Block C (Health Services)

- No apparent structural damage
- Building is habitable with minor repairs or temporary cladding to some doors and windows

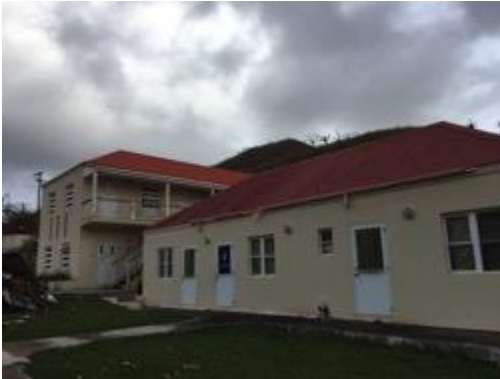
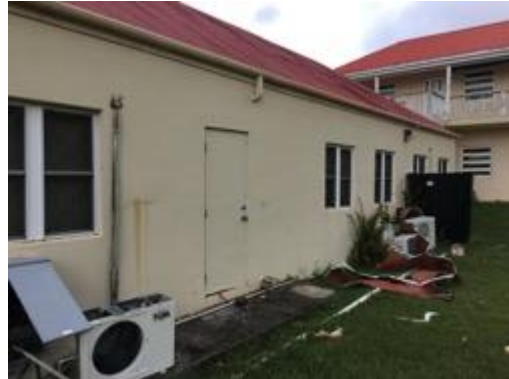
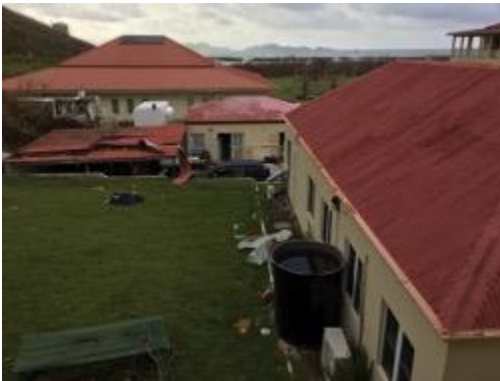
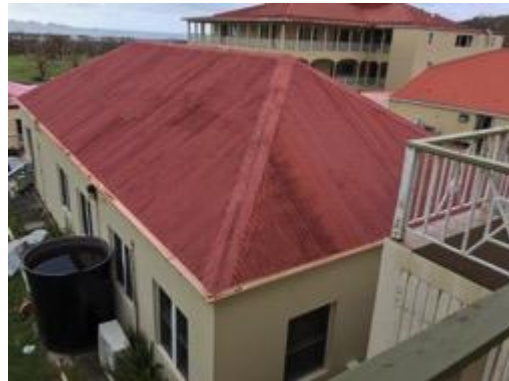
d) Block D (UWI Library and adjacent Building)

- No apparent structural damage
- Building is habitable

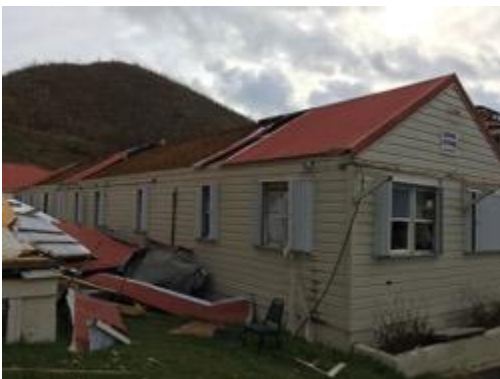
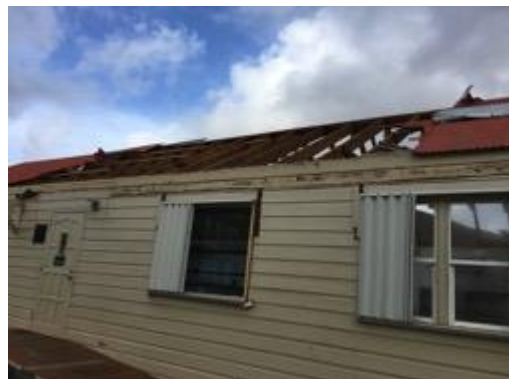
e) Block D (Book Store)

- No major structural damage
- High damage to roof. Sheathing and cladding to be replaced (75%)
- Building is not weather tight. Most windows damaged and need to be replaced.

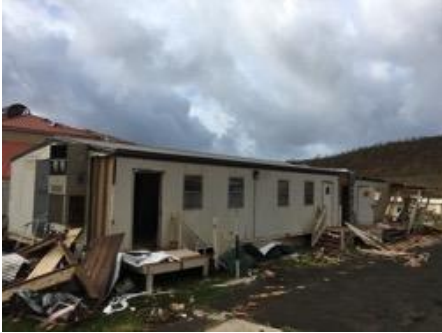
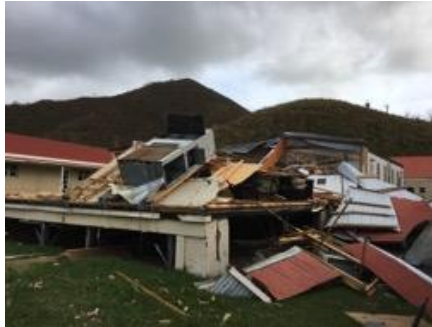
f) Block E (Next to Book Store)

- 50% of building reduced to rubble
- Remaining structure appears to be structural sound
- 20% of walls need recladding
- Building can be occupied following installation of temporary shuttering and temporary covering of some roof areas.

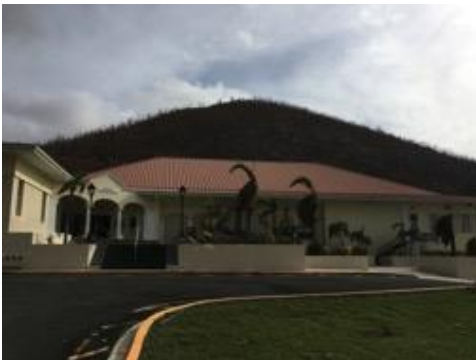
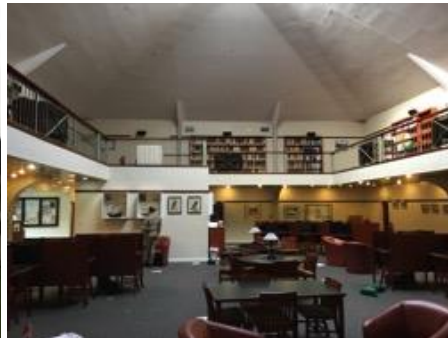
g) Block E (Learning Resource Centre)

- No apparent structural damage
- Building is habitable with no signs of internal/external damage
- Building is fully powered by gen set
- Occupied by security/porters

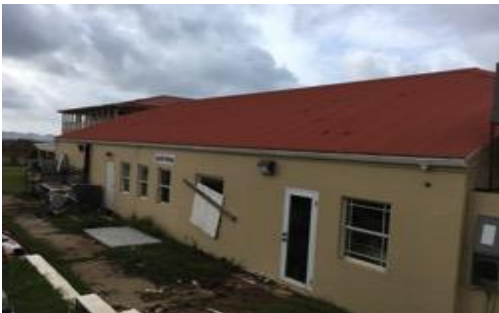
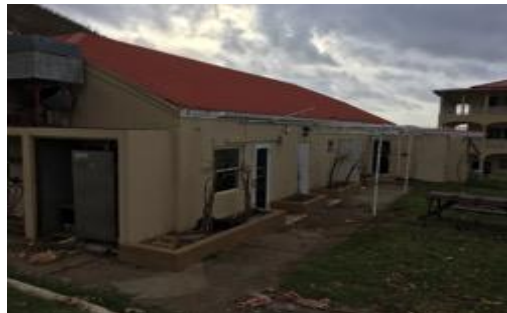
h) Block E (Kitchen)

- No apparent structural damage
- Building is habitable with minor repairs or temporary cladding to some doors and windows.
- LPG gas supply is intact. Kitchen can be used after internal clean up

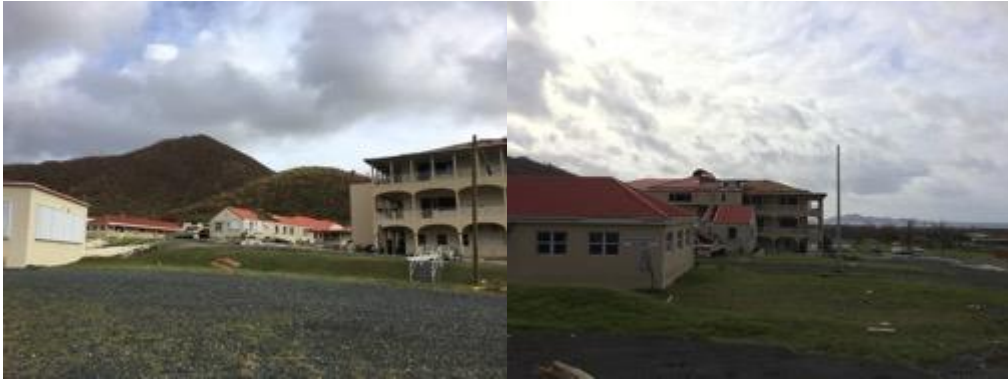
i) Block E (Main Building)

- No apparent structural damage
- Building is readily occupiable with some repairs or temporary cladding to some doors, windows and roof.
- Suffered water on some floors but can be easily dealt with

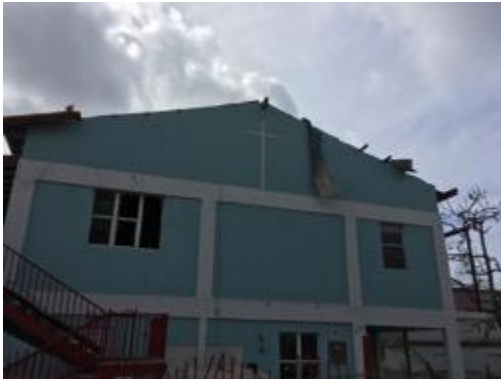
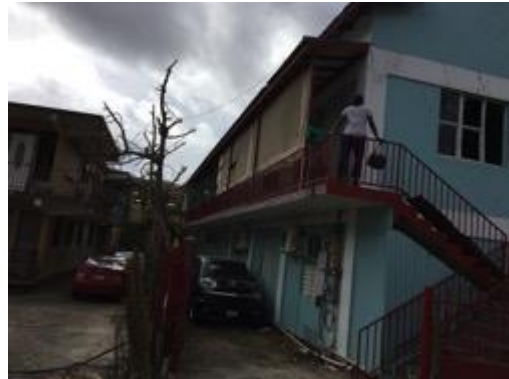
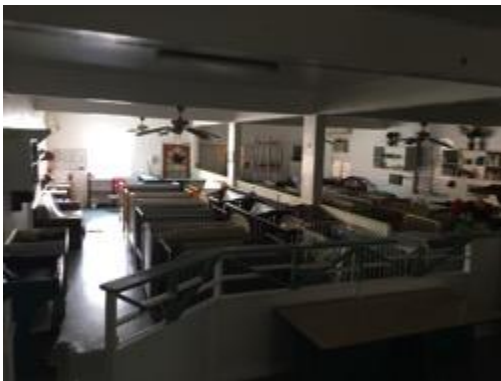
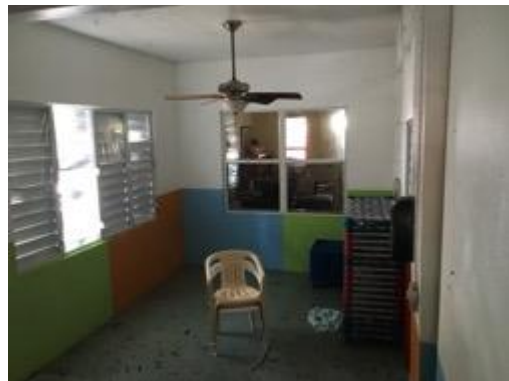
4.14.10 New Testament Church of God Learning Centre

The structural integrity has not been compromised. The building can be occupied with minimal resources.

- Medium debris levels
- Minor damage to eastern section of roof. Temporary shuttering can be employed.
- No mobile signal on site
- Confirmed operational gen set (75 kVA)
- Confirmed water storage tank under Kitchen, capacity unknown
- Usable Kitchen with intact gas supply
- Capacity for approx. 30 people
- No confirmed occupants
- No mobile signal

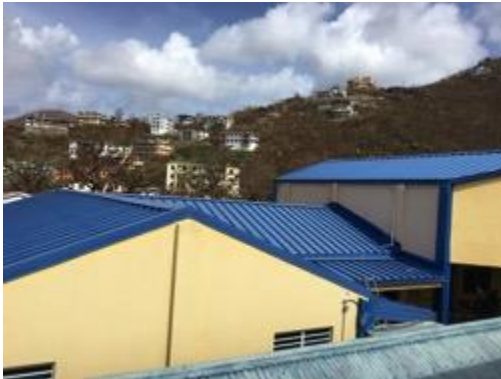
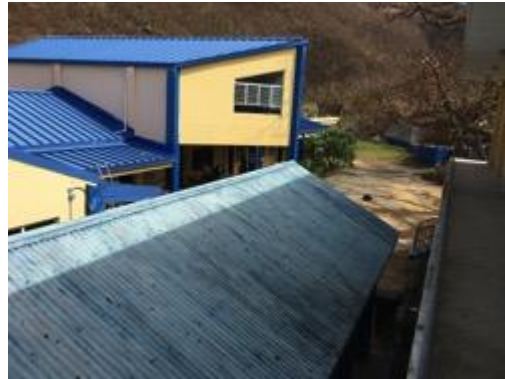
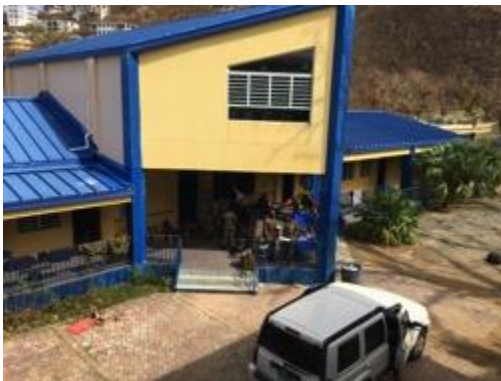
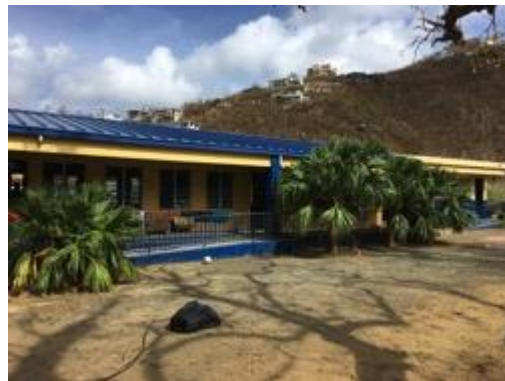
4.14.11 Alexandrina Maduro Primary School

The structural integrity has not been compromised. One block is currently occupied by the CARICOM Disaster Relief Unit. Other block can be occupied with minimal resources.

- Low debris levels
- Minor damage to some areas on the roof of each building
- No mobile signal on site
- No confirmed gen set. CDRU has small generators on site
- Confirmed water storage tank on eastern side of property
- Slightly water logged. Can be easily removed.
- No confirmed occupants in eastern block
- No mobile signal
- Confirmed water supply from pipes via storage tank located on hill.

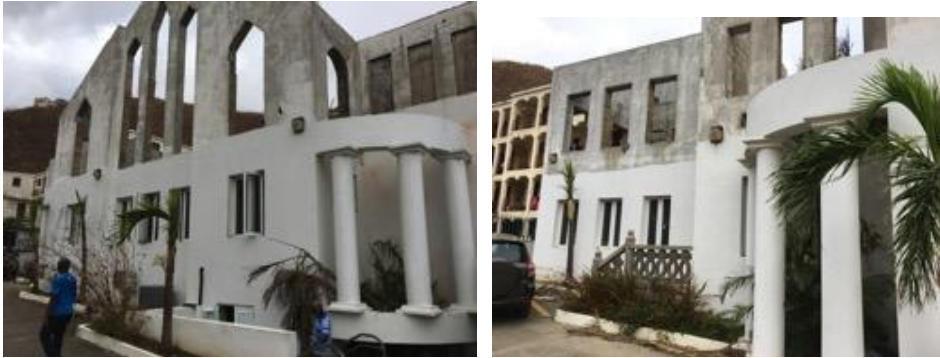
4.14.12 Visions Child Development Centre

The structural integrity has not been compromised. Ground floor is secure and currently used as a worship area and distribution centre. Basement is in good condition with minor water logged areas. Pastor is willing to accept items in need of distribution.

- Low debris levels
- No visible structural damage to building
- No mobile signal on site
- No confirmed gen set or power on site

- Confirmed underground water storage tanks (14,221gals & 14,116gals)
- Slightly water logged. Can be easily removed.
- Unconfirmed occupants
- No mobile signal
- No water supply

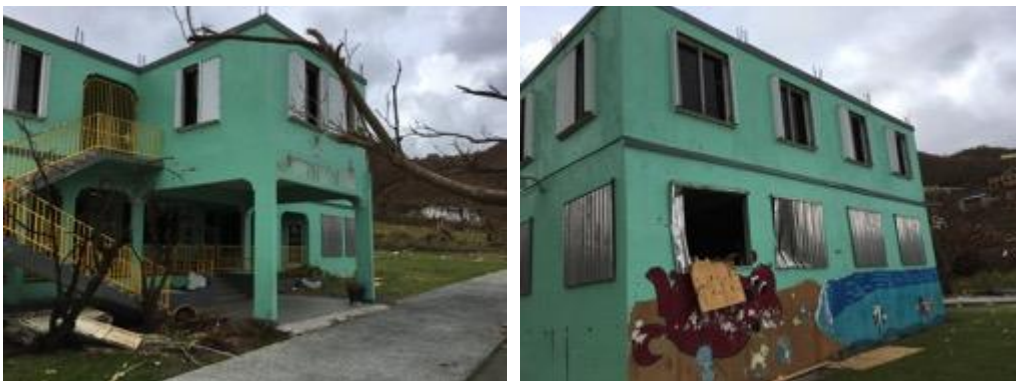
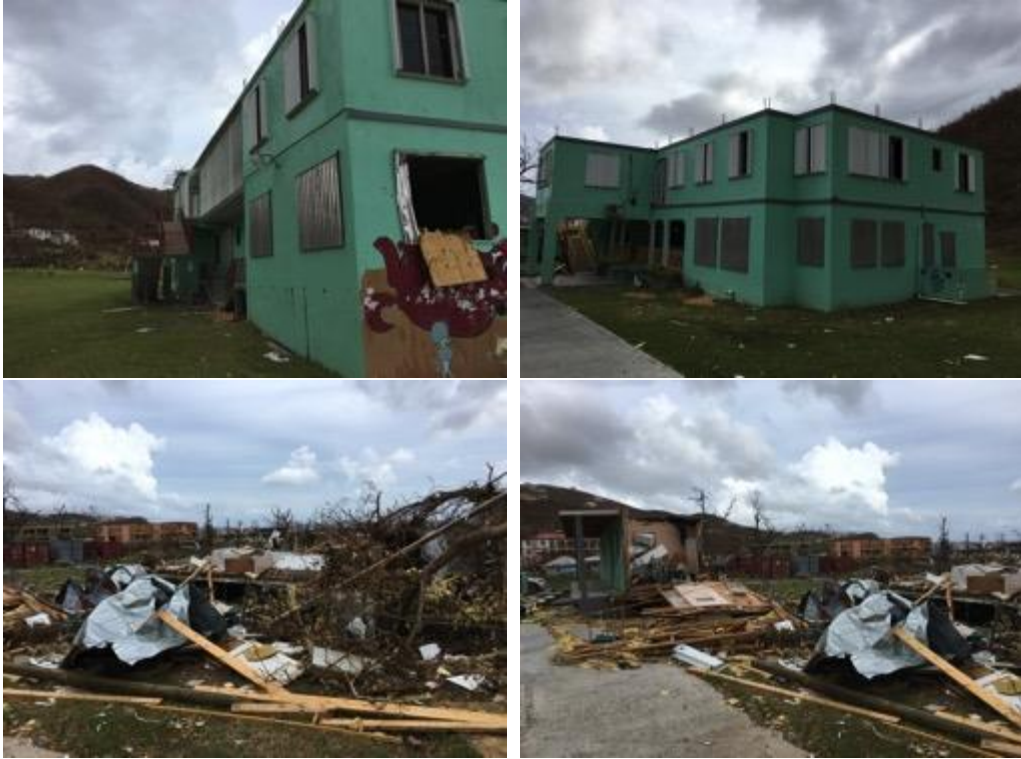
4.14.13 First Impressions

The structural integrity of the main block has not been compromised. Building can be occupied with minimal resources.

- Medium debris levels
- No visible structural damage to main block
- No mobile signal on site
- No confirmed gen set or power on site
- Confirmed underground water storage tank
- Localised area affected by water. Can be easily removed.
- Unconfirmed occupants
- No mobile signal
- No water supply

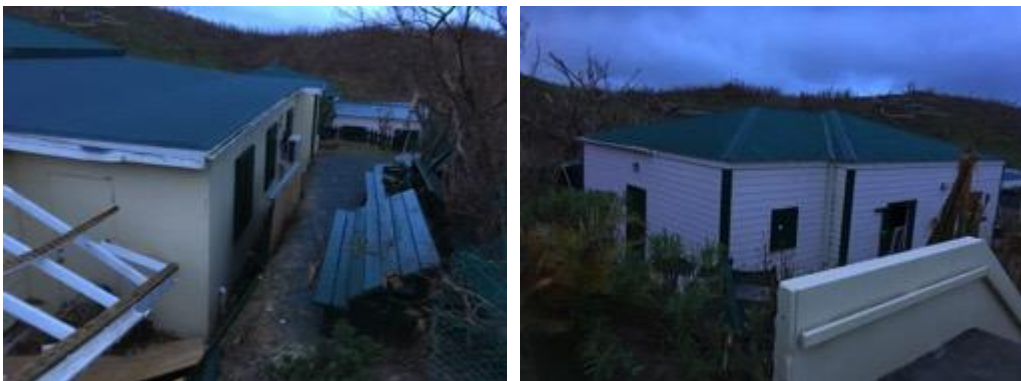
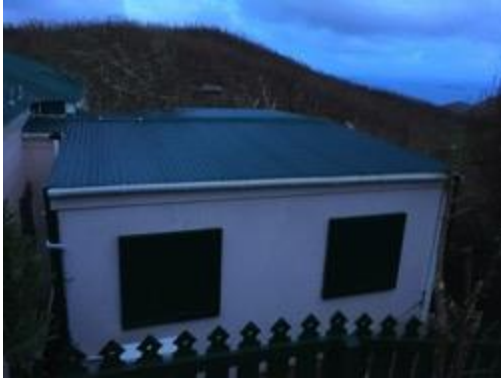
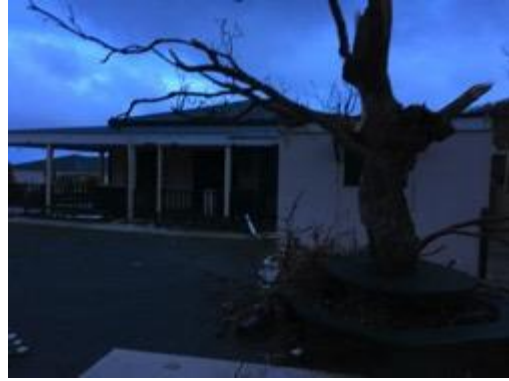
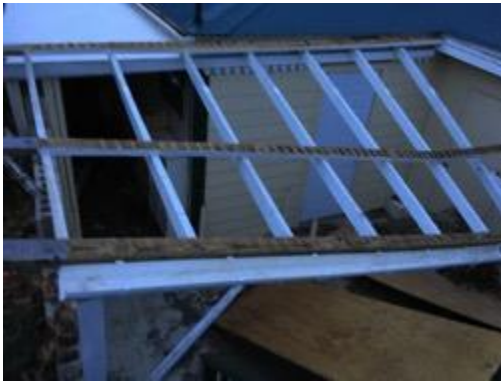
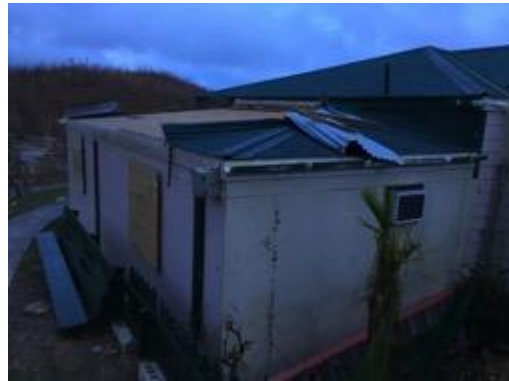
4.14.14 Century House Montessori & Little Penguins Montessori

The structural integrity of the buildings on site has not been compromised. The roofs of each building are intact barring the lean-to roofs of 2 minor rooms. Buildings can be occupied with minimal resources

- Kitchen is intact
- Confirmed water storage (2No. plastic tanks & 1No. underground tank)
- Low debris levels
- Overall structure appears to be in very good condition
- Unconfirmed occupants
- No mobile signal
- No water supply

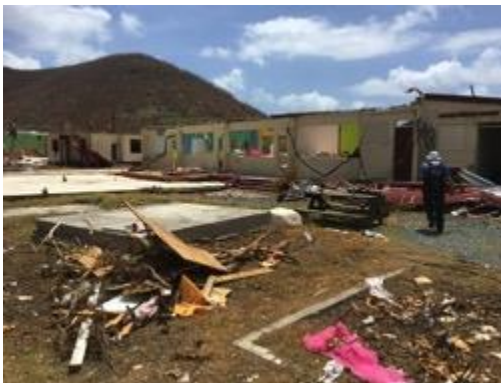
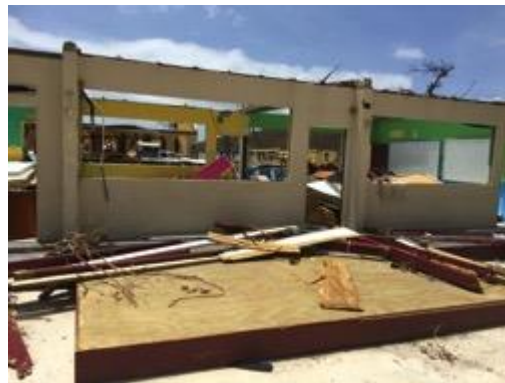
Each building at this site has lost the entire roof structure. Despite this, the structural integrity of the remaining buildings does not appear to have been affected. This school is incapable of being restored in the immediate future due to lack of, and strain on local resources.

- High debris levels
- No apparent damage to remaining superstructure
- No mobile signal on site
- No confirmed underground water storage tank
- No water supply
- No Confirmed Gen set
