Sofia Water Tank Inspection Report

A visual and physical inspection of the tanks was conducted on April 18 and 19, 2016. The visual inspection was conducted by observing all tank components and the tank structure. Physical inspection was conducted using a metal probe and 500g rebound hammer. The entire surface of the tank was sounded with the hammer at 300 intervals. Areas of suspected delamination were further tested with the rebound hammer and metal probe to identify areas of possible spalling. Tank appurtenances were inspected for signs of deterioration and for operational problems.

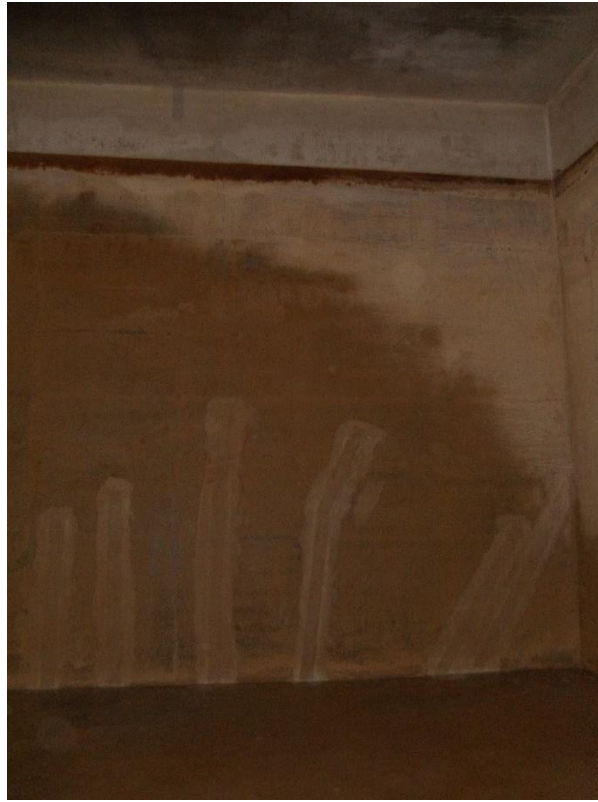
Image 1 - Repaired Cracks

- c. Epoxy injection crack sealing- where observed cracks exceed 0.8mm, inject NSF 61 certified epoxy grout sealer into cracks in accordance with the manufacturer’s instructions.

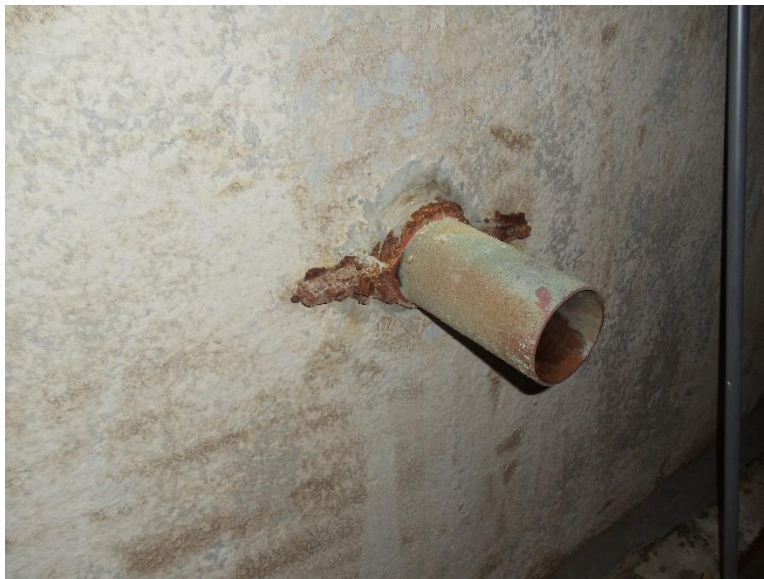
Image 2 - Recirculation intake penetration

4. Pipe penetrations- remove all external sealant applied to pipe penetrations inside tank. Clean, apply corrosion inhibitor and paint seal clamps and clamping hardware or replace as necessary. Reapply external sealant to cleaned opening.

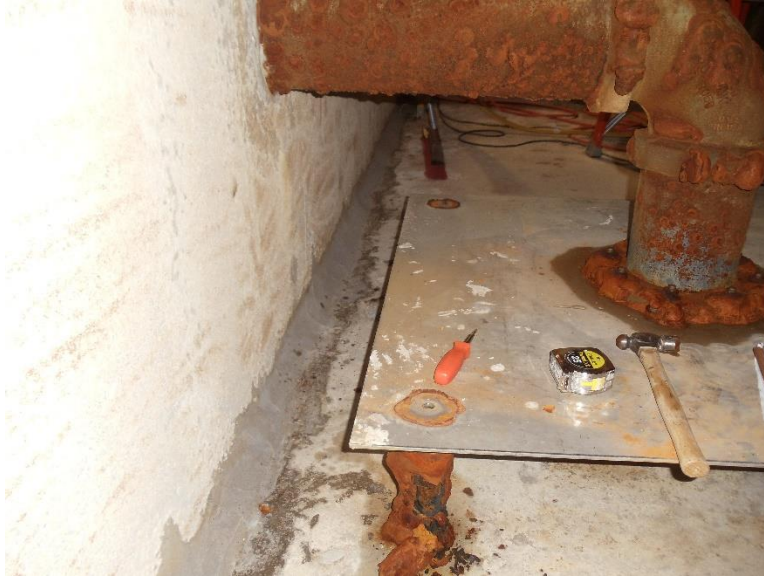
3. Fire pump intake pipe- The intake pipe for the fire pump is corroded, particularly where it attaches to the anti-vortex plate. The pipe should be cleaned, coated with a rust inhibitor and coated with an NSF 61 certified paint. After cleaning and before painting, bolts attaching the anti-vortex plate should be inspected. Bolts exhibiting excess material loss should be replaced. An improved arrangement would be to create a di-electric break between the plate and pipe using a rigid Teflon gasket and Teflon washers between the plate and pipe. Alternately, cathodic protection in the form of a zinc anode could be attached to the inlet pipe.

Image 3 Fire Pump Inlet

3. Fire pump anti-vortex plate attachment bolts – clean and descale fire pump intake pipe. Examine and replace bolts exhibiting excess material loss. Consider installing di-electric break between plate and pipe, or zinc anode on pipe to prevent corrosion. Pipe should be coated with corrosion inhibitor and painted with an NSF 61 approved paint.

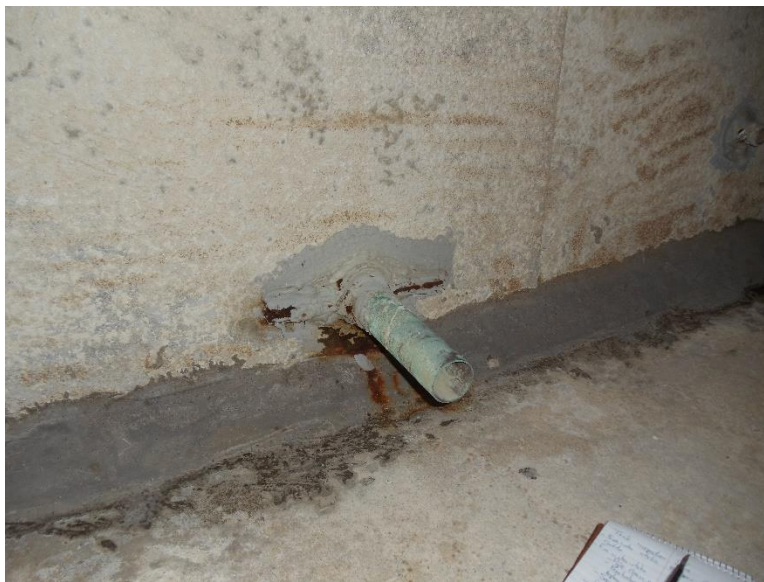
Image 4 - Water level Pipe Penetration

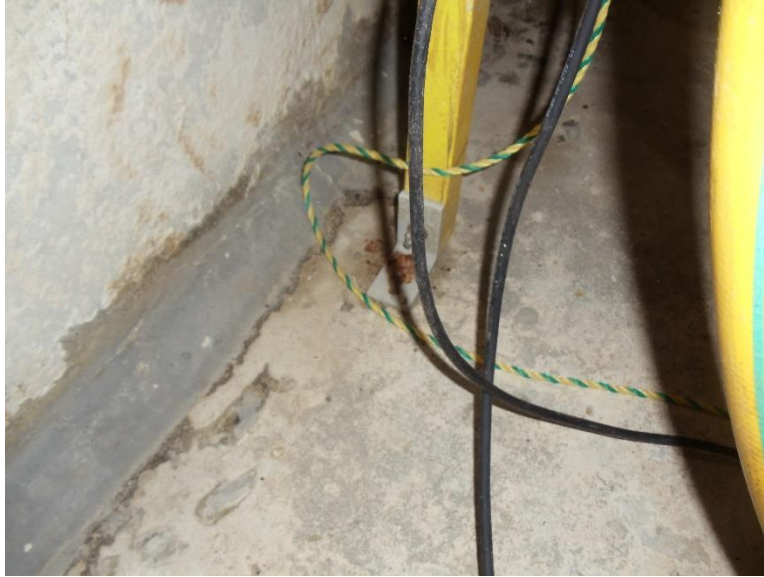
1. Ladder anchor bolts corroded- The ladder was installed using either low quality stainless steel or carbon steel anchors. These have corroded and should be replaced.

Image 5 - Corroded ladder anchors

1. Repair access ladder mounts – remount access ladders with 12.5mm drop in anchors fabricated of noncorrosive material such as 316-d Stainless steel, or phosphor bronze. Drop-in anchors should have a minimum pullout strength of 250 kg and a shear strength of 500 kg. Anchors should be installed in accordance with manufacturer’s instructions.

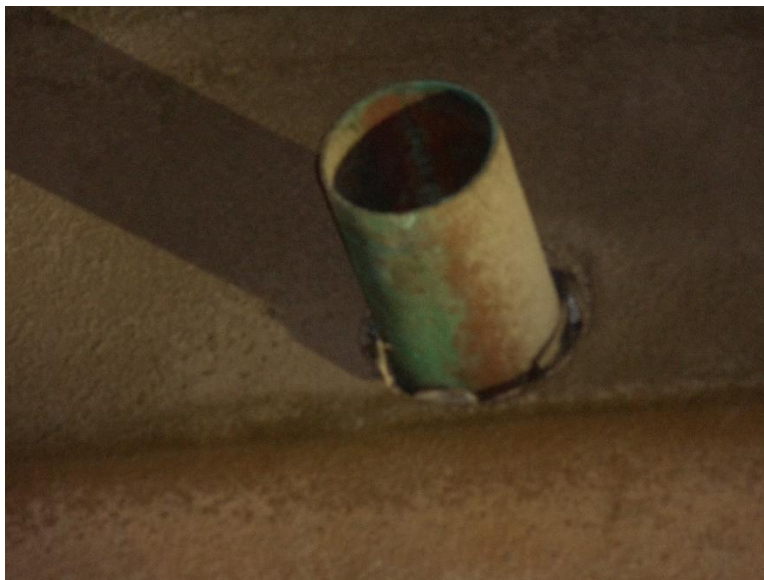
4. Tank vent- The tank vent pipe penetration in tank 1 did not appear to be properly sealed. This penetration should be sealed to prevent infiltration into the tank. Similarly, the vent riser seal has deteriorated and should be replaced on both tanks.

Image 6 - Unsealed vent / overflow

5. Install sealant to vent pipe penetration- Install sealant to vent pipe penetration from interior and exterior of tank.
6. Inspect and replace electrical lighting circuit within tank – Open boxes and inspect wiring connections. Replace corroded connections, fixtures, boxes, etc. Install new weather seals on boxes to remain.

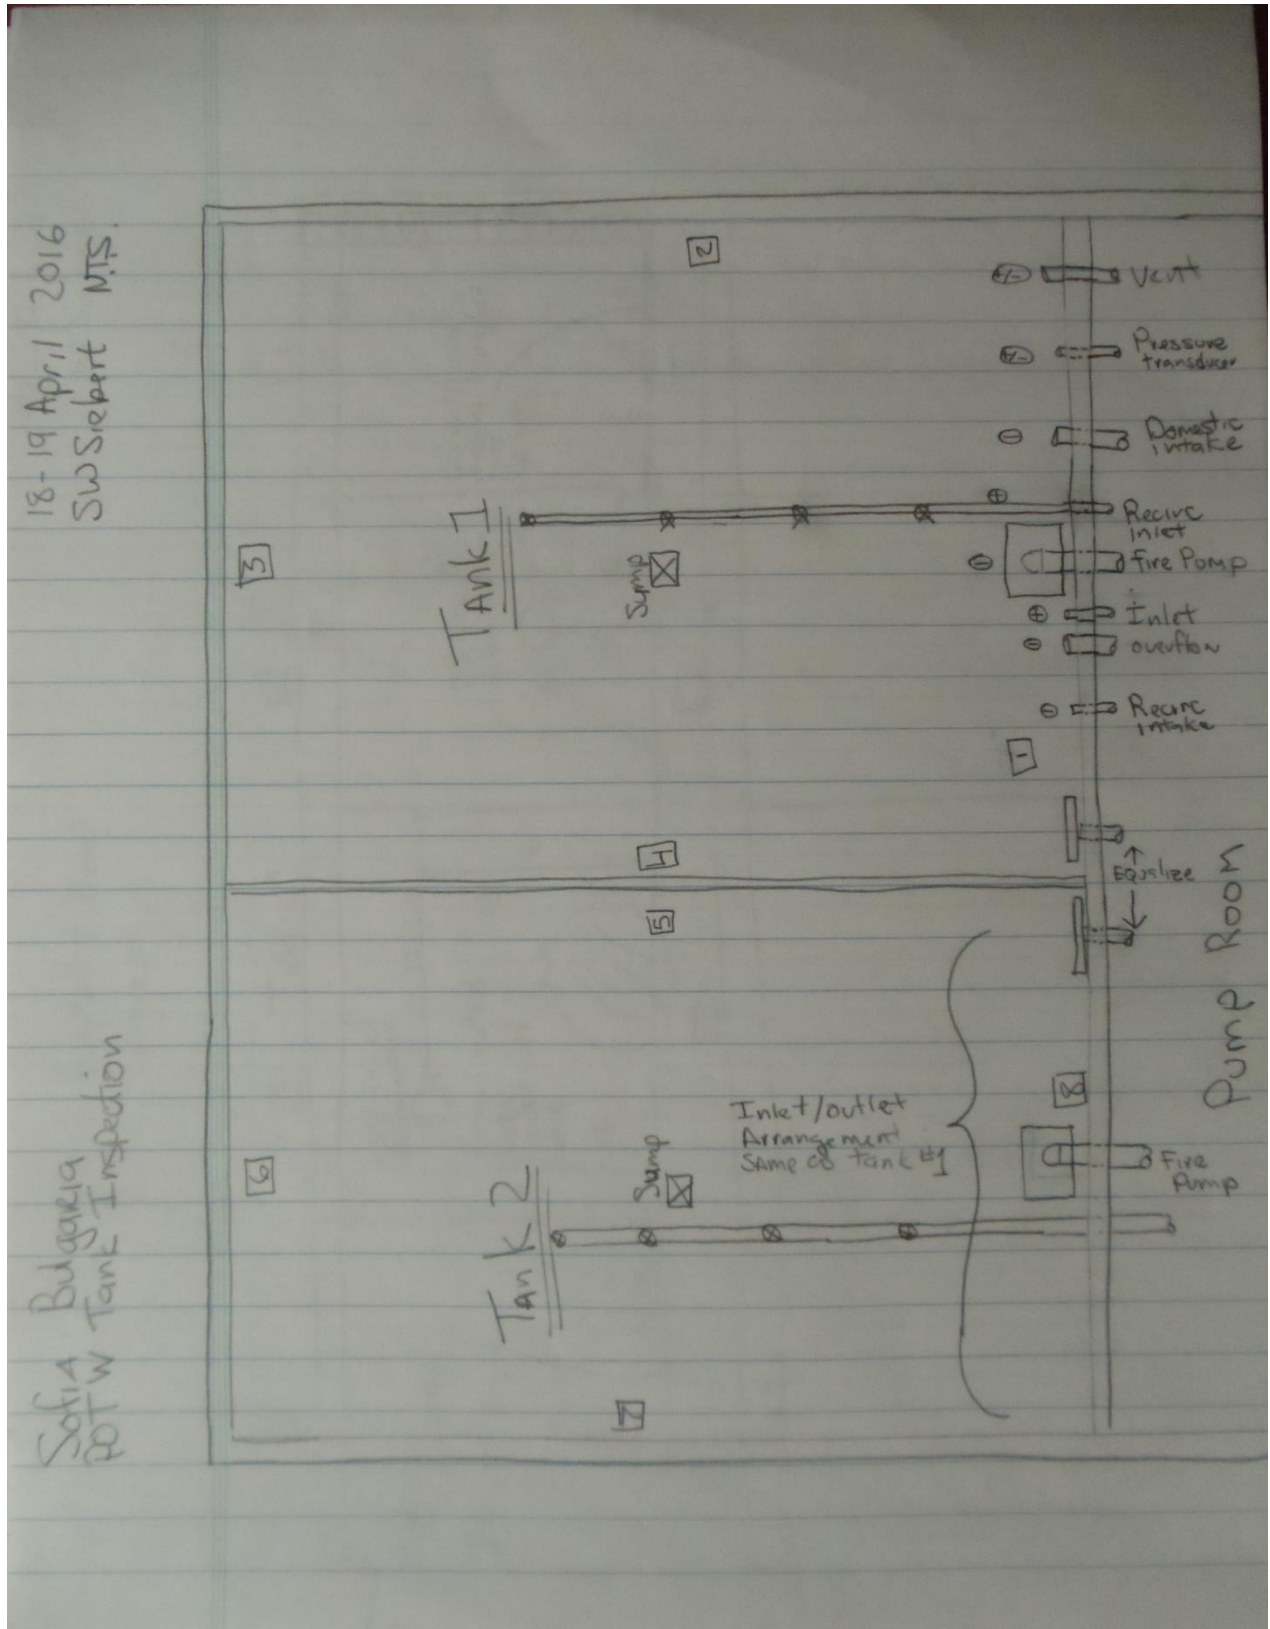
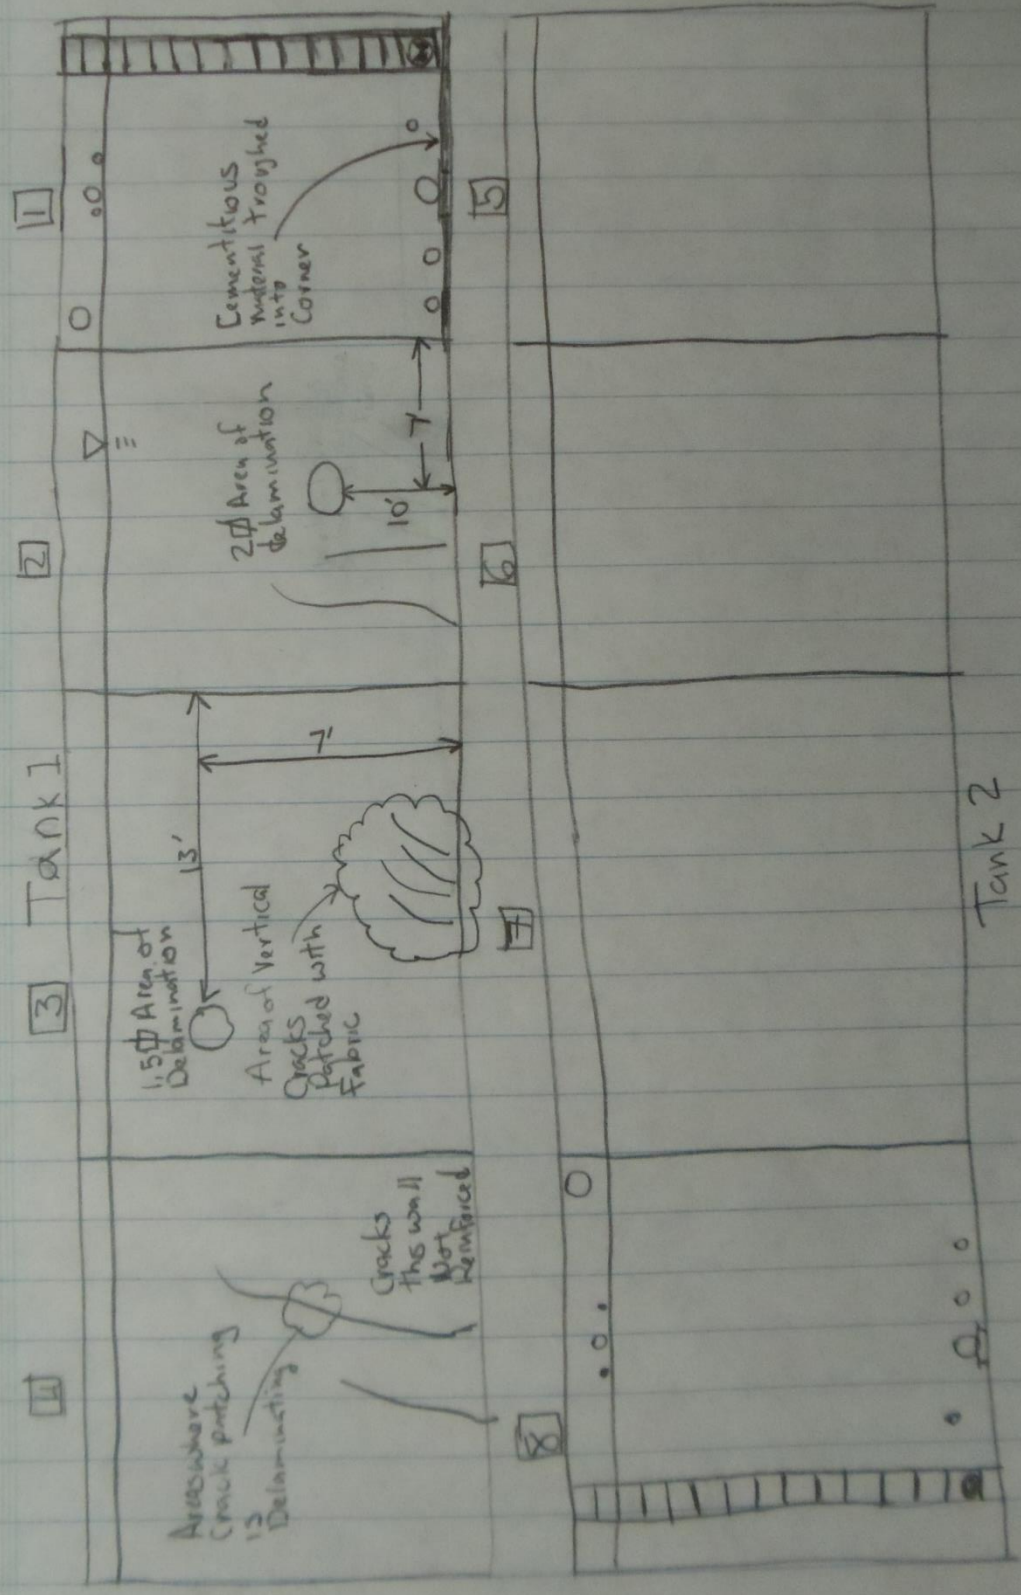
Tank Exploded View
Sofia Bulgaria

7. Tank Structure- The tank structure was found to be in good overall condition. Several locations were found where concrete delamination around rebar were detected. In all of these areas, the concrete remained sound with no evidence of spalling observed. These areas are shown in the attached sketch. Evidence of past crack repairs were observed. These repairs consist of the application of additional brushed on cementitious sealer with and without woven fabric reinforcement. Evidence of delamination of the crack repairs were observed. Cementitious crack seal was applied along the entire joint between the wall and floor on the wall adjacent to the pump room. Evidence of seepage through this wall on the pump room side was observed.
