Soil Corrosion Test for Stainless Steel Water Supply Pipes

VOLUME 3: 10-YEAR BURIAL TEST RESULT REPORT

©1997 Japan Stainless Steel Association

Translated 2020 for the Nickel Institute, Toronto, Canada

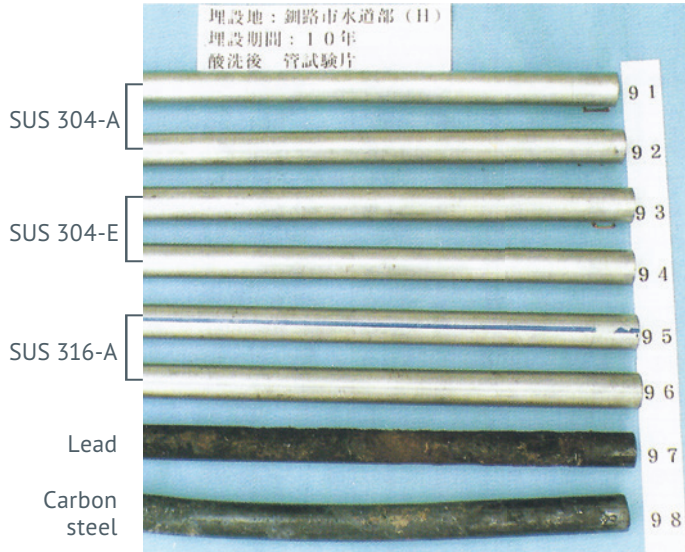
Kushiro (H) test site (after pickling)

304 and 316 stainless steel pipes buried horizontally: At some test sites, brown staining or brownish-red spots occurred on some parts of the pipe surfaces. However, corrosion was not found during observation after water washing or pickling.

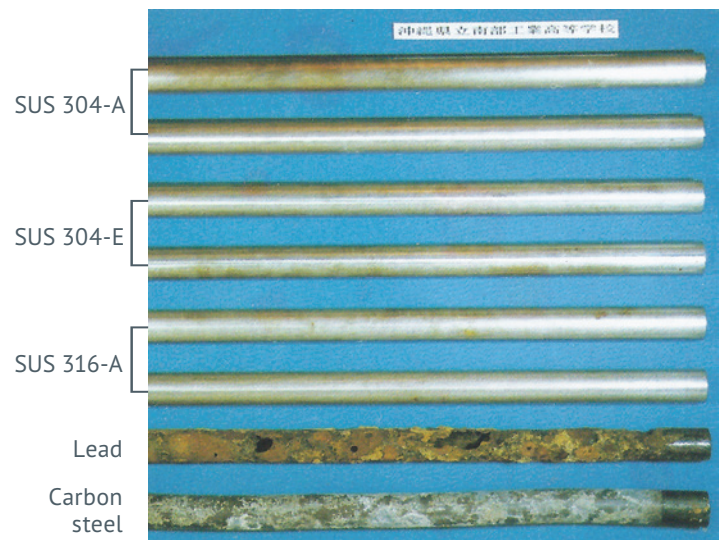
Okinawa (X) test site (after water washing)

Most of the stainless steel pipes that were corroded were those buried in Okinawa, which is in a marine environment. The characteristic points at this site in terms of the corrosion types is that the proportion of pitting corrosion was about 4.5 times that of the crevice corrosion, while the number of horizontally buried pipes that were corroded was the same as that of the vertically buried pipes that were corroded. These characteristics

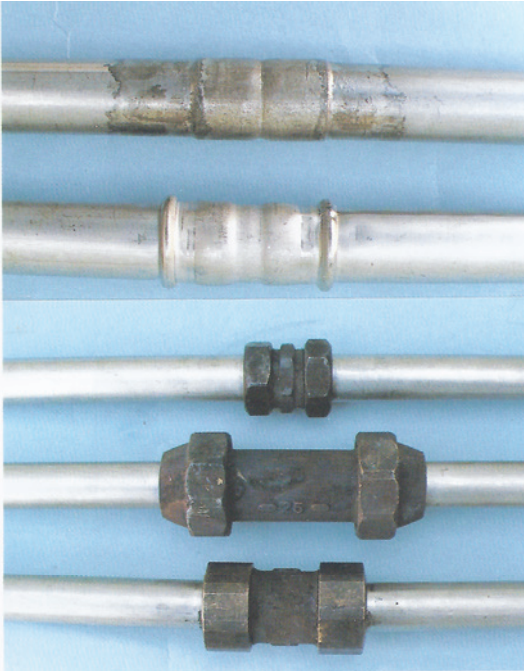
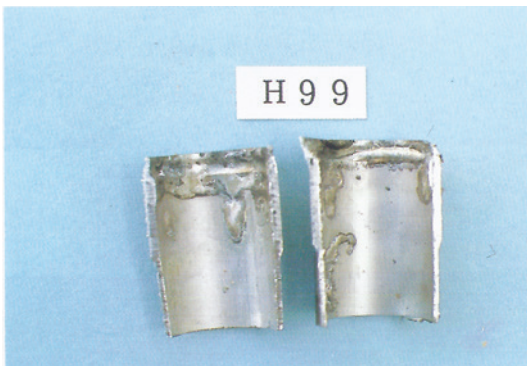
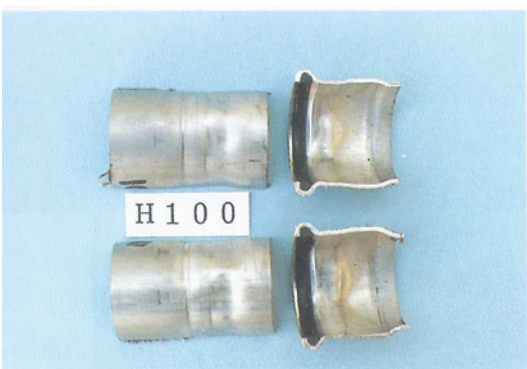
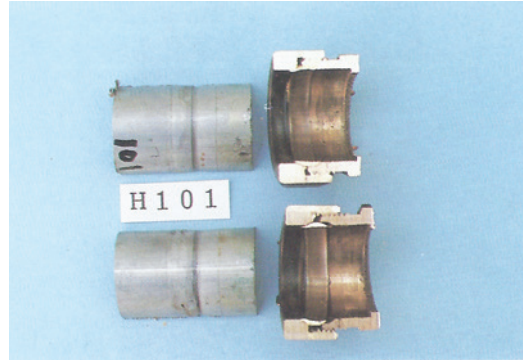
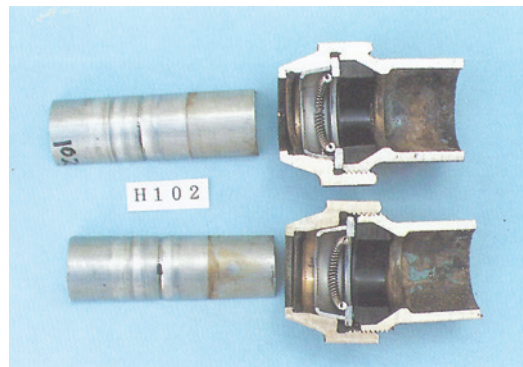
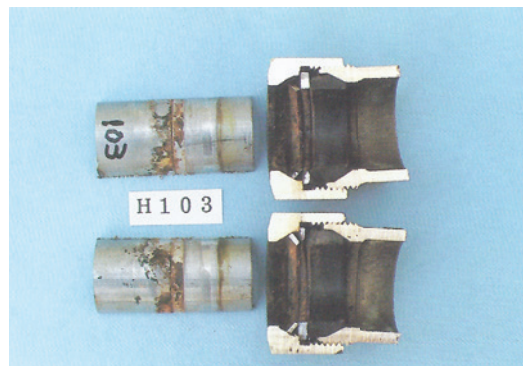
Photo 2 Appearance of Pipes with Couplings (Kushiro (H) Test Site)

After the samples were divided into pipes and coupling bodies, it was found that, as shown in *Table 5*, only 304 stainless steel pipes connected by flexible couplings (B) in Yabuzuka (K) became corroded, and in Okinawa (X), the pipes

connected by flexible couplings became corroded. On the other hand, when looking at coupling bodies, corrosion was found on a significant number of solder-type, compression-type (manufactured by BC) and flexible couplings. A great deal of pitting corrosion was found on both pipes and couplings in Okinawa, while widely spread local corrosion was found on the main islands.

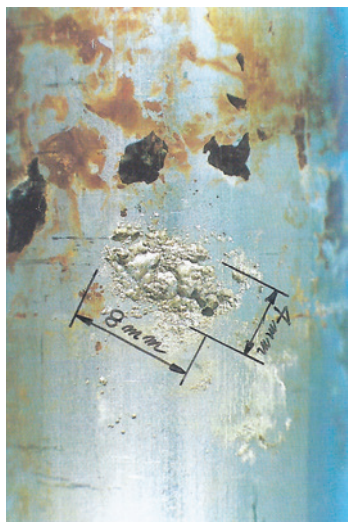
(1) Appearance

Photo 5 Crevice Corrosion that Occurred under the Vinyl Tape Covering (Okinawa (X) Test Site, Vertically Buried Pipe)

- 1) Although 304 stainless steel pipes buried horizontally exhibited slight staining, they exhibited good corrosion resistance and were not subject to pitting or other types of corrosion at many test sites. At the test site which was in a marine environment, however, crevice corrosion occurred under the vinyl tape covering.

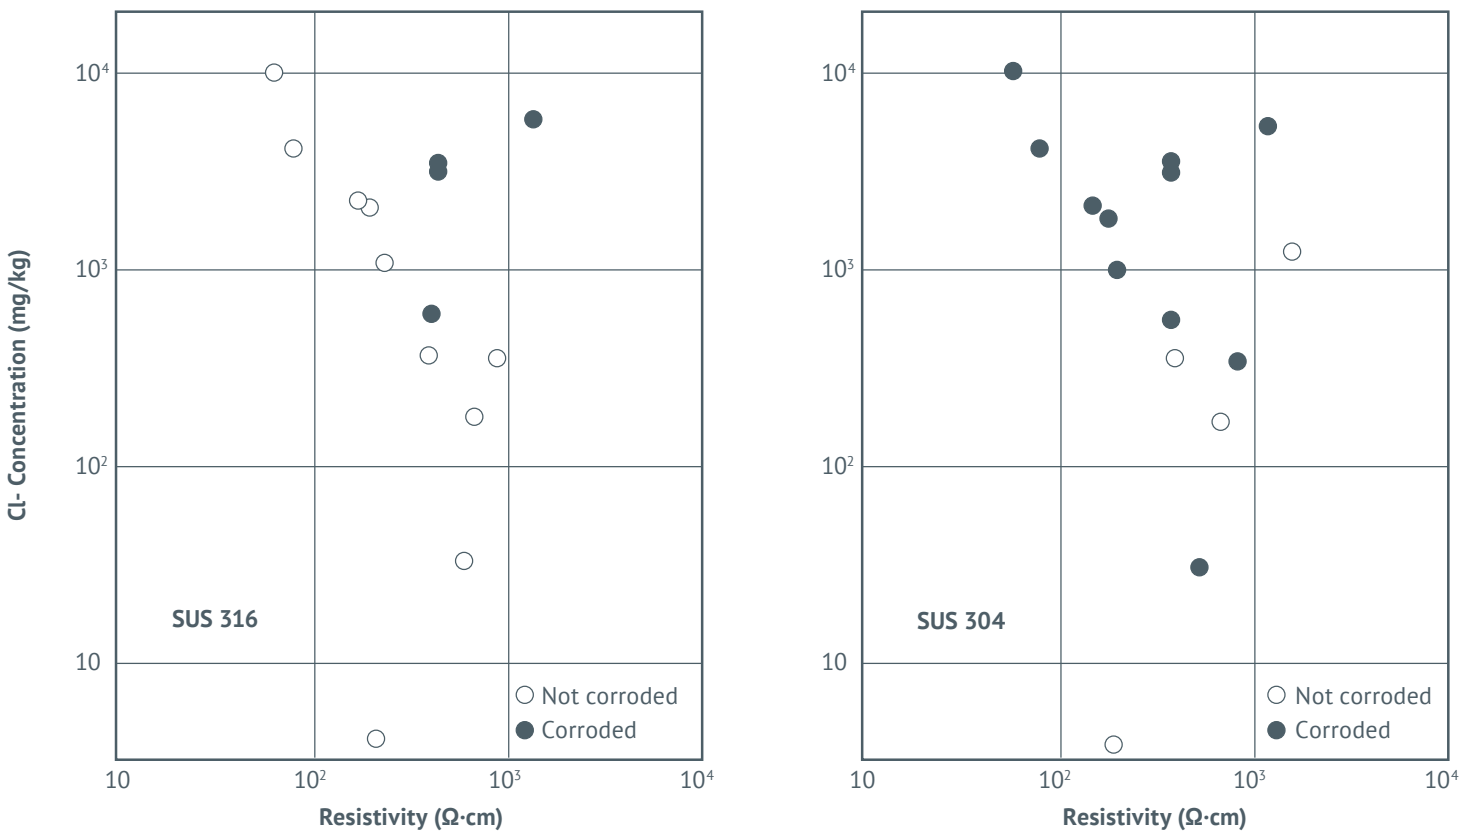
Figure 1 Relationship between the Pitting Corrosion on Stainless Steel and Cl⁻ Concentration/Resistivity of the Soil

Figure 1 shows the relationship between the pitting corrosion on stainless steel and Cl⁻ concentration/resistivity of the soil based on the soil corrosion test results from NBS. As shown in this figure, the occurrence tendency of pitting corrosion on stainless steel has a higher correlation with the Cl⁻ concentration than with the soil resistivity. Furthermore, 304 stainless steel is likely to suffer pitting corrosion when the Cl⁻ concentration is 300 mg/kg or more, while 316 stainless steel is unlikely to suffer it even when the Cl⁻ concentration is remarkably high. On the other hand, excluding Okinawa, the soils at test sites where this test was performed have 100 mg/kg or less of Cl⁻ concentration, indicating that their corrosiveness to stainless steel is low.
