Insurance assesor 'summary of damage' *Orca*

Technical analysis of Musto lifejacket worn by skipper of *Orca*

FLEETWOOD TESTING LABORATORY
EVALUATION OF
MUSTO 150N INFLATABLE LIFEJACKET
ON BEHALF OF
MARINE ACCIDENT INVESTIGATION BRANCH
MOUNTBATTEN HOUSE
GROSVENOR SQUARE
SOUTHAMPTON
SO15 2JU
UK

ORCA: accident leading to a fatality on 8 June 2014

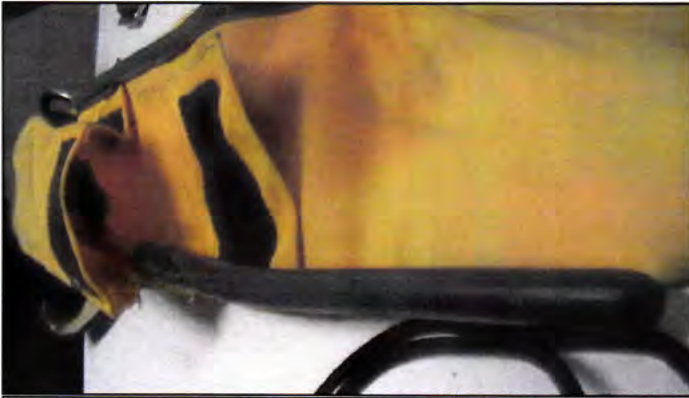
The yellow cover fabric was worn. There were no visual signs of any damage or defects to the cover fabric. The black webbing is faded in parts on the back double shoulder straps. The front pocket containing the VHF radio was in an open position. The VHF radio aerial was damaged as the internal metal coil of the aerial was exposed (see Fig. 3). The VHF radio was wedged in to the pocket and we were unable to remove the radio from the pocket. The VHF radio cord handle was found loose inside the pocket (see Fig. 4).

Fig.3. Damaged aerial on VHF radio.

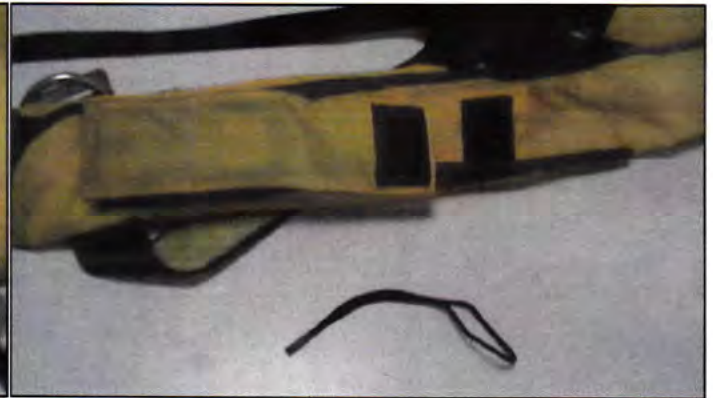
Fig.4. Front pocket with VHF radio and loose cord handle.

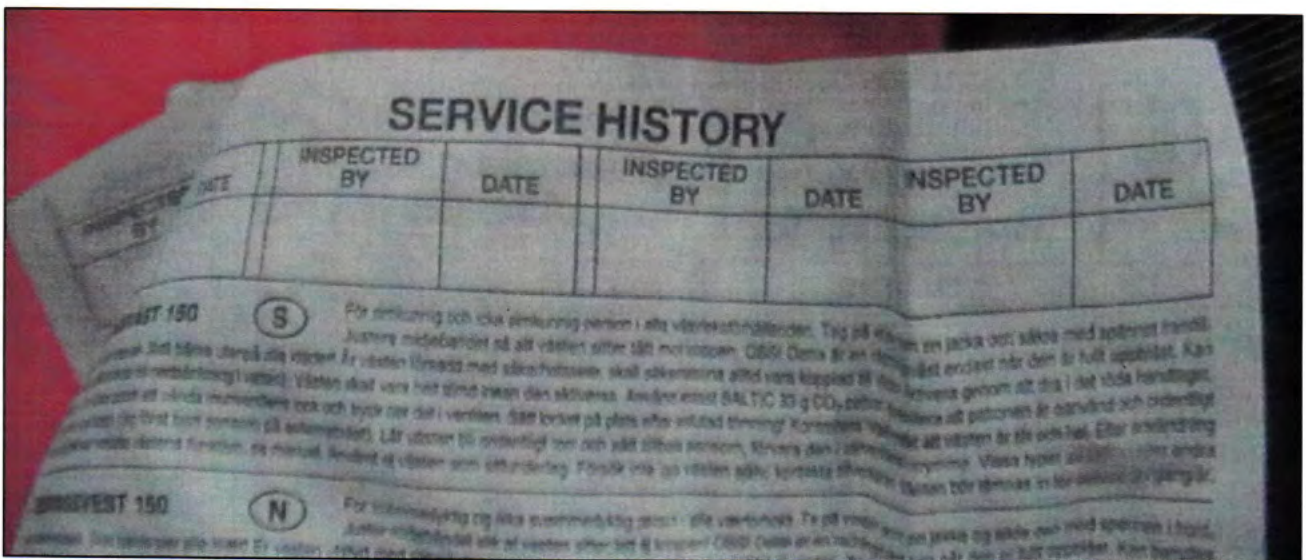
There is no record of the lifejacket being serviced on the lifejacket service record.

Note: The information on the lifejacket for servicing recommendations states; 'This lifejacket should be serviced once a year. Refer to agent.'

Fig.9. Internal label (back) – service history record.

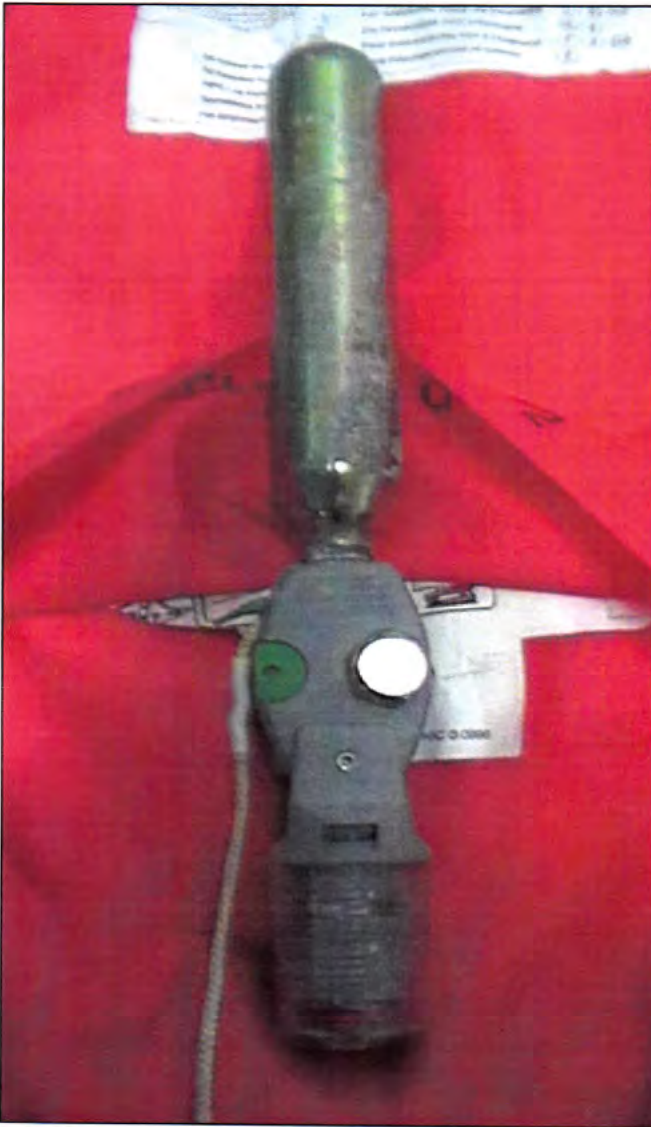
On inspection the inflation mechanism's green manual indicator clip was still present indicating that the manual pull cord had not previously been activated. The automatic cap was showing red which indicates that the automatic element had previously activated, this is seen in Fig. 10.

The CO₂ cylinder showed signs of corrosion to the main body and more severely around the thread (see Fig.11 and 13). The cylinder was not fitted correctly as it was sitting loosely in the thread of the inflation mechanism. It was also possible to move the cylinder back and forward whilst it was screwed into the inflation mechanism.

Fig.10. Halkey Roberts inflation mechanism fitted with CO₂ cylinder (as received).

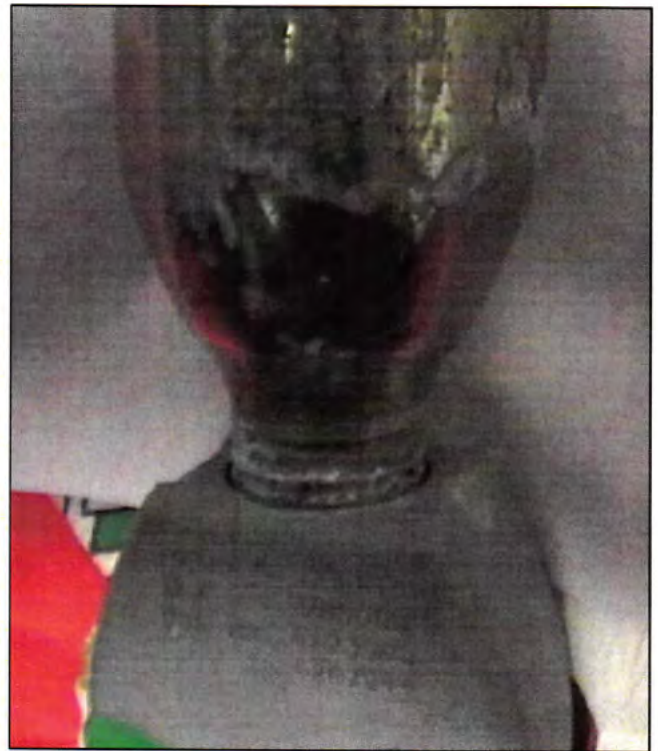
Fig.11. Corrosion around cylinder thread.

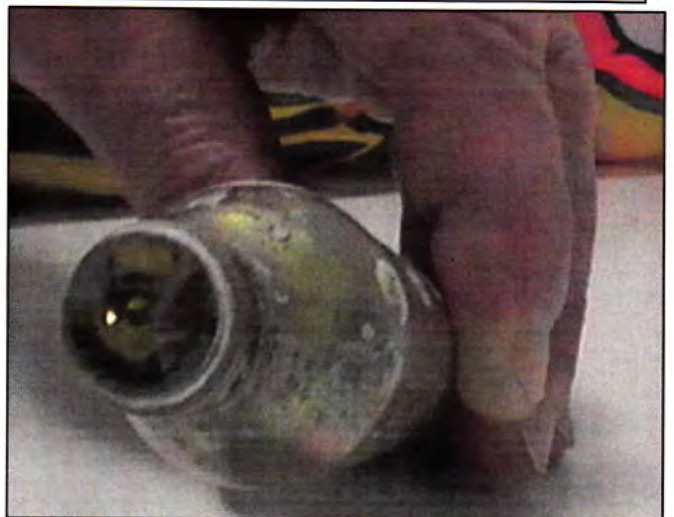
When the cylinder was fully unscrewed from the inflation mechanism there was no evidence of piercing, or attempted piercing of the cylinder cap (see Fig.12). The weight of the cylinder was checked, the weight was 134.9g.

Fig.12. Condition of cylinder cap when unscrewed.

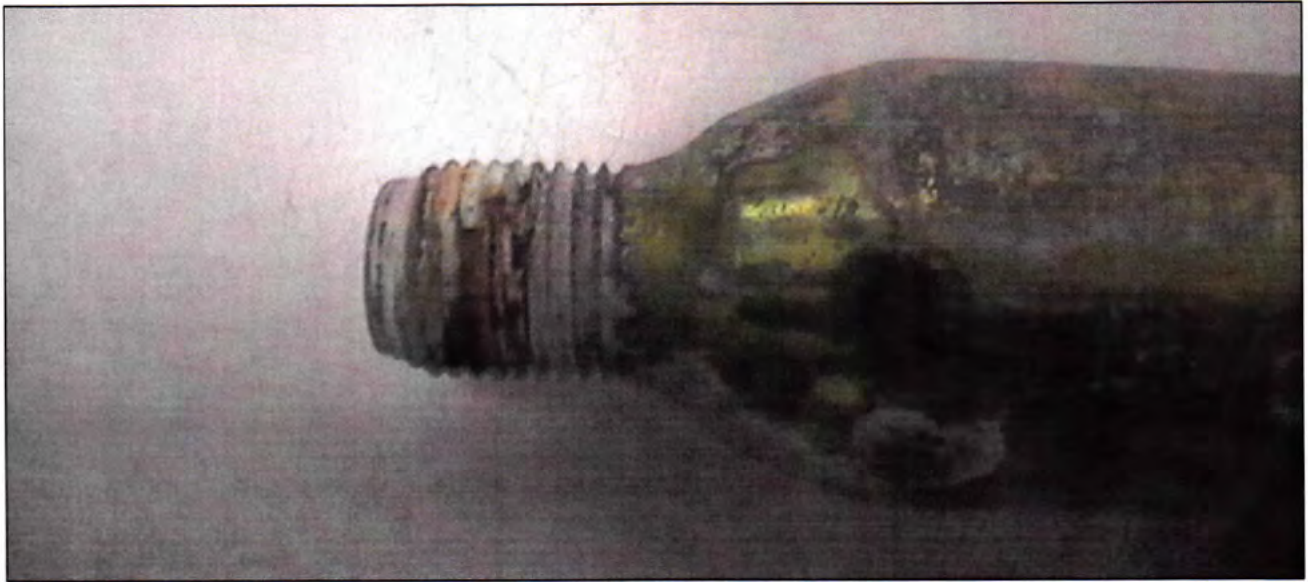
Fig.13. Corrosion around cylinder thread when removed.

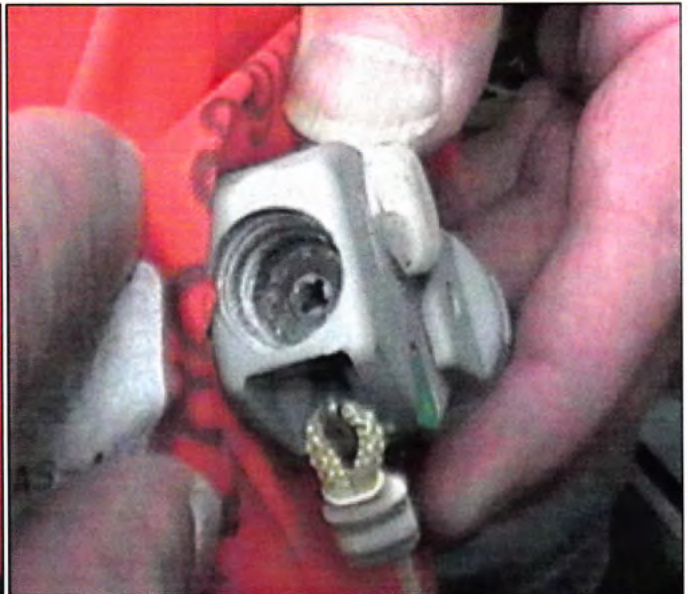
Fig.15. Halkey Roberts inflation mechanism thread – damage at top of thread.

1. The damage to the top of the thread of the inflator is most likely due to the CO₂ cylinder not being screwed in to the inflation mechanism correctly, allowing movement of the cylinder over time and resulting in damage to the top of the thread. This damage did not affect the correct functioning of the inflation mechanism.
2. There was no other damage or defects found on the lifejacket or lifejacket components.
3. Markings of the deck safety harness label, CO₂ cylinder and automatic bobbin indicate a manufacture date of 1997. The lifejacket markings indicate a maximum lifespan of 10 years for this model of lifejacket.
4. There is no record of servicing of the lifejacket and therefore the lifejacket has not been serviced according to the manufacturer's instructions.

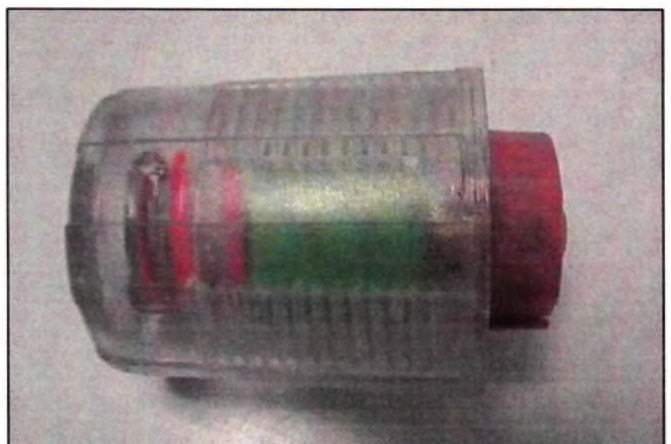
The automatic cap was unscrewed from the main body of the inflation mechanism to inspect the automatic inflator components. There was a white residue present, as seen in Fig.14. This is further indication that the system had previously automatically activated. The Halkey Roberts red bobbin was marked with HRC 02/97. This indicates a manufacture date of February 1997.

Fig.16. Halkey Roberts automatic cap with bobbin.

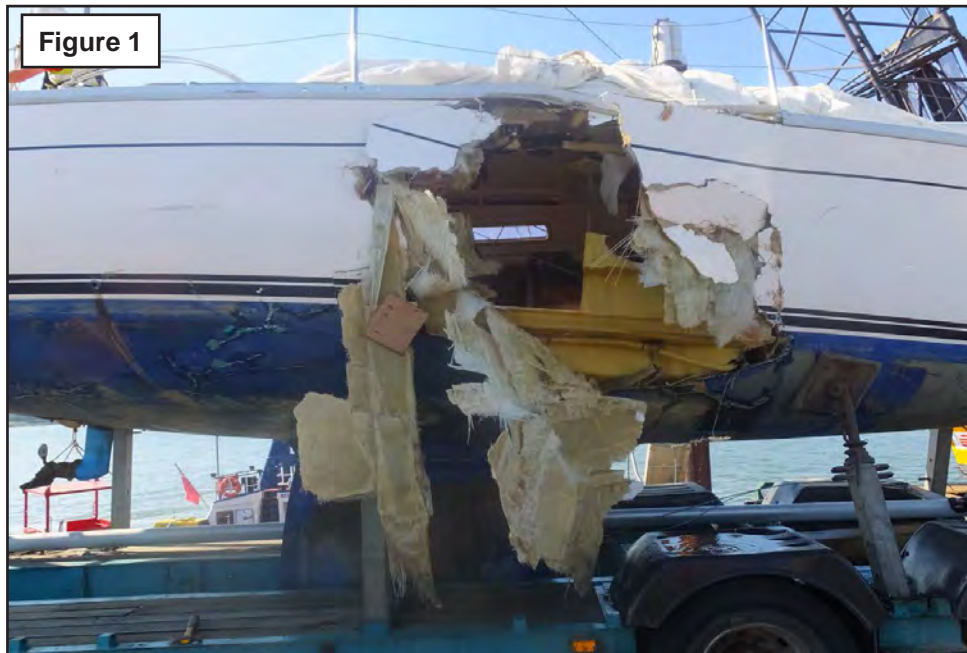
Figure 1

At 1331 on 8 June 2014 the dredger *Shoreway* and the sailing yacht *Orca* collided 7 miles off Felixstowe. Damage to *Orca* was catastrophic (**Figure 1**) and it sank within minutes of the collision. The yacht's skipper was rescued from the water by *Shoreway's* rescue boat but the skipper's wife could not be found despite an extensive air and sea search. Her body was recovered from the sunken yacht by divers the next day. There was no damage to *Shoreway*.
