Space Shuttle Body Flap Actuator Bearing Testing for NASA Return to Flight

Abstract

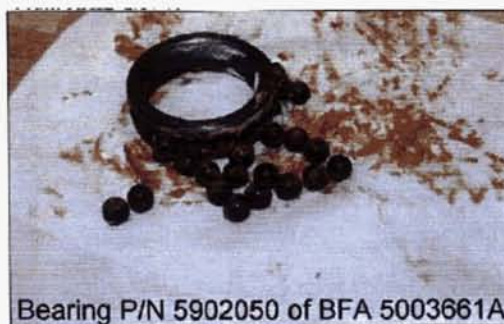
Figure 2. Body Flap Shaft Bearing S/N V6L009

Visual inspection of P/N 5902050, S/N V6L009, revealed a black, tribological coating on the balls and race wear tracks (Figure 3). It should be noted that no other bearing in the Body Flap or Rudder/Speed Brake actuators was found to contain the black, tribological coating on the wear surfaces. Minor corrosion was noted on the inner and outer raceways. The grease present in the bearing was brown in appearance due to the tribological decomposition of the Braycote 601 grease and iron oxide wear debris. The recommendation based on microscopic examination analysis was to replace the bearing since the wear surfaces were black and it suffered Brinell damage during disassembly.

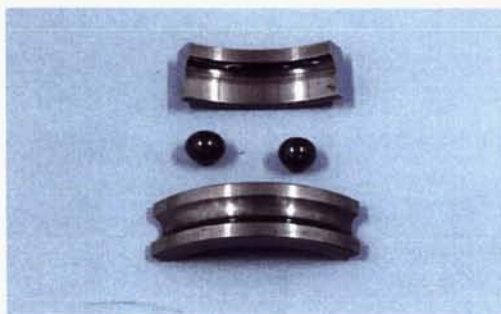
Figure 3. Black bearing after sectioning and cleaning

Note black balls and the dark bands present on the raceways.

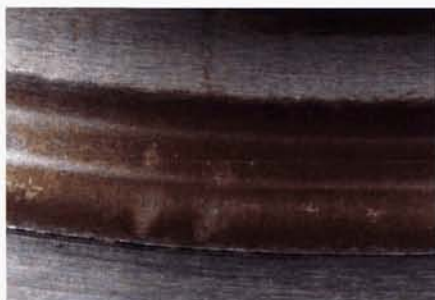
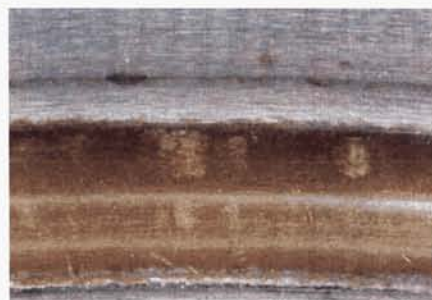
Further work performed in 2004 by Hamilton Sundstrand, Inc. reported that the inner ring contained a black tribological coated band. The black band or wear track possessed a smooth matte finish with a grain boundary like structure. Outside the black wear track, the original surface was still evident along with the original finish marks. The outer ring contained a similar black coated wear band (Figure 4). The wear surface of the outer race was similar in appearance to the wear surfaces present on the balls.

Figure 4. Magnified views of the black wear tracks in the inner race (left) and outer race (right) are shown. Note the false brinelling marks. The dark brown color is an optical aberration of the black color.

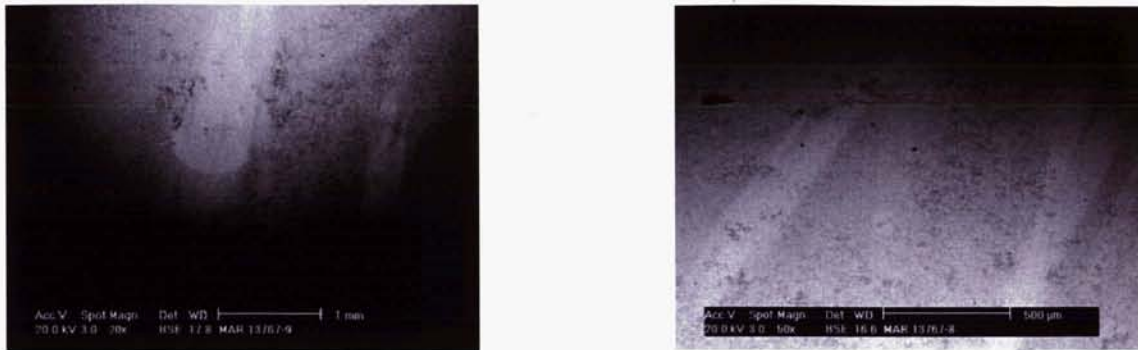
Scanning electron microscopy was performed on segments of the black ball bearing by various groups [5]. The segments examined included the balls, inner raceway and outer raceway. Analysis of the balls by energy dispersive spectroscopy (EDS) revealed that the black tribological coating was composed of carbon and iron oxide. The coating was porous and appeared to be uniform over the entire ball surface. A few skid marks were noted (Figure 5). In addition, each ball possessed a moon-shaped spot that appeared to have penetrated the burnished coating. The spot was probable caused by a drop of rain

water absorbing corrosive chemical from the degraded grease and dissolving the black coating during Shuttle storage.

Figure 5. Scanning electron micrograph of black ball showing spot (left) and skid marks (right)

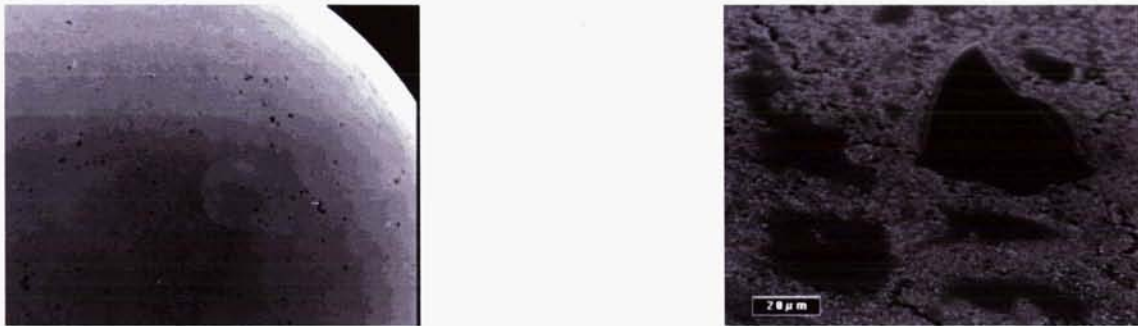
Figure 6. Scanning electron micrographs of the black ball (left) and magnification of particle present on the ball surface (right)

Higher magnification of the ball revealed some particles present on the ball (Figure 6). The presence of aluminum and silicon, in addition to other elements detected by EDS on these particles, were likely attributed to the bentonite clay additive present in the Braycote 601 grease and not contamination as was originally proposed. Analysis of the inner and outer raceways showed surfaces similar to the black ball. EDS performed on those surfaces detected the carbon iron oxide coating found on the black balls. Examination of the inner raceway away from the burnished band showed the original finishing marks which gradually translated into a smoother region as the burnished area was approached (Figure 7). Figure 8 shows the surface for the coating present on the black ball obtained by surface profilometry.

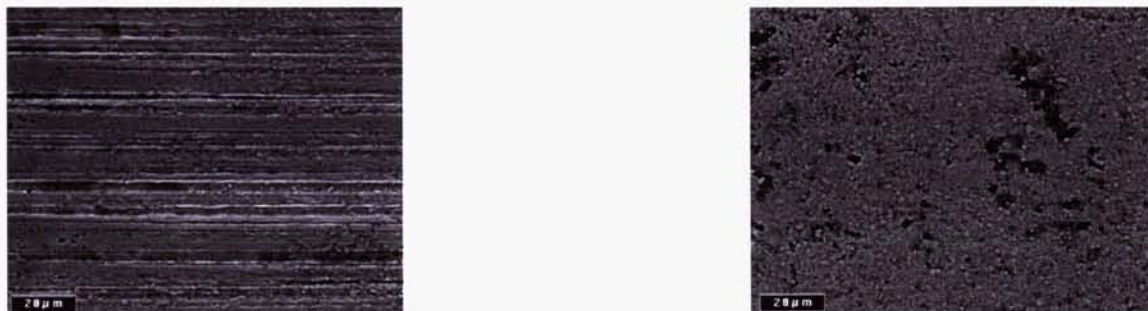
Figure 7. Scanning electron micrograph of the outer raceway in the region above the burnished band (left), and within the burnished band (right)

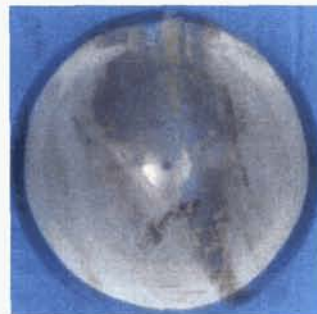
A photograph of a ball from BF-003 is shown in Figure 14. The photograph showed some banding and blue discoloration due lubricant degradation. The test lubricant was found to be in good condition. It was creamy white in color with some brown red areas caused by the early stage of lubricant degradation.

Figure 14. Ball from BF-003 after 48 Mission life test

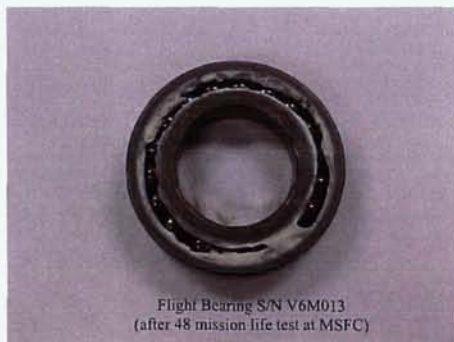
After testing, the lubricant appeared to be in good condition. The grease in the bearings was still creamy white with only a few areas of reddish brown discoloration (Figure 15). Balls from flight bearing showed significant banding due to normal wear and possible lubricant degradation (Figure 16).

Figure 15. Flight bearing SN V6M013 after 48 mission life test

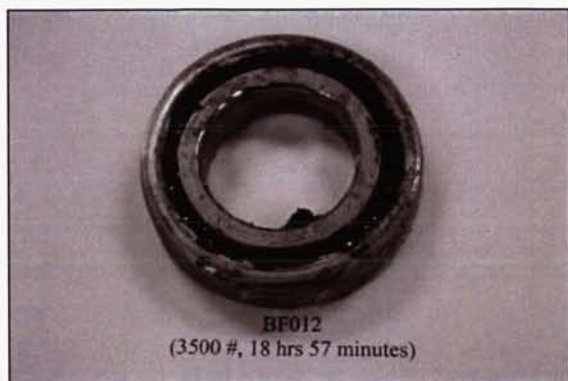
In general, failed bearings exhibited severe wear. A failed bearing is shown in Figure 17 and 18. The onset of wear started when the lubricant between the ball and race was completely consumed or degraded. Shear plastic deformation occurred between the race and ball steel to cause adhesive wear or severe wear. Due to high friction and heat generation, the local ball temperatures rapidly increased and caused oxidation and discoloration of bearing balls. In some case, the balls were highly discolored and almost black. The test lubricant in the failed bearings was very dark in color with significant degradation and metallic wear debris.

Figure 17. Failed Test Bearing BF012

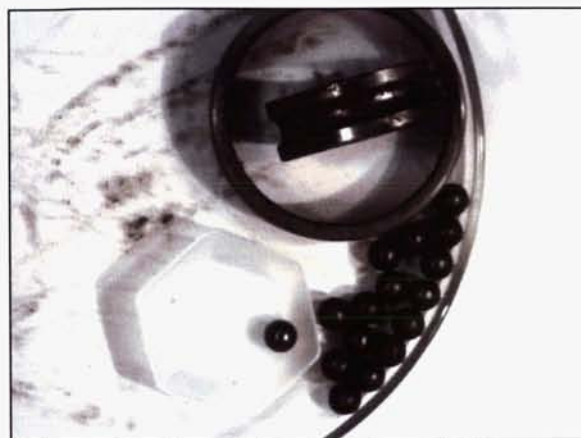
Figure 18. Failed Test Bearing BF012 (disassembled)
