Structural Condition Assessment

City of Bridgeport
RemGrit Shot Tower and Stack
889 Barnum Avenue
Bridgeport, CT 06608

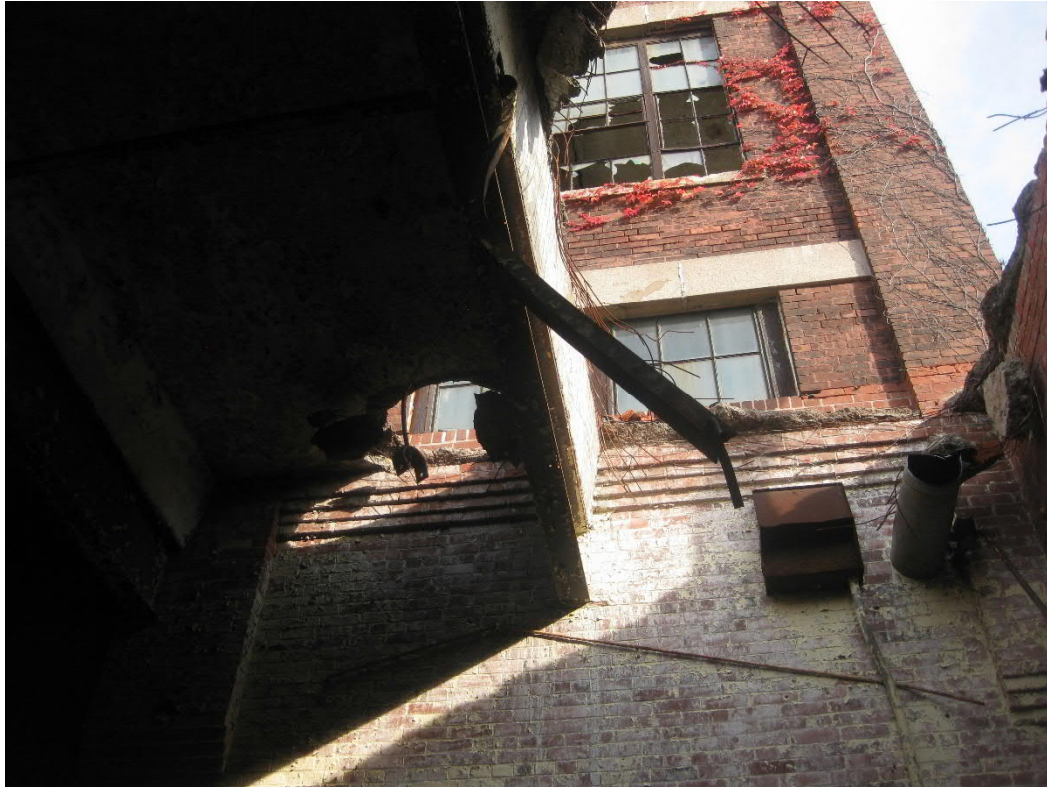
Photo #2 – Failure at low roof deck at second floor level

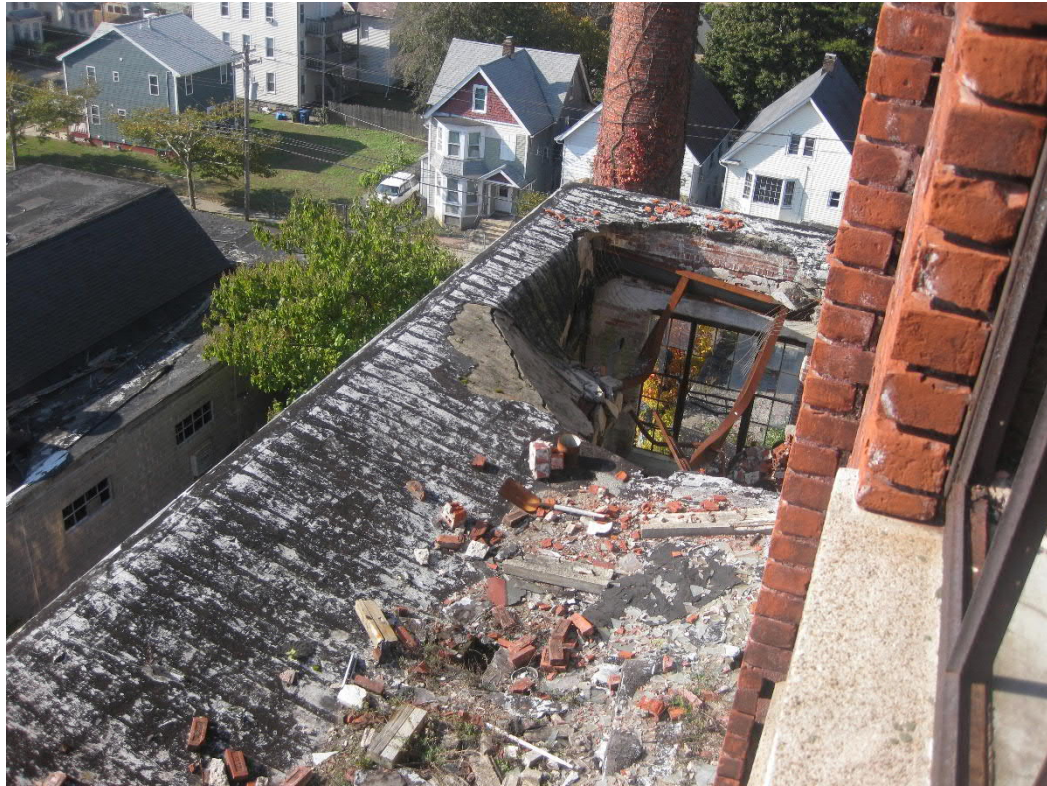
Photo #3 – Failure at low roof at fifth floor level

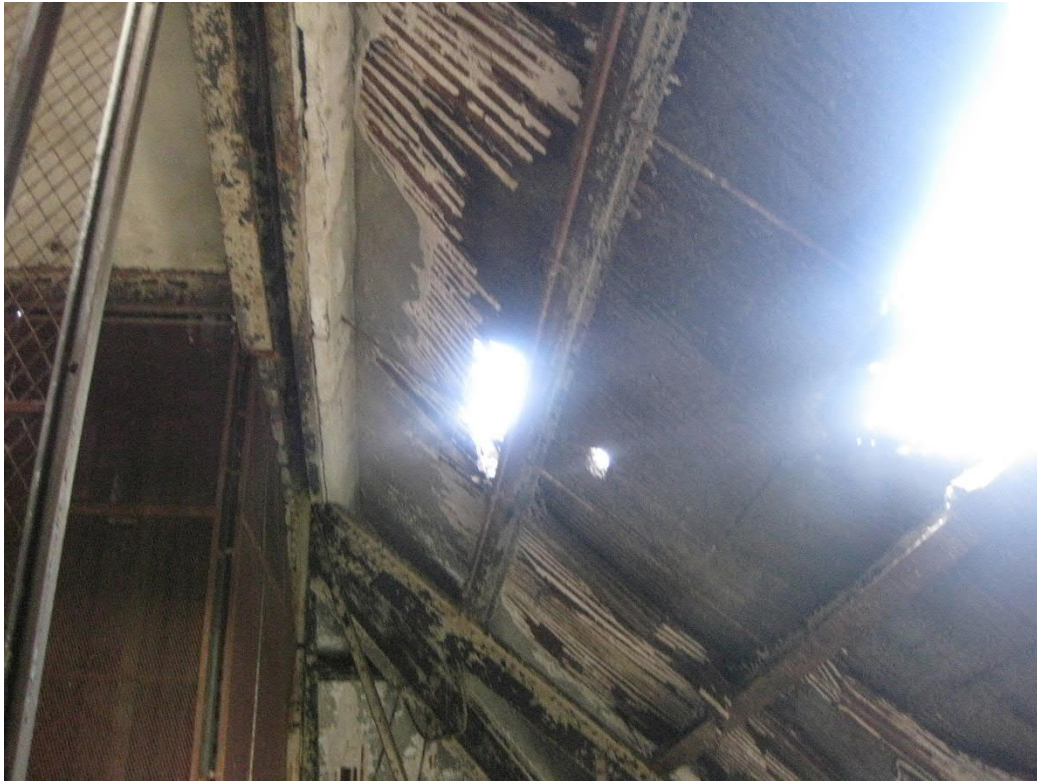
Photo #4 – Failed sections of sloped roof at north side

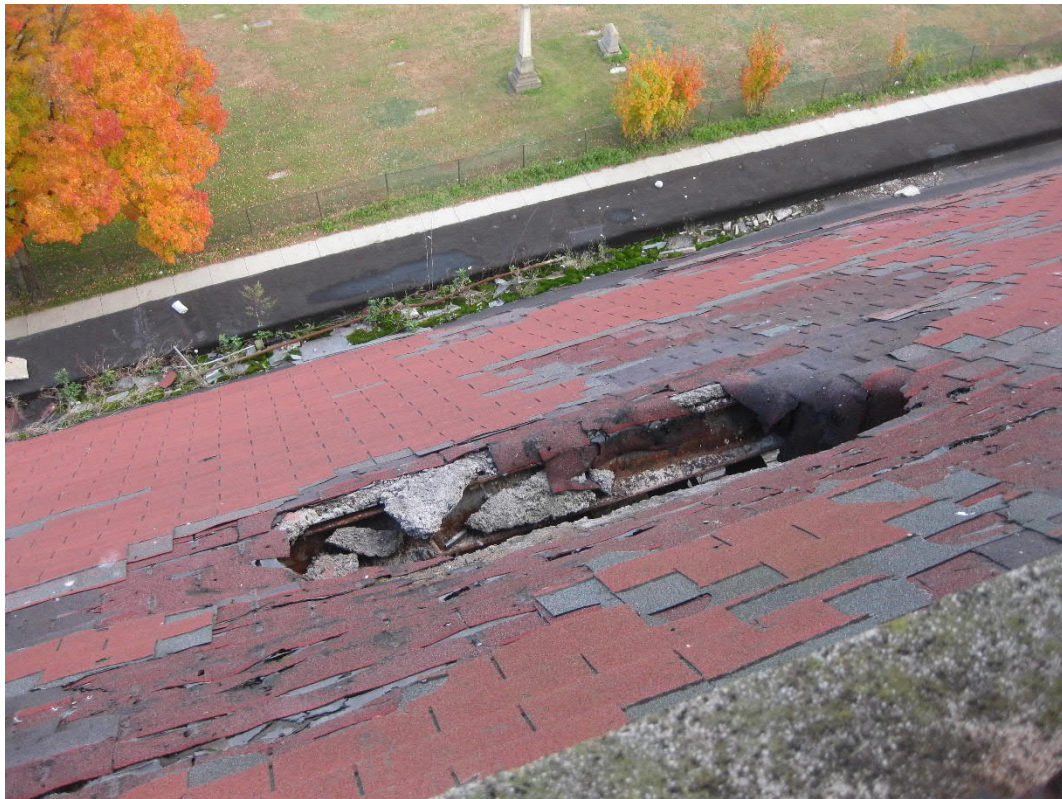
Photo #5 – Hole in sloping roof deck on north side

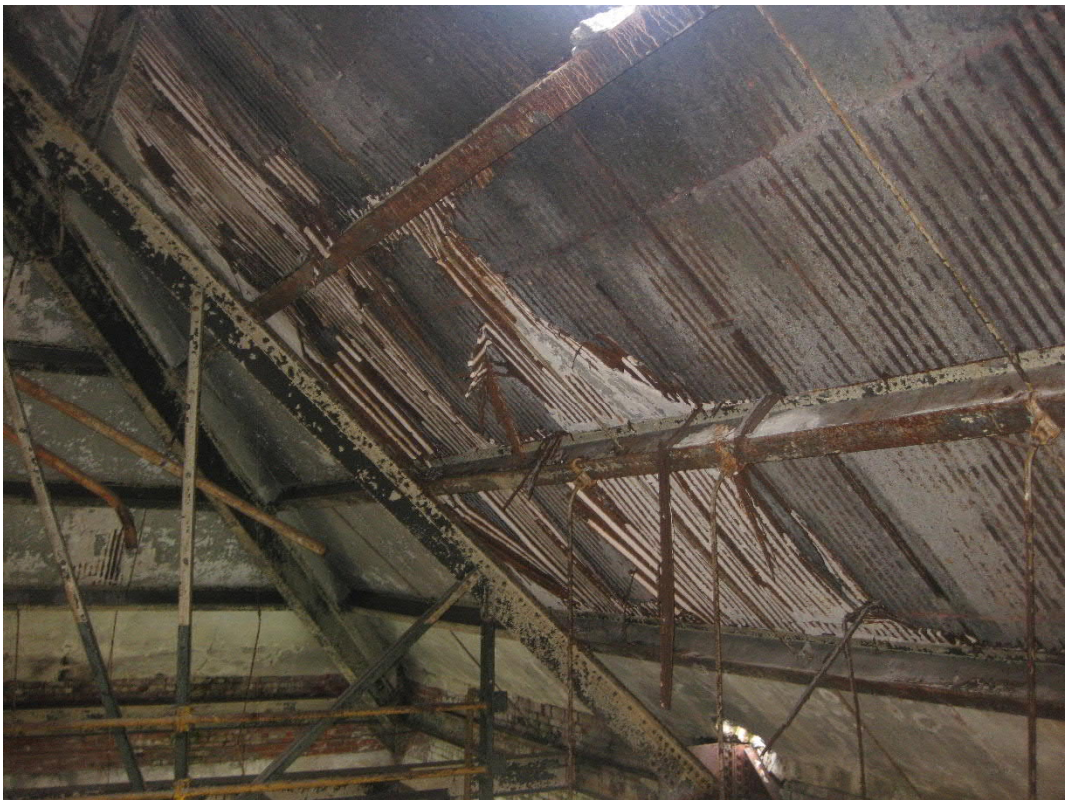
Photo #7 – Failed metal deck and rusted framing on north side of sloping roof

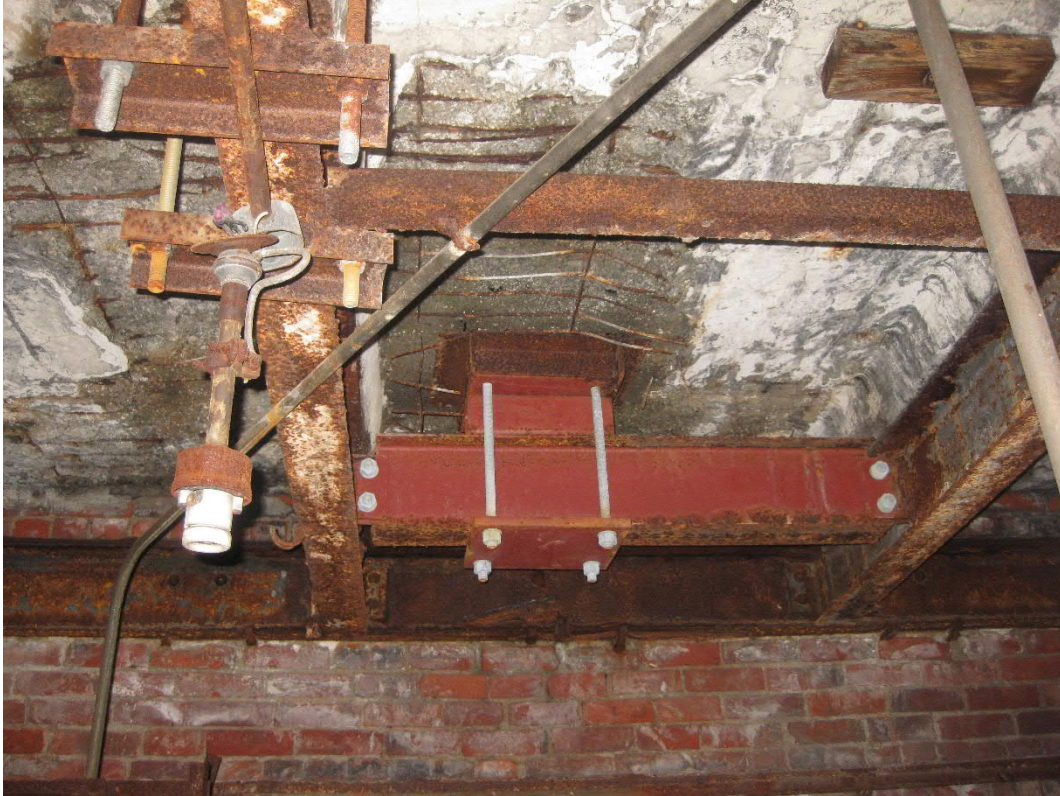
Photo #8 – Spalling concrete roof deck and rusted framing at upper roof

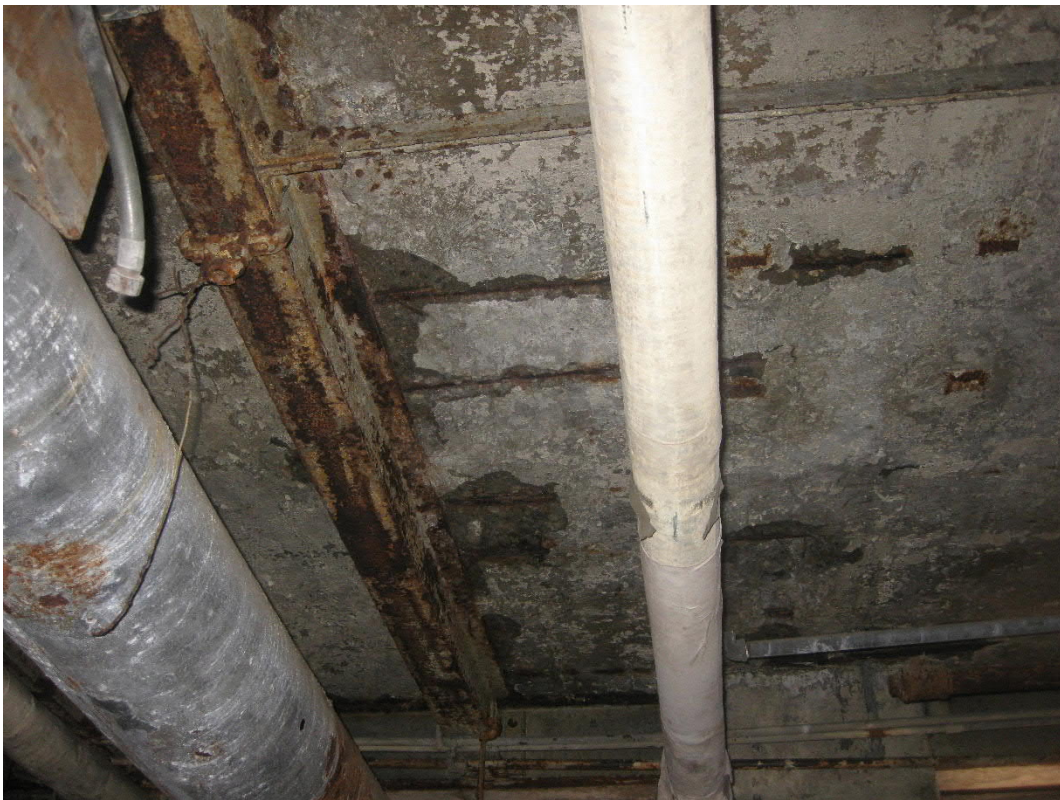
Photo #9 – Concrete deck damage and rusted steel at second floor

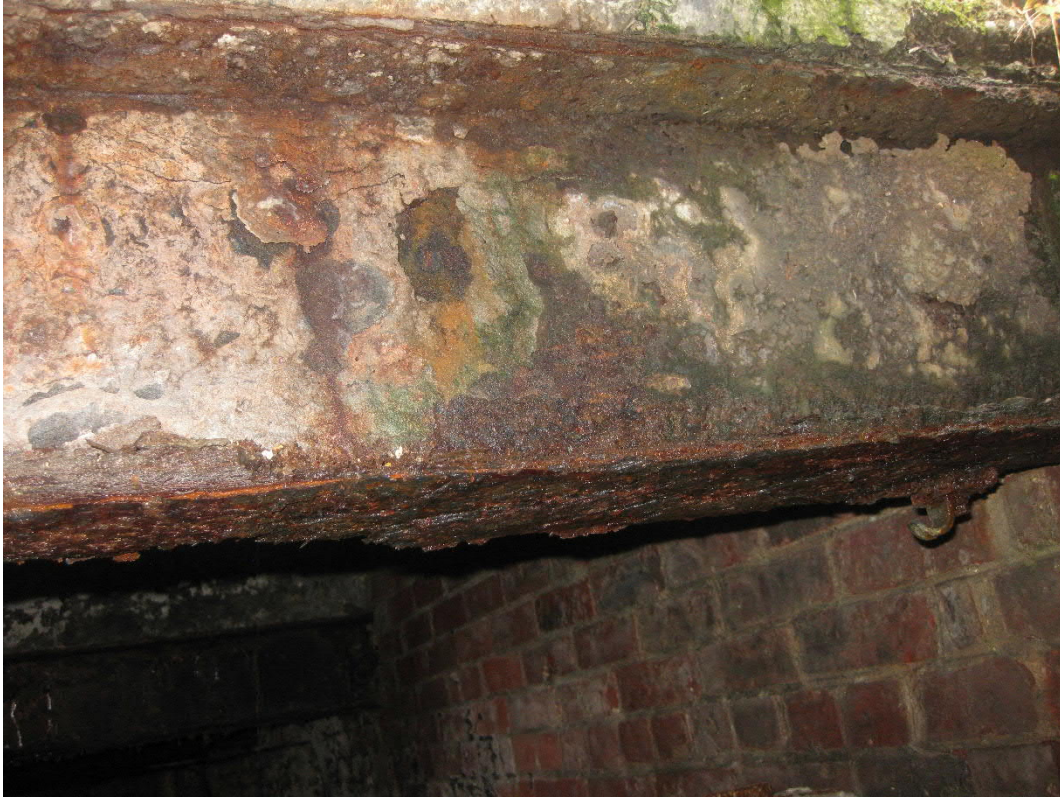
Photo #10 – Rusted framing at first floor

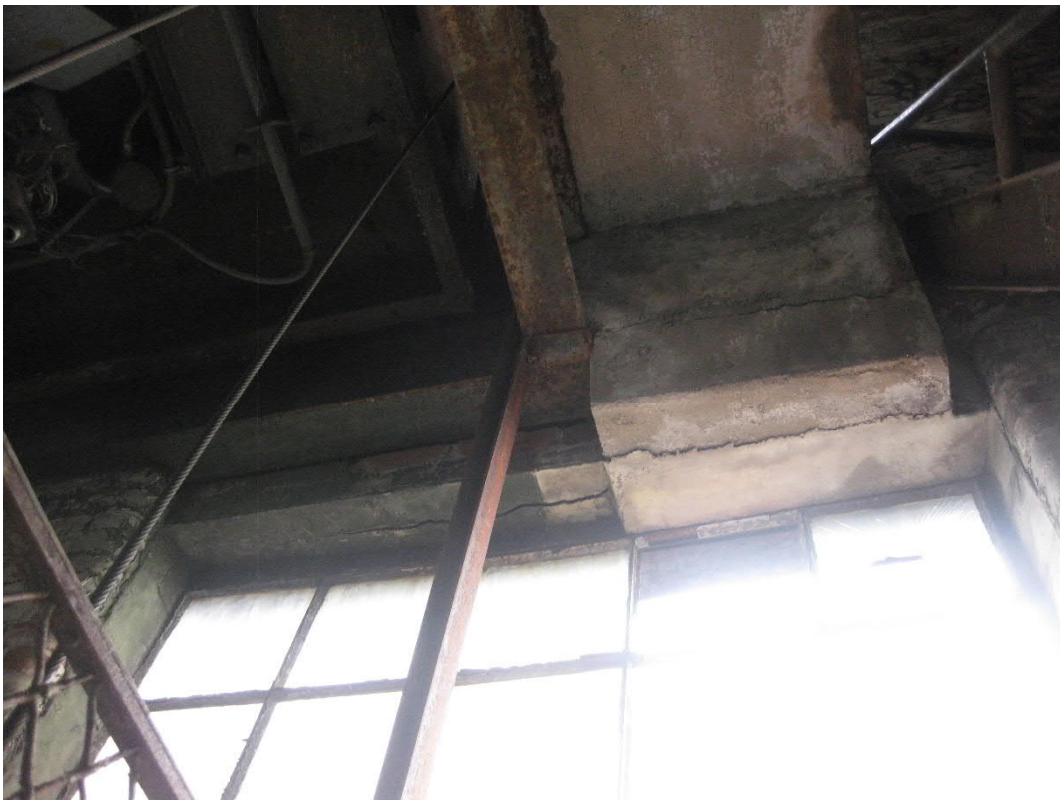
Photo #11 – Cracked lintel at window head

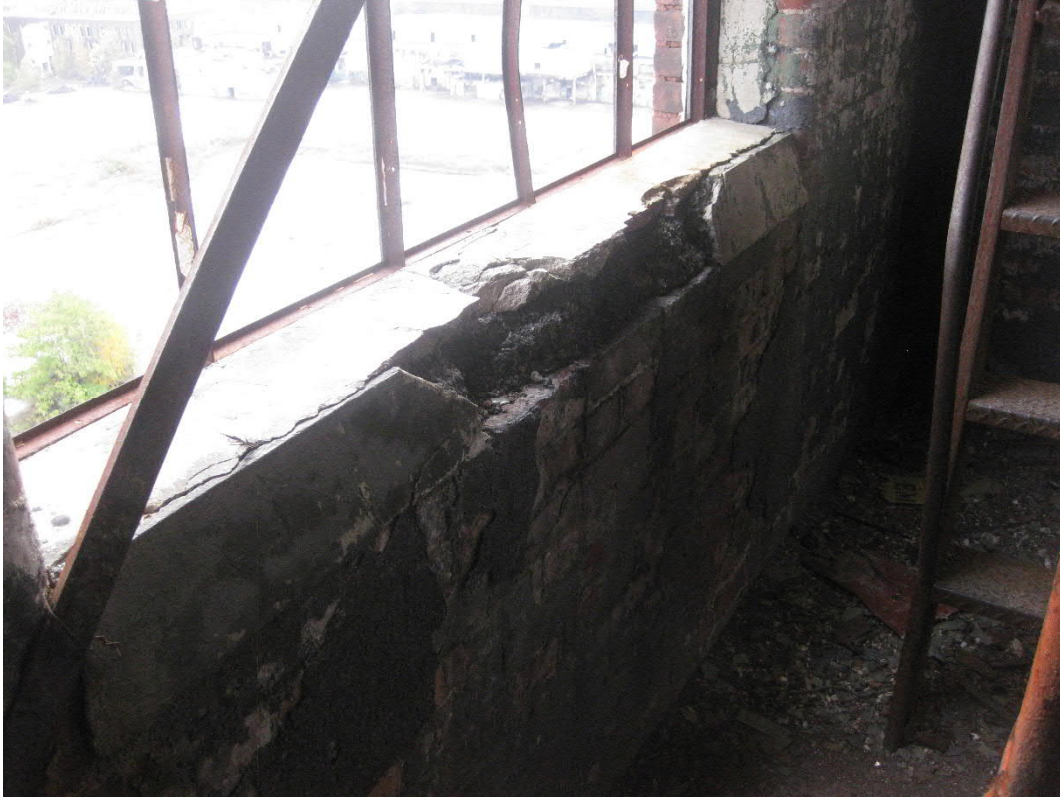
Photo #12 – Damaged window sill and frame

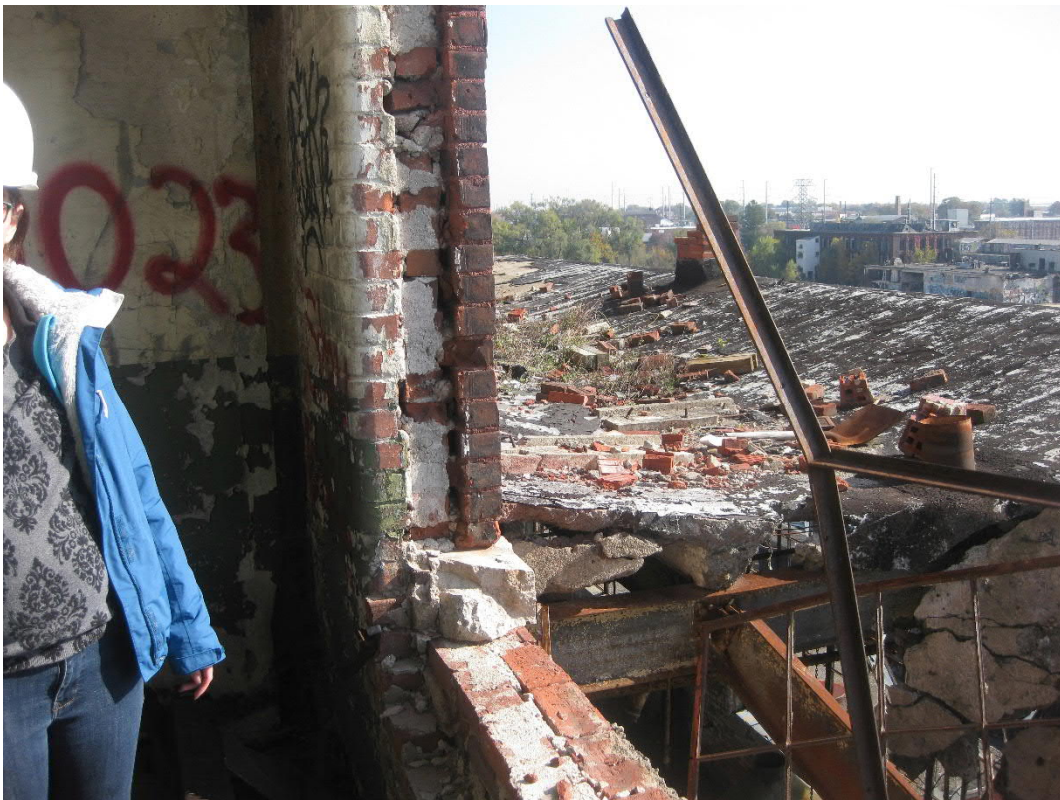
Photo #13 – Damaged window frame, sill and jamb

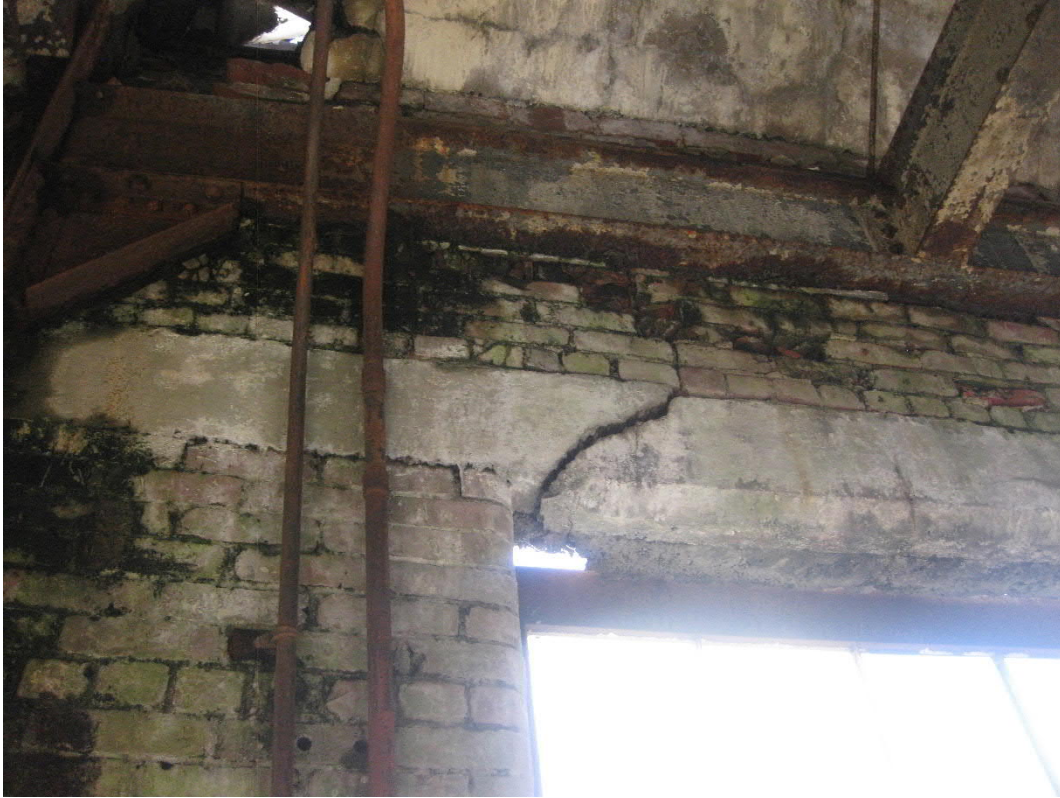
Photo #14 – Failed concrete lintel

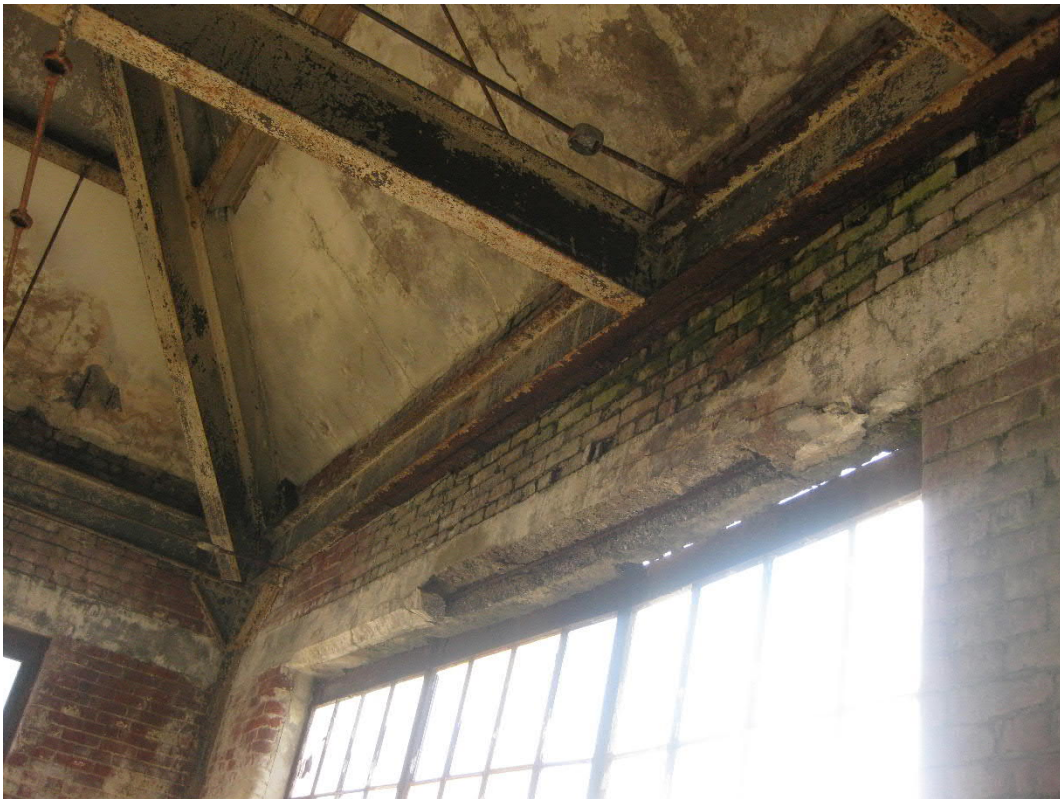
Photo #15 – Damaged concrete lintel

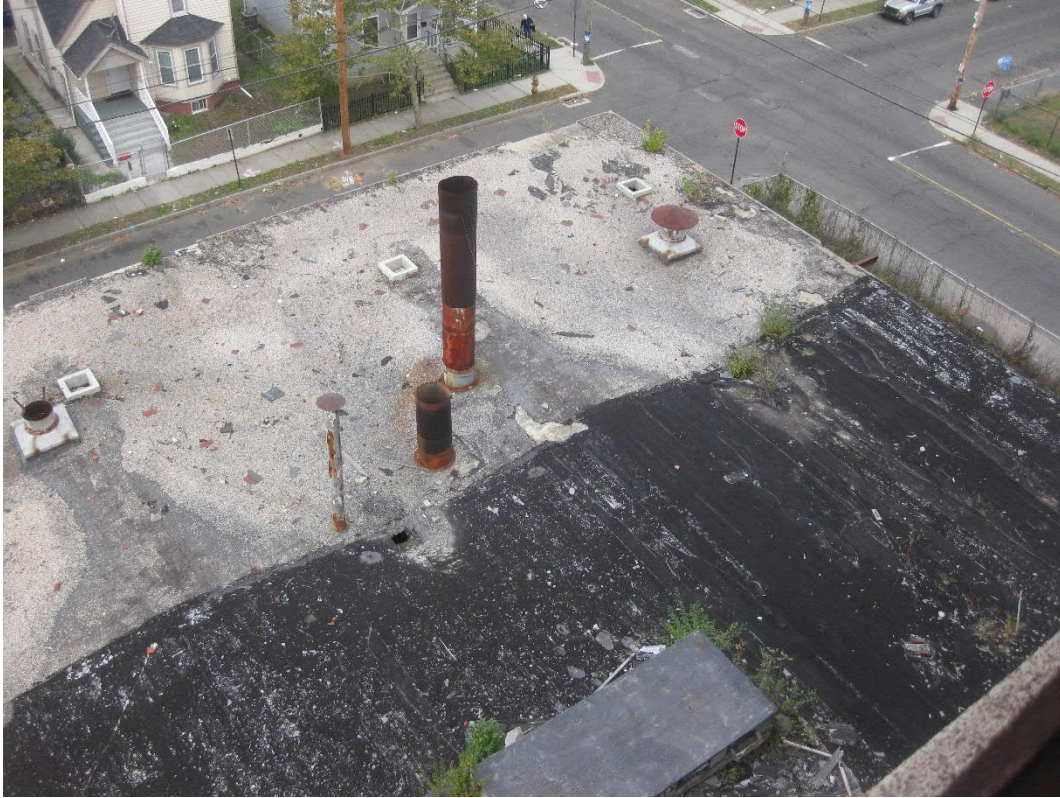
Photo #16 – Failed roofing at low roof

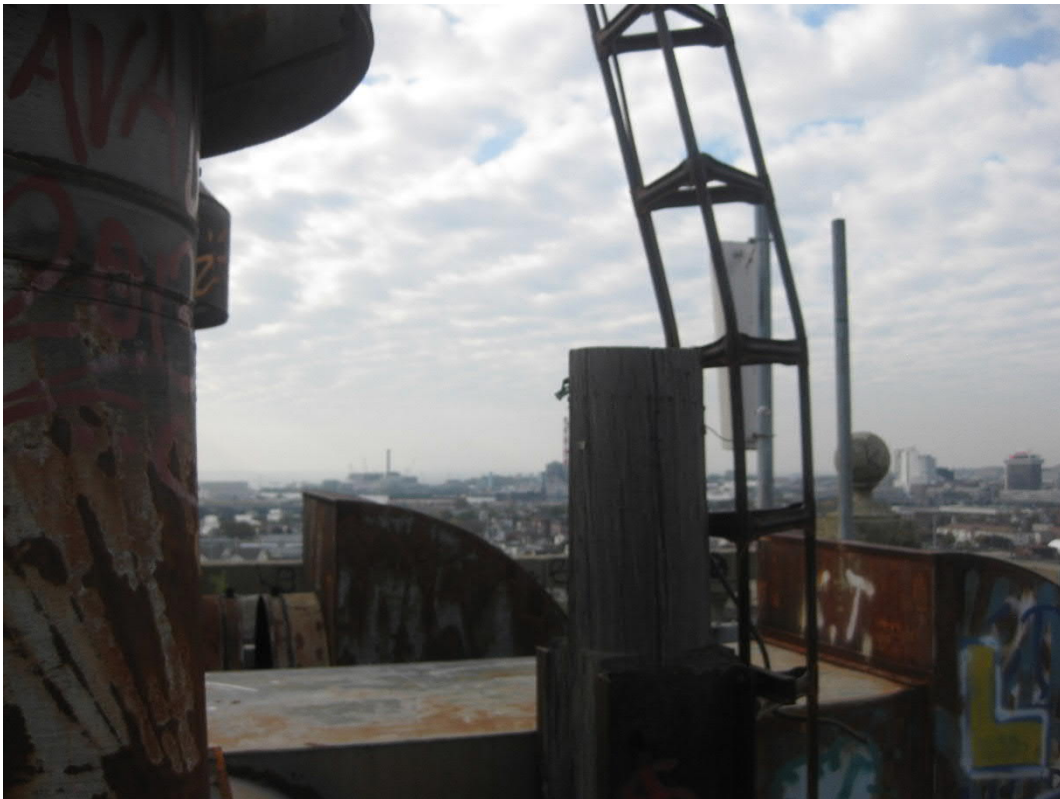
Photo #17 – Damaged antenna mast

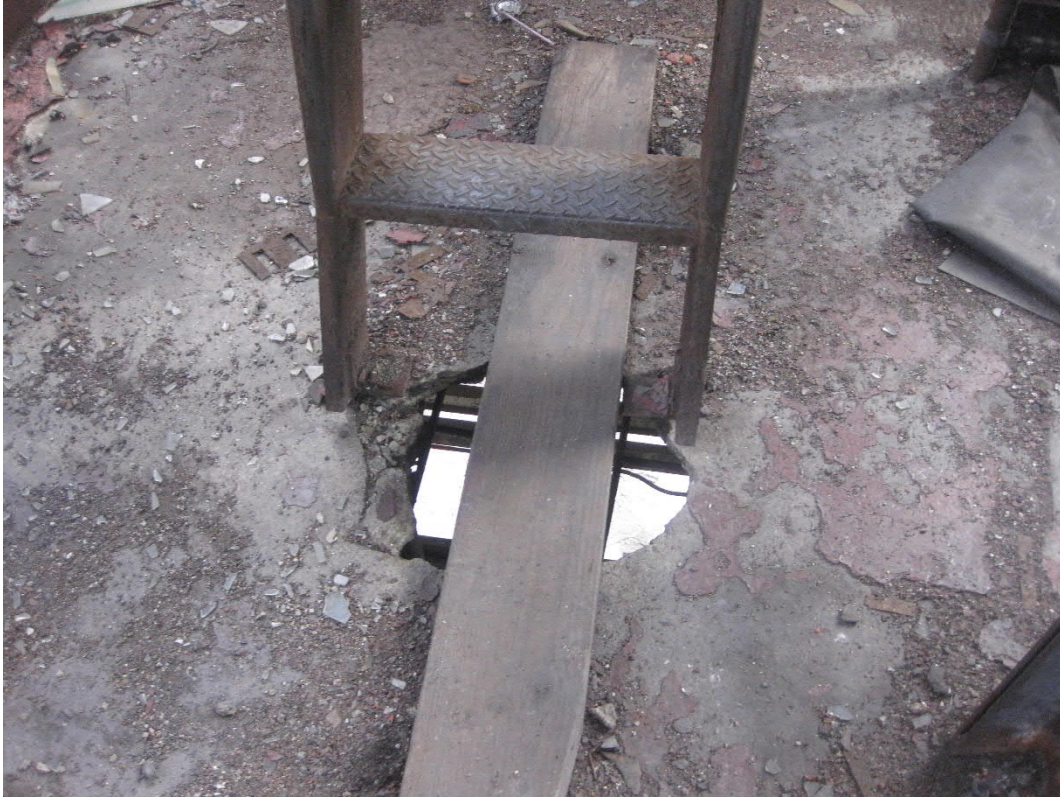
Photo #18 – Hole in 7th floor slab

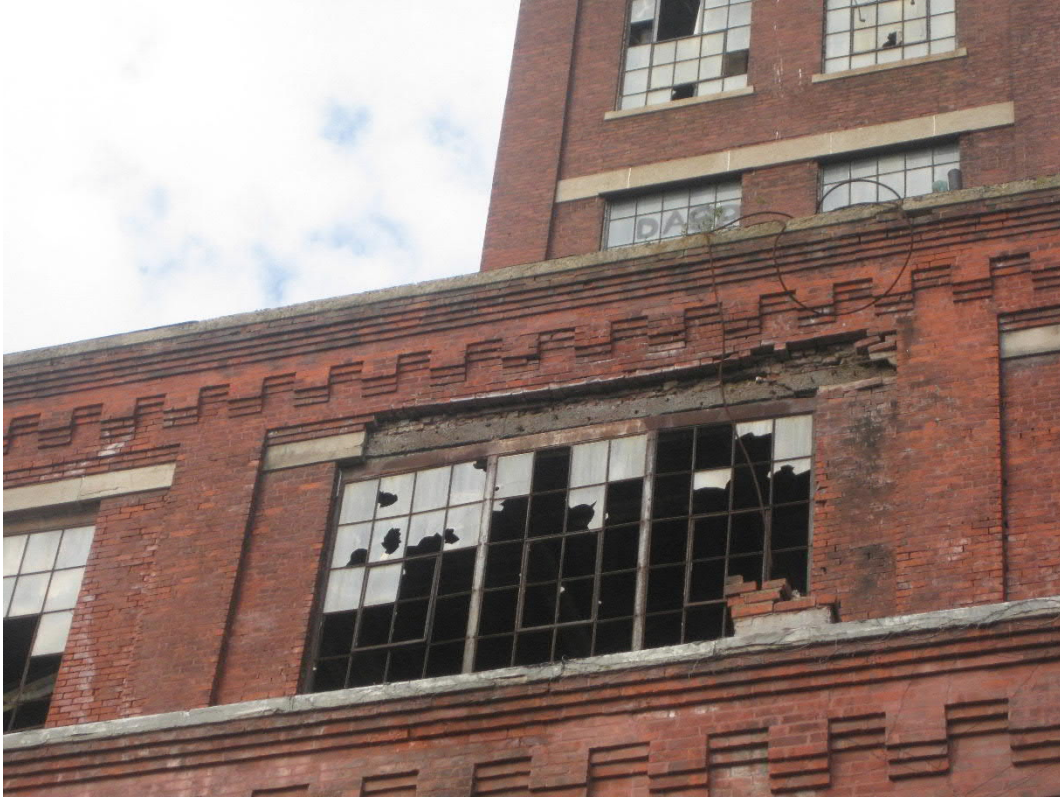
Photo #20 – Damaged concrete lintel at south face

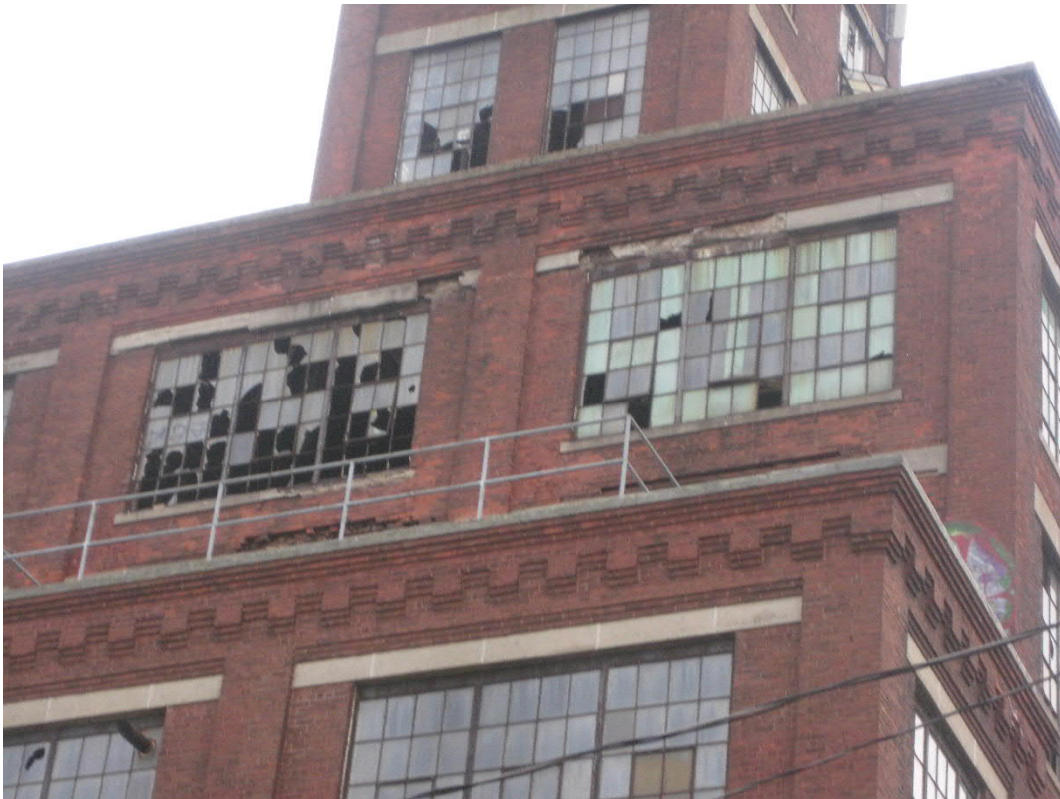
Photo #21 – Damaged concrete lintels at north face

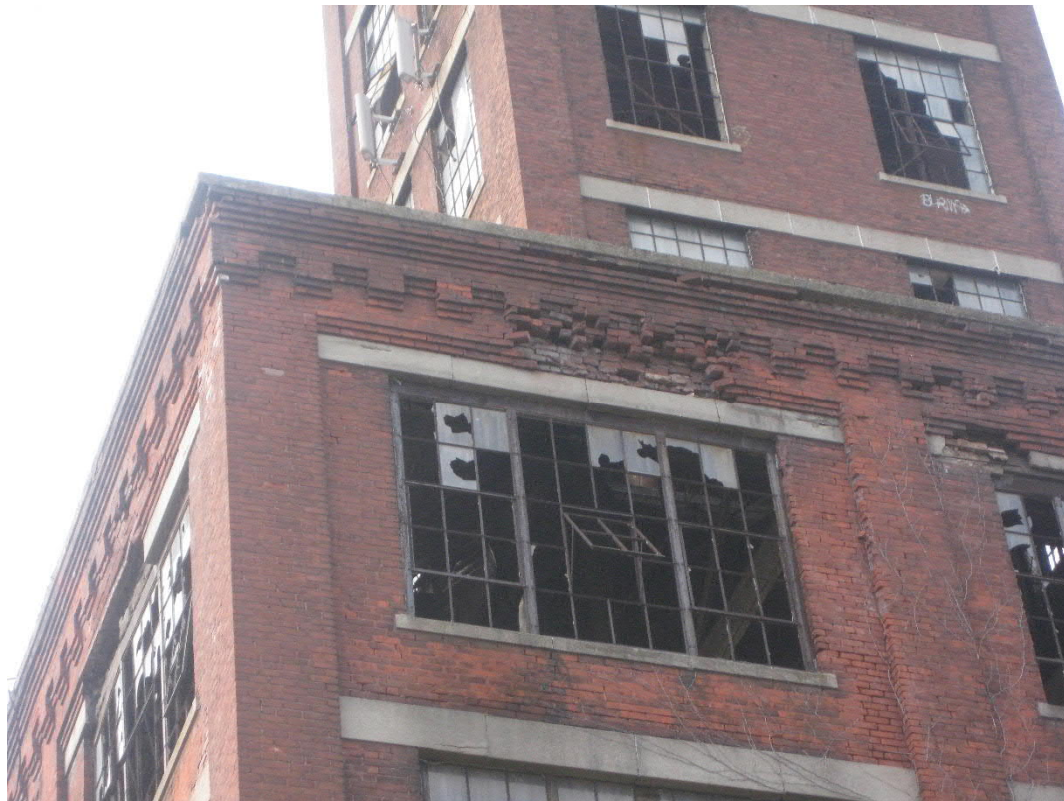
Photo #22 – Damaged brick at east face

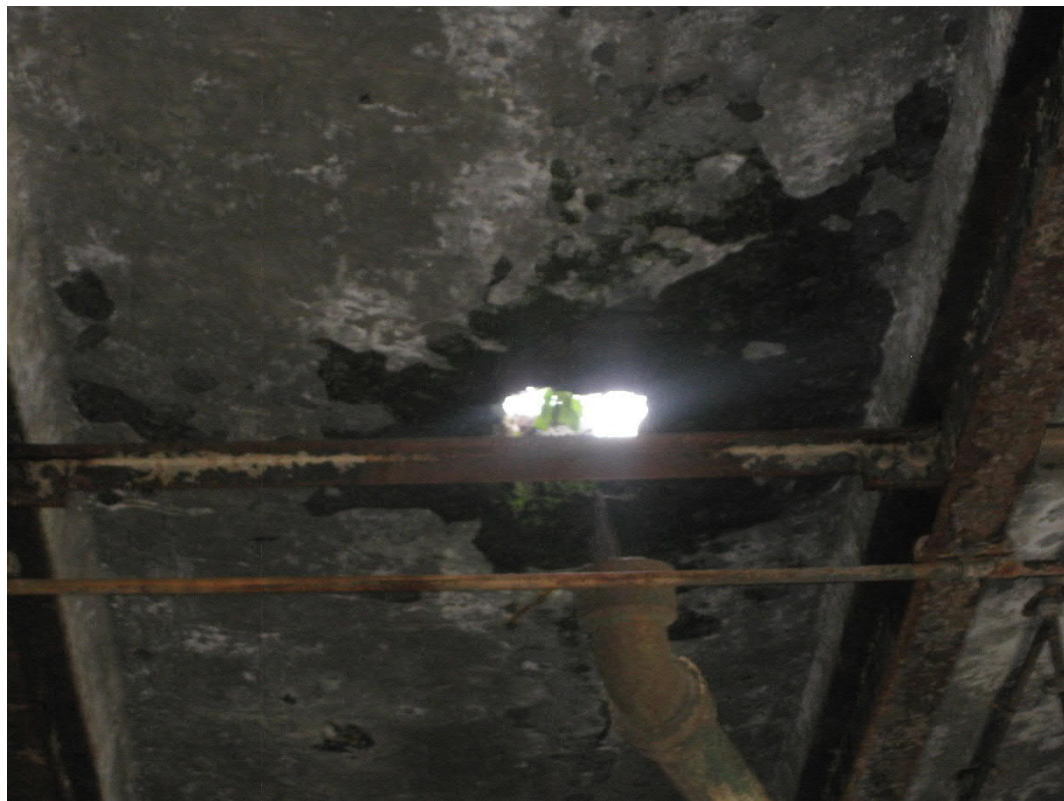
Photo #23 – Roof deck damage at removed drain pans

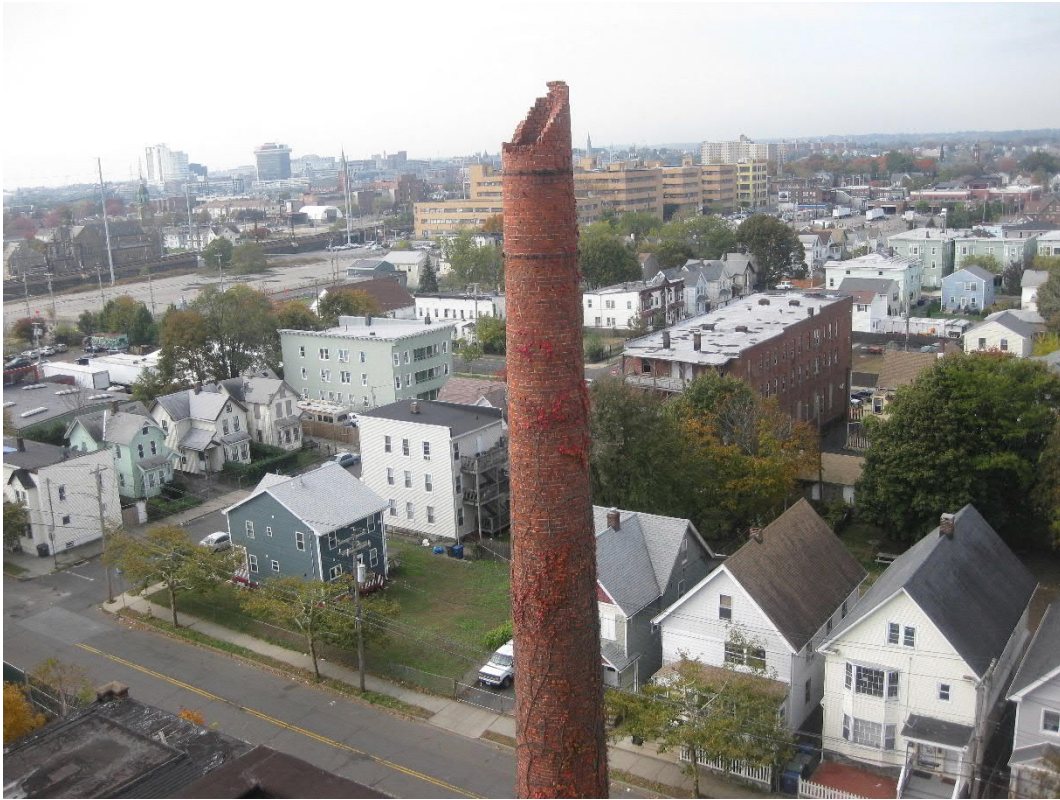
Photo #24 – Upper portion of stack

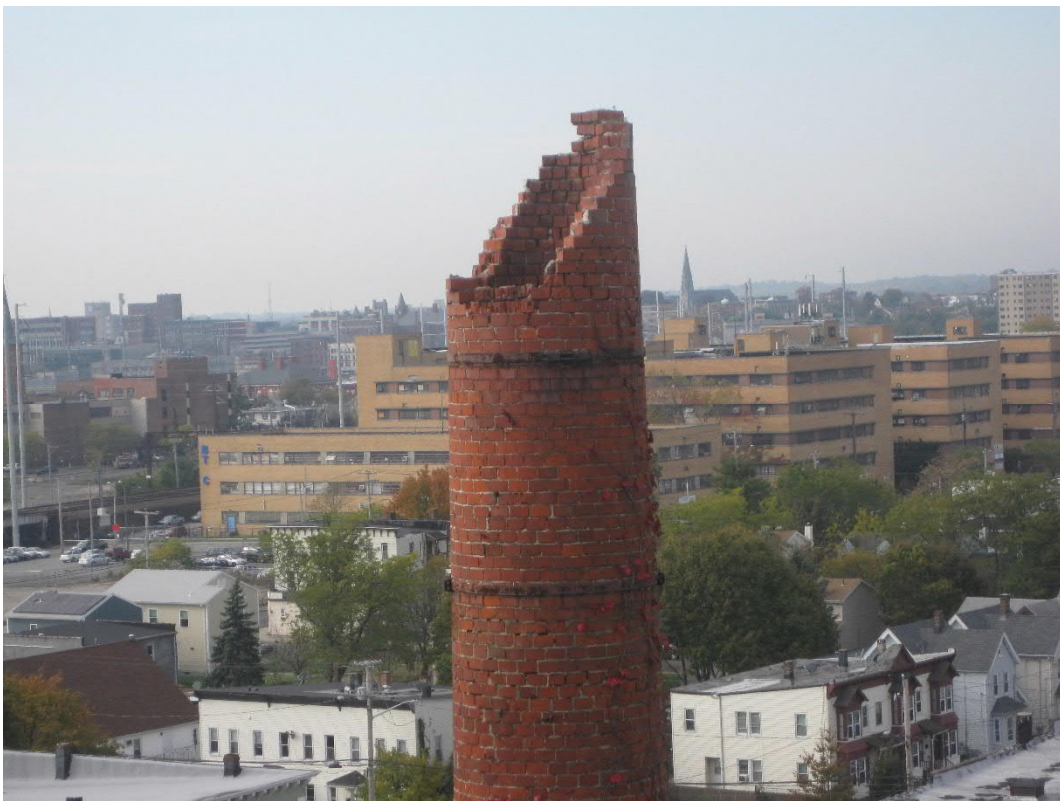
Photo #25 – Damage, loose bricks and steel bands at top of stack
