Organizational Results Research Report

Structural Steel Coatings for Corrosion Mitigation

FINAL Report

October 2010

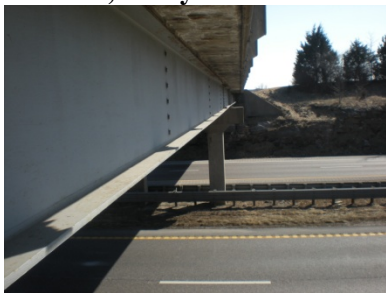
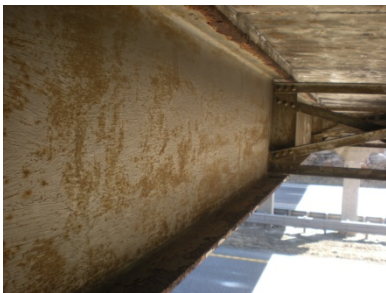
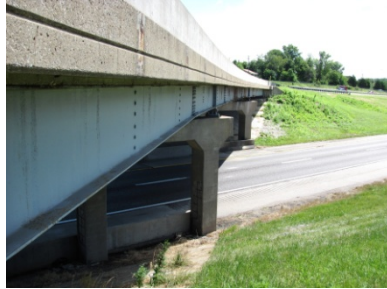
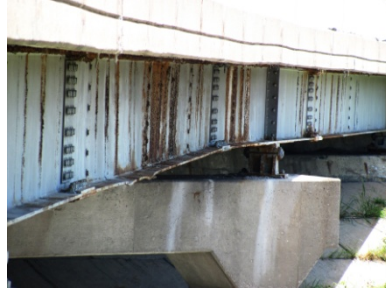
A0557	2006	Good	Fair	Poor	Poor
A1256	2006	Fair	Fair	Fair	Fair
G0519	2006	Good	Fair	Good	Fair
L0928	2006	Good	Poor	Poor	Poor
L0928: One end of the facia girder was in good condition, the other end was in very poor condition. Partially recoated.

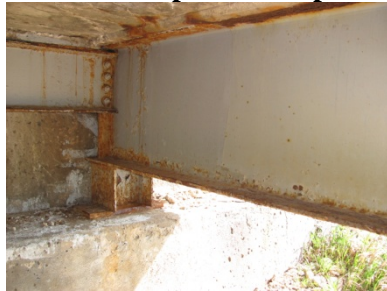
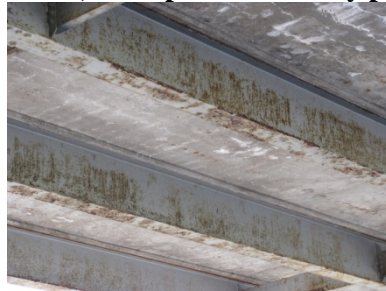
A0025:End- span was in poor condition, mid-span was in very poor condition. Partially recoated.

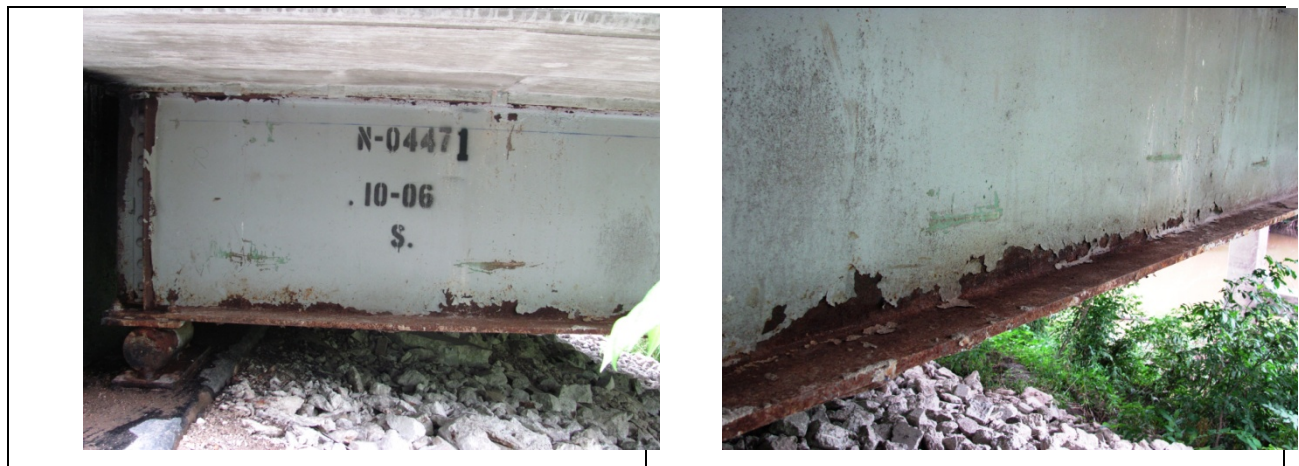
Figure 4.2 Example of System S Coating with Early Failure, End-span of Fascia Girder.

An example of the over-coating with an early failure is shown in Figures 4.2 and 4.3 below. The photos below show zone painting, or limited over-coating by a maintenance crew.

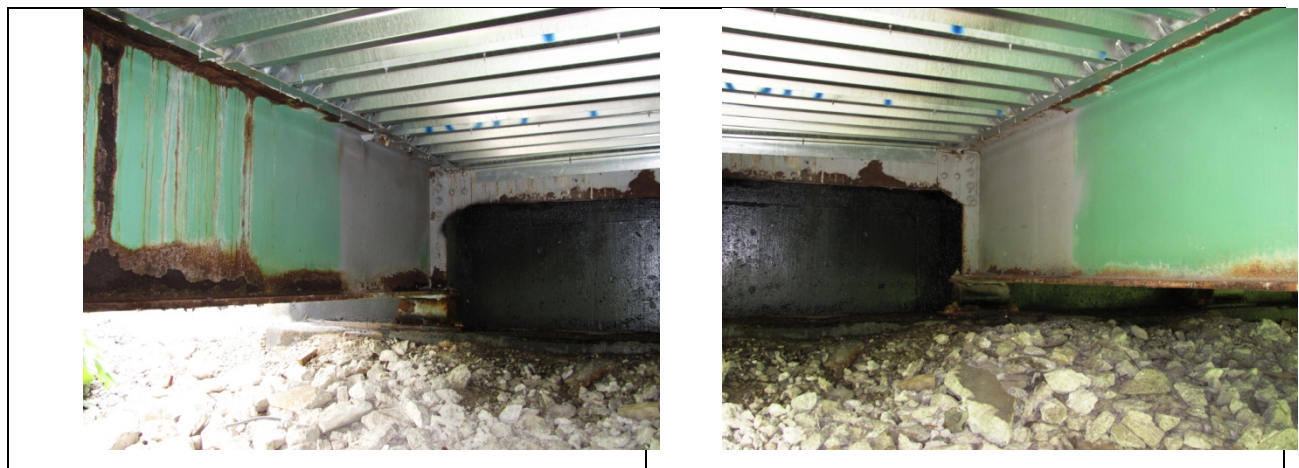
Interior end- span approximately 3 feet overcoated with System S

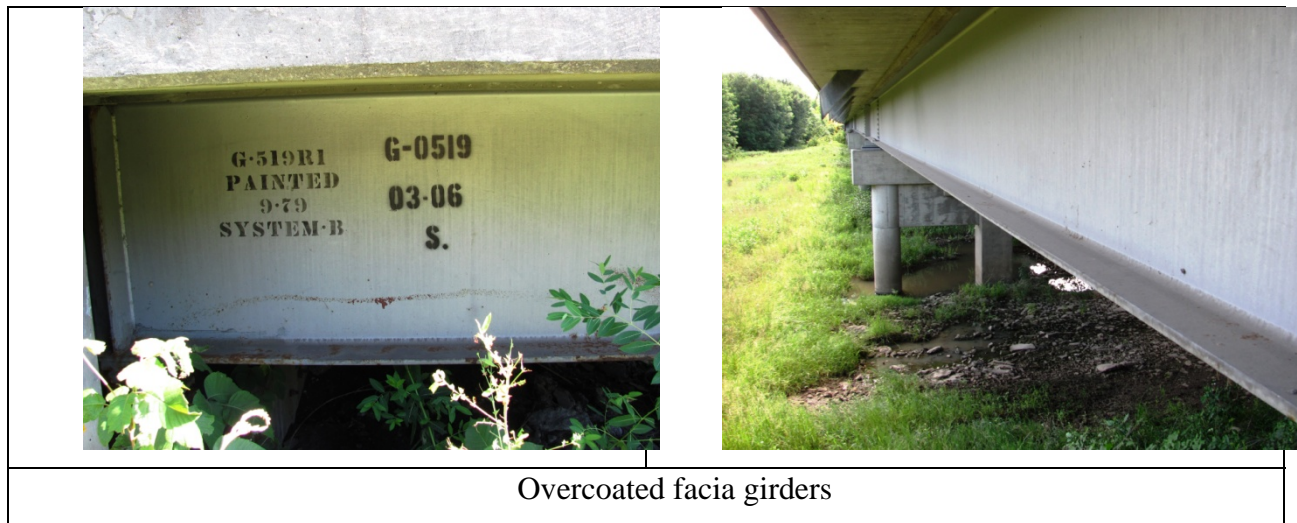
Figure 4.4 Example of System S Overcoating with Good Performance.

In contrast, Figure 4.4 below shows the fascia girders and beam-end for a bridge overcoated in 2006 with a beam-end rating of fair. Rust amount is less than 1%. This bridge shows good performance of the overcoat with regard to its condition rating. In this case the over-coating is performing well, though there is some rust-back beginning to appear in certain areas near the beam-ends where there is leakage from the expansion joint. In this case, a bridge deck renovation with prestressed panels and extended scuppers is successfully keeping deck drainage from the superstructure.

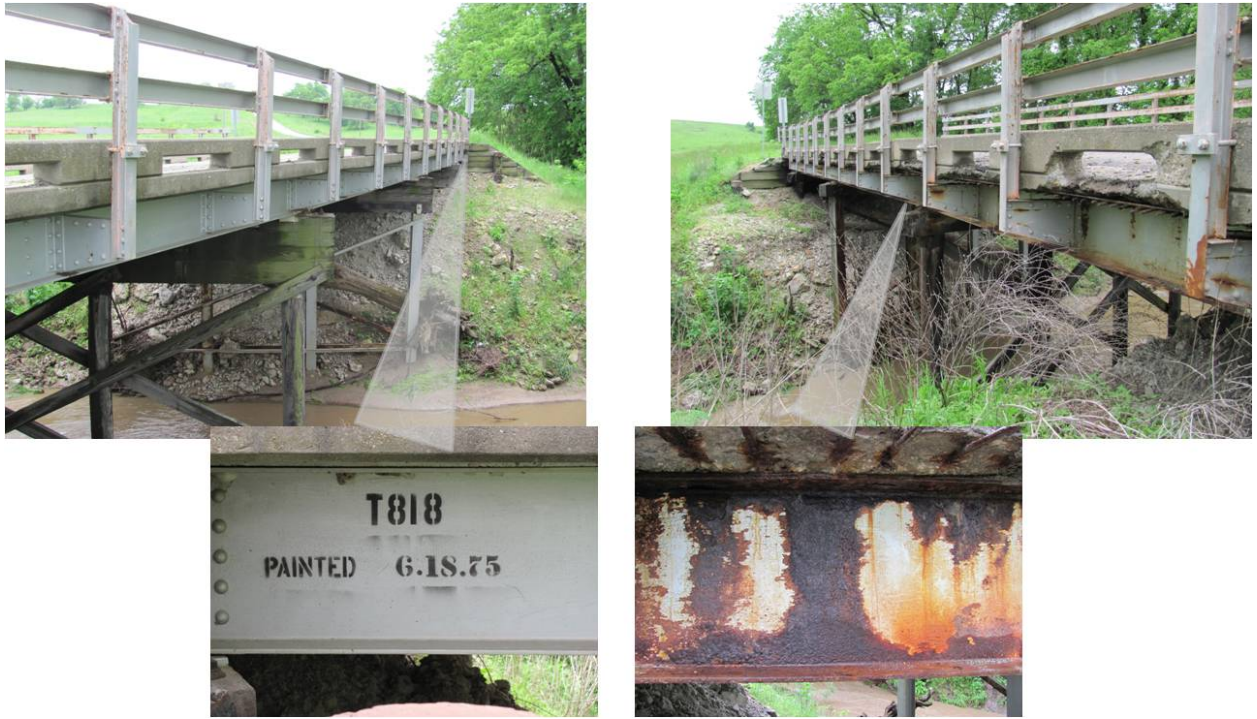
Figure 4.7 Example of the Effects of Deck Drainage on Coating Condition.

An example of the deck drainage issue is shown in Figure 4.7 that shows a System A coating after 35 years of service life. In this case, the deck drains primarily through deck drains on one side of the bridge. On the uphill side, where little drainage occurs, the coating system is in nearly pristine conditions after a little more than 35 years in service. On the other hand, on the downhill side where the primary deck drainage is occurring, the coating system is in advanced stages of deterioration and in very poor condition. As this Figure illustrates, the age in service of the coating has little relevance to its condition; the condition is driven primarily by the drainage patterns at the particular bridge.

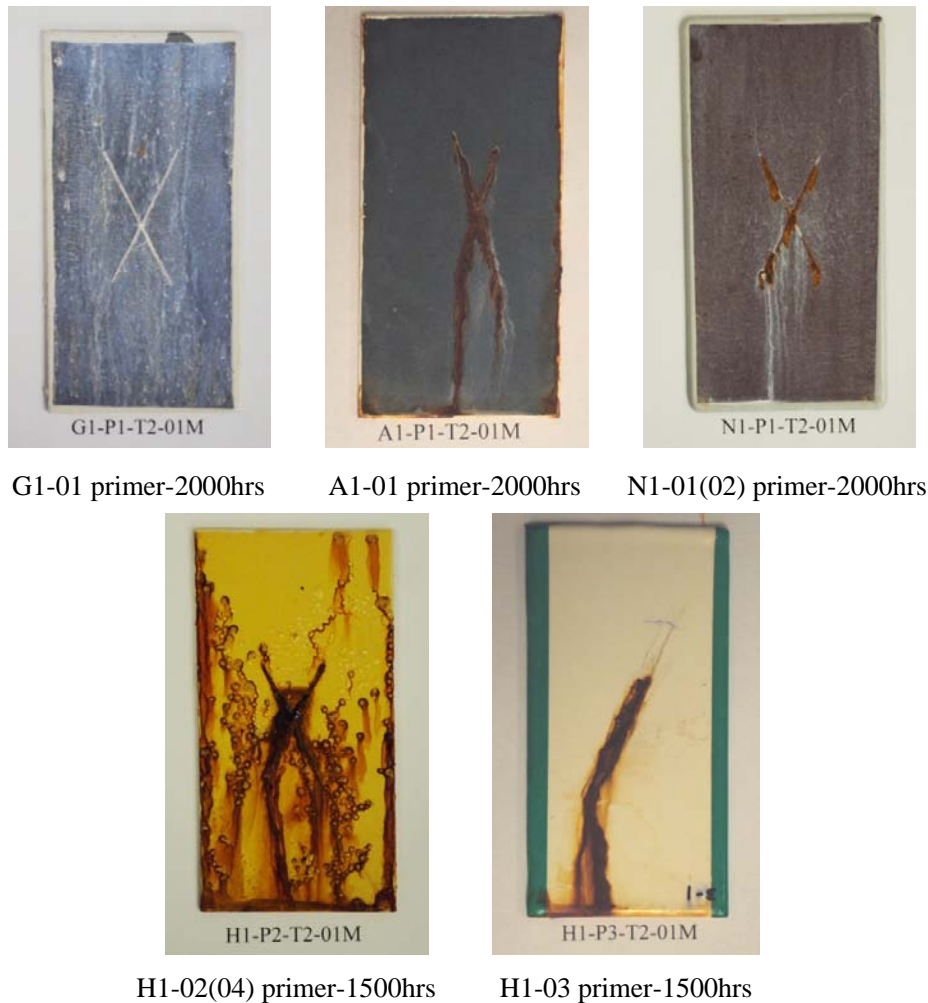
Figure 5.1 Primer Performance After 2000 (or 1500)-hour Salt Fog Test.

According to the evaluations and descriptions presented in Table 5.6, system G, having high solid inorganic zinc silicate as its primer, performed the best of all the systems in phase I. Systems A1-01, N1-01, and N1-02 performed well as expected due to the existence of organic primer. System A1-01, which used a polyaspartic polyurea as the topcoat, and system N2-02, which used a fluoropolymer topcoat, had remarkable performance in the lab tests. Both of these systems had better (i.e. higher) adhesion strength and higher UV weathering stability than other coatings with zinc primer. Besides system A1-01, systems H1-03, H1-04, and I1-02 also performed very well as far as polyurea type coatings systems were concerned in the salt fog testing evaluation. Some polyurea type coatings investigated had less desirable test results due to the inferior performance of their primers. The primers were vulnerable to the salt fog test which can be seen in Figure 5.1.

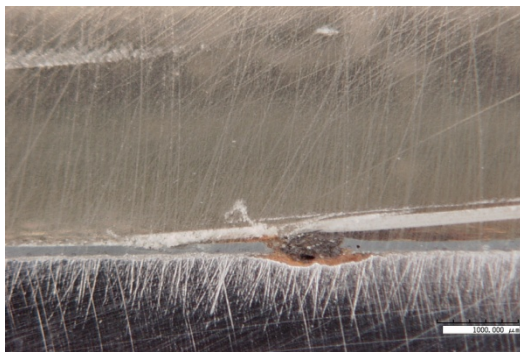
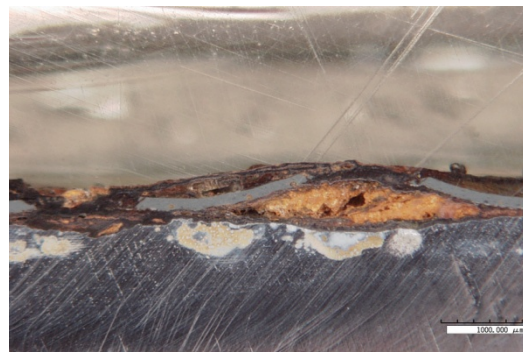
System H1-01 1500-hr & 3000-hr interface characterizations

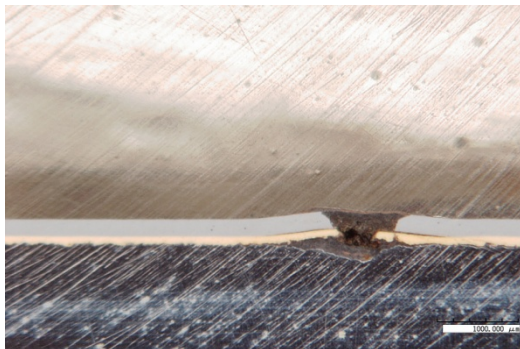
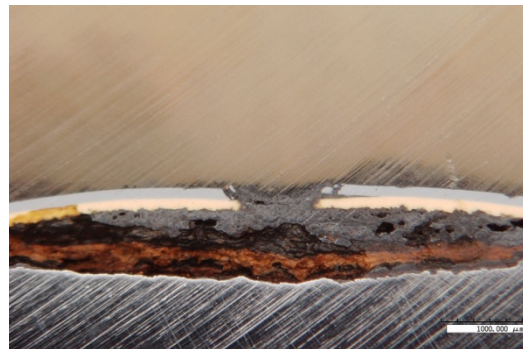
System H1-02 1500-hr & 3000-hr interface characterizations

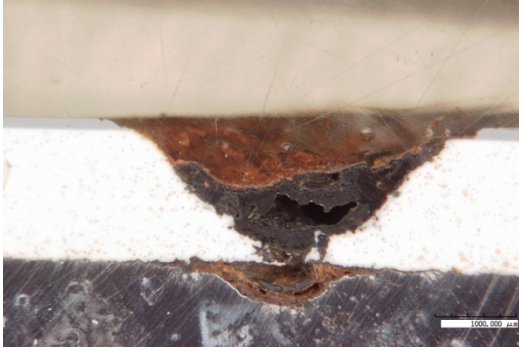
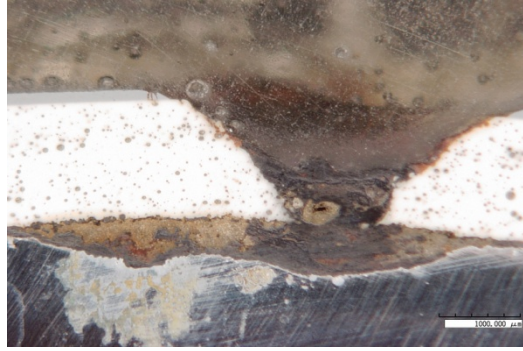
System H1-03 1500-hr & 3000-hr interface characterizations

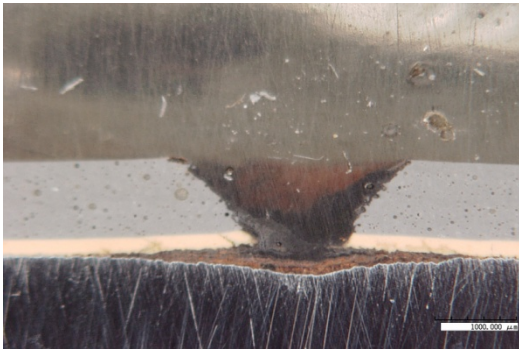
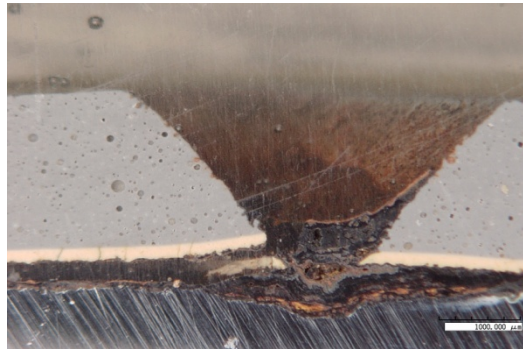
System H1-04 1500-hr & 3000-hr interface characterizations

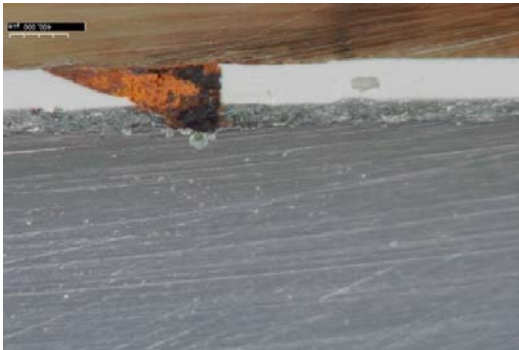
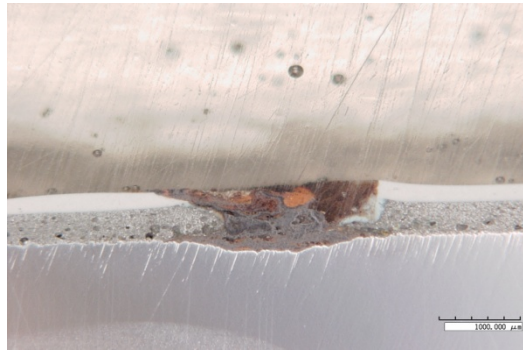
easy peeling of the primer from the substrate. The epoxy primer was not effective and durable in the salt induced corrosion environment. The primer for system A1-01 provided cathodic / sacrificial protection to the bare steel even over 3000 hr salt fog test. The corrosion was limited within an area shown in the image (see Fig. 5.8) by synergic action of micaceous iron oxide and zinc. Systems N1-0# did not perform as well as system A1-01. The rust creepage developed underneath the primer within a limited range. The zinc primers for systems N1-0# were not sacrificial enough. System G performed very well as expected. Observed for system A1-01, the inorganic zinc primer of system G acted as a cathode to protect the steel substrate from corrosion. Systems I1-0# used urethane primers. They did not perform very well in salt fog test. The rust creepage grew fast underneath the coating systems.

System A1-01 1500-hr & 3000-hr interface characterizations

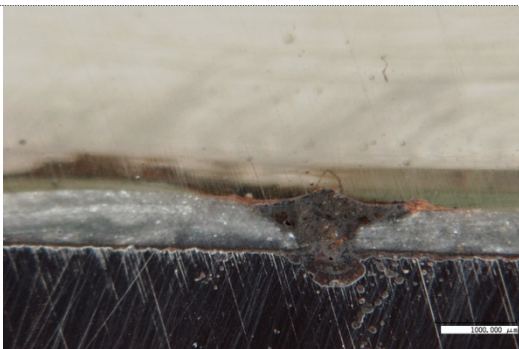
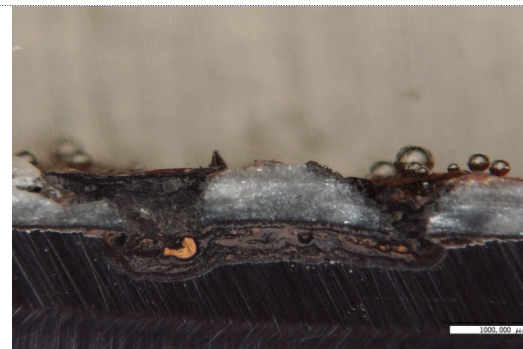
System P1-01 1500-hr & 3000-hr interface characterizations

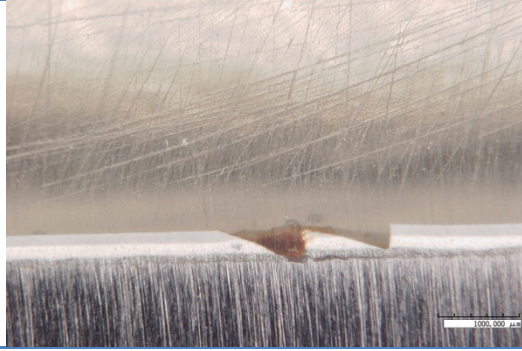
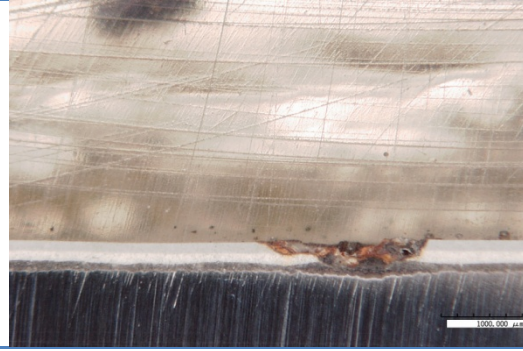
System G1-01 1500-hr & 3000-hr interface characterizations

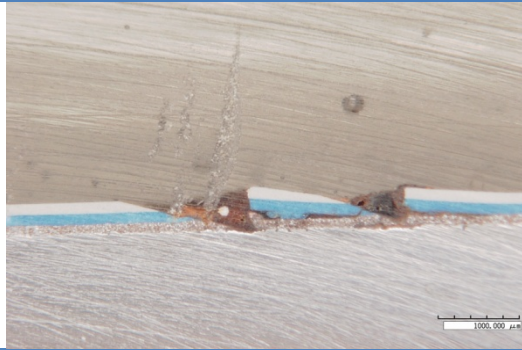
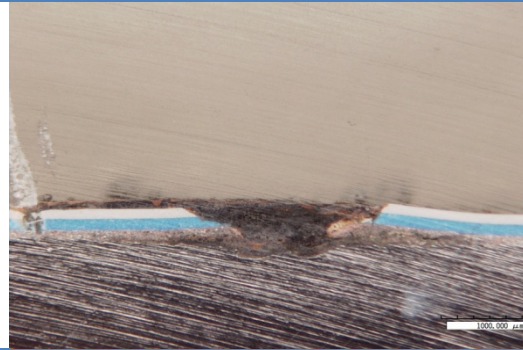
System N1-01 1500-hr & 3000-hr interface characterizations

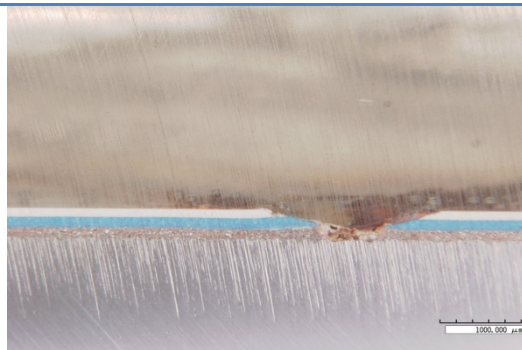
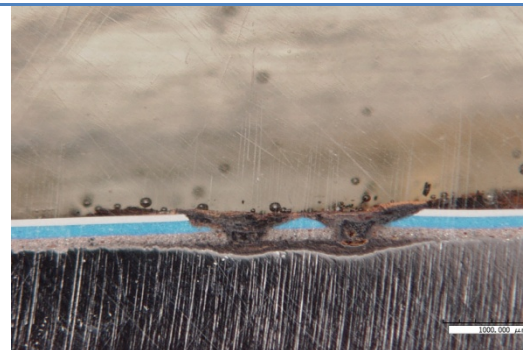
System N1-02 1500-hr & 3000-hr interface characterizations

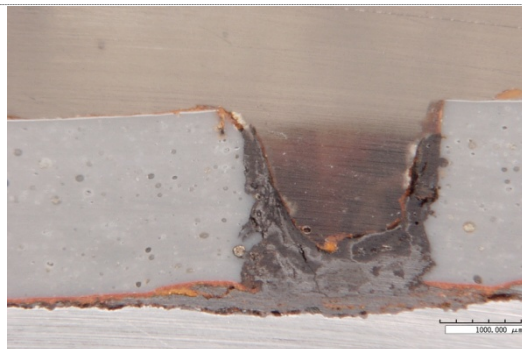
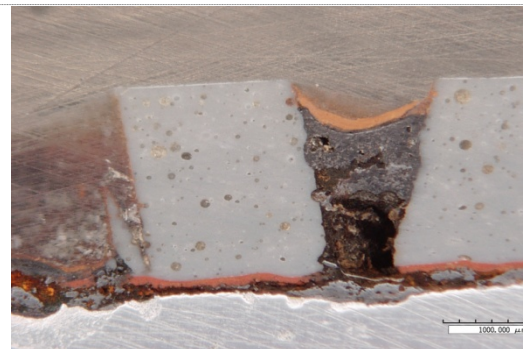
System I1-01 1500-hr & 3000-hr interface characterizations

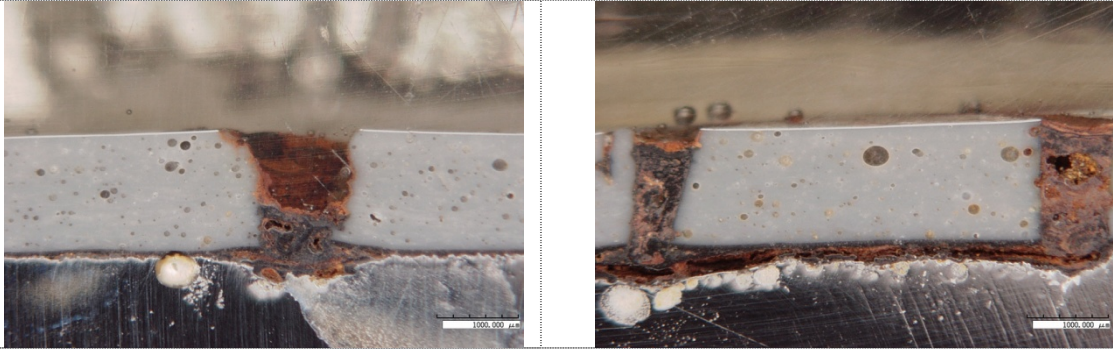
System II-02 1500-hr & 3000-hr interface characterizations

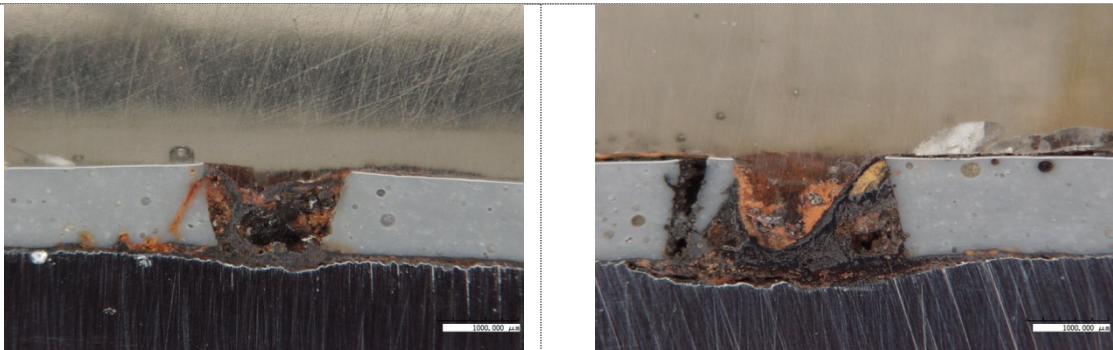
System II-03 1500-hr & 3000-hr interface characterizations
