Service Action

Code: 97U3

Subject: 2006-2007 Rabbit/R32/ GTI, 2005-2007 Jetta/Jetta Wagon, 2007-2008 Eos and 2006-2007 Passat/Passat Wagon
Inspect Front Seat Side Impact Airbag Connectors & Install Wiring Harness Kit(s), if Necessary

REVISED January 10, 2013**Revision Summary**

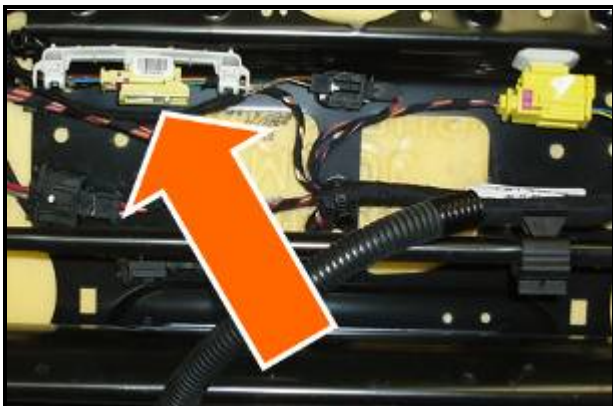
⇐ Look under each seat to inspect for the Yazaki connector –arrow- contained in seat wiring

Tip: The Yazaki connector –arrow- may or may not be contained in holder as pictured

⇐ If connector –arrow- is contained in either one or both seat wiring, continue to Section B

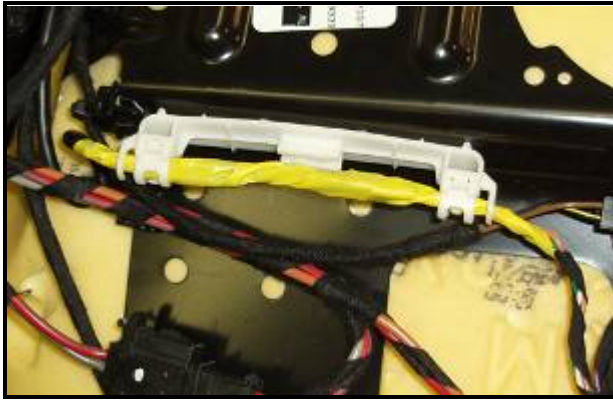
⇐ If Yazaki connector (previous picture) has been removed and seat wiring harness repaired as pictured, Work Complete for that seat, reposition seat to customer original setting(s)

Tip: The seat wiring harness repair may or may not be contained in holder as pictured
