Sudden Acceleration in Vehicles with Common Rail Diesel Engines

Ronald A. Belt
Plymouth, MN 55447
1 July 2016

Abstract: An explanation is given for sudden unintended acceleration (SUA) in vehicles with common rail diesel engines. SUA is explained by an increase in the gain of the common rail pressure controller that leads to more fuel being injected into the engine than the throttle map specifies. The gain increase is caused by an erroneous battery voltage compensation coefficient produced by a negative voltage spike occurring while the battery voltage is being sampled. The erroneous battery voltage compensation coefficient increases the fuel injected into the engine, causing an increase in the engine speed, which causes the next iteration of the throttle map to issue a new common rail pressure set-point that is even higher than the previous one. The result is a runaway engine speed without the driver's foot being on the accelerator pedal. No diagnostic trouble code (DTC) is produced because all the engine sensors and actuators are working normally except for the battery voltage compensation coefficient, and this compensation coefficient is not checked for an erroneous value. Thi

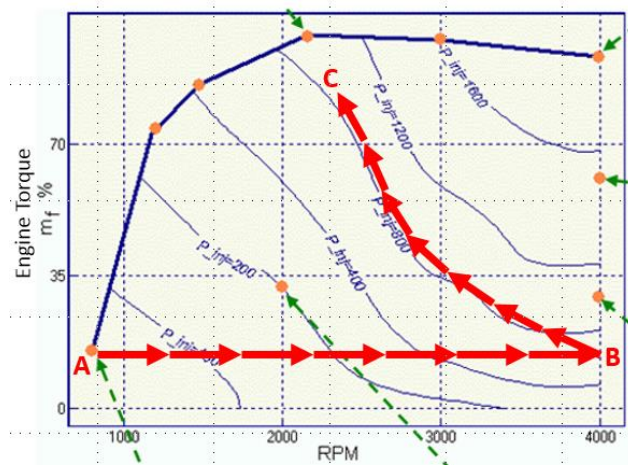
The process causing a runaway of the engine speed is explained more clearly in Figures 3 and 4. Figure 3 shows the normal operation of the set-point map in the open-loop feed-forward engine controller. Normally, when the driver requests a higher engine torque via pressing on the accelerator pedal, the rail pressure set-points are selected from the dark blue envelope curve based on driver's request for torque and the current engine speed, producing the upward-going trajectory A-B. When the driver releases the accelerator pedal, the rail pressure set-points are selected from the downward-going curve B-A to allow the engine speed to slowly decline instead of going back to idle abruptly. Figure 4 shows what happens during a sudden acceleration incident. During a sudden acceleration incident the rail pressure set-points follow the horizontal curve A-B to cause the engine speed to increase to the maximum speed in the map in less than one second without the driver pressing on the accelerator pedal. When a load is placed on the engine by the vehicle encountering an obstacle or by the brakes, the engine speed decreases and the engine torque increases along the constant pressure curve B-C causing the vehicle to jump over obstacles and causing the driver to feel that the brakes are acting like an accelerator.

Fig 4. During sudden acceleration the pressure set-points follow the horizontal curve A-B to cause the engine speed to increase to the maximum speed in the map in less than one second without the driver pressing on the accelerator pedal. When a load is placed on the engine by the vehicle encountering an obstacle or by the brakes, the engine speed decreases and the engine torque increases along the constant pressure curve B-C causing the driver to feel that the brakes are acting like an accelerator.

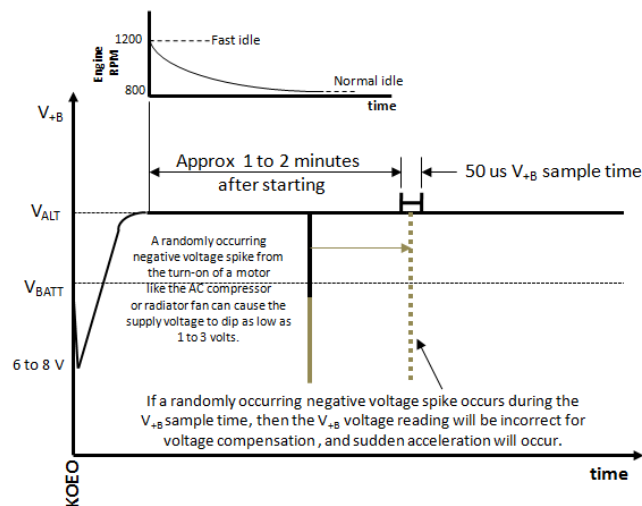
This SUA mechanism can even explain the SUA incident rate observed in a population of vehicles over a given time. If the battery voltage is sampled one to two minutes after the engine is started, as shown in Figure 5, then the probability of sudden acceleration occurring is related to the likelihood that a randomly occurring negative voltage spike occurs during the 50 microsecond long sampling time. We can estimate this probability by counting how many 50 microsecond sampling times occur during an interval of one to two minutes, and then multiplying this result by the number of times the vehicle is started in one year, which we can assume to be once a day. The result is:

Fig 5. The +B battery voltage is sampled 1 to 2 minutes after the engine is started when the engine is at the normal idle speed of 800 RPM. If a randomly occurring negative voltage spike occurs during this sample time, then the +B battery voltage compensation applied using this incorrect battery voltage reading will cause sudden acceleration.

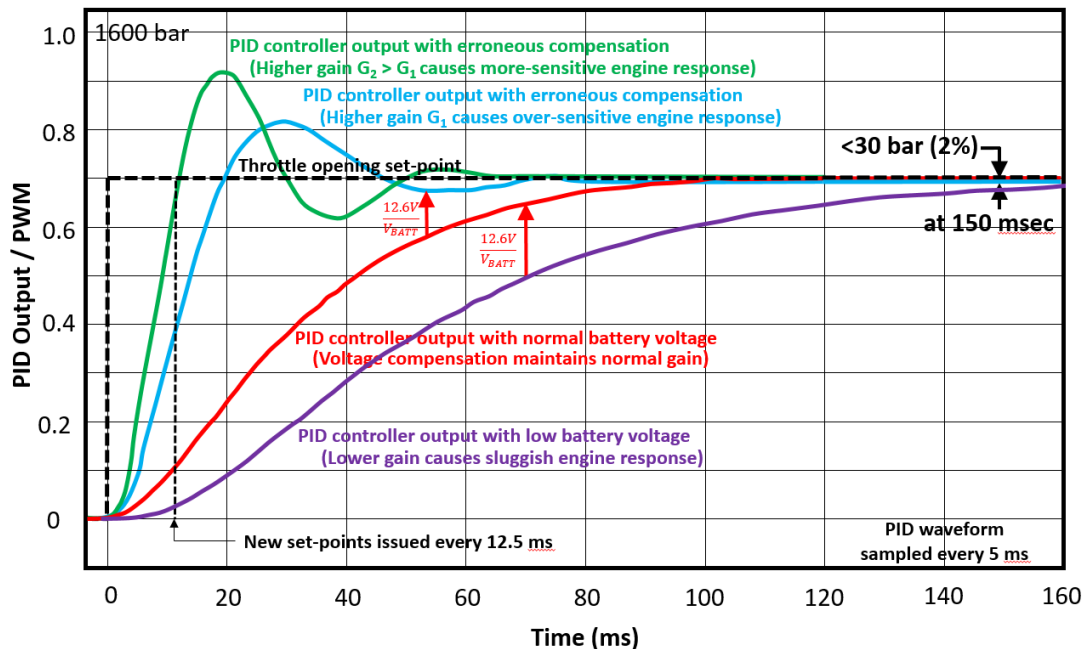
Figure 6 shows the PID output for different values of the battery voltage compensation coefficient. The red curve is the normal output that satisfies the PID specifications of Table 2. If the battery voltage drops because the battery is temporarily discharged, then PID output changes to the violet curve, and the engine response becomes more sluggish if the PID output is not compensated for battery voltage. However, if battery voltage compensation is applied, then the violet curve is raised back up to the red curve, and the engine maintains its normal operation. This achieves the desired constant operation of the PID controller.

Figure 6. Output waveforms for the rail pressure PID controller for different values of the battery voltage compensation coefficient.

Consider, now what happens when an erroneous battery voltage compensation coefficient arises as a result of the battery voltage being sampled during a negative voltage spike. In this case, the erroneous battery voltage compensation coefficient is applied to the normal red curve, resulting in a curve that has overshoot like the blue or the green curve. A larger erroneous battery voltage compensation coefficient means more overshoot, causing the engine to have a more sensitive response and a higher engine speed. This means

that the gain of the PID controller effectively changes, because the PID waveform is sampled while overshoot is occurring before the PID waveform converges to its set-point value. If the erroneous battery voltage compensation coefficient is large enough, then gain of the PID controller can increase enough so that the PID waveform saturates at the maximum rail pressure during the overshoot. But saturation of the PID waveform is not necessary to produce sudden acceleration. One only needs an increase in the gain of the pressure controller over the gain that was assumed when the set-point map was calibrated. If this pressure controller gain increases, then the engine speed will increase, causing a higher set-point to be issued on the next iteration through the map. Since these map iterations occur every 12.5 milliseconds, one can have 80 iterations in one second, causing the engine speed to run away in less than one second.
