LTB01254NAS1

TECHNICAL BULLETIN

Engine MIL Illuminated With DTC P0299-77 Stored

MODEL:	MODEL YEAR:	VIN:	APPLICABILITY:
Discovery (LR)	2017-2018	000001-075312	TDV6 3.0L Diesel
Range Rover Sport (LW)	2016-2018	100003-808712	TDV6 3.0L Diesel
Range Rover (LG)	2016-2018	212697-510666	TDV6 3.0L Diesel

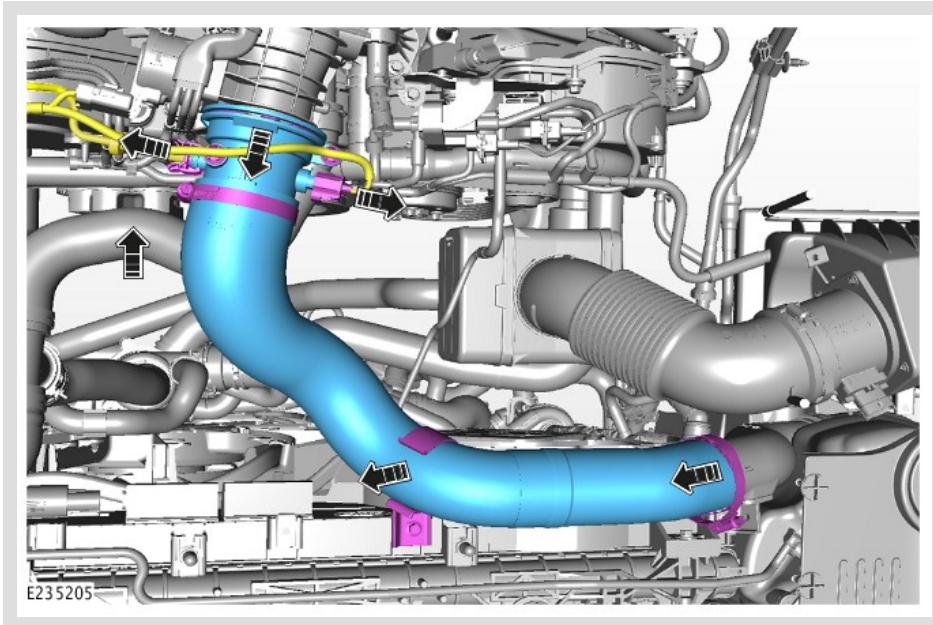
This may be caused by the charge air cooler hose collapsing internally.

Remove and discard the charge air cooler hose.

- 1 Disconnect the vacuum pipe from the charge air cooler hose.
- 2 Disconnect the electrical connector from the charge air cooler hose.
- 3 Release the securing clip.
- 4 Disconnect the charge air cooler hose from the electronic throttle body.
- 5 Disconnect the charge air cooler hose from the top of the charge air cooler.
