TECHNICAL SERVICE BULLETIN

Intermittent Grinding Noise From Integrated Wheel Ends (IWEs) While Driving In Two Wheel Drive (2WD)

18-2273

Ford 2013-2018 Expedition
2013-2018 F-150
Lincoln 2013-2018 Navigator

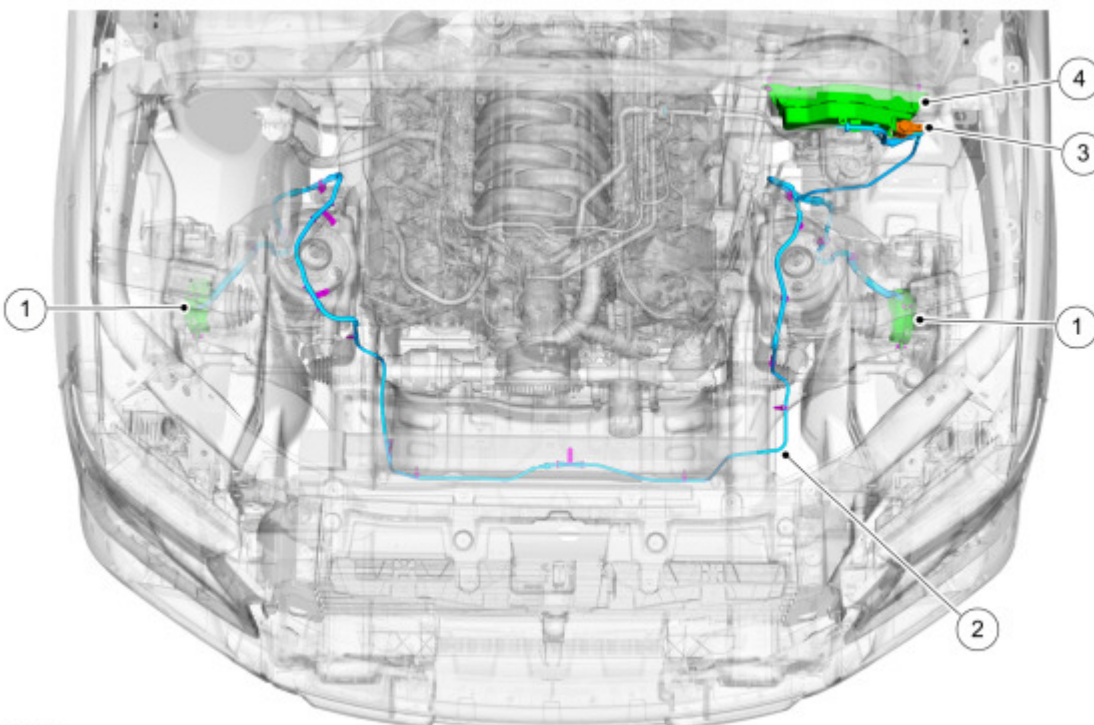
Figure 1

1. Inspect the IWE vacuum hoses. Refer to Workshop Manual (WSM), Section 308-07A. Are there any disconnected or damaged vacuum hoses? (Figure 1)

- (1). Yes - this article does not apply. Refer to WSM, Section 308-07A for normal diagnostics.
- (2). No – proceed to Step 2.
