Technical Service Bulletin

97 No start (DTC P068A00)

97 14 43 2036764/3 April 14, 2014. Supersedes Technical Service Bulletin Group 97 number 14-42 dated March 31, 2014 for reasons listed below.

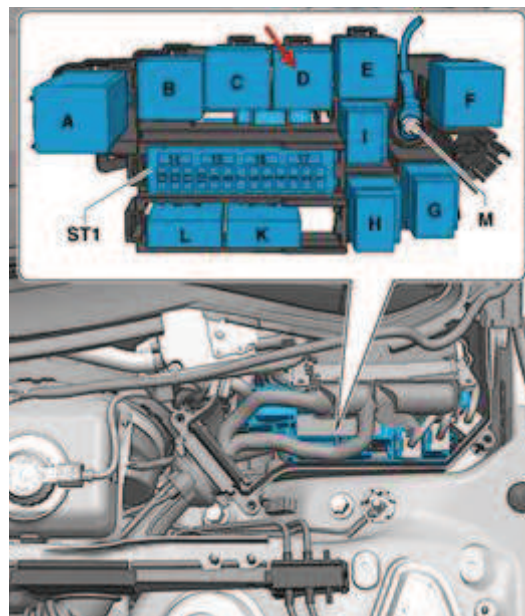
Figure 1. Location of J271 relay (D), as shown in Elsa.

2. Check Elsa for the location of the J271 relay (*Wiring diagrams* >> *Component locations* >> *Component Locations: Relays*) (Figure 1).

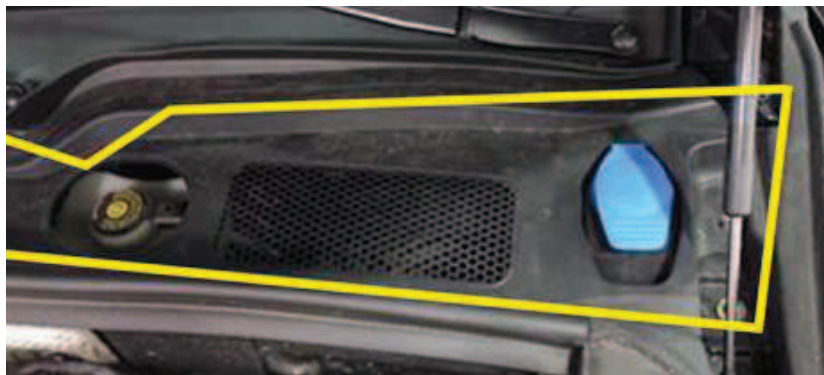
Figure 2. Plenum cover.

3. Remove the plenum cover (Figure 2).

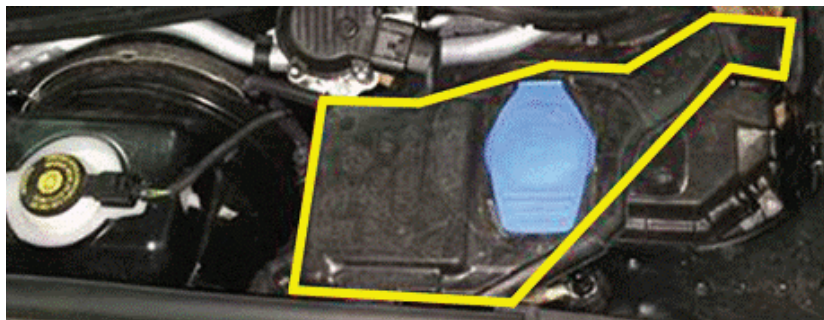
Figure 3. Washer reservoir filler neck.

4. Remove the washer reservoir filler neck (Figure 3).

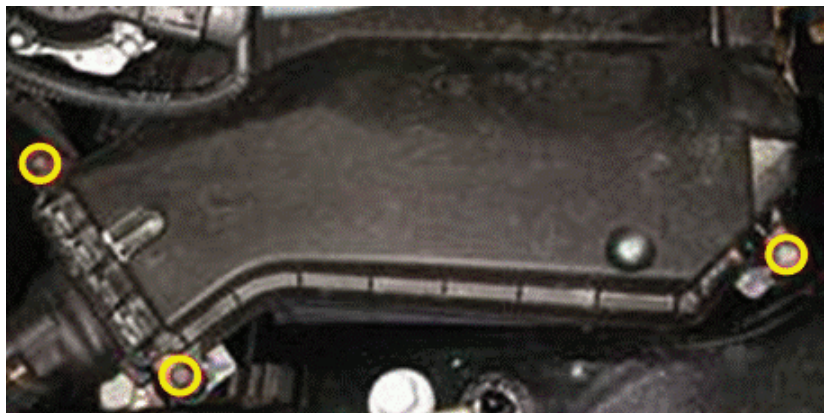
Figure 4. Screws to be removed (outlined).

5. Remove screws to gain access to the relay/fuse panel (Figure 4).

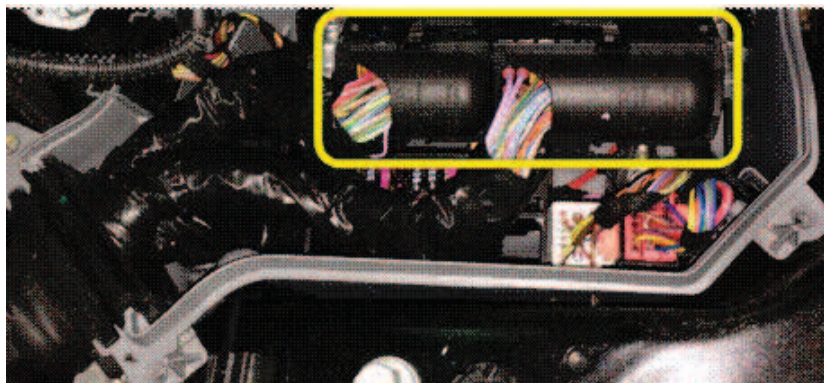
Figure 5. Engine control module (ECM).

6. Remove the ECM (Figure 5).

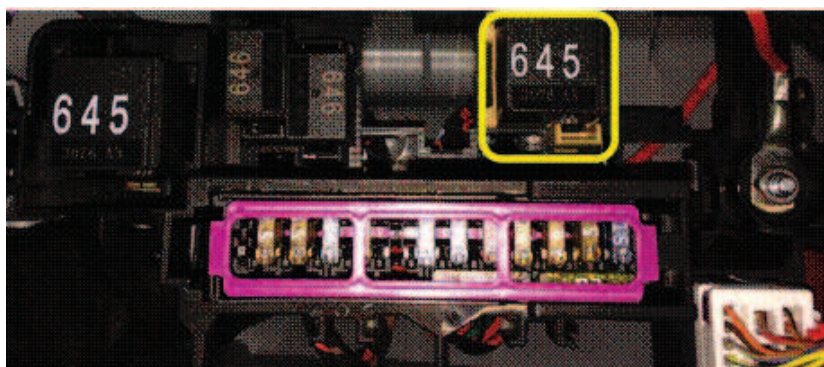
The motronic engine control module power supply relay, J271, is not functioning properly. Because the J271 relay controls battery voltage (Terminal 30) via a ground signal sent from the ECM, numerous faults can occur in multiple control modules when it is not functioning properly.

Figure 6. J271 relay (outlined).

7. The J271 relay is now accessible (Figure 6).

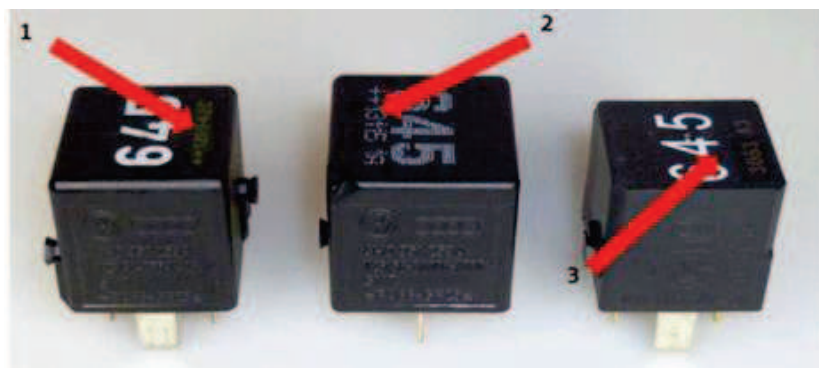
Figure 7. Relay manufacture data: Tyco Electronics relay with a yellow label (1), Tyco Electronics relay with a white label (2), Hella relay with a white label (3).

- If the relay is from Tyco Electronics and has a yellow label (Figure 7, 1), replace the relay and proceed to step 10.
- If the relay is from Tyco Electronics and has a white label (Figure 7, 2) or from Hella and has a white label (Figure 7, 3), do not replace the relay. Proceed to step 9.

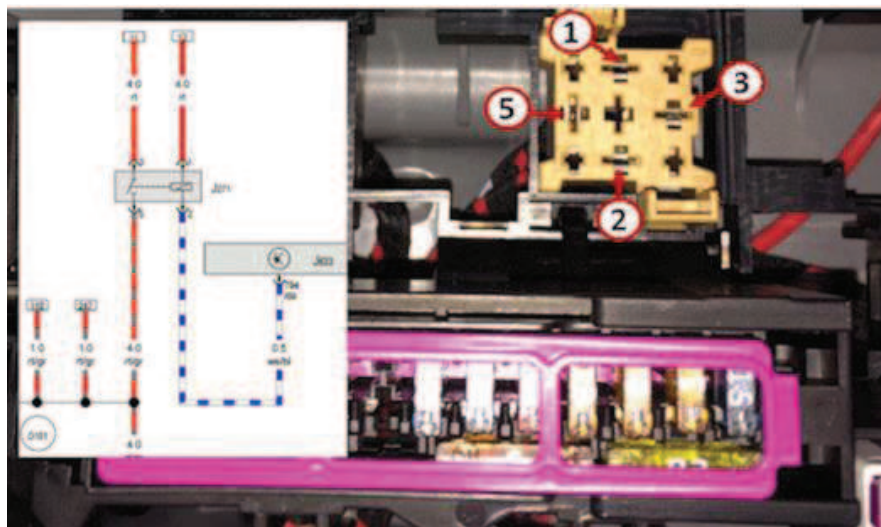
Figure 8. J271 relay pins. Terminal 1: 30 power from SA2, Terminal 2: switched ground from J623, Terminal 3: 30 power from SA2, and Terminal 5: switched power from J271.

10. Check for battery voltage on J271 relay harness terminals 1 (85 power) and 3 (30 power) (Figure 8 and Figure 9).

If no voltage is found, do not proceed with this bulletin. Continue with diagnosis.

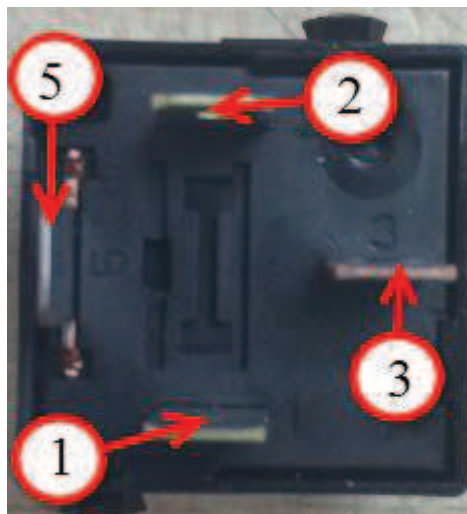
Figure 9. Relay terminal locations. Terminal 1: 85 Terminal 2: 86 Terminal 3: 30 Terminal 5: 87
