The 2010 Maule, Chile Earthquake: Lessons and Future Challenges

■ INTRODUCTION

In March 2010, Risk Management Solutions (RMS) deployed two reconnaissance teams to the region to investigate the impacts from the earthquake and tsunami. These teams spent two weeks in the field, collaborating with engineers and seismologists from other organizations, including the University of Chile, the USGS, and Stanford University. Post-event field reconnaissance, in its ability to rapidly and precisely make observations about the impacts from a disaster, is critical in the management of emergency response activities in the short term and the understanding of natural hazards in the long term.

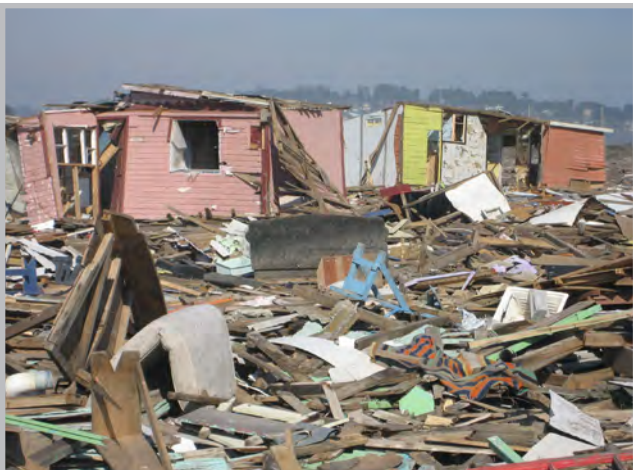
Tsunami damage in Llo-Lleo, Chile, south of San Antonio, following the 2010 Maule, Chile Earthquake (Source: RMS)

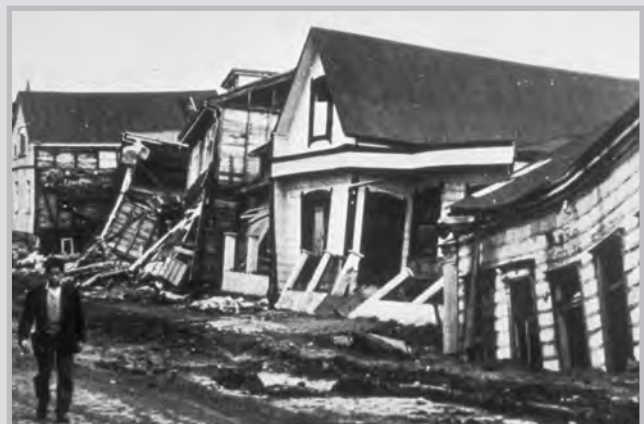
Damage to wood frame dwellings in Valdivia, Chile, following the May 22, 1960 Chile Earthquake (Source: National Aeronautics and Space Administration)

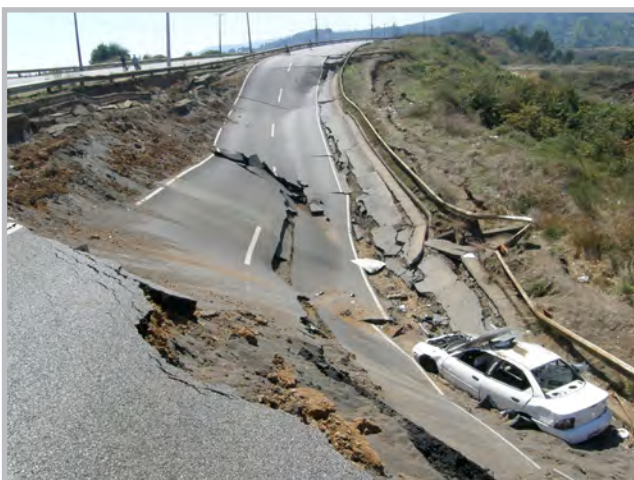
Damage to roadway near Lota, Chile following the 2010 Maule, Chile Earthquake (Source: RMS)

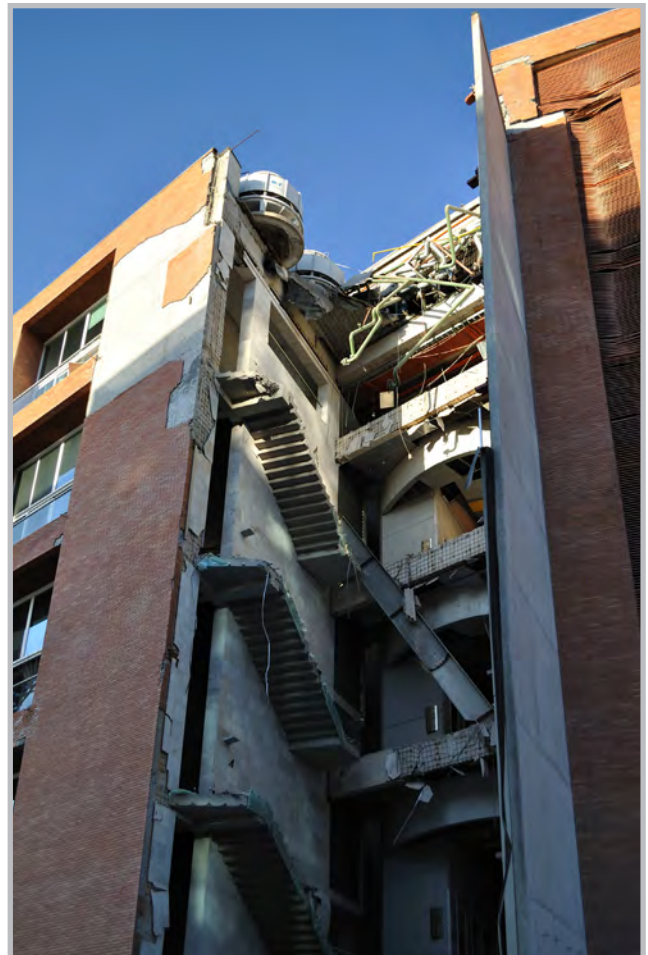
A building in the Huechuraba district of Santiago that sustained heavy damage as a result of ground motion amplification in the basin (Source: RMS)

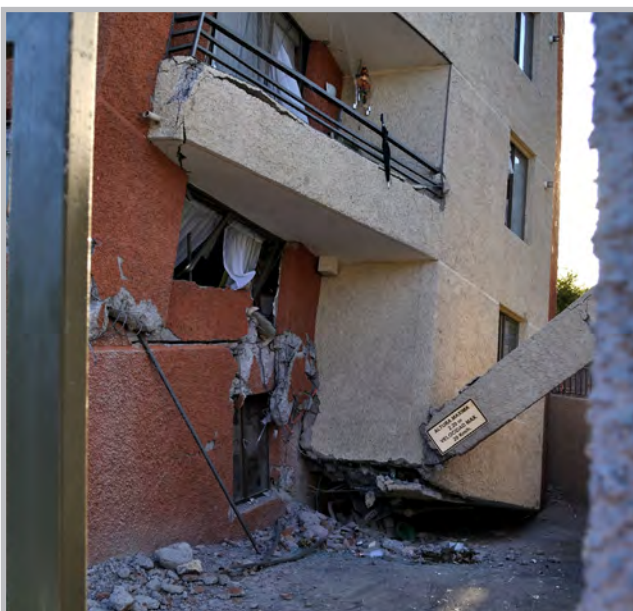
Soft story failure of a multi-family residential building in Maipú, Chile (Source: RMS)

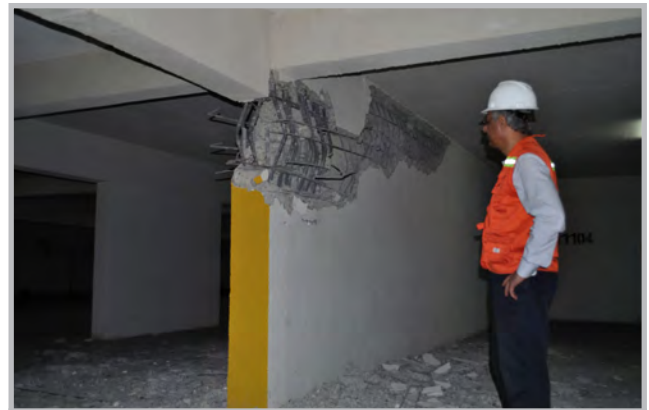
Shear wall failure observed in Viña del Mar, Chile, illustrating insufficient confinement and poor detailing of hooks (Source: RMS)

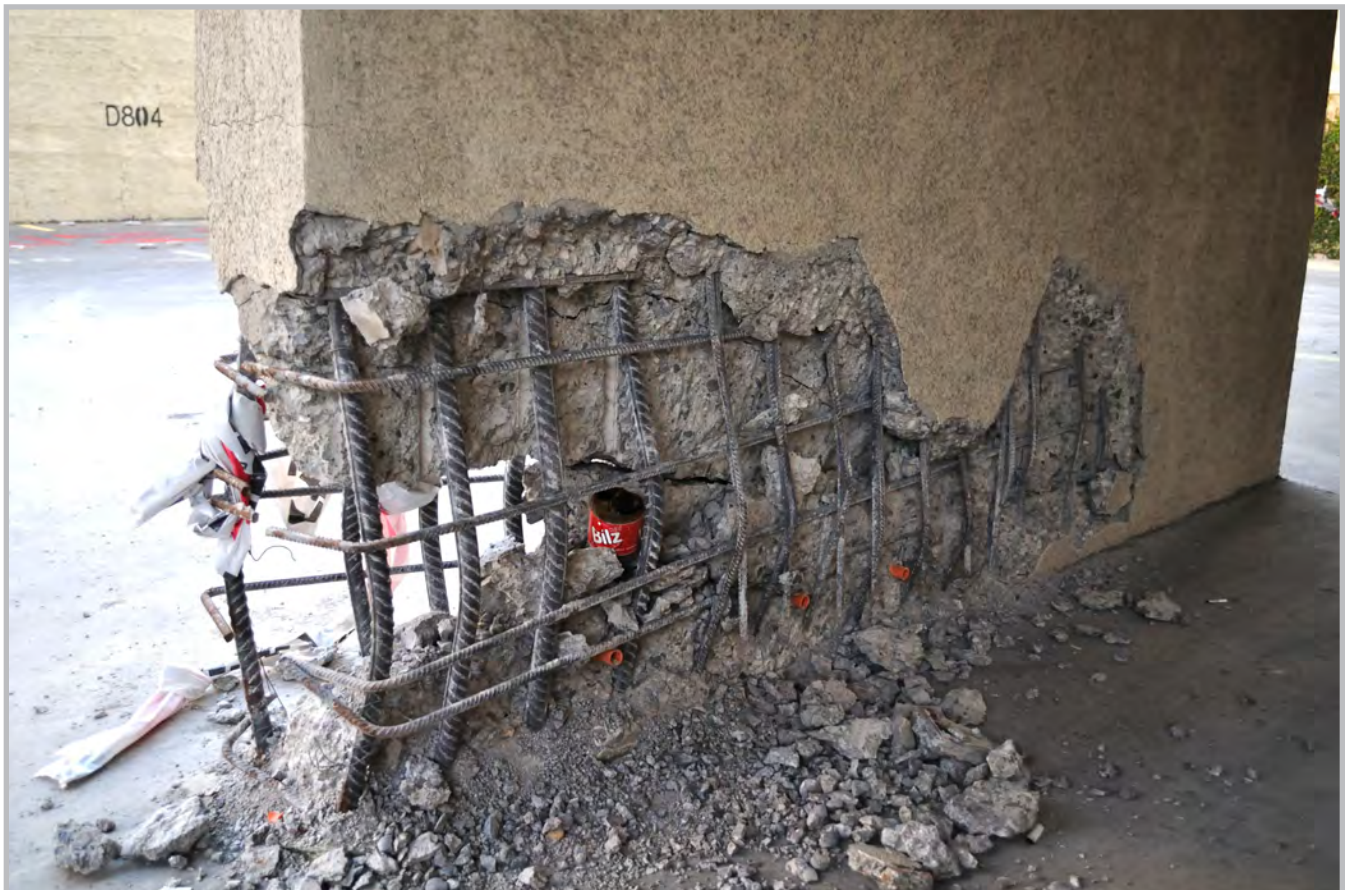
Damage in a tall apartment building in Viña del Mar, Chile; the shear wall failure was likely a result of poorly-detailed transverse reinforcement and insufficient wall thickness, as the concrete ruptured in compression and its longitudinal bars buckled (Source: RMS)

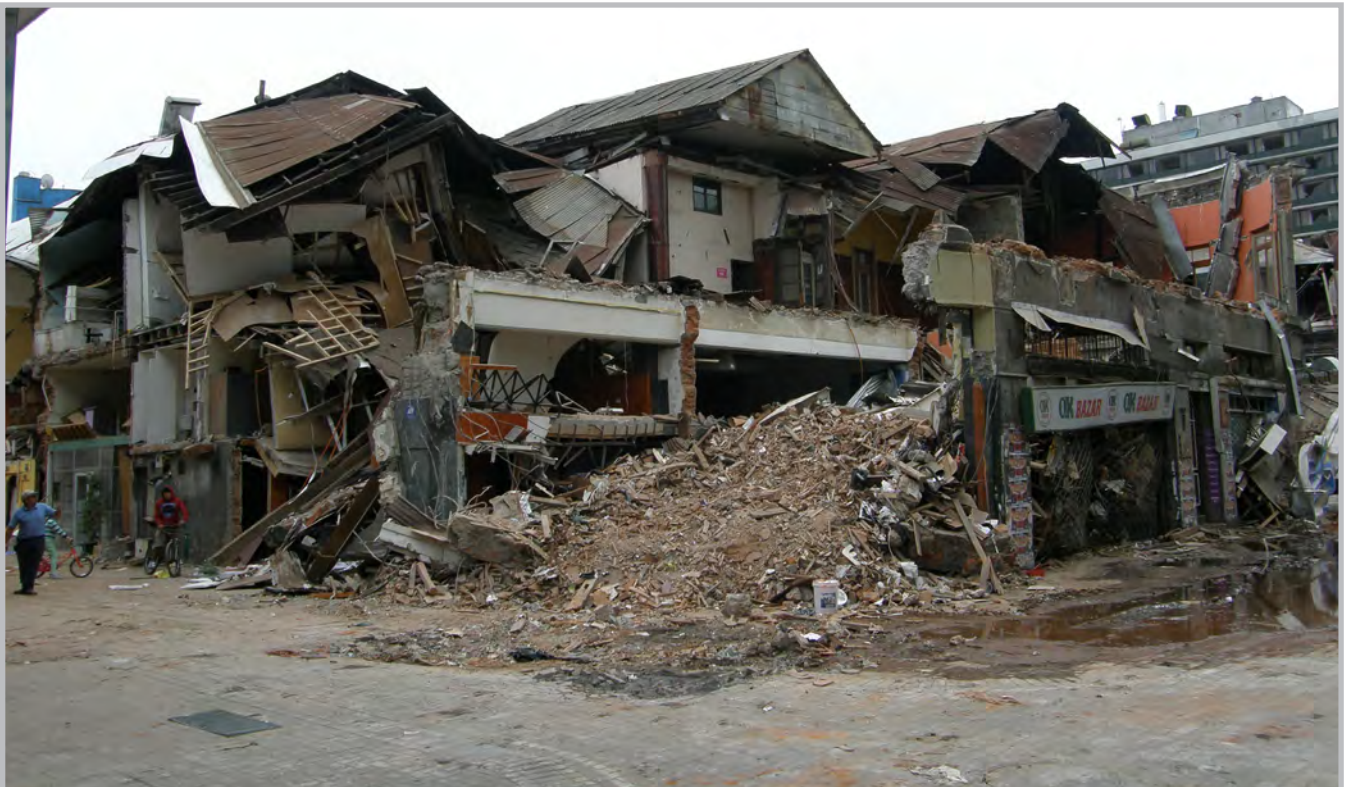
Collapse of low-rise confined masonry commercial structures in Concepción, Chile (Source: RMS)

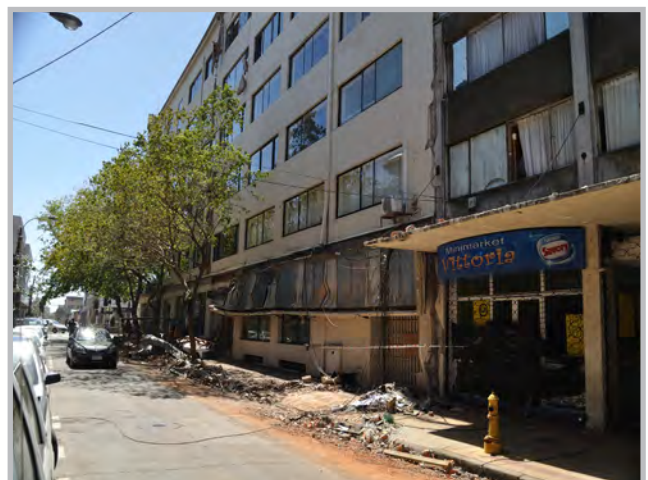
Damage to commercial buildings in Concepción, Chile (Source: RMS)

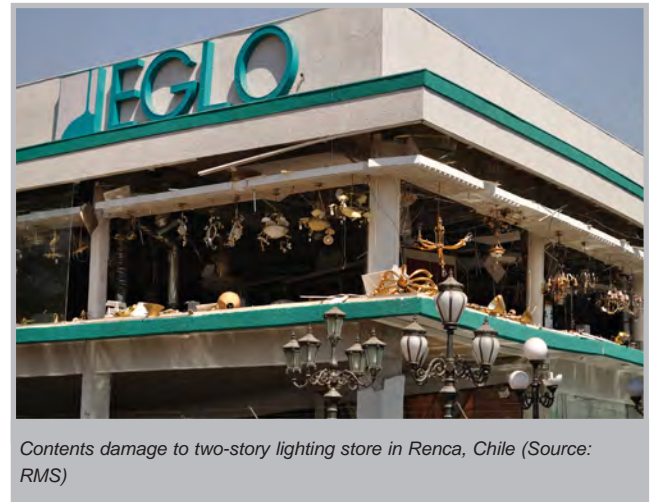
Contents damage to two-story lighting store in Renca, Chile (Source: RMS)

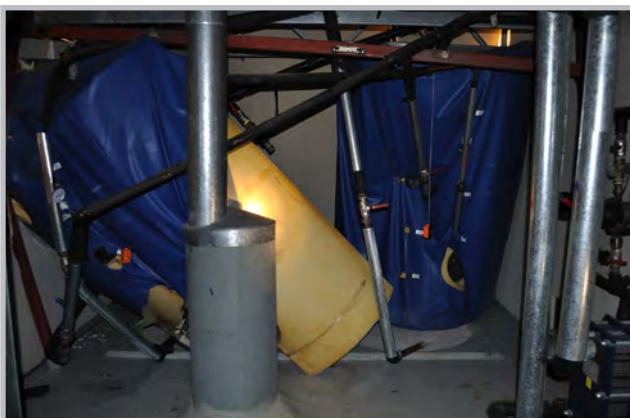
Overturning of a water tank on the top floor of an apartment building in Viña del Mar, Chile (Source: RMS)

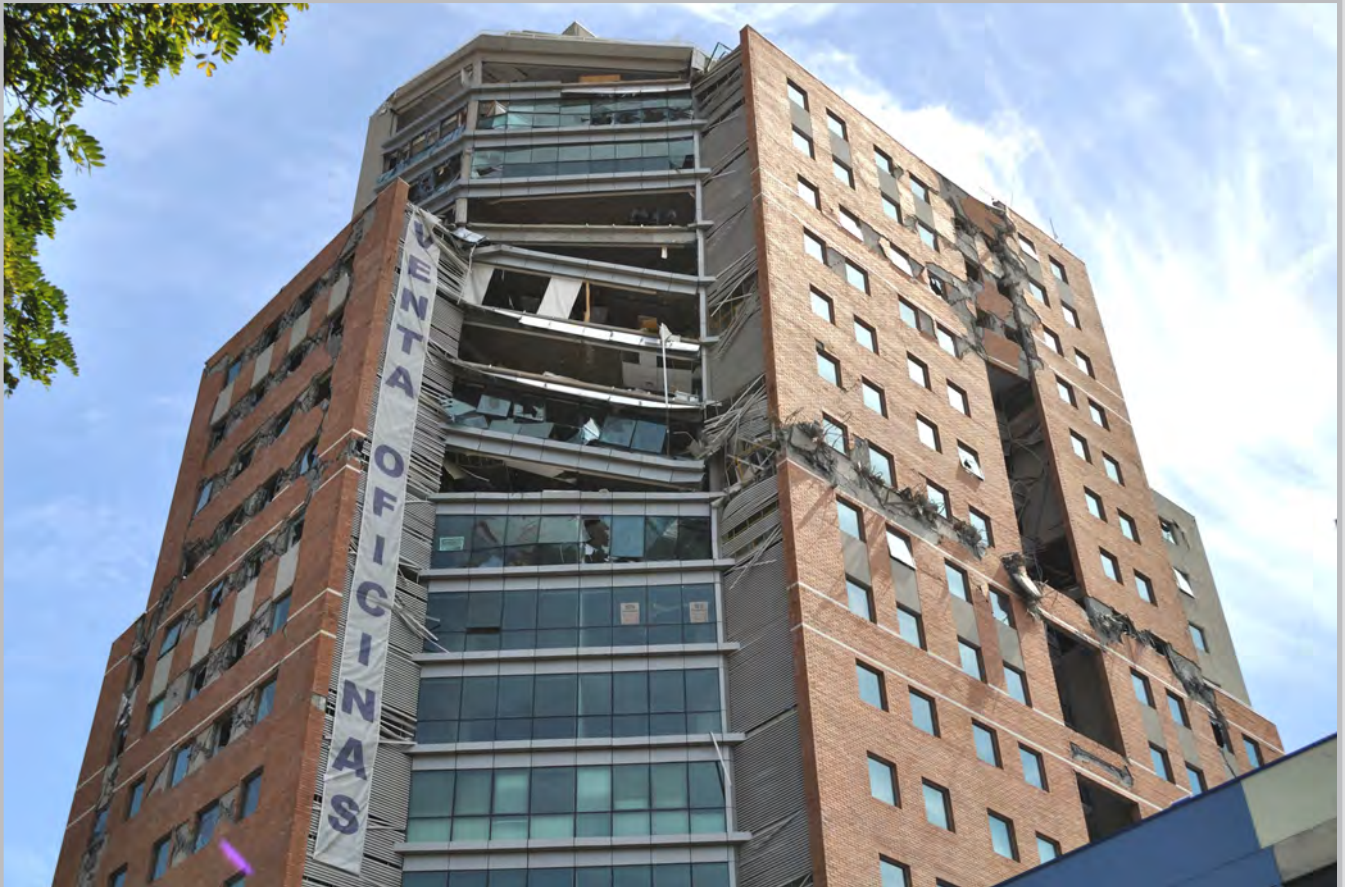
Partial collapse of O'Higgins Tower in Concepción, Chile (Source: RMS)

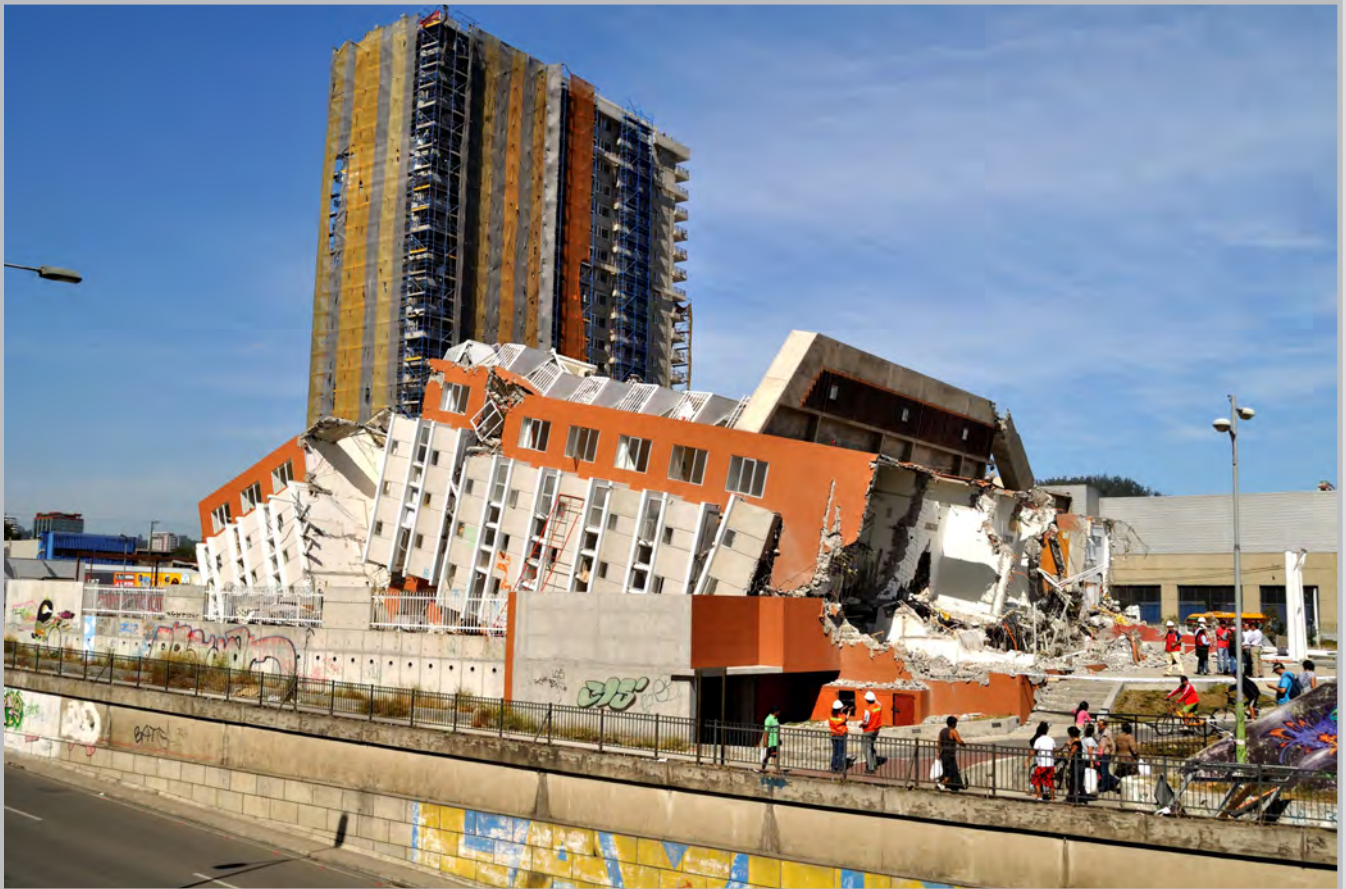
Overtuned Alto Río building in Concepción, Chile (Source: RMS)

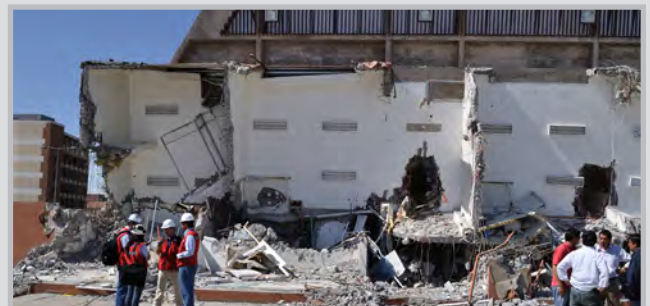
The west side of the Alto Río building, illustrating the slender shear walls at the ground level. (Source: RMS)

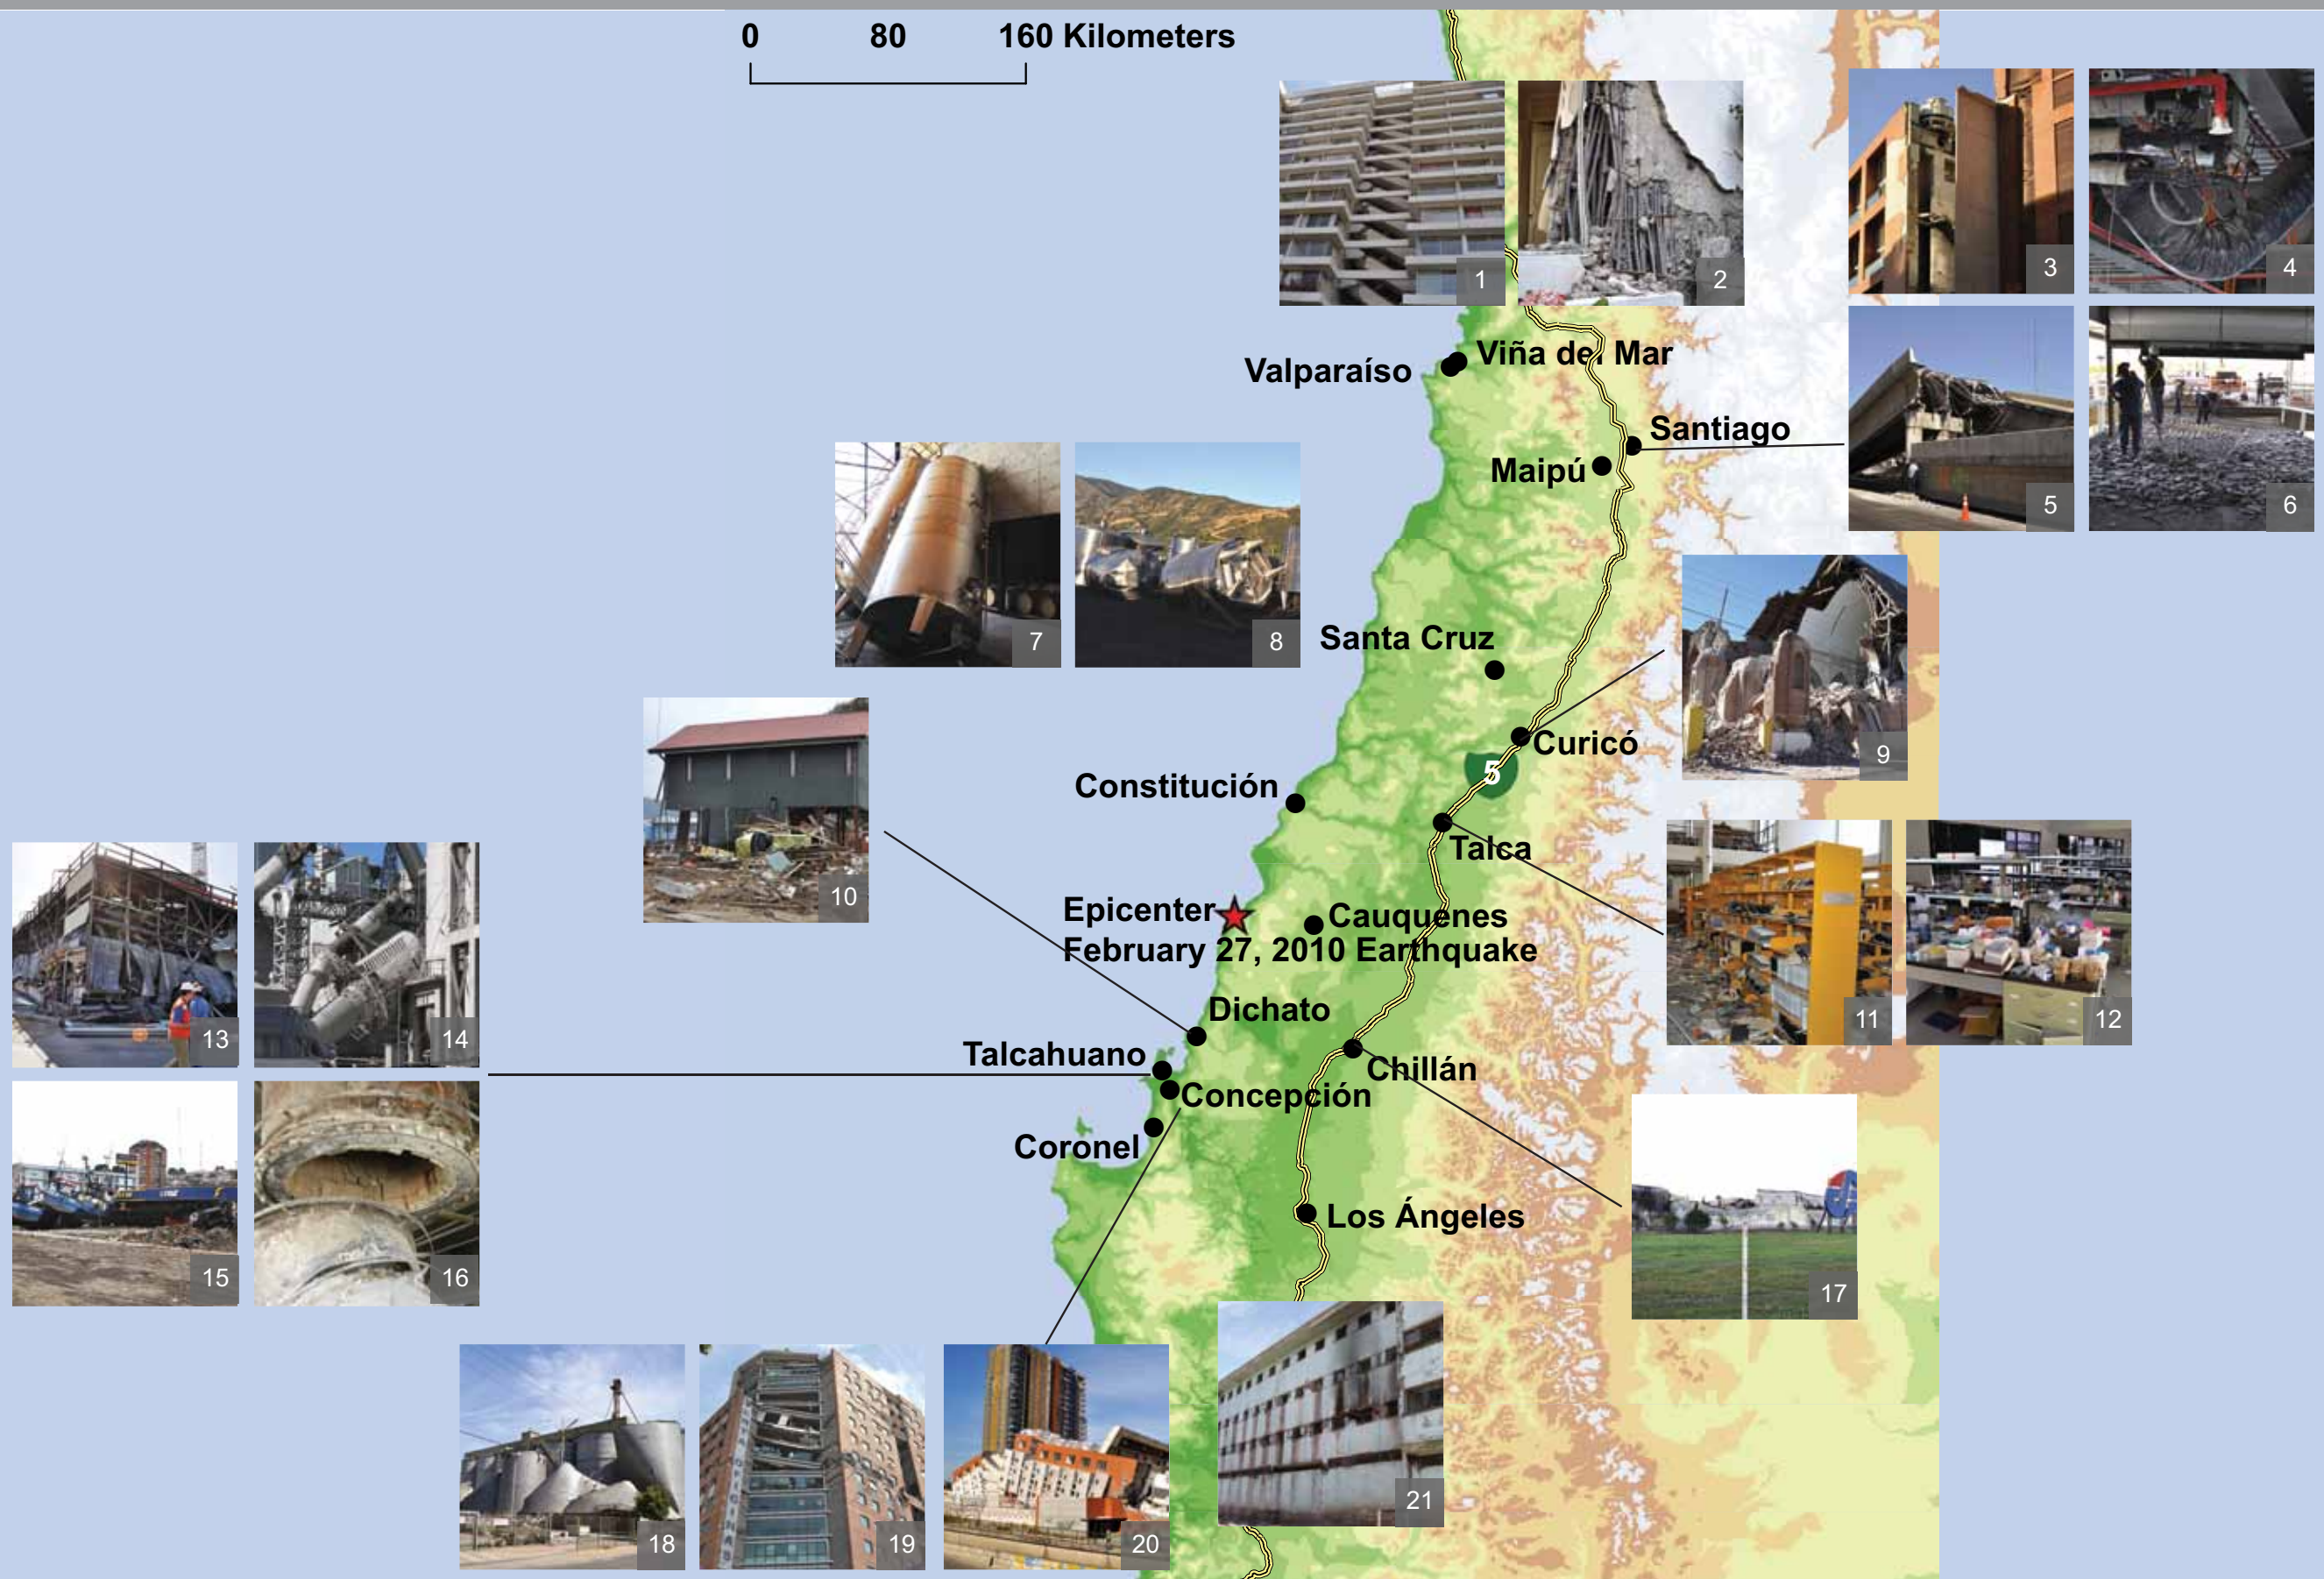
Damage across the impacted region of central Chile, as captured by the RMS reconnaissance teams: (1) the 14-story Edificio Festival in Viña del Mar, built in 1978, suffered severe damage to the stairwells that span two sections of the building; (2) the end of this shear wall in the Edificio Festival ruptured under high compression loads and revealed an abundance of longitudinal reinforcement with little shear reinforcement; (3) buildings in the Huechuraba comuna of Santiago suffered heavy damage as a result of ground motion amplification in the basin; (4) the fire sprinklers at Santiago's International Airport released water over the main terminal; sprinkler systems contributed to contents and business interruption losses throughout the affected area; (5) a series of freeway overpasses in Santiago collapsed due to inadequate connections at the end supports; commuters were forced to use detours through side streets; (6) pedestrian walkways were on the brink of collapse at the main terminal of Santiago's International Airport; (7) the wine in these two storage tanks was salvageable, but nearly a dozen other tanks at this particular winery suffered total losses when they overturned or ruptured; (8) overturned wine tanks are piled along the property line at this vineyard's warehouse in Santa Cruz; inside, stacks of wine cases were filled with broken glass and spilled wine; (9) the entire front section of this landmark cathedral in Curicó collapsed during the earthquake; historic buildings, including many cathedrals, collapsed as a result of their highly vulnerable unreinforced masonry walls; (10) the first floor of this two-story home was entirely swept away and stuffed with debris when tsunami waves crippled the coastal town of Dichato; (11) at the University of Talca, thousands of books in the university library fell off the shelves and were drenched by the fire sprinkler system; (12) the chemistry lab at the University of Talca suffered heavy contents losses as lab equipment and materials fell off shelves and countertops; (13) the cooling towers at a petroleum refinery collapsed during the ground shaking, contributing to business interruption losses; (14) overturned cooling tower at a cement factory in Talcahuano shut down the plant for several weeks; (15) boats were swept down city streets and crashed into commercial buildings as a result of the tsunami waves in Talcahuano; (16) damaged and misaligned equipment at the cement factory in Talcahuano required months for inspections and repairs; (17) a distribution center in Chillán suffered heavy earthquake damage and subsequently lost an entire warehouse to fire following the earthquake; (18) several grain silos ruptured at a facility in Concepción; (19) the O'Higgins Tower in downtown Concepción suffered local, partial collapses in several locations; the building will have to be demolished; (20) the newly-constructed 15-story Alto Rio building completely overturned during the earthquake; (21) severe damage to a confined masonry detention facility in Los Angeles; attempts at escape by the prisoners were thwarted by guards.

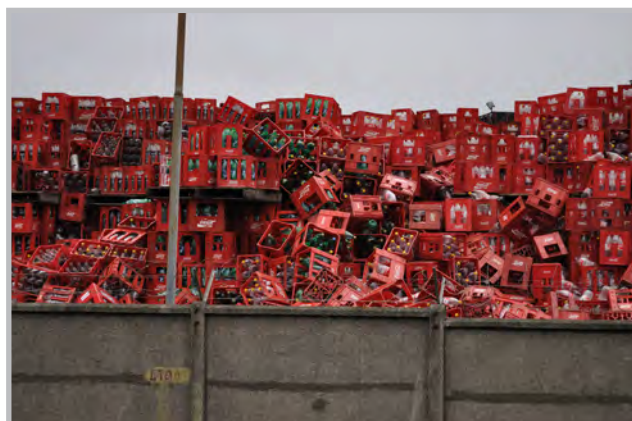
Damage to the stock of soda bottles in a facility in Talcahuano, Chile (Source: RMS)

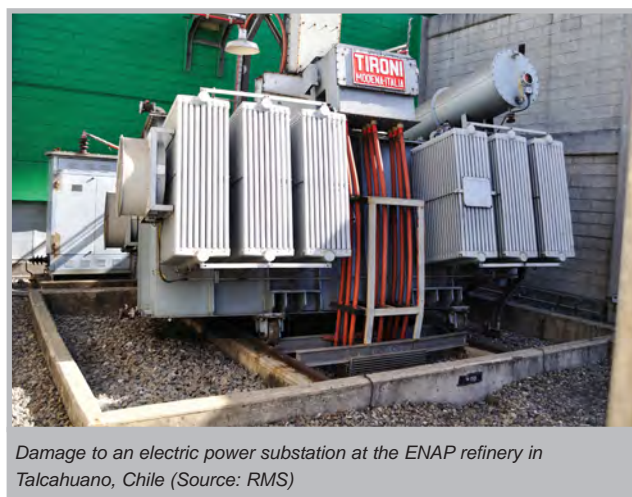
Damage to an electric power substation at the ENAP refinery in Talcahuano, Chile (Source: RMS)

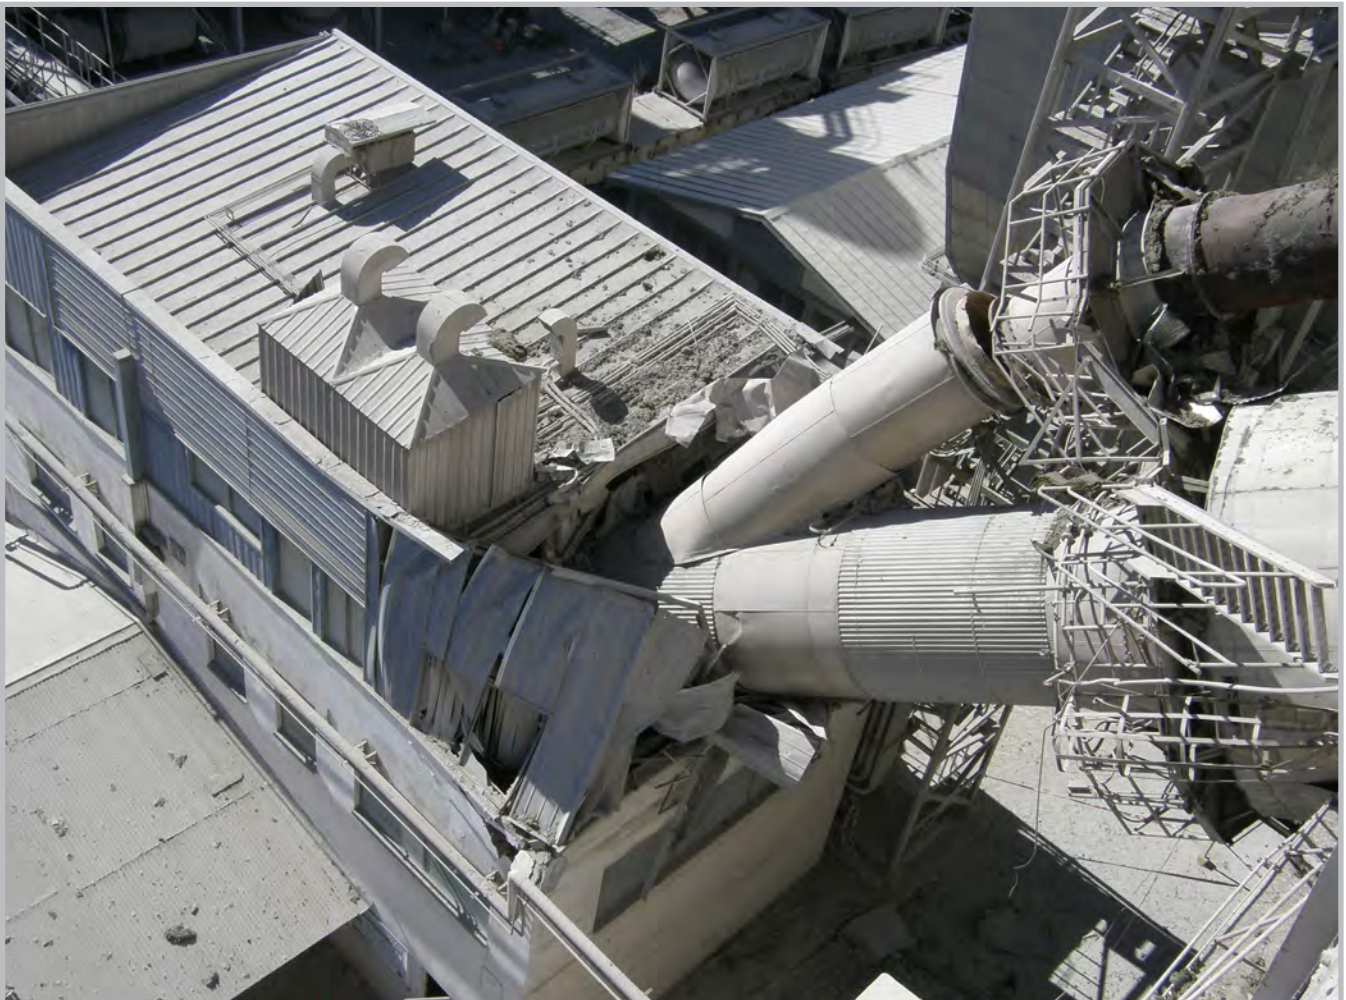
Collapse of a cooling tower at the Bío Bío cement factory in Talcahuano, Chile; fortunately, the failure of this tower did not impact the facility's production, as it was part of a backup system (Source: RMS)

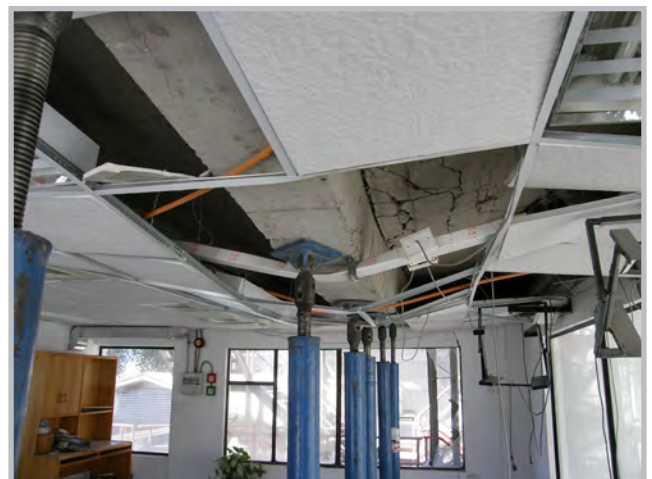
The cooling tower collapse (in picture above) caused the flexural failure of a beam in the operations unit of the Bío Bío cement factory in Talcahuano, Chile (Source: RMS)

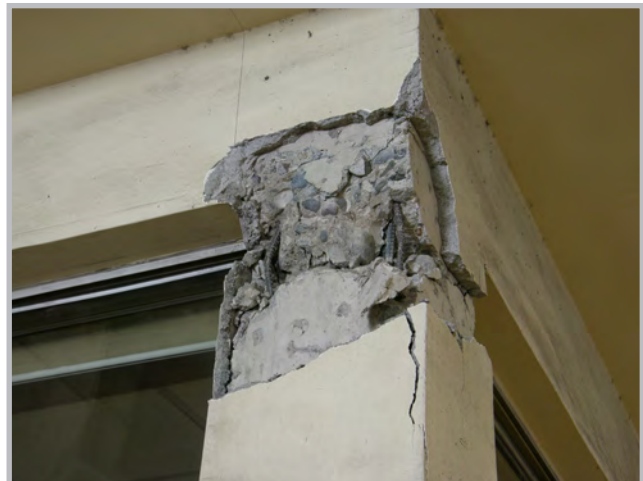
Failure of a reinforced concrete column as a result of lack of transverse reinforcement in the administrative office of the Inchalam wire manufacturing plant in Talcahuano, Chile (Source: RMS)

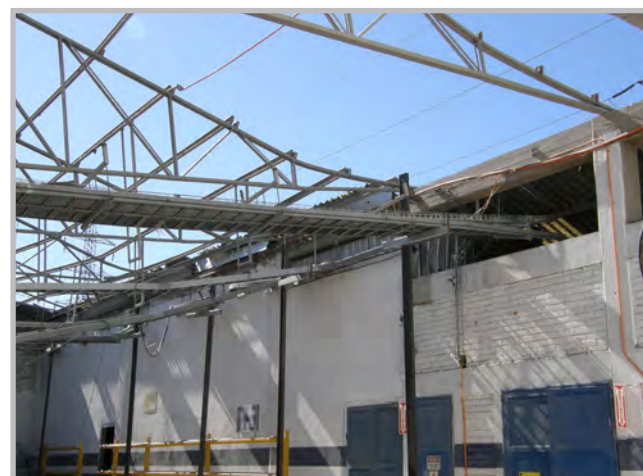
Light metal roof failure at the Inchalam wire manufacturing plant in Talcahuano, Chile (Source: RMS)

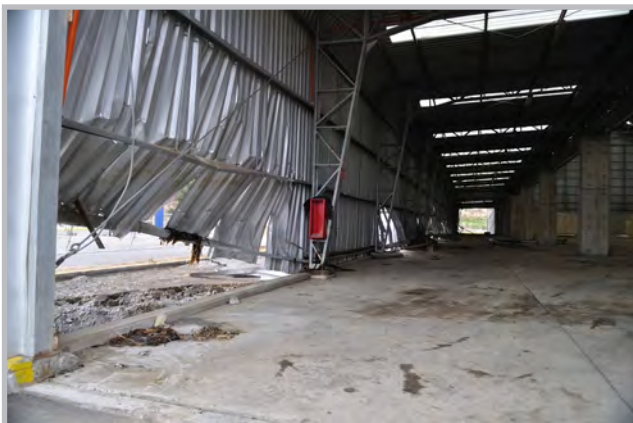
Tsunami damage in an industrial facility in Penco, Chile (Source: RMS)

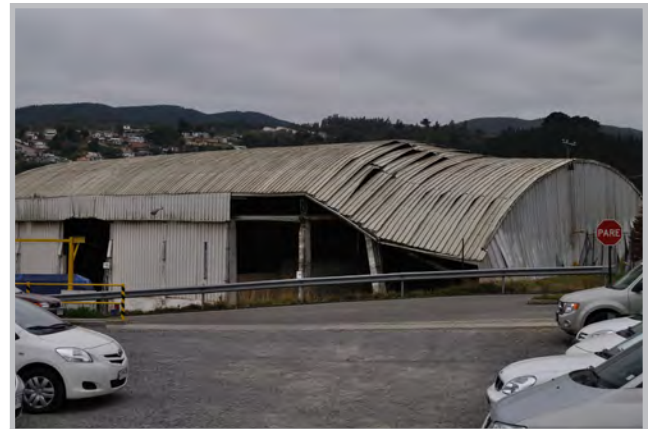
Observed damage to the Lirquén glass manufacturing facility in Penco, Chile (Source: RMS)

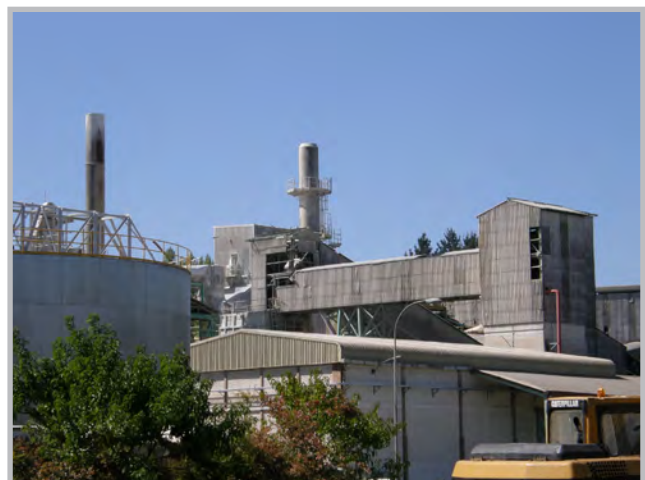
A pulp mill shutdown as a result of the earthquake in Laja, Chile; the plant was awaiting a detailed inspection before resuming operations (Source: RMS)

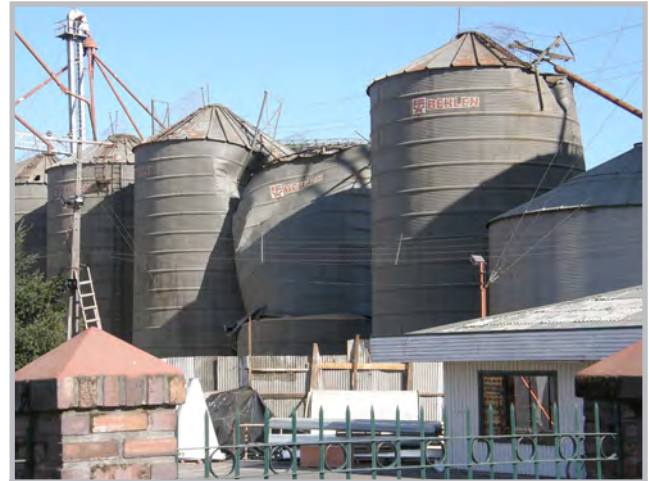
Failure of grain silos near Coronel, Chile (Source: RMS)

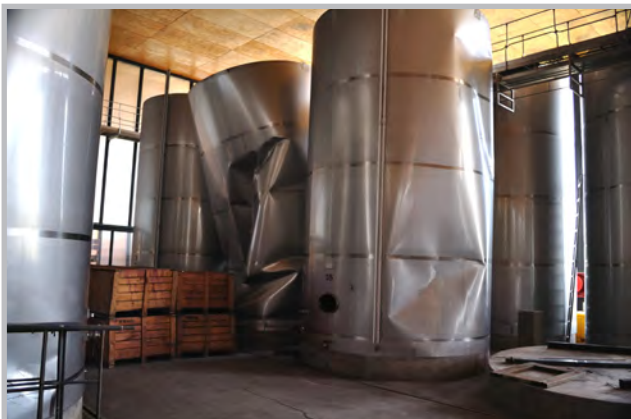
Damage to stainless steel storage tanks resulted in considerable amounts of contents loss to the Chilean wine industry (Source: RMS)

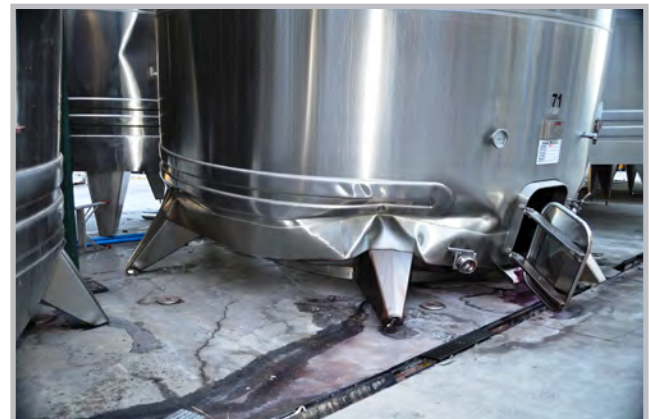
Close-up of the support failure in a cylindrical stainless steel wine storage tank (Source: RMS)

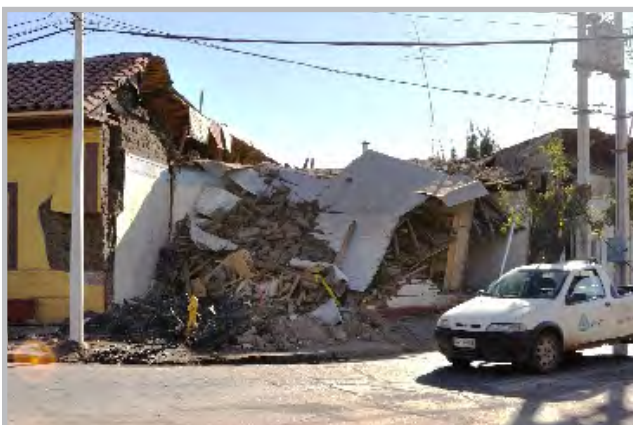
Collapsed adobe residential structure in Santa Cruz, Chile (Source: RMS)

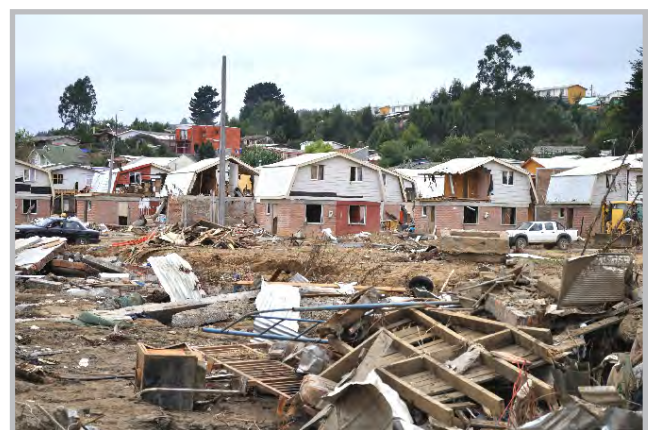
Destruction along the coastline in the town of Dichato due to tsunami waves following the 2010 Maule, Chile Earthquake (Source: RMS)

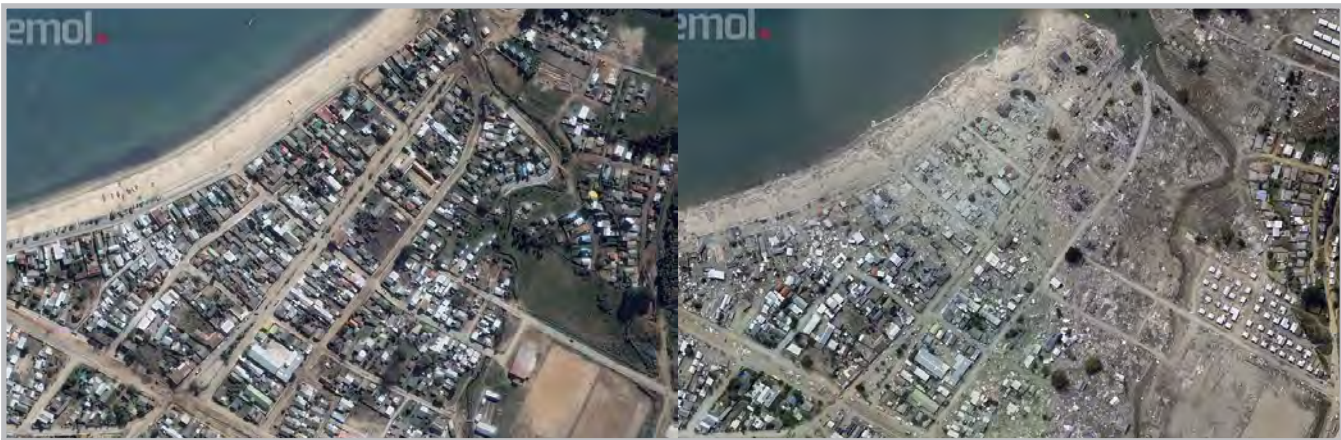
Aerial view of the city of Dichato before the tsunami waves (left) and after the tsunami waves (right), illustrating the complete destruction of buildings in their path (Source: http://www.emol.com/especiales/2010/fotos_AD/terremoto_antesydespues/index.htm)

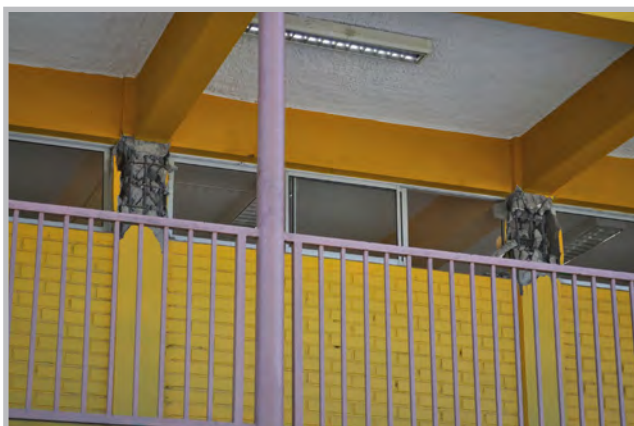
Damage to reinforced concrete “short columns” in a school building in the Santiago region (Source: RMS)

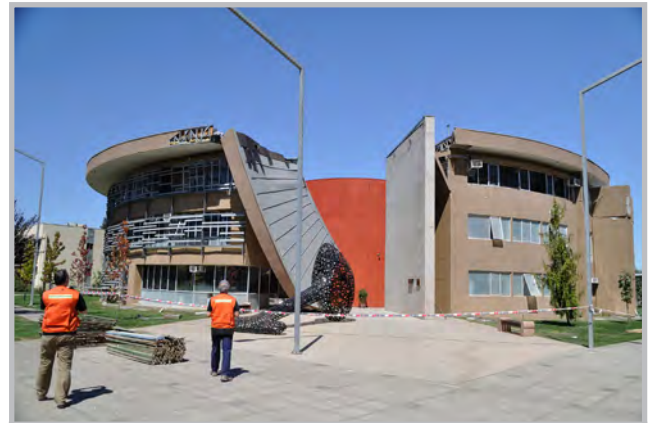
Damage to a chemistry building on the University of Talca's campus: a section of the roof detached from the wall and collapsed onto the walkway below (Source: RMS)

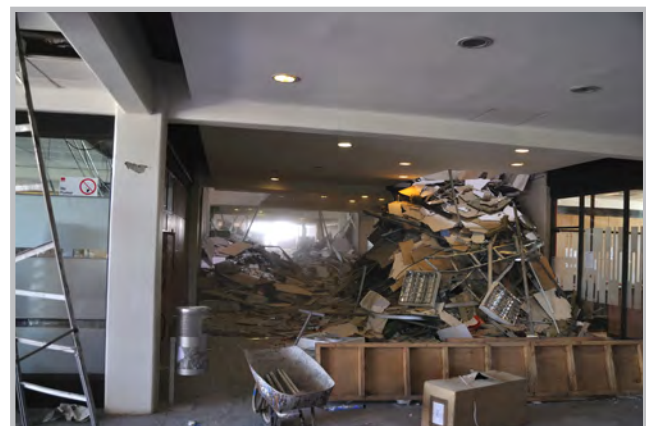
A massive pile of debris was extracted from a building on the campus of the University of the Americas in Concepción, Chile (Source: RMS)

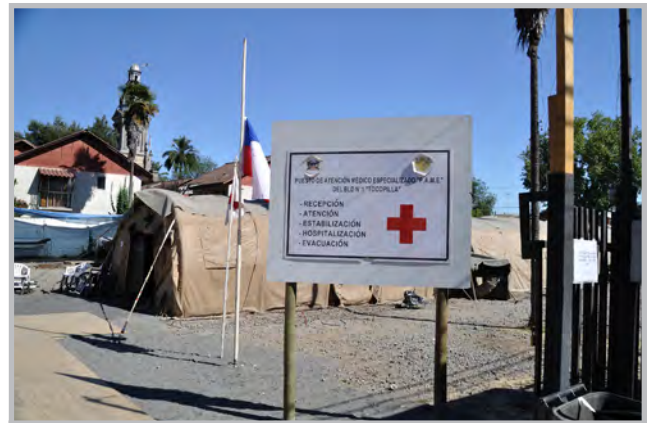
With a hospital in Curicó, Chile, severely damaged, tents were set up to accommodate patients (Source: RMS)

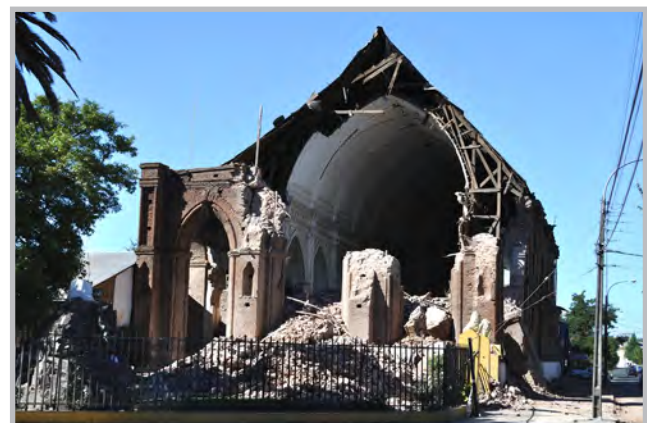
Damage to a historic church in Curicó, Chile: collapse of the Iglesia San Francisco's front tower and entrance (Source: RMS)

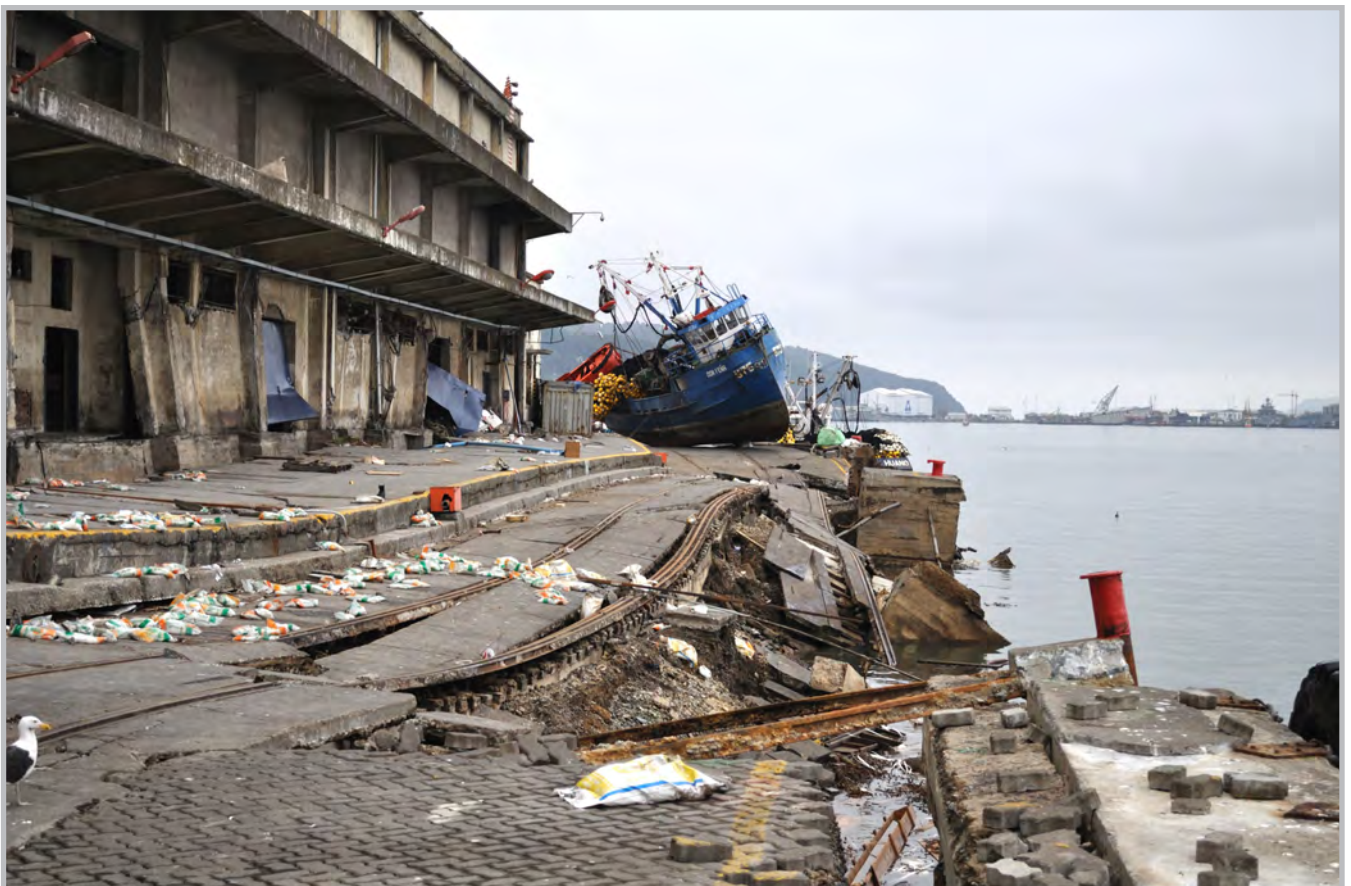
Destruction of the port facilities in Talcahuano, Chile (Source: RMS)

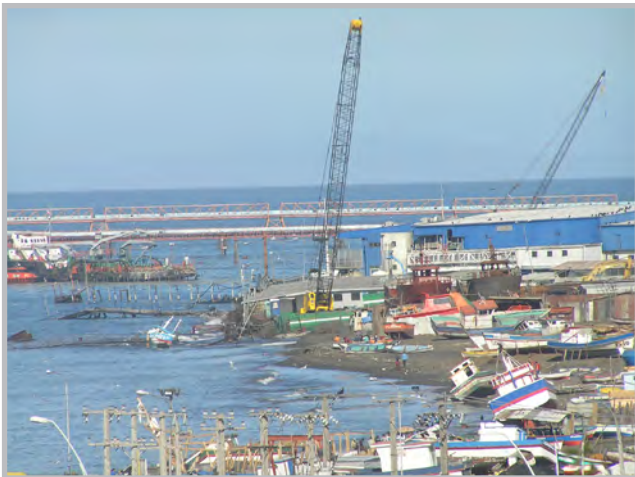
Damage to the port in Coronel, Chile (Source: RMS)

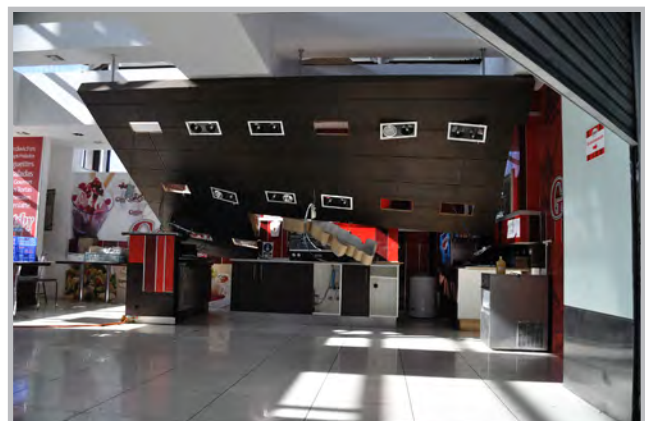
A suspended ceiling fell onto the counters of an airport cafe in the Comodoro Arturo Merino Benítez International Airport (Santiago International Airport) (Source: RMS)

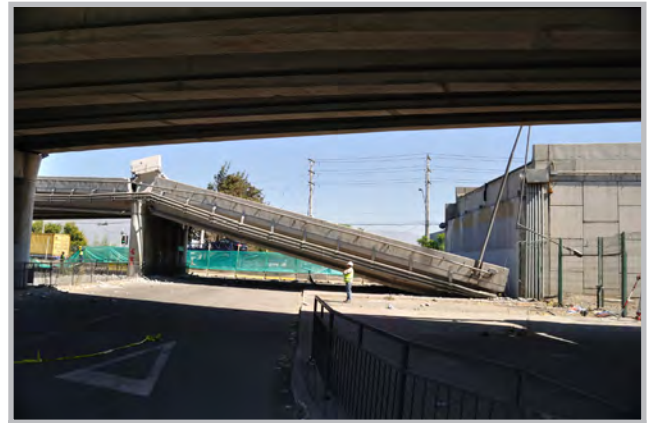
Collapsed span of the Autopista Vespucio Norte Express, connecting the Santiago International Airport to downtown Santiago (Source: RMS)
