The 2010 Maule, Chile Earthquake: Lessons and Future Challenges

■ INTRODUCTION

In March 2010, Risk Management Solutions (RMS) deployed two reconnaissance teams to the region to investigate the impacts from the earthquake and tsunami. These teams spent two weeks in the field, collaborating with engineers and seismologists from other organizations, including the University of Chile, the USGS, and Stanford University. Post-event field reconnaissance, in its ability to rapidly and precisely make observations about the impacts from a disaster, is critical in the management of emergency response activities in the short term and the understanding of natural hazards in the long term.

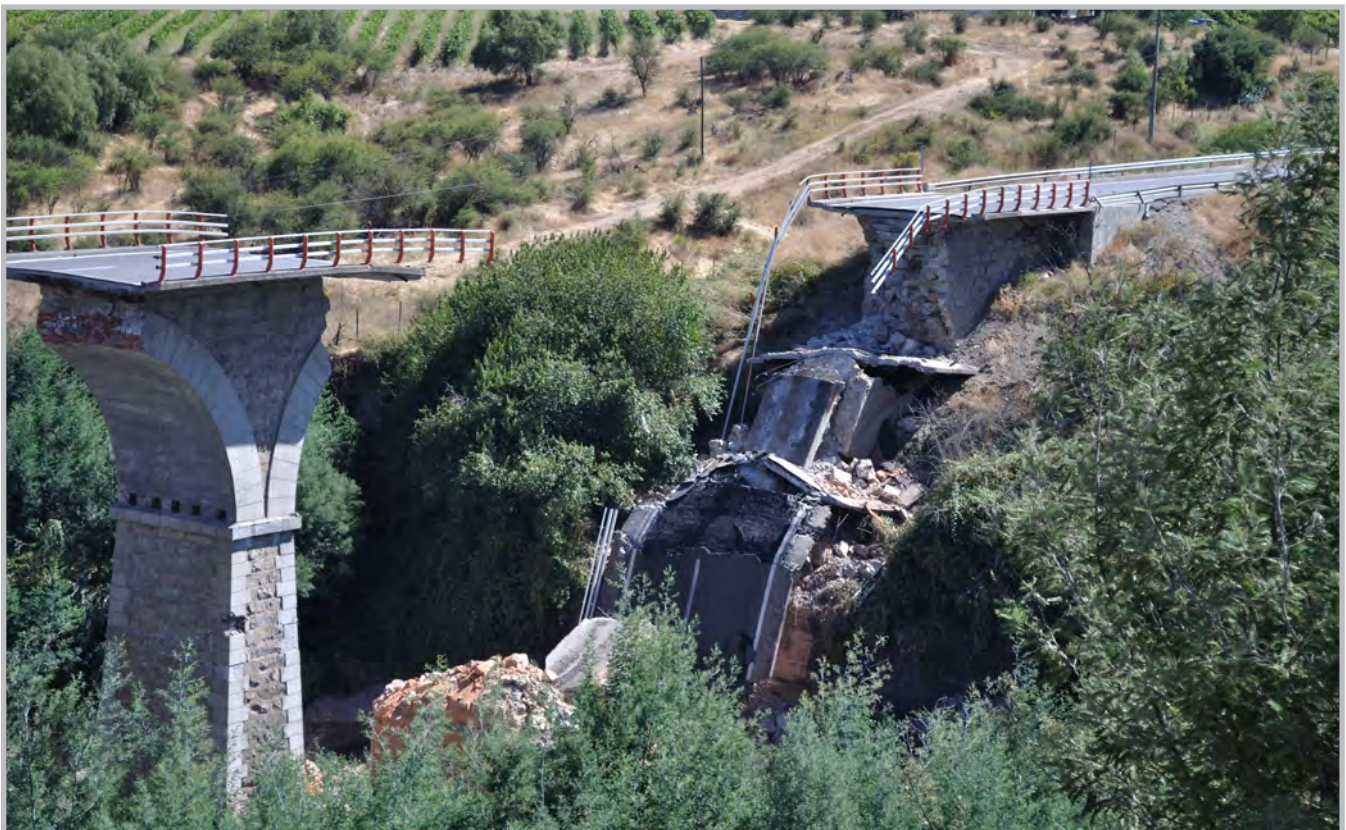
Collapse of an unreinforced masonry bridge, located between Curicó and Talca along Chile's Ruta 5 and spanning the Río Claro (Source: RMS)

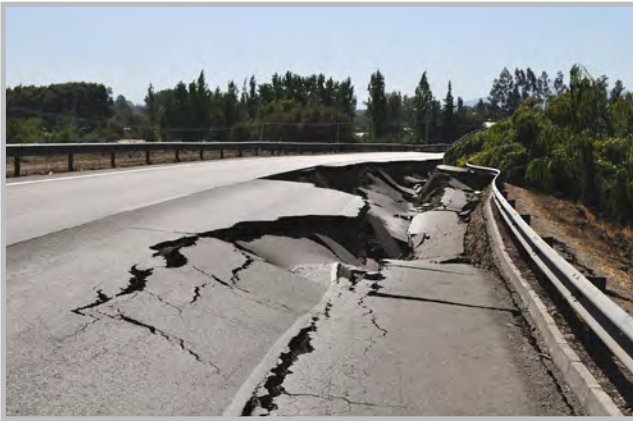
*Buckled roadway along Chile Highway 5 (Ruta 5), south of Santiago
(Source: RMS)*

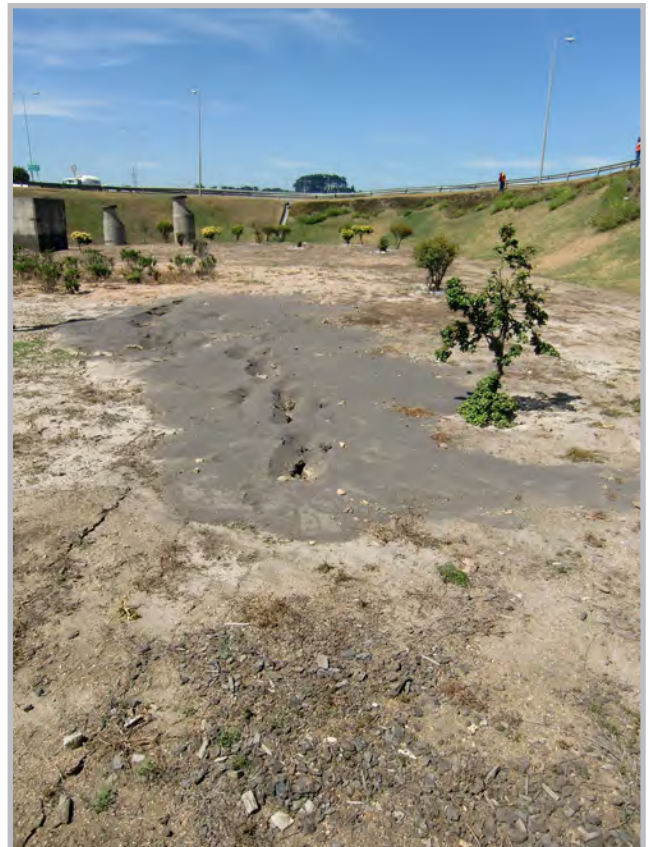
*Evidence of liquefaction (sand boils) near the Juan Pablo II Bridge, which spans the Biobío River and connects Concepción to San Pedro de la Paz
(Source: RMS)*

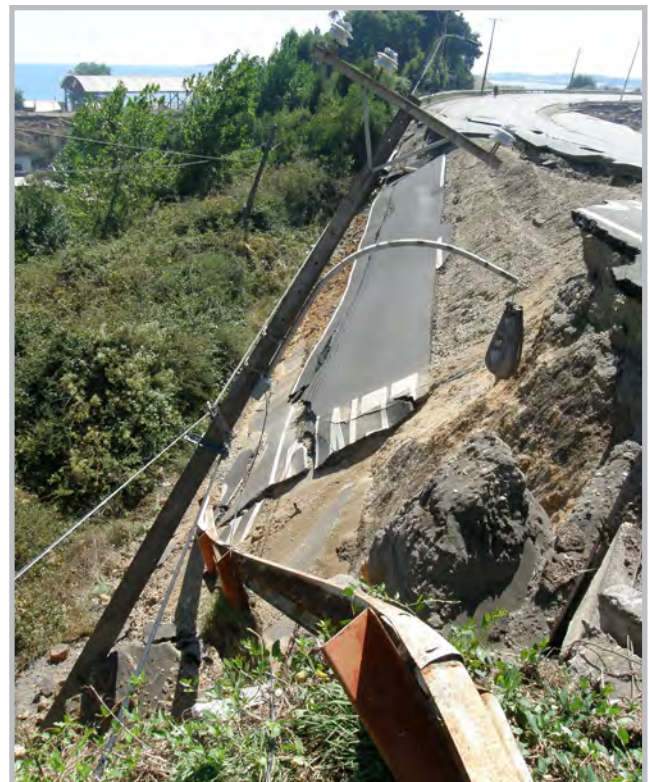
Failure of an overhead transmission line in Lota, Chile (Source: RMS)

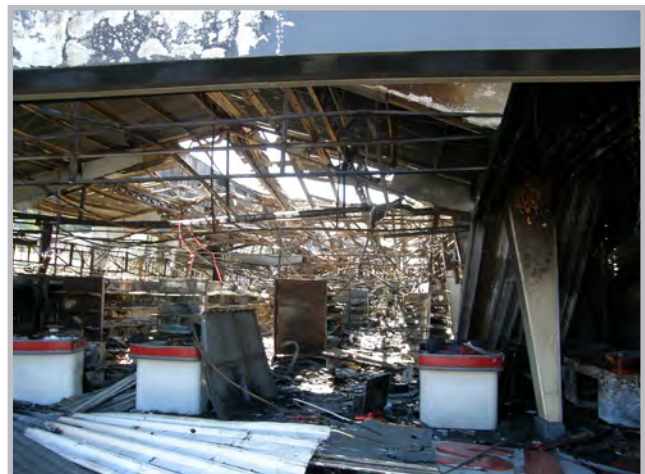
Grocery store in Coronel, Chile, destroyed by fire following the 2010 Maule, Chile Earthquake (Source: RMS)
