TIS Service Bulletin Page 1 of 4

THE INSTRUMENT CLUSTER DISPLAYS VARIOUS CHECK **CONTROL MESSAGES**

MODEL

F25 (X3)	F26 (X4)	
Produced up to July 31, 2016

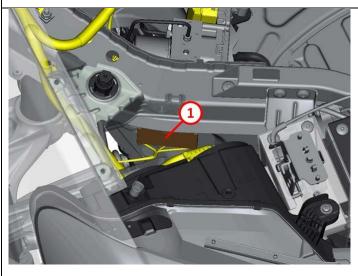
Right Front Strut Tower

Note: The replacement harness has a pink/blue wire instead of a red/blue wire at the DSC hydraulic unit.

- Route the new wiring harness into the engine compartment
 Fasten all the wiring harness mountings (blue arrows)
- Install the windshield washer hose
 (4)
- Reinstall the ground cable and nut
 (3)
- Plug all connectors (red arrows)
- Raise the DSC hydraulic unit (1) carefully and plug in the harness connector (2)
