The Kansas City Hyatt Regency Walkways Collapse

Investigation of the Kansas City Hyatt Regency Walkways Collapse

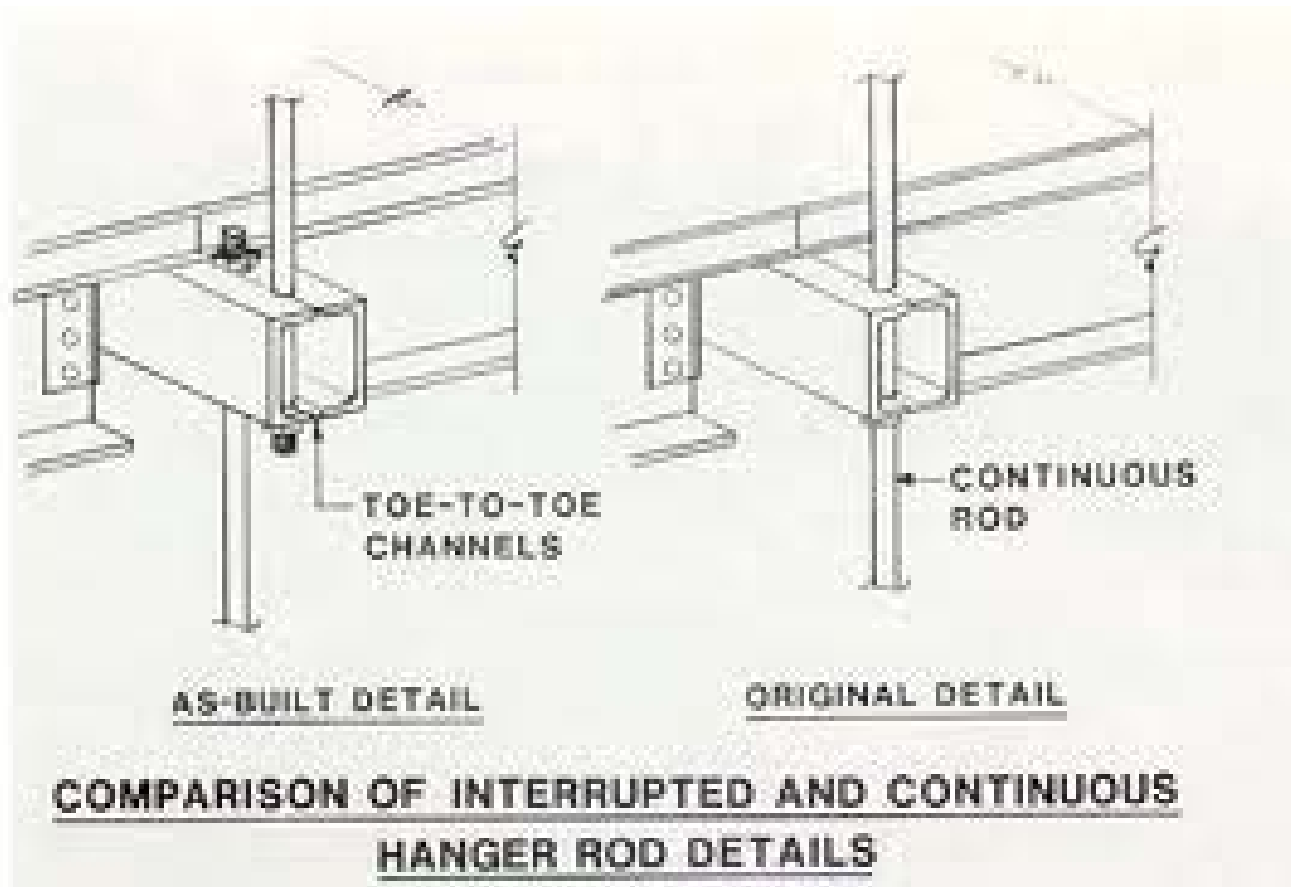
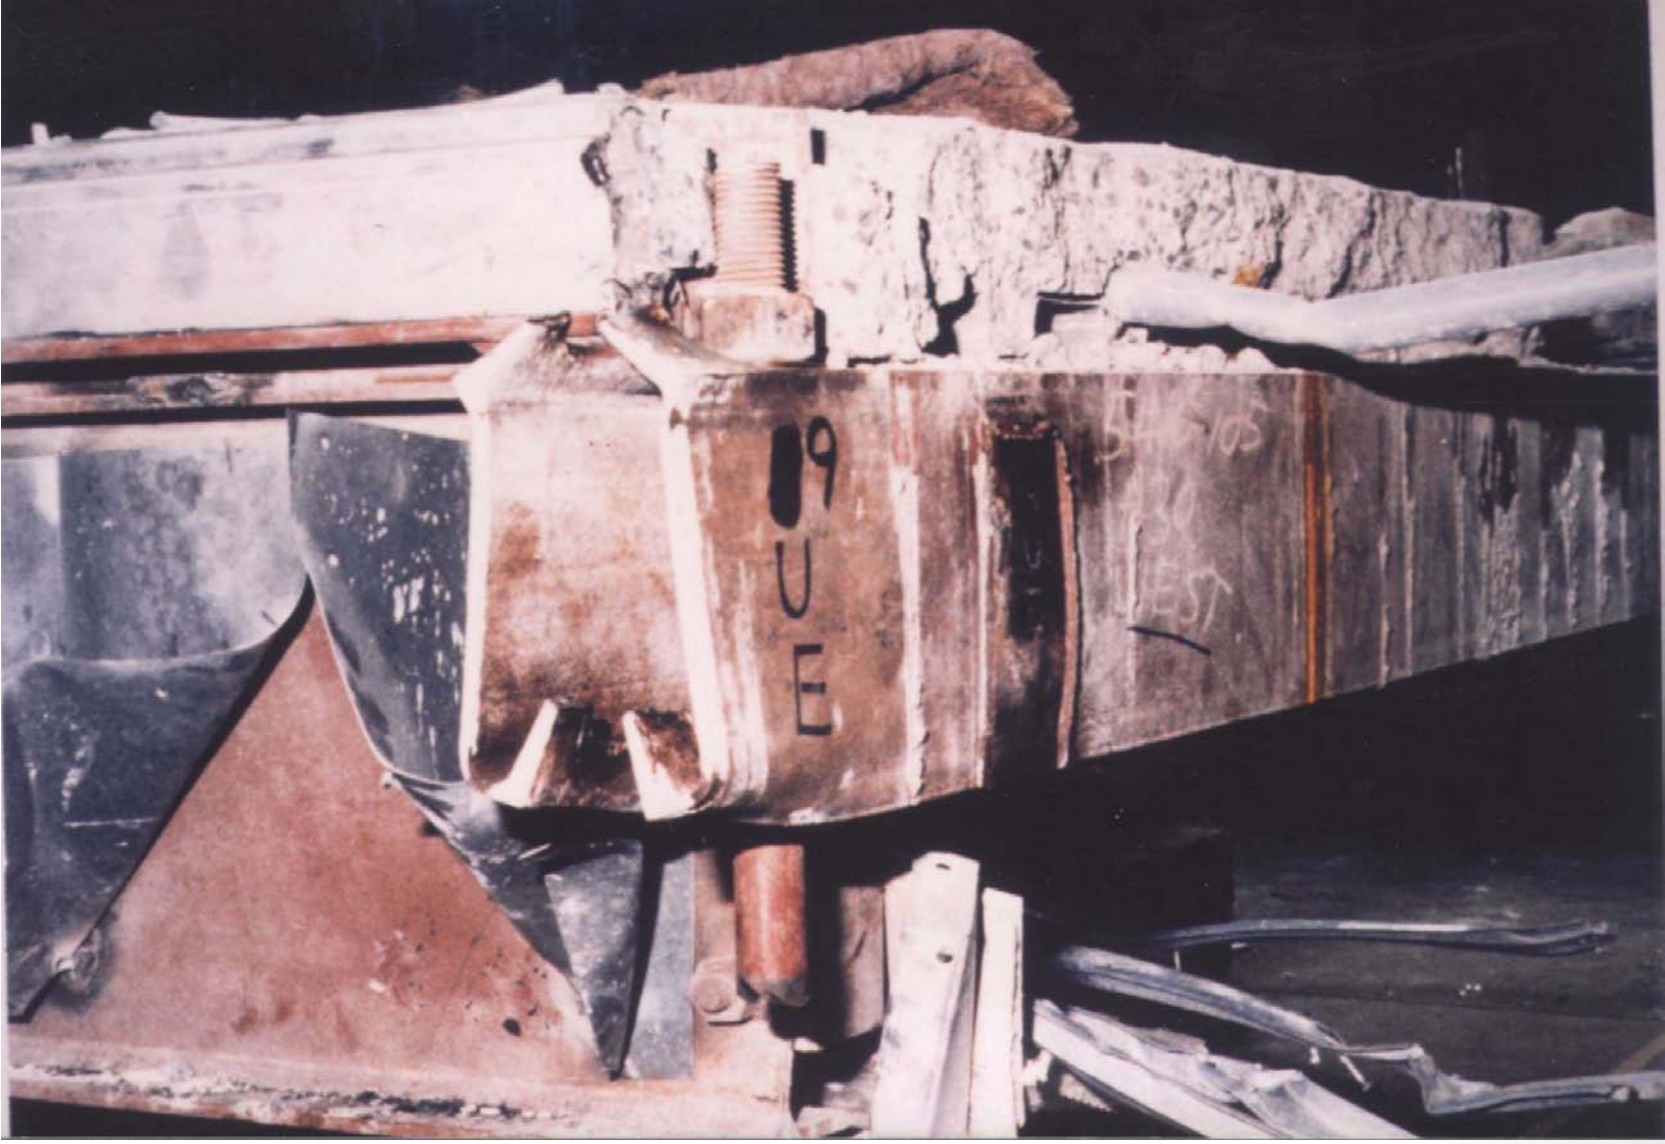
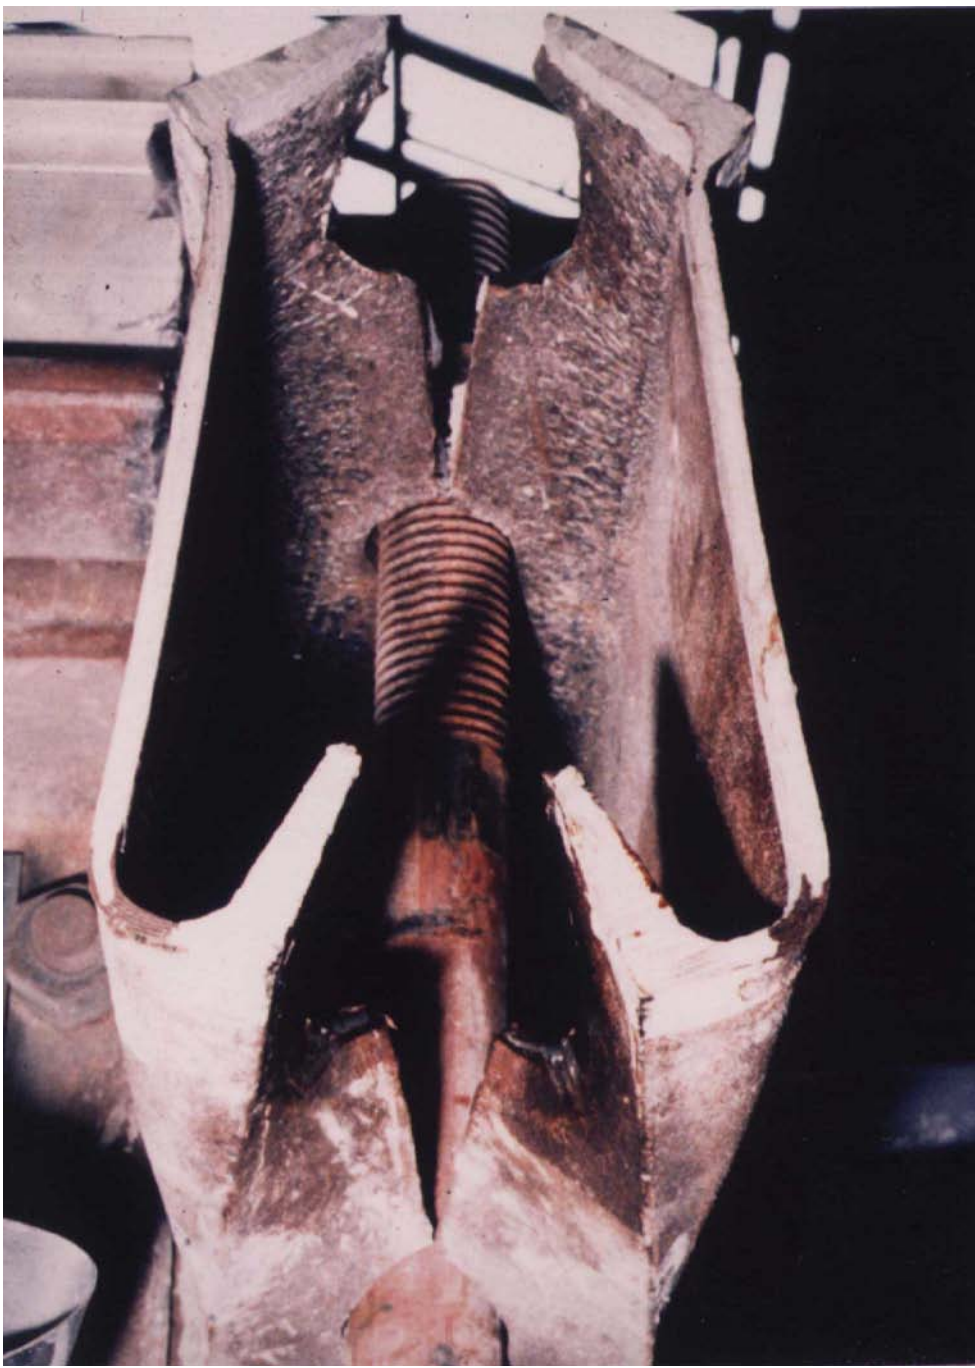
- Three suspended walkways
 - 2nd floor suspended from the fourth
 - 3rd floor off-set
- Probable Cause
 - Load capacity on box beam hanger connections
 - Per accident investigation, the original design was 60% below the Kansas City Building Code
 - Construction change doubled load on connection

- Box beam / hanger rod connection

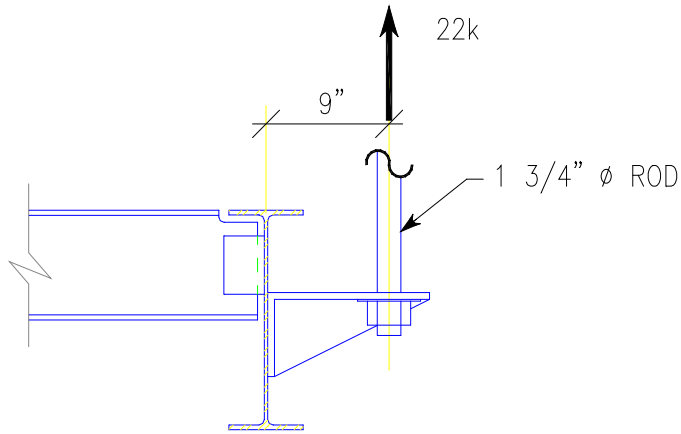
ORIGINAL DETAIL

- 1st Walkway connection detail shows eccentric hanger to angle on the side of W16 stringers
- Mid 1978: Architect request rods supporting bridges be changed from 1 3/4" to 1 1/4". Plans are revised to 2-MC 8 channels in lieu of W8x10.
- Engineers Revised sketch of detail shows single rod w/ $F_y=60$ centered on 2 channels placed toe to toe with axial load of 22k
- August 1978 Draftsman transfer sketch to final drawings leaving off the yield strength of the rod and axial load.

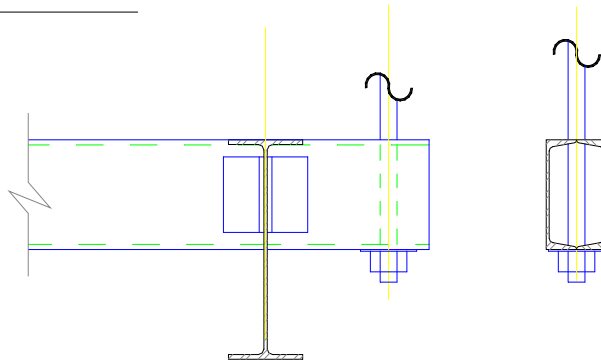
REVISED DETAIL
(AS TRANSCRIBED BY DRAFTSMAN)

- No rod size
- No reaction
- No rod strength

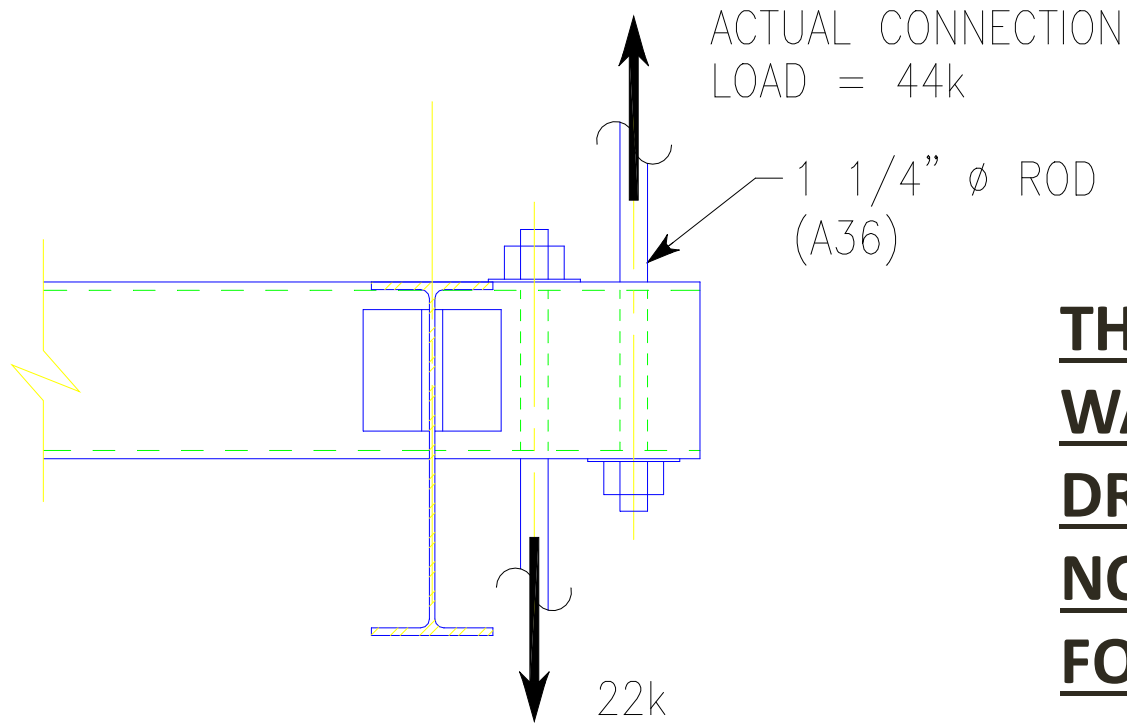
AS BUILT

THIS CONNECTION
WAS NEVER
DRAWN
NOR SUBMITTED
FOR APPROVAL

- Single Rod Concept detail on engineer's drawing noted as conceptual only
- Fabricator design connection
- Picked up during shop drawing check as not designed
- After atrium collapse picked up during design re-check which should have been a thorough design document check
