Feasibility Study for
The Town of Glenrock, Wyoming

The Lincoln Building

July 29, 2013

Structural Assessment of the Bronco Building Glenrock, Wyoming

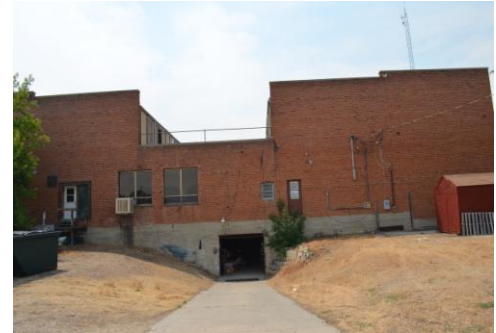
Structurally, the portions of the foundation observed were in fair to good condition. Cracking was observed around the perimeter foundation walls at several locations.

Visible Foundation Wall at
North Elevation

In general, repair of the foundations is low priority. It is suggested that the concrete cracks be repaired.

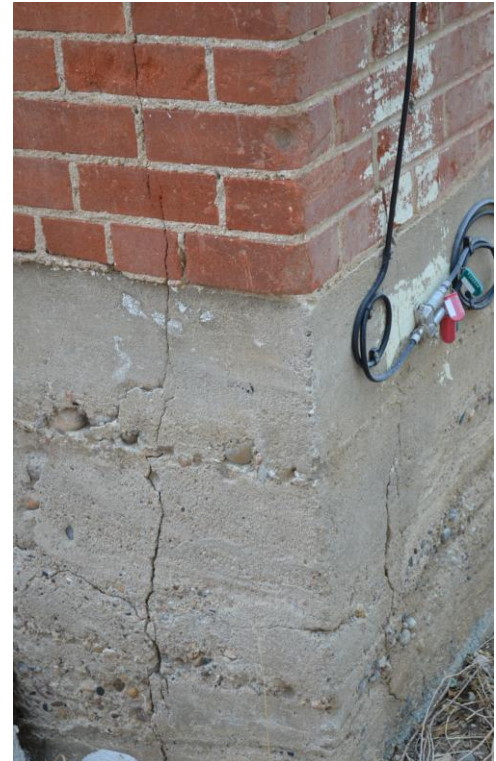
Example of Visible Cracking in
Foundation Wall

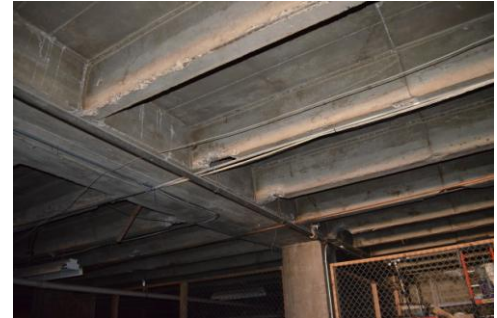
Typical Floor Framing

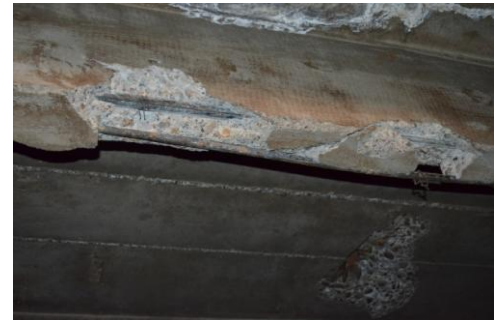
The condition of the existing floor framing is dependent on the member type. The joists are in fair condition with visible deterioration and exposed reinforcement at several locations. It appears the reinforcement did not have adequate clearance from the form work when the members were cast. The beam sections appear to be in good condition.

Damaged Concrete & Exposed Reinforcement in Joist

The damaged concrete should be patched and repaired to extend the life of the structure.

Repair damaged concrete at the main level framing to prevent additional deterioration and to assist with extending the life of the structure.

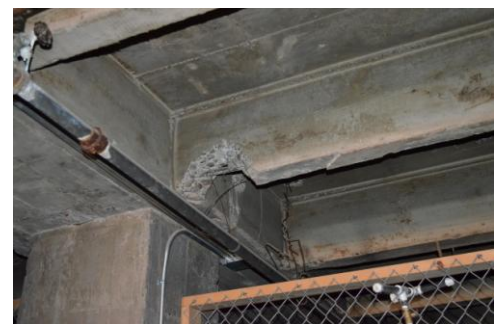
Damaged Concrete & Exposed Reinforcement in Joist

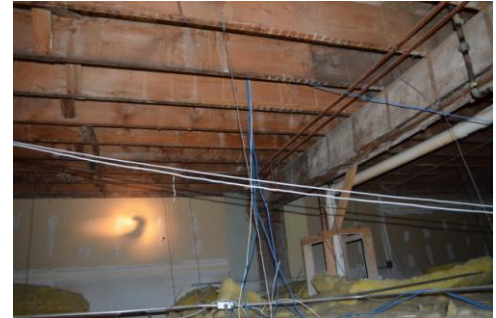
The existing floor framing that was observed is in good condition.

Floor Joist &
Dropped Beam

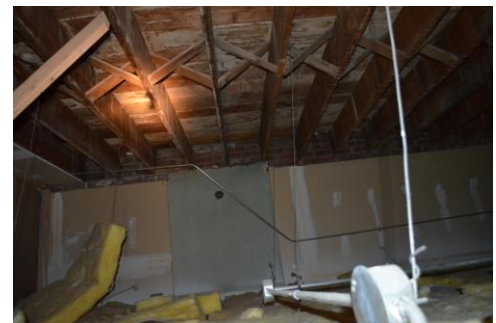
Joist Blocking

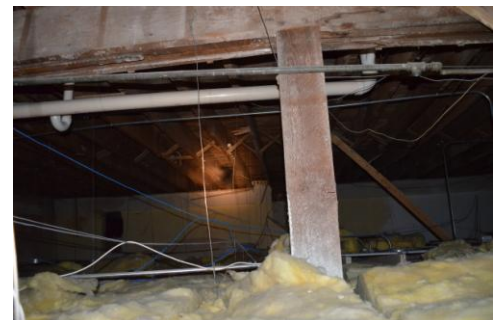
Beam Bearing at
Timber Column

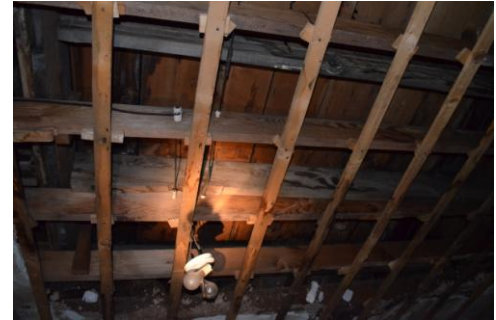
The roof framing above the classroom and garage additions are in good to fair conditions. Water staining was observed throughout the roof framing, however major deterioration was not. It is assumed that the water damage and staining occurred prior to the recent re-roofing project. Therefore, it is assumed that no additional corrective measures are required.

Exposed Roof Rafters and
Ceiling Joists

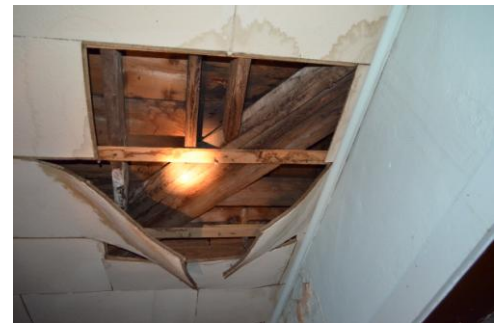
Diagonal Beam at Corner of
"U-Shape" Area

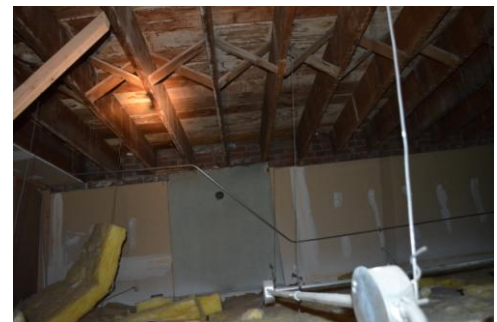
Joist Blocking
