The Stabilization of Gilboa Dam, New York, Using High Capacity Rock Anchors: Addressing Service Performance Issues

Kessi E. Zicko, Gannett Fleming, Harrisburg, PA, U.S.A.

Abstract

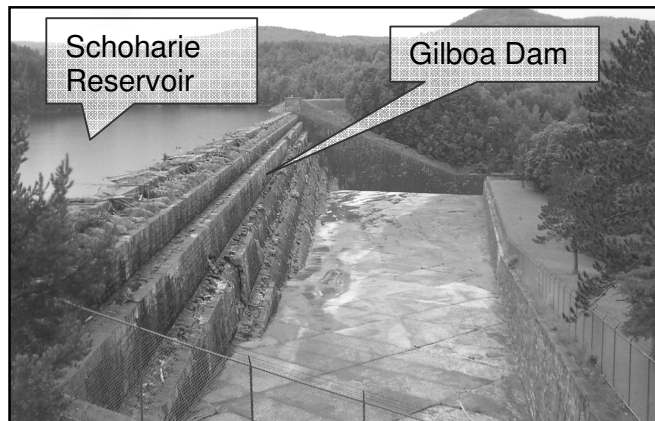
Figure 1. Gilboa Dam in summer 2003.

In early fall 2005, during the preliminary design phase for dam reconstruction, preliminary analyses showed that sliding stability of the spillway structure did not meet current New York State dam safety criteria and was marginal for the 1996 record flood (JV 19Dec 2005). Given the critical nature of the reservoir both in terms of public safety to over 8,000 residents living downstream and dependability for New York City's water supply, an interim stability improvement project was implemented for completion before the end of 2006, years prior to the major reconstruction. The design and construction phases of this interim project were completed in an unprecedented time frame of twelve months.

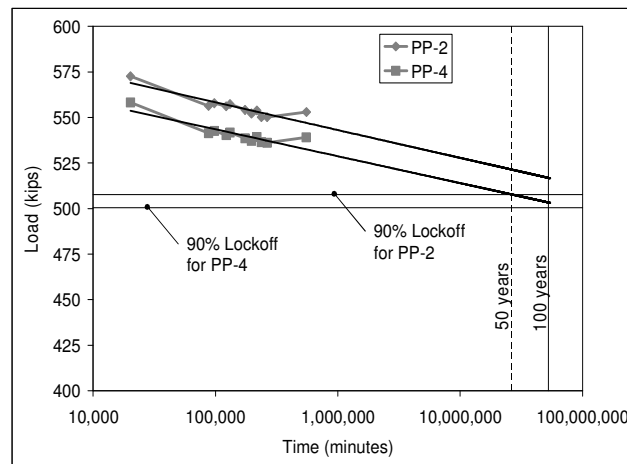
Two pre-production anchors were equipped with permanent load cells after completion of the performance and creep testing and were locked-off at 70% GUTS. Load cell readings for these “sentinel” anchors were recorded intermittently for one year, or approximately 6 months beyond completion of the anchor contract. The results are shown in Figure 5, a semi-log plot of the anchor loads over time. Assuming a 100-year service life for the dam, it is apparent that 91% to 92% of the anchor lock-off load will be available, which corresponds closely to the design loads of the anchors within the spillway.

Figure 5. Results of load-cell monitoring of “sentinel” anchors.

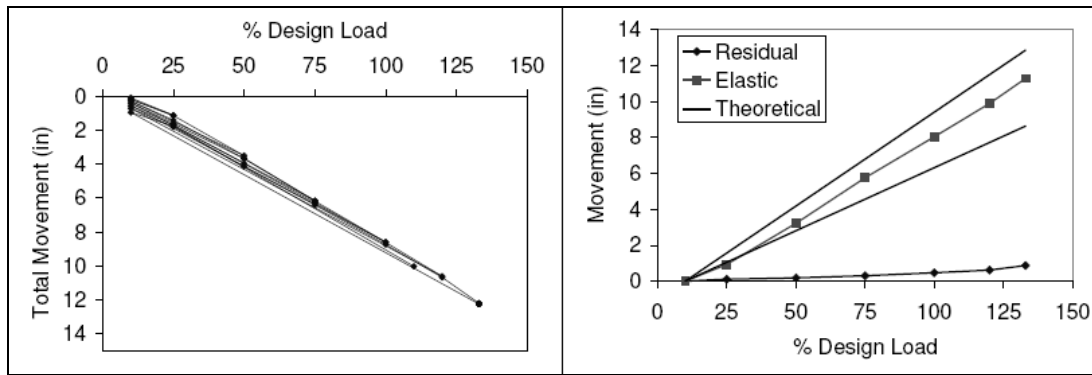
With the exception of one anchor, which is discussed below, all of the rock anchors were successfully stressed per the contract documents. Of these 78 anchors, 73 anchors performed adequately during Performance Testing and passed the 10 minute creep test, which required the strand elongation not to exceed 0.04 inches. Due to excessive elongation during the 10 minute creep test, the 5 remaining anchors were subjected to the 60 minute creep test, which they subsequently passed with strand elongation not exceeding 0.08 inches. Typical Performance Test results are shown in Figure 6 in terms of total, elastic and residual movement.

Figure 6. Movements recorded during Performance Testing of Anchor A40, a vertical 58-strand anchor.

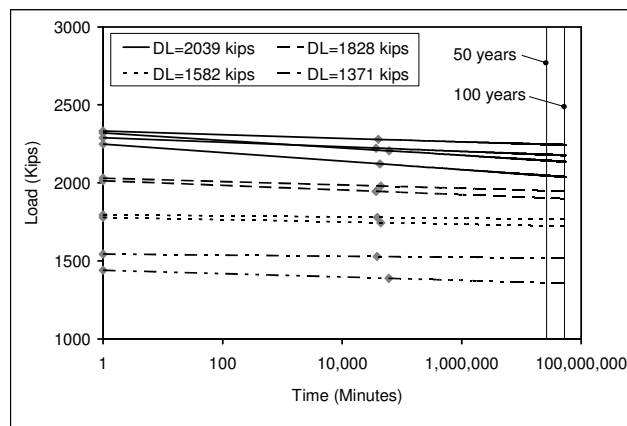
Following locked-off of each anchor, an initial lift-off test was conducted to verify that load was successfully transferred to the anchor bond zone. Each of the anchors was within the contract limits of 5% of the specified lock-off load, which was 110% Design Load. Approximately 30 days after the initial lift-off test, 6 vertical and 4 inclined anchors were subjected to an extended lift-off test. The term “extended” simply refers to the time between the initial and second lift-off tests and does not imply that load was applied and subsequently held for an extended period of time. The lift-off loads were graphed similarly to the “sentinel” anchors (Figure 7). Extrapolation of the data indicates that the anchor load available at the end of the 100-year service life will be between 99% and 112% Design Load.

Figure 7. Results of initial and extended lift-off testing of 10 production anchors.
