The Uniform Building Inspection Report™

Single Family Residence:

7619 Sunfaire Lane, Sacramento, CA. 95823

7/30/2013, 12:30:00 PM

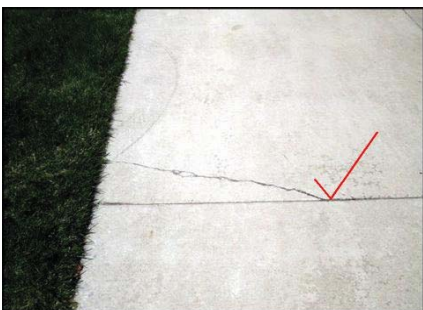
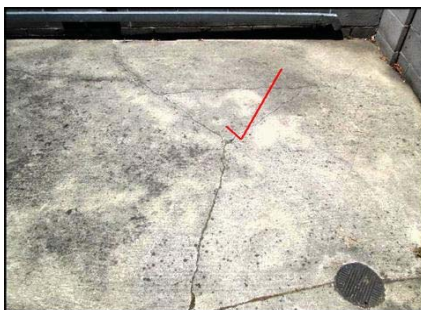
[P] 0210.01: Concrete cracks noted. Concrete cracks are typically noted on driveways, walkways, patios and garage floors. Most cracks are due to settlement or expansive soils.

RECOMMENDATION: Seal cracks that are big enough to support a toothpick with a

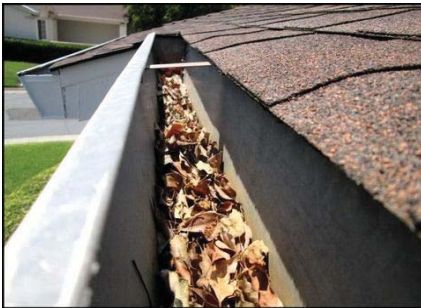
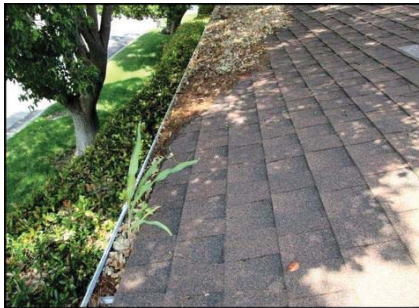
[P] 1290: Gutters need cleaning. Gutter cleaning is considered routine homeowner maintenance. RECOMMENDATION: Clean & review all gutters. See Photo(s) 1290.

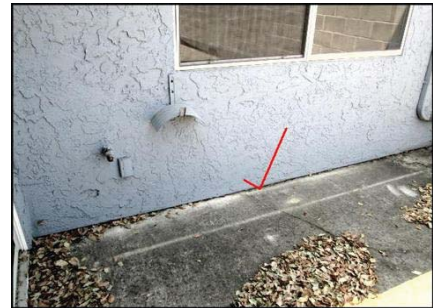
Photo: 1420 (1)

[P] [M] 1420: Stucco weep screed blocked with dirt or concrete. Noted in the rear yard. 4" of clearance is the building standard for the area under the stucco walls except for doorways where 1" is allowed. Newer stucco walls are designed to drain moisture from inside the wall through the weep screed at the bottom. The 4" recommended clearance helps to keep debris from collecting in this area preventing the wall from draining. RECOMMENDATION: Monitor this area frequently and clear any obstruction found. If a

blockage is present moisture may enter the building along adjacent base boards.

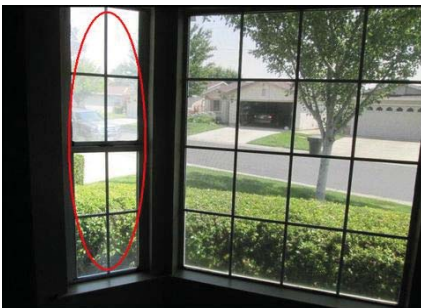
Photo: 1510.01 (1)

There are condensation stains between the glazing of the dual pane windows. This condition indicates seal failure. RECOMMENDATION: Repair or replacement is recommended.

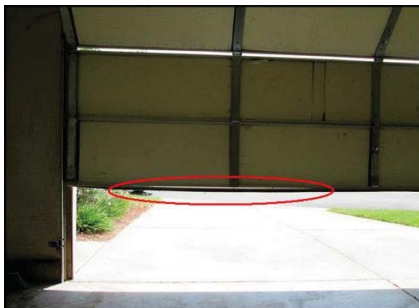
Photo: 1700.04 (1)

Weather seal is loose.

RECOMMENDATION: Secure seal as needed.

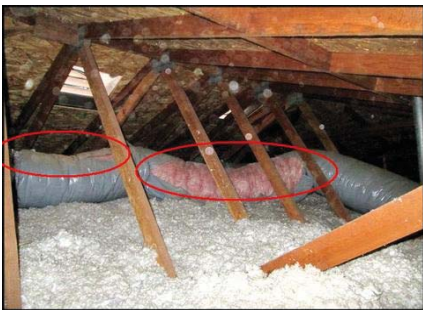
Photo: 2210.04 (1)

[D] 2210.04: Ducting vapor retarder wrap damaged.

If the ducting is used for cooling, this condition may cause condensation to form in the insulation surrounding the ducting possibly leading to moisture damage to the ceiling below.

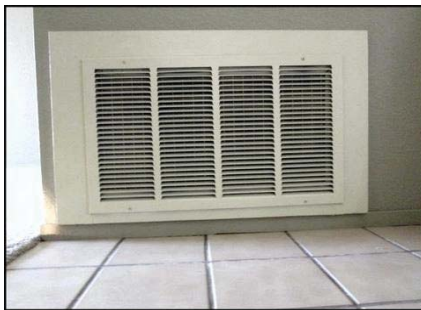
Photo: 2250.01 (1)

[E] 2250.01: Filter dirty.

RECOMMENDATIONS: Clean or replace air filters on a regular basis to maintain system

performance. Replacing filters once a year may be enough. Check filters frequently during the first year to determine best replacement intervals.

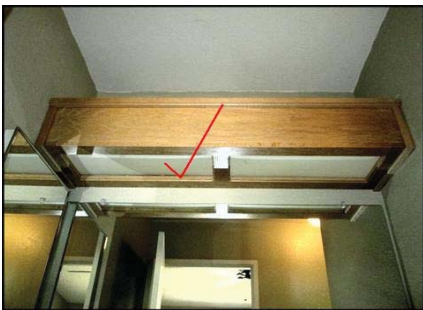
Photo: 5500 (1)

switch / bulb, tube / ballast failure / no fixture)

Noted in the hall bath. One or more lights failed to turn on. This may be due to a missing or faulty bulb. Sometimes a loose wire or faulty, switch or weak ballast is the cause.

[E] [E] 5500: Lighting inoperative. (possible

RECOMMENDATION: Replace missing or damaged bulbs. Make additional repairs if needed.

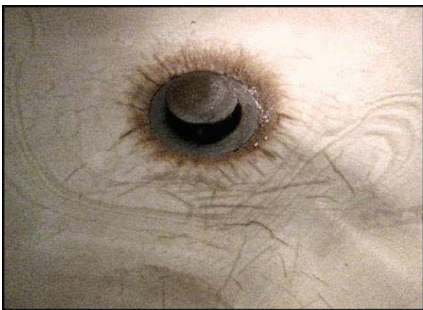
Photo: 6300.03 (1)

[A] 6300.03: Lavatory checked.
I observed stains and checking in master and hall bath vanity sinks.

RECOMMENDATION: Consider repair or replacement.
See Photo(s) 6300.03.

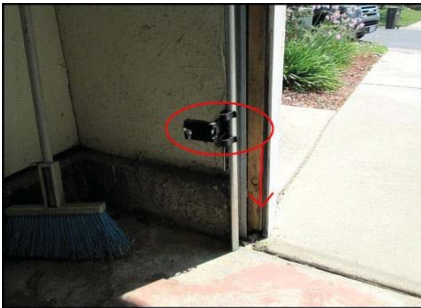
Photo: 7040.12 (1)

[E] [C] 7040.12: Electric eye sensors for vehicle door not properly installed. Standard safety installation guidelines recommend sensor height from floor not to exceed six inches. RECOMMENDATION: Adjust sensors as needed. See Photo(s) 7040.12.

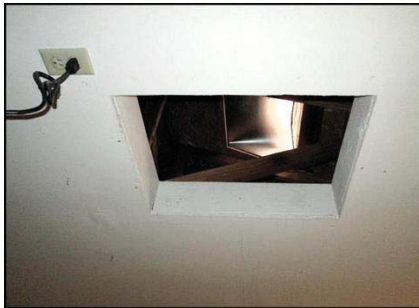
Photo: 7150.01 (1)

[C] 7150.01: Fire resistant wall or ceiling holed. Attic access cover for garage ceiling is missing. RECOMMENDATION: Provide a cover made of 1/2" sheetrock or other fire rated material to keep a garage fire from quickly spreading to the interior of the building. See Photo(s) 7150.01.

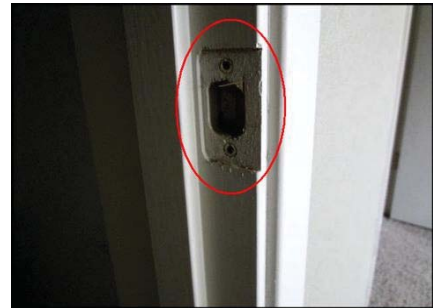
Photo: 7410.02 (1)

[E] 7410.02: Door striker or striker plate missing. Noted in the guest bedroom at door to hall bath. RECOMMENDATION: Replace missing striker plates. See Photo(s) 7410.02.

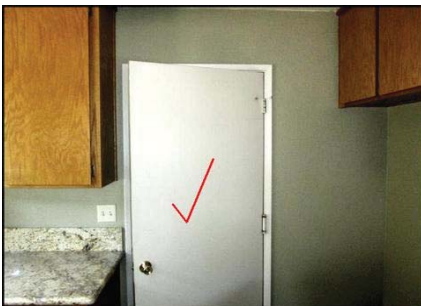
Photo: 7490.02 (1)

[C] 7490.02: Fire resistant door self-close mechanism needs adjustment. Noted on the garage to house door. RECOMMENDATION: Adjust or replace self closing hinge as needed. See Photo(s) 7490.02.

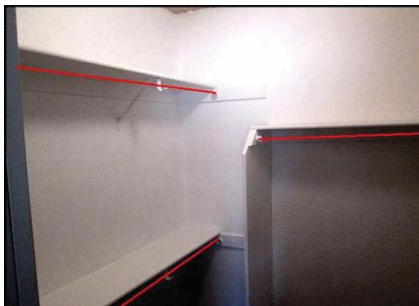
Photo: 7640.04 (1)

[E] 7640.04: Closet rod missing. Noted at several closets. RECOMMENDATION: Replace missing rods where needed. See Photo(s) 7640.04.

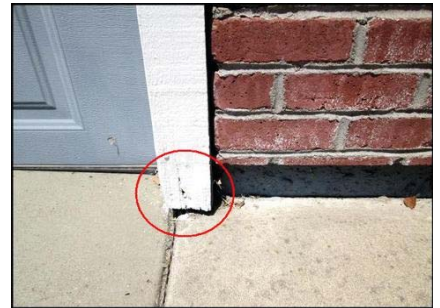
Photo: 9840 (1)

[A] 9840: Wood deterioration noted on building member. Some wood deterioration was noted at the bottoms of door frames. **RECOMMENDATION:** Refer to your structural pest inspection report (if obtained) for all

locations and repair costs before purchasing the property.
See Photo(s) 9840.
