Kansas Department of Health and Environment

**Third Five-Year Review
Report**

**Landfill Subsite of the
Obee Road Superfund Site
Hutchinson, Reno County
Kansas**

September 2010

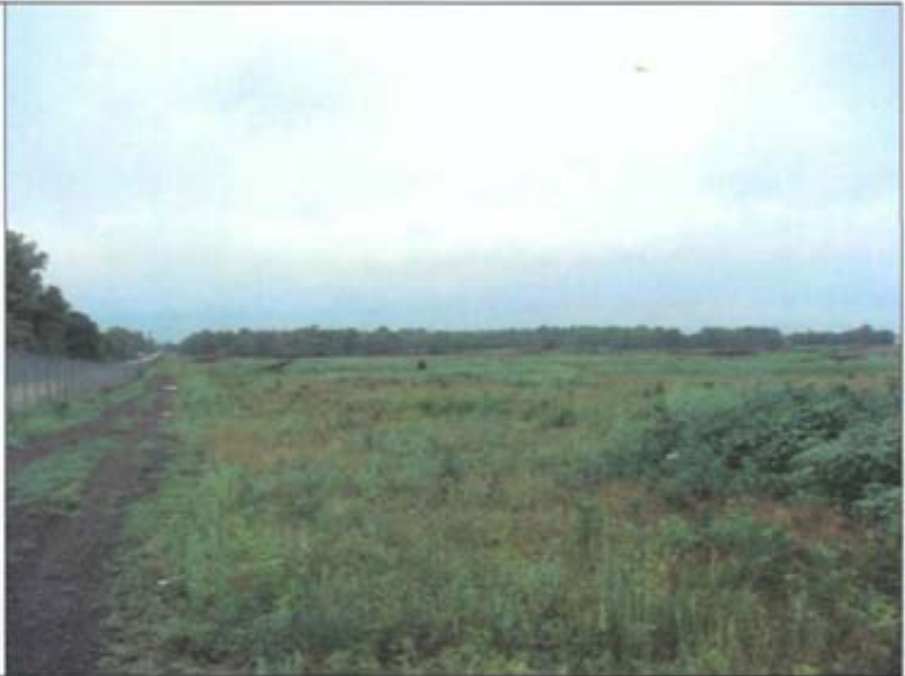
Subject: Northeast side of the Obee Road Landfill looking to the south.

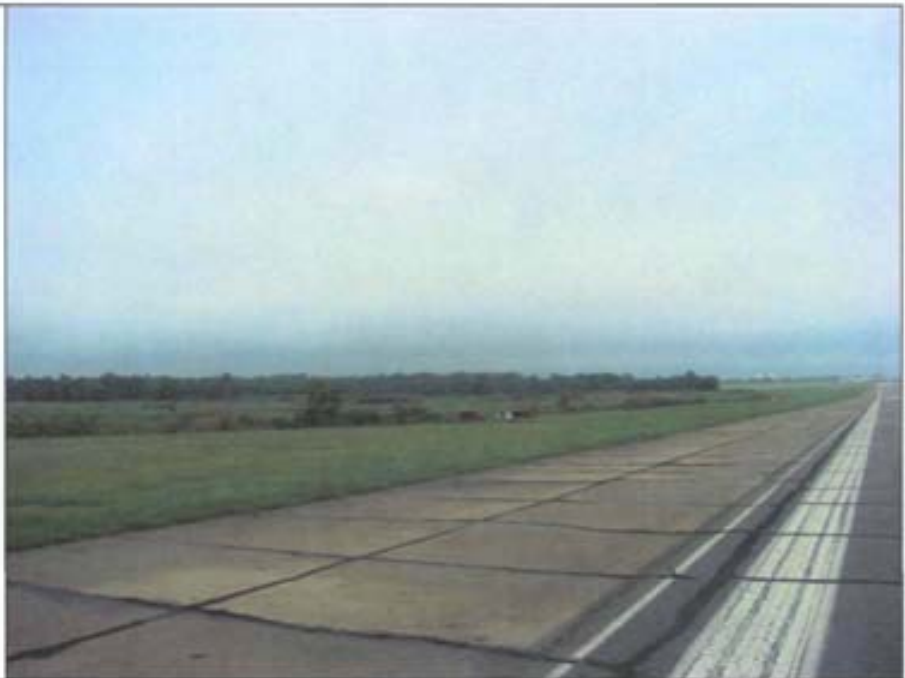
Subject: View of the north part of the landfill from the airport runway.

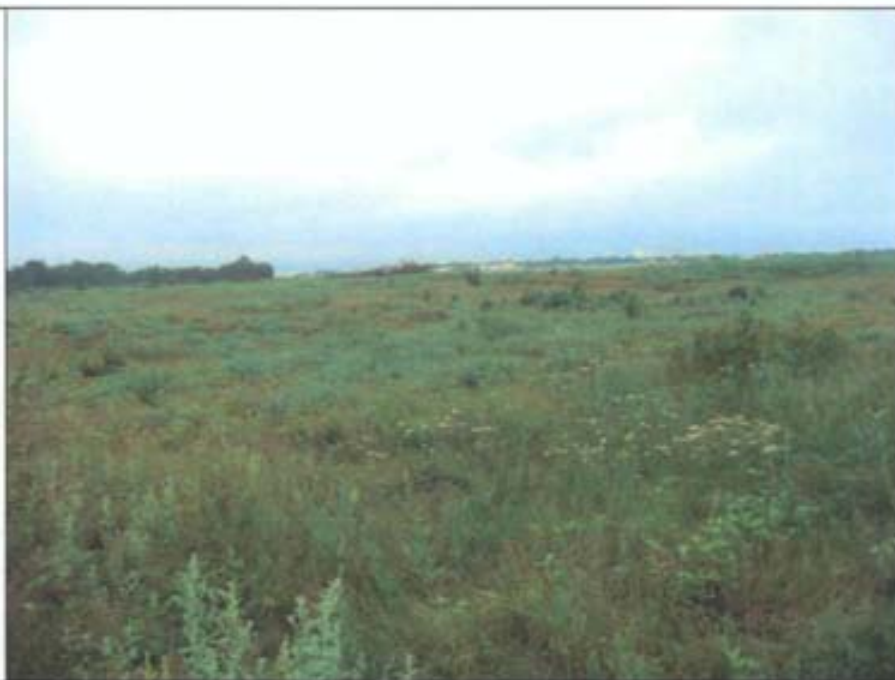
Subject: View of the north part of the landfill.

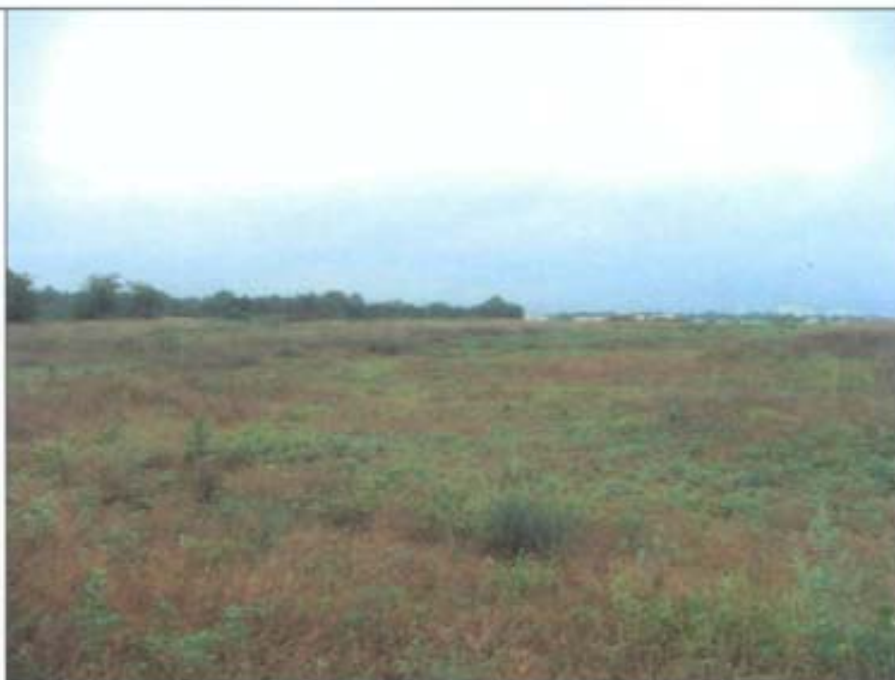
Subject: View of the north part of the landfill.

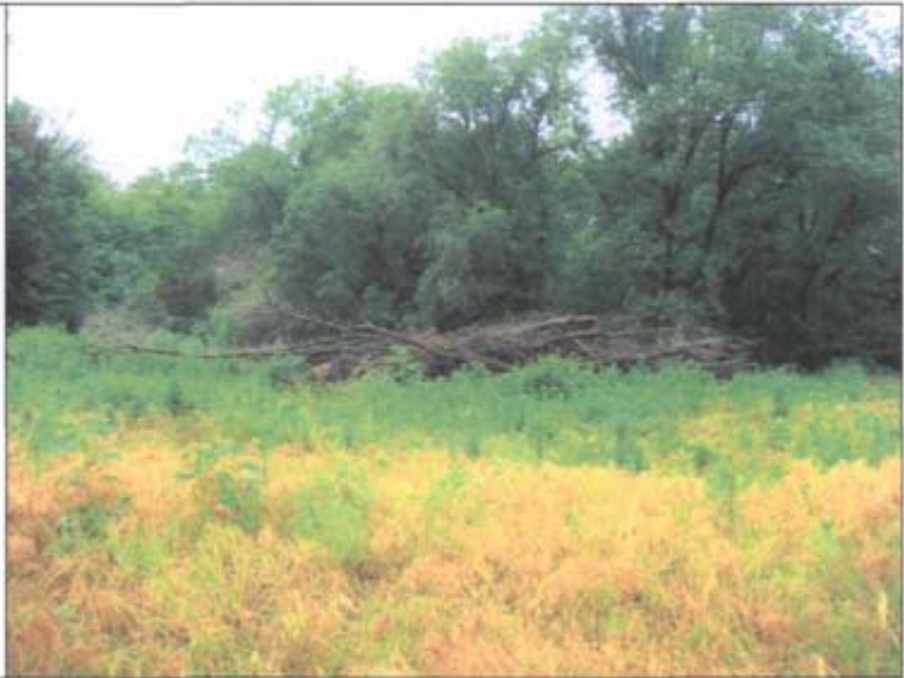
Subject: East central part of the landfill showing heavy vegetation. Pile of tree limbs is leftover from tree removal activities.

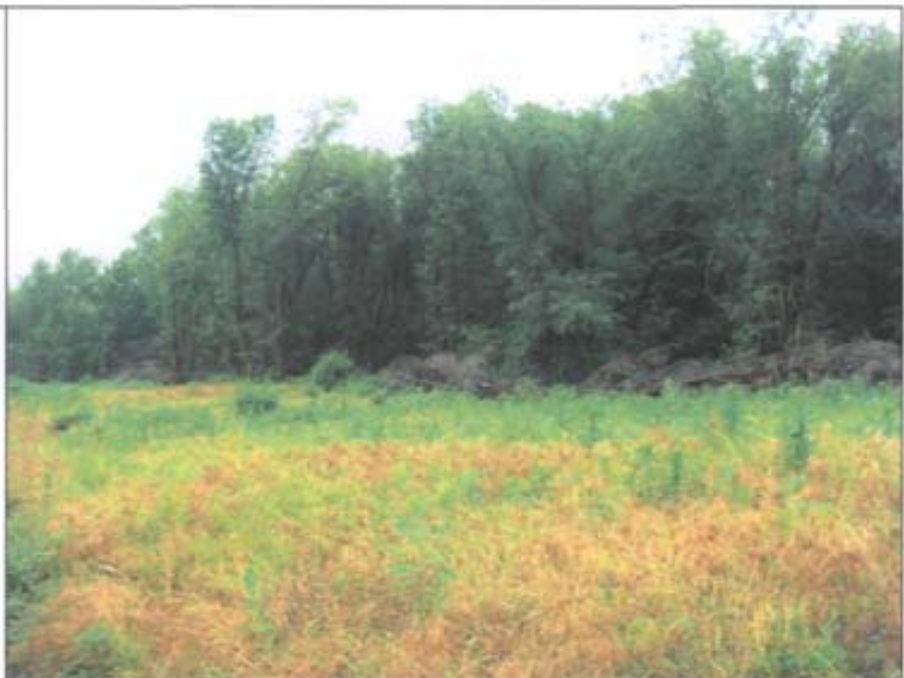
Subject: View of the east side of the site. Shows heavy vegetation in central part of the site. Pile of tree limbs is leftover from tree removal activities.

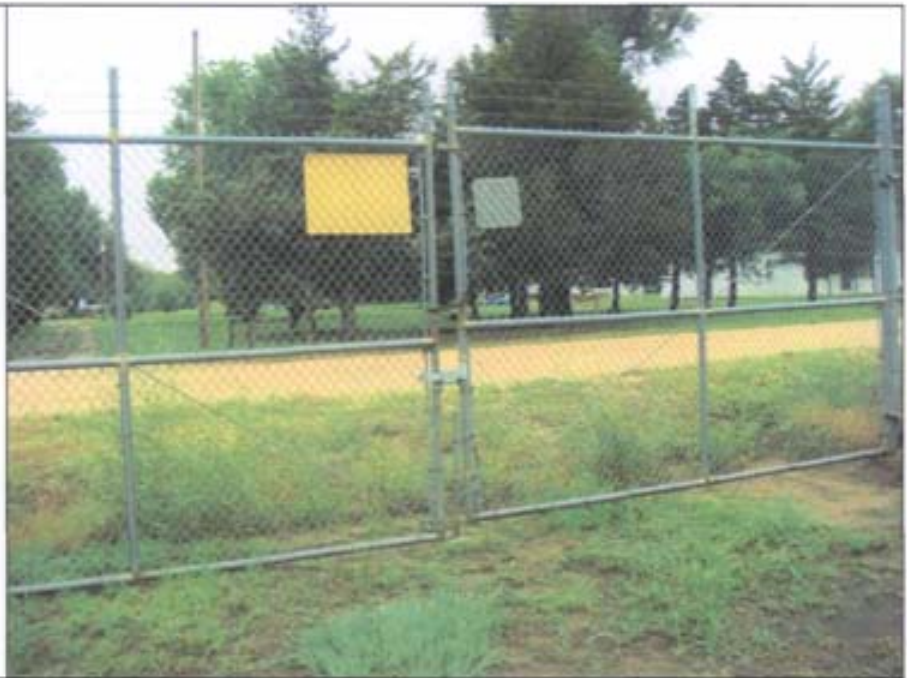
Subject: View of locked access gate on the east side of the site.

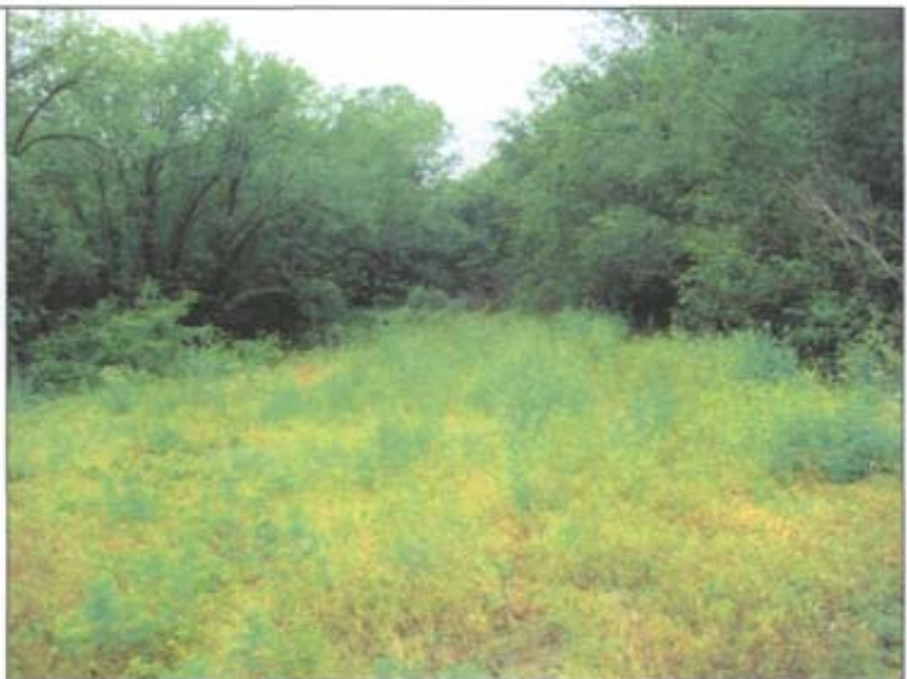
Subject: View of the site opposite of the locked access gate.

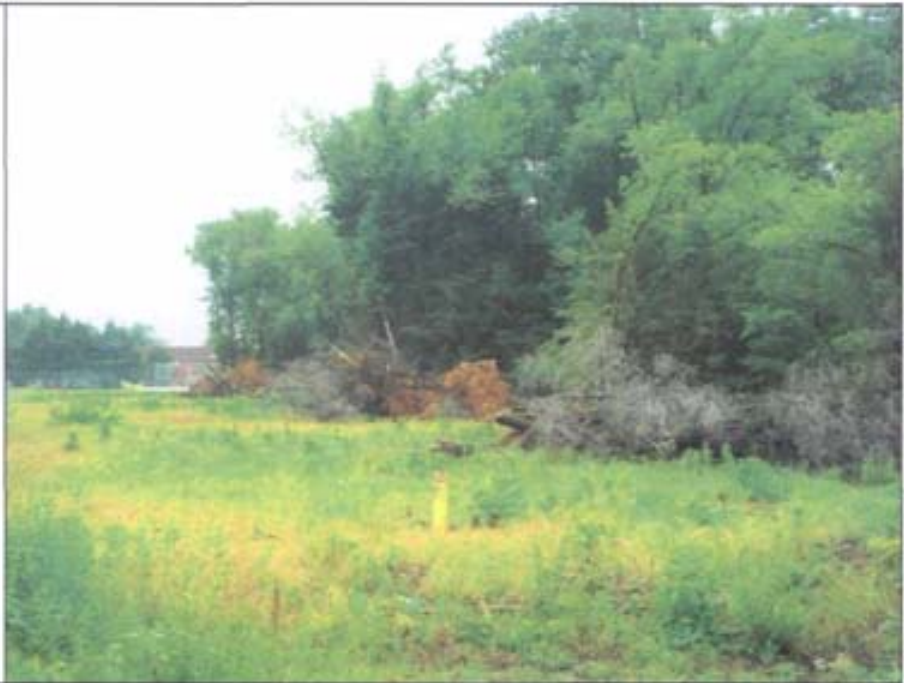
Subject: View of the southeast part of the site. The Obee School property is in the background. Monitoring well MW-10D is in the foreground. Heavy vegetation is present in this part of the site. Piles of tree limbs is leftover from tree removal activities.

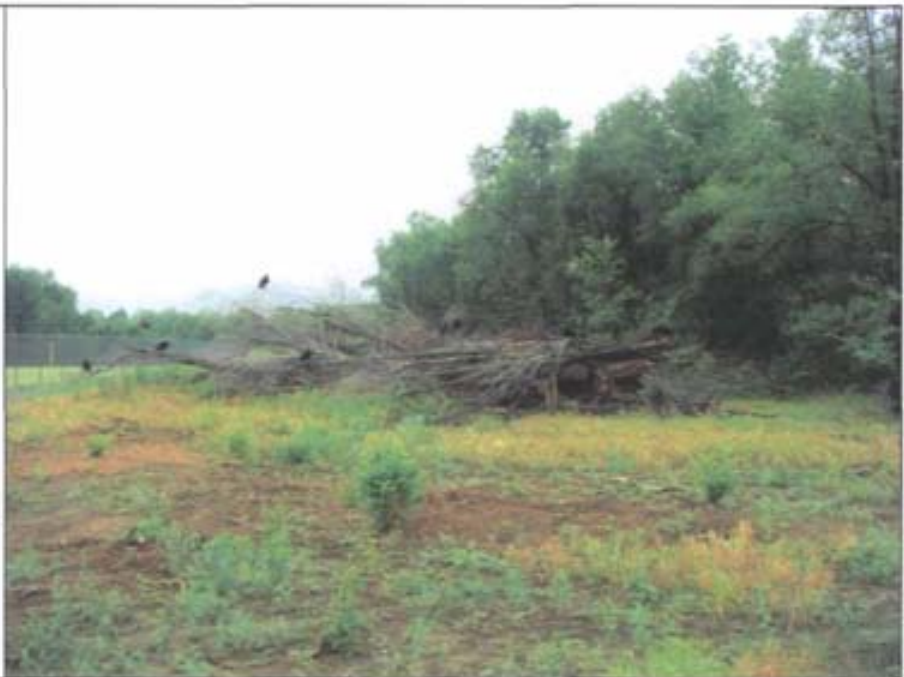
Subject: Southeast corner of the site. Security fence is located to the south. Several turkeys are perched on a pile of tree limbs. The Federal Aviation Administration has been encouraging the City of Hutchinson to remove trees from the site to reduce habitat for wildlife that could interfere with airport operations.

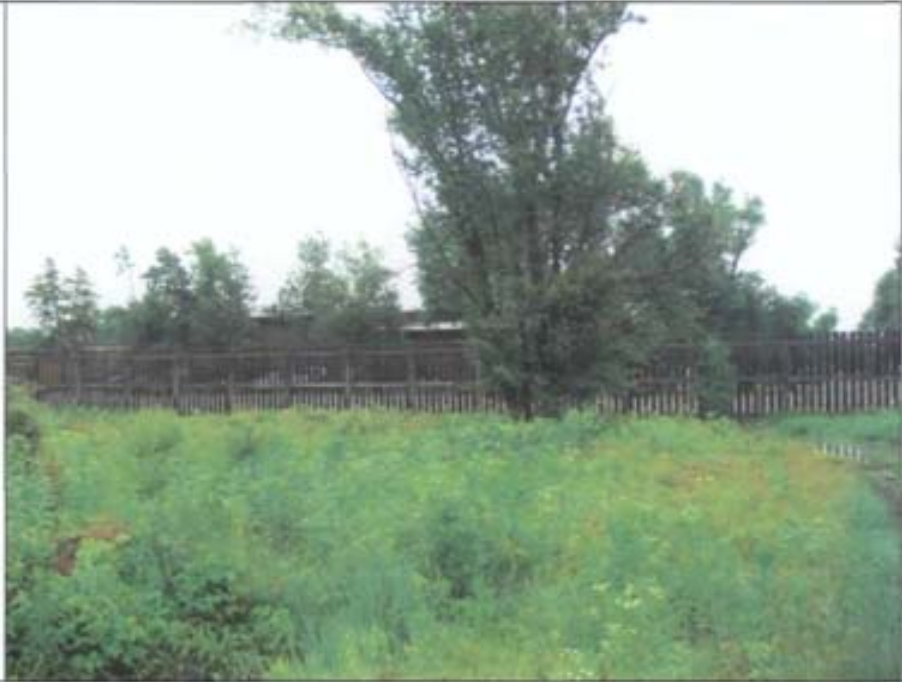
Subject: View of fence along the south side of the site with the Obee School on the other side.

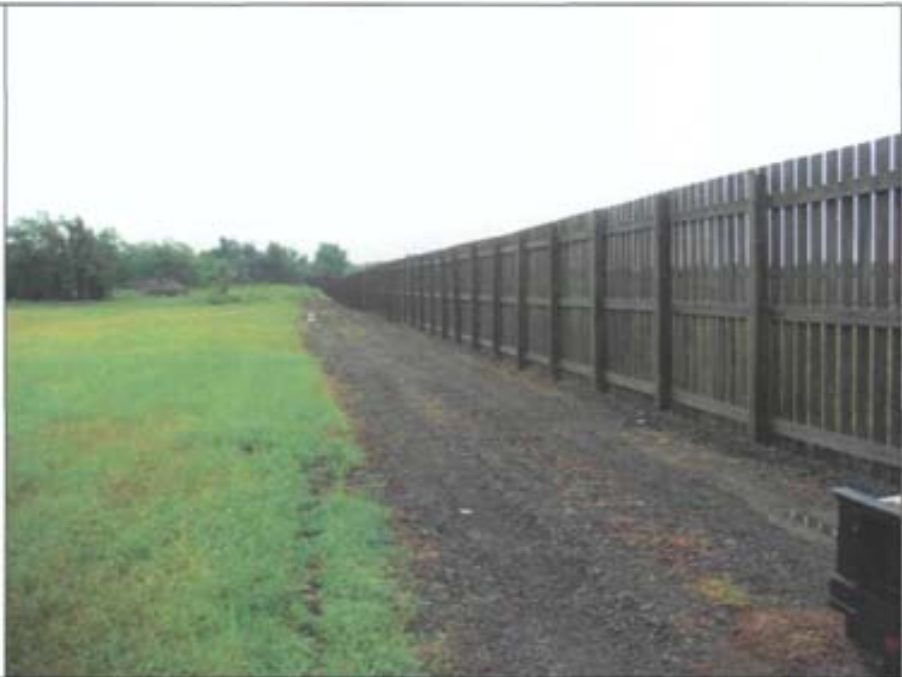
Subject: View of fence along the south side of the site.

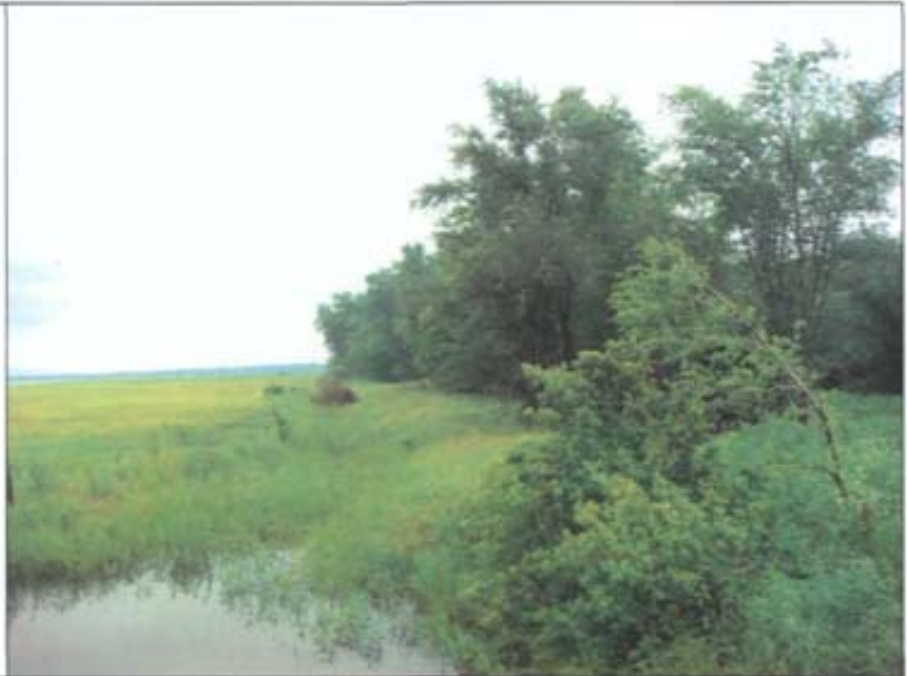
Subject: Southwest corner of the site looking to north along the west edge of the Landfill Subsite. Ponded water in a ditch from a recent rain in the foreground.

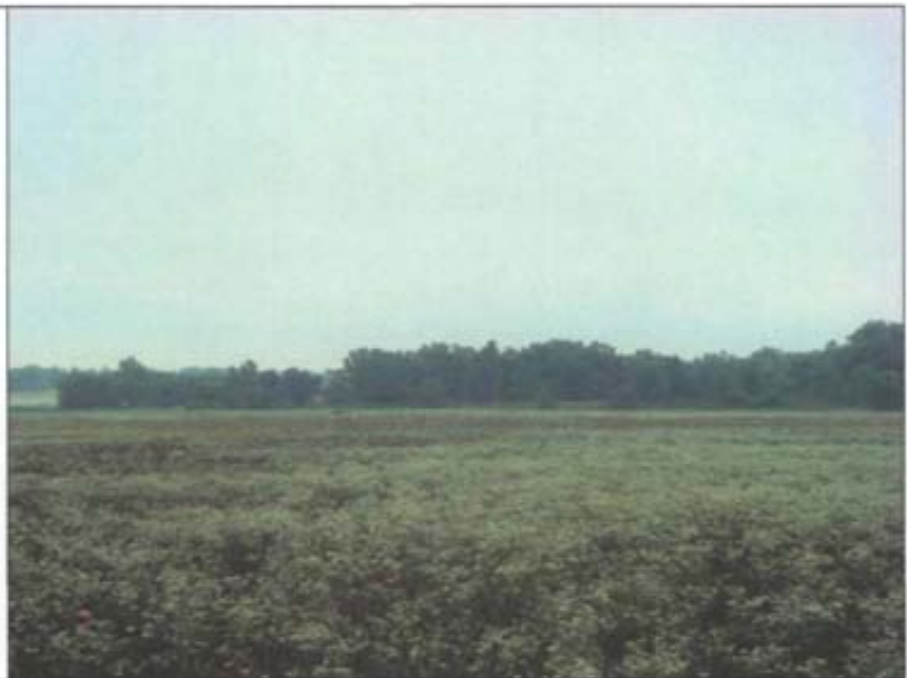
Subject: Central part of the site. Picture taken from the west side of the airport looking to the east.

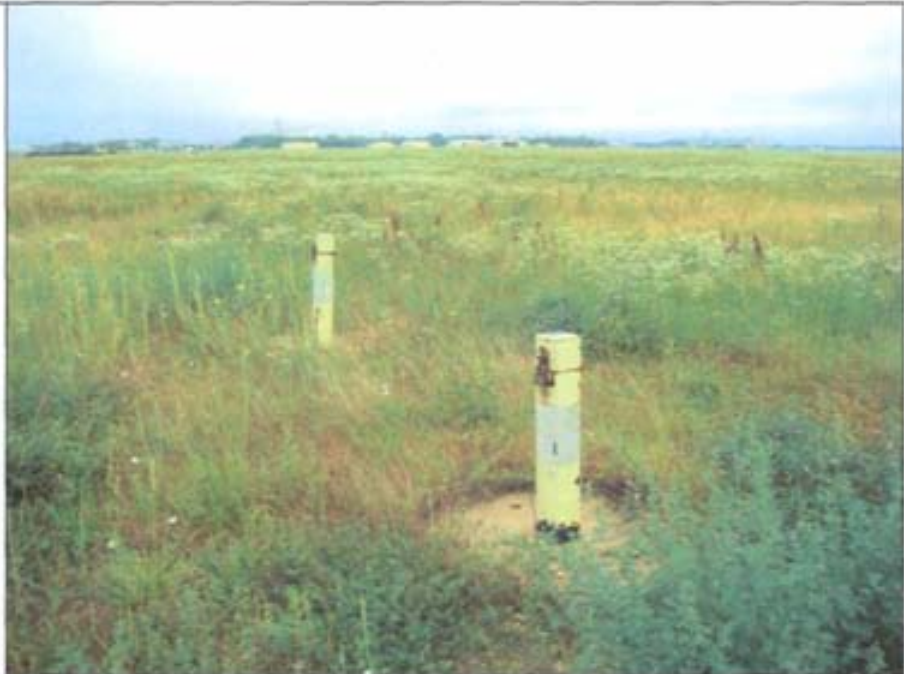
Subject: Monitoring wells
MW-14S and MW-14D.

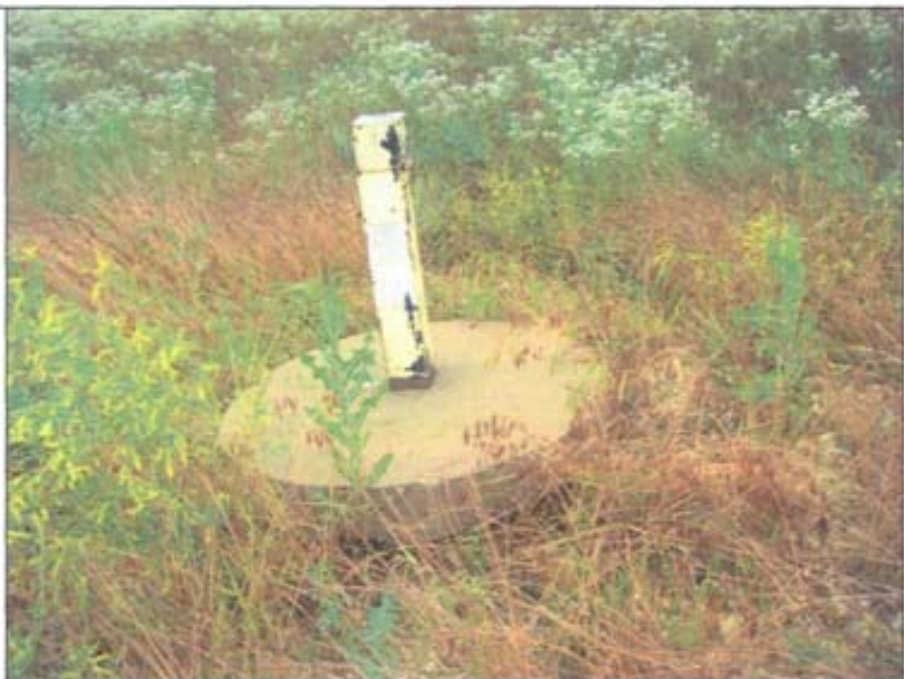
Subject: Monitoring well
MW-15S. Soil around the
concrete base has eroded
away.

Recommendations for the Landfill Subsite include: 1) conducting one monitoring well sampling event once before the next five year review; 2) plugging monitoring wells MW-1 and MW-15S; 3) continuation of annual inspections of the fence around the site; and 4) annual review and evaluation of the effectiveness of deed restrictions.

Analytical results for monitoring well samples collected in April 2010 indicate VOCs are not present at detectable concentrations and are not migrating off site. KDHE may request that the City of Hutchinson conduct a groundwater sampling event prior to the next five year review. Inspections of the fence and evaluation of the effectiveness of deed restrictions should continue to be conducted on an annual basis. Inspection of monitoring wells indicated problems with two of the wells, MW-1 and MW-15S. Due to their location relative to the landfill and their poor condition, these two wells should be plugged and abandoned. Recommendations for the Site are summarized on Table 6.

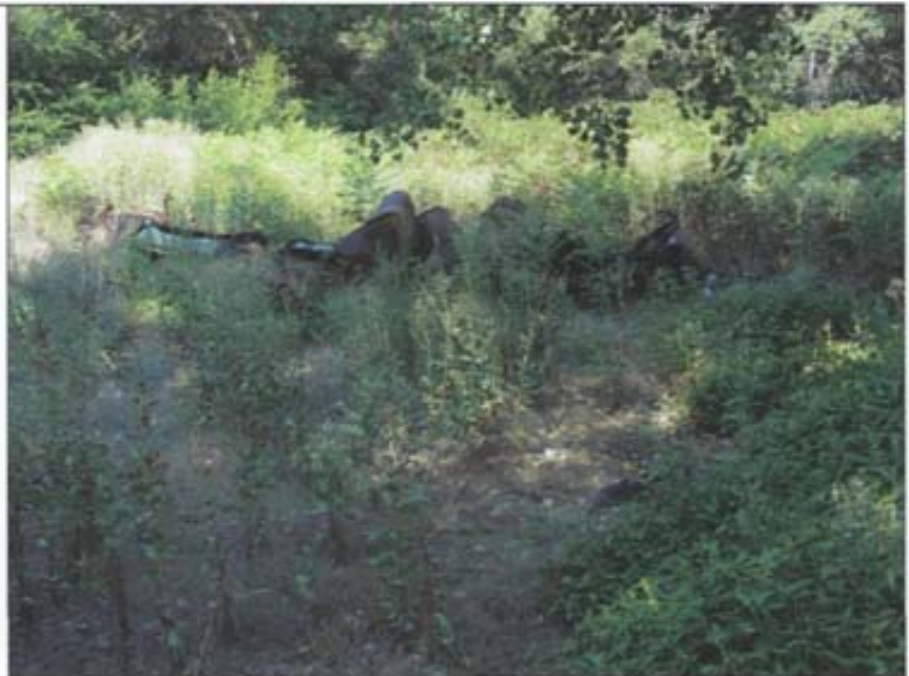
Subject: View of pieces of metal debris sitting on the surface of the landfill.

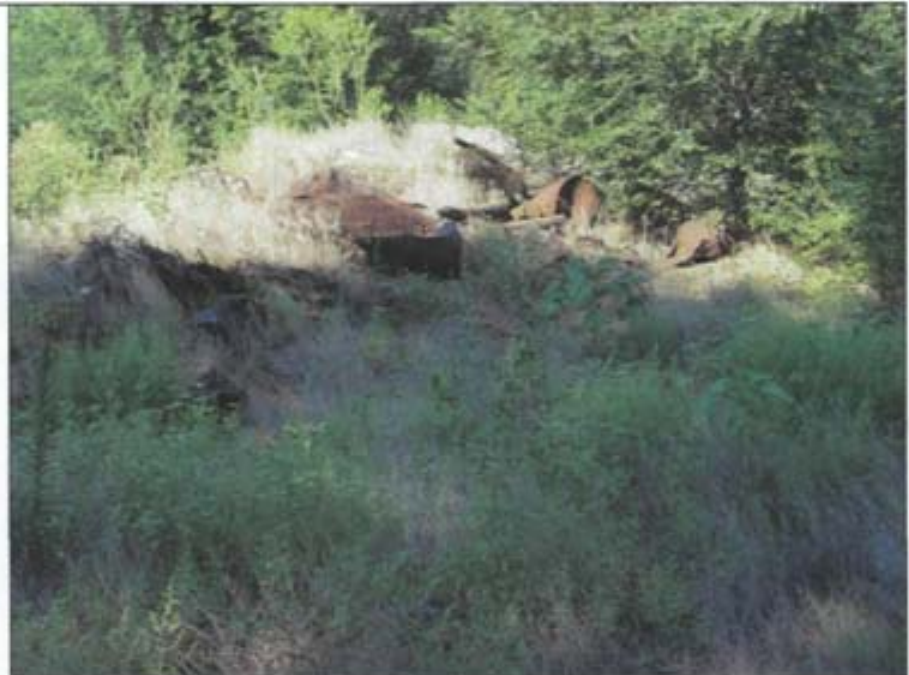
Subject: Metal debris sitting on the surface of the landfill.

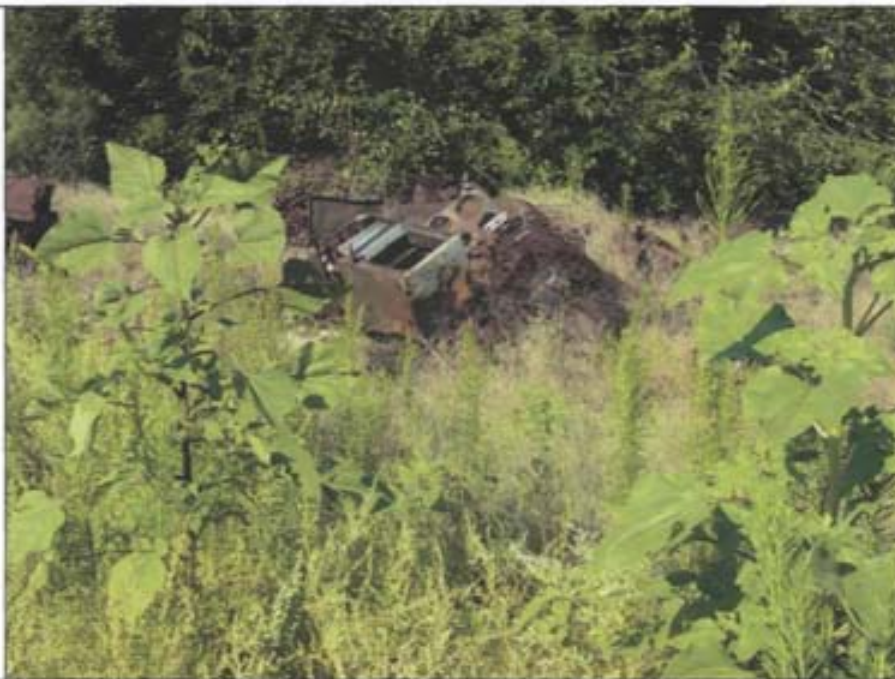
Subject: View of pieces of metal debris sitting on the surface of the landfill.

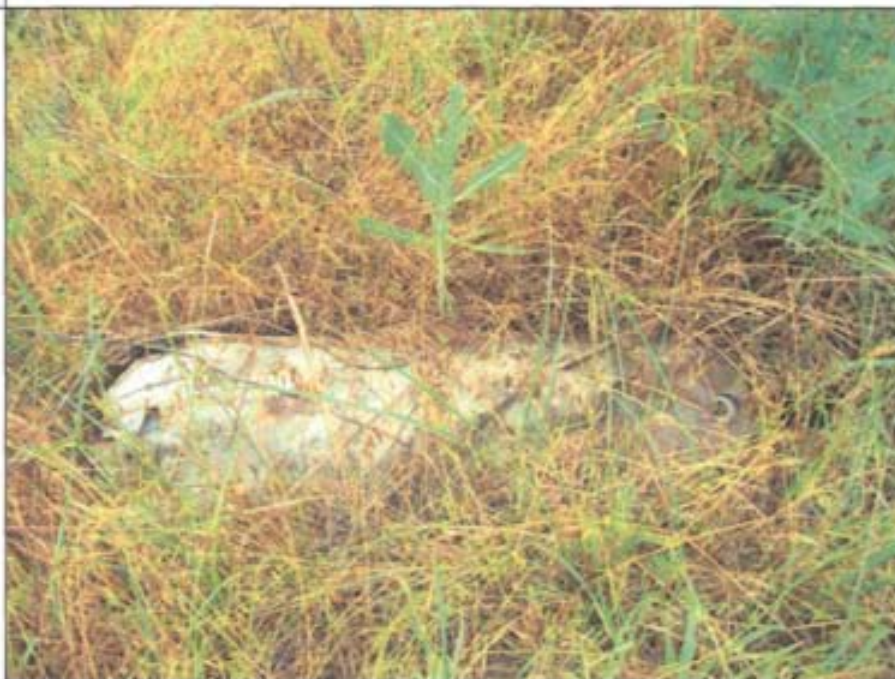
Subject: Metal debris at the surface of the landfill.
