Throttle lift-off clunking noises at drive shafts of front axle

Topic number	LI33.30-P-056665
Version	4
Function group	33.30 Final drive, differential, drive shaft
Date	08-05-2019
Validity	Models: All Mercedes-Benz cars with front-wheel drive and 4x4 vehicles
Reason for change	Validity for new model series updated.
Reason for block

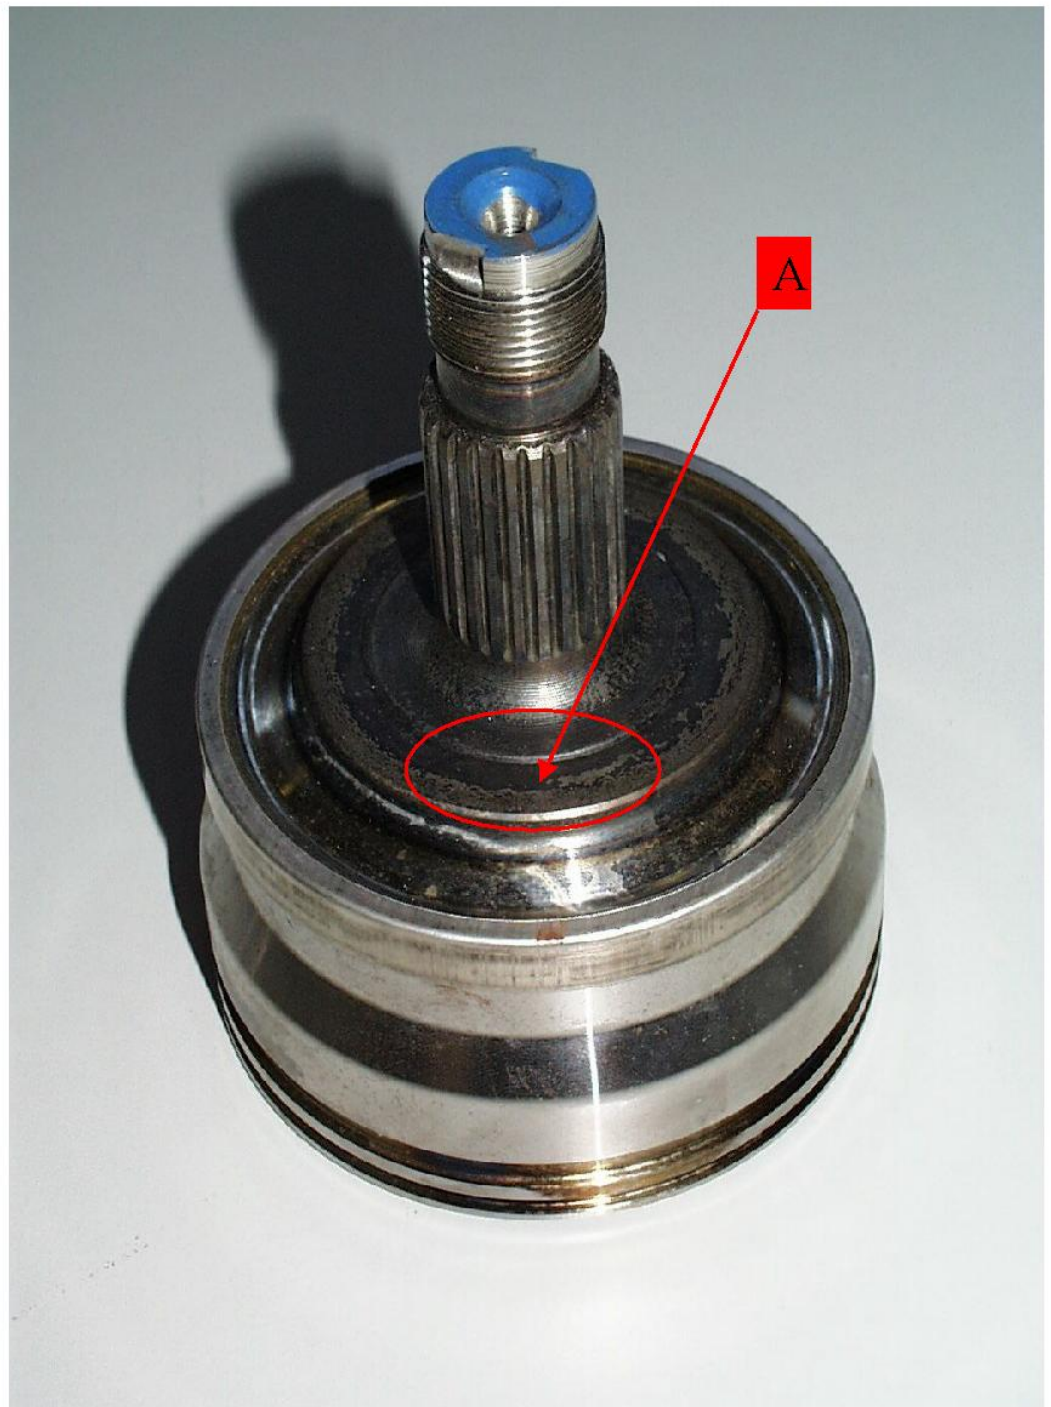
Gelenkgehäuse aussen
vor.jpg:

If the complaint is eliminated by experimentally loosening the outboard collar nut (by 1 turn), the concern may be due to micromovement in the connection between the wheel bearing inner race and the joint housing of the side shaft.

1. Remove outboard side shafts (extract outer joint gearing from wheel hub)
2. Clean contact surface A (see image file in attachment "Outer joint housing before") before coating with Molykote paint (free of dust and grease)
3. Coat contact surface A (see image file in attachment "Outer joint housing after") with Molykote and leave to dry for one hour in removed condition
4. Reinstall side shafts
