## TIMKEN - HUB UPDATE

There has been an increase of warranty returns on Timken 513138 due to:

# PRODUCT BULLETIN

## Drivetrain - ABS Lamp ON/DTC's Set/Grinding Noise

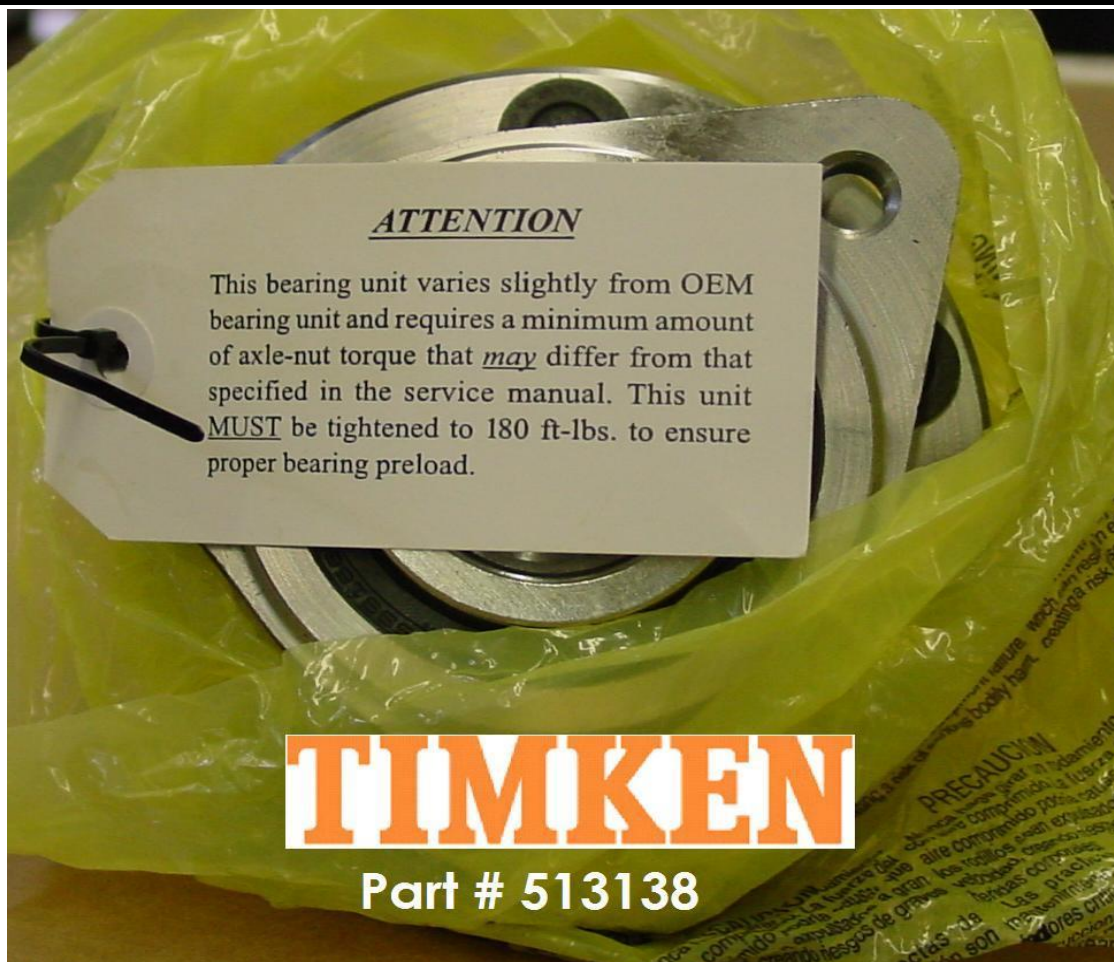
**ISSUE 1: Improper Torque:** The majority of units show signs of the improper torque used to set the bearing preload. Per the tag attached to the Timken units, they **REQUIRE 180 ft. lbs of torque** to properly set unit preload. Note Below: This hub fits many applications with OEM torque specs from 105-185 ft. lbs.

**ISSUE 2: Improper Seating Of Axle To Hub:** Sand off the rust and corrosion around the axle seating area with a fine- to medium-grade sandpaper. Take your time when doing this and make sure it's as clean as possible. Make sure the bearing assembly sits snug against axle or clamp pressure will not hold.

**AXLE NUT MUST BE REPLACED TO MAINTAIN CONSISTANT CLAMP PRESSURE**

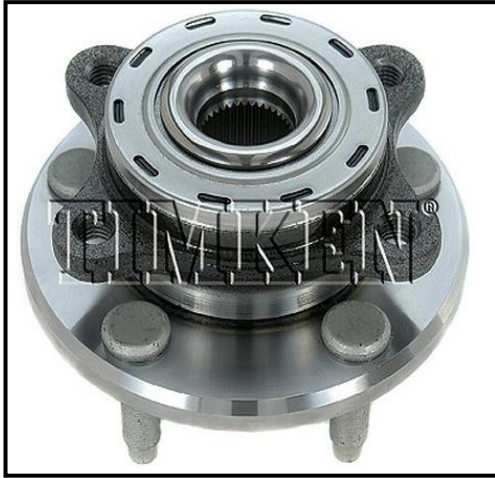
**OEM Original With Cover**

Ford reviewed the warranty info on this unit and made a decision to remove this inboard cover plate. The units without the cover plate were tested and there were no issues with performance observed. The original units with cover plate had some noise due to contamination between the cover plate and seal. Ford has approval to removal the cover plate.

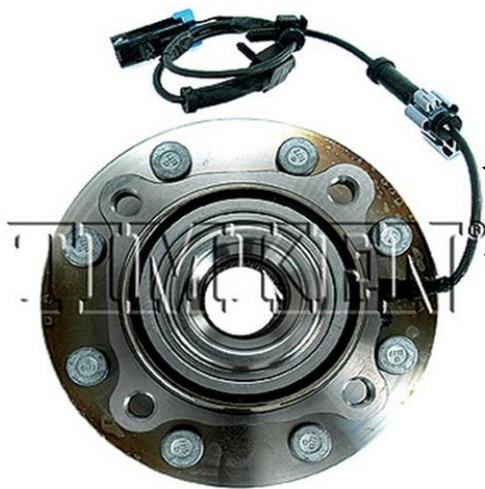
**SMALLER DIAMETER ABS SENSOR WIRE**

**NO ADDITIONAL COVERING COMING OFF THE SENSOR**
