SUBJECT: SPECIAL SERVICE CAMPAIGN (SSC) – 10F
(2000 - 2001 MY ECHO AND AVALON TETHER ANCHOR UPGRADE)

Toyota will initiate a Special Service Campaign (SSC) to upgrade the child restraint tether anchors on certain 2000 - 2001 MY Echo and Avalon vehicles.

SPECIAL SERVICE CAMPAIGN 10F

PART A (2000 - 2001 ECHO)

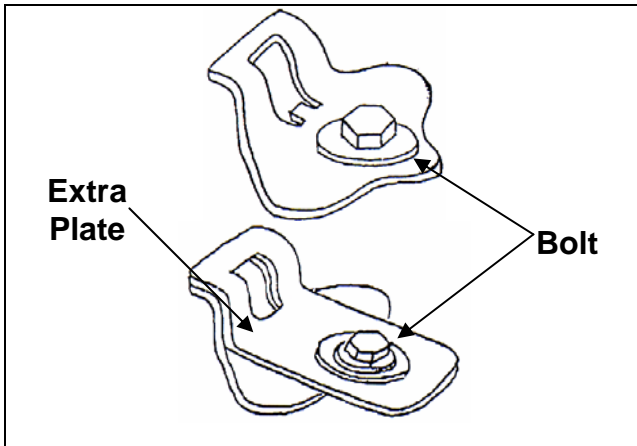
1. **INSPECT THE UPPER TETHER ANCHORAGES FOR EXISTING COUNTERMEASURES**
 - (a) After confirming VIN eligibility through TDN/TIS and checking for an SSC completion label, check the upper tether anchors for the countermeasures shown in the picture.
 - (b) If either of the countermeasures exist, the vehicle does not require this campaign. Return the vehicle to the customer.

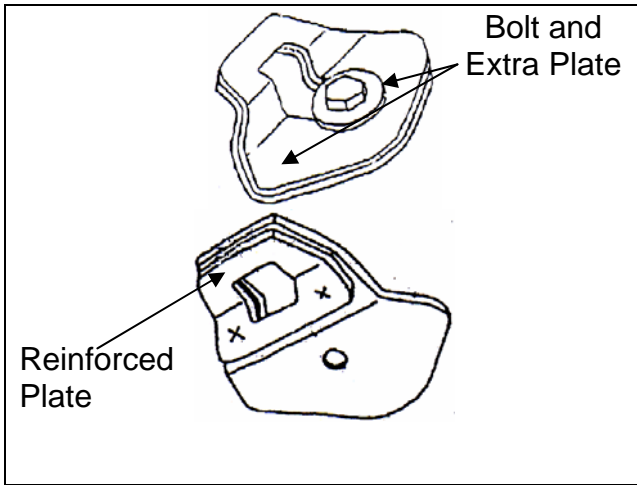
1. INSPECT THE UPPER TETHER ANCHORAGES FOR EXISTING COUNTERMEASURES

- (a) After confirming VIN eligibility through TDN/TIS and checking for an SSC completion label, check the upper tether anchors for either of the countermeasures shown in the picture.
- (b) If the countermeasures exist, the vehicle does not require this campaign. Return the vehicle to the customer.
