SUBJECT: **Special Service Campaign (Recall) 80C – Phase 1**
 Certain 2004 - 2006 Model Year Sienna Vehicles Equipped w/Power Back Door (Power Rear Liftgate)

SPECIAL SERVICE CAMPAIGN (SAFETY RECALL) 80C

2004 THROUGH 2006 MODEL YEAR SIENNA
EQUIPPED WITH POWER REAR LIFTGATE STRUTS
(POWER BACK DOOR STAYS)

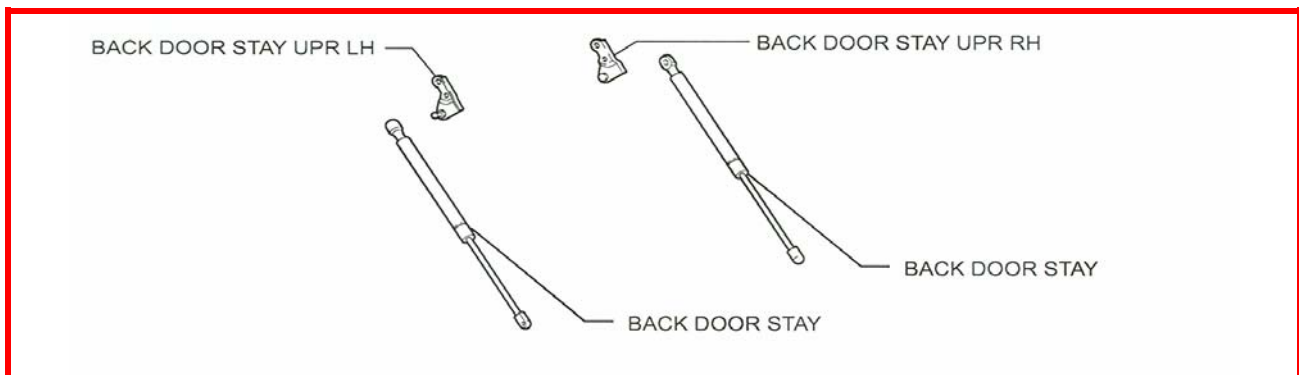
REAR LIFTGATE BRACKETS AND REAR LIFTGATE STRUTS

Toyota has determined that the gas struts used to help lift and support the Power Rear Liftgate in some Sienna vehicles are wearing out sooner than expected. As the gas struts deteriorate, the performance of the Power Rear Liftgate will begin to degrade, and the Power Rear Liftgate will operate more slowly than when the gas struts were new. If this condition is not repaired, the gas struts may not be able to support the weight of the liftgate when it is open. Eventually, the gas struts could deteriorate to the point that the liftgate will fall about ten inches after it reaches the fully open position, at which point the power motor will engage and power the liftgate to the fully closed position. This condition may cause injury to a person who is struck by the liftgate when it falls or when it is closing. Therefore, Toyota will conduct an SSC for the Power Rear Liftgate Struts.

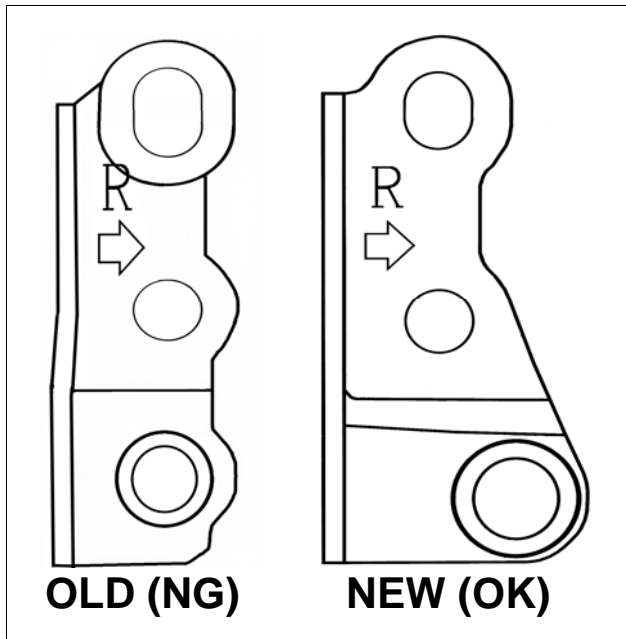
1. VERIFY THE SHAPE OF THE REAR LIFTGATE MOUNTING BRACKETS

- Inspect the shape of both the Rear Liftgate Mounting Brackets (Vehicle side).
- If the new bracket type (wider shape) is found on both sides proceed to step 2.
- If the old bracket type (narrower shape) is found on either side, replace both struts and brackets using kit number 04008-011AE as outlined in TIS/Repair Manual.

NOTE: Failure to replace the old style brackets will cause premature wear to the new liftgate struts.

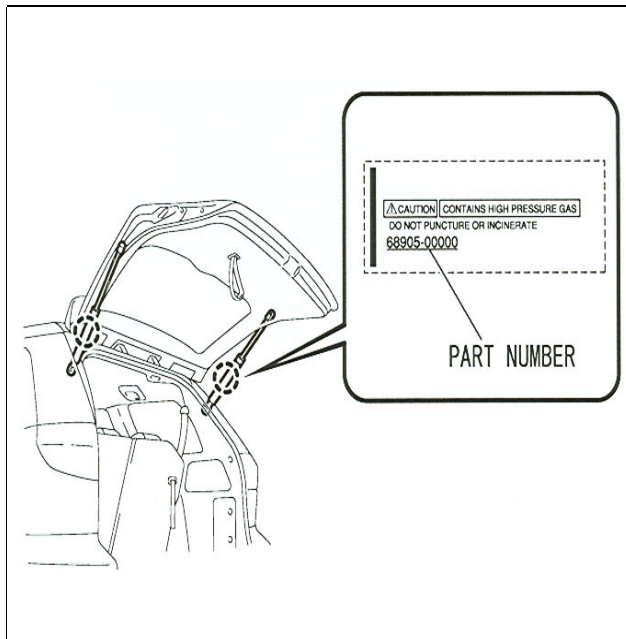
2. VERIFY THE PART NUMBER OF THE REAR LIFTGATE STRUT

- Inspect the rear liftgate strut part number on both left and right hand sides.
- If the current part number is found on both struts and both brackets are verified as being new, no further action is required, vehicle is OK.
- If old part number (as seen in the chart below) is found on either strut, replace both struts and brackets using kit number 04008-011AE as outlined in TIS/Repair Manual.

NOTE: If the part number cannot be verified due to damage, replace the back door stay.

PART NAME	OLD PART NUMBER (NG)	CURRENT PART NUMBER (OK)
BACK DOOR STAY (REAR LIFTGATE STRUT)	68905-08020	68905-AE012 or 68905-AE013 (Included in Kit P/N 04008-011AE)
	68905-AE010	
	68905-AE011
