Subject: MAZDA DEALER NOTICE - SERVICE BULLETIN RELEASE

01-001/14 - 2014-2015 MAZDA6 - MASTER WARNING LIGHT IS ON AND INSTRUMENT CLUSTER WARNING MESSAGE IS DISPLAYED (DTC P1794 AND P2502)

| Subject: MASTER WARNING LIGHT IS ON AND INSTRUMENT CLUSTER WARNING MESSAGE IS DISPLAYED (DTC P1794 AND P2502) | Bulletin No: 01-001/14 |

2014-2015 Mazda6

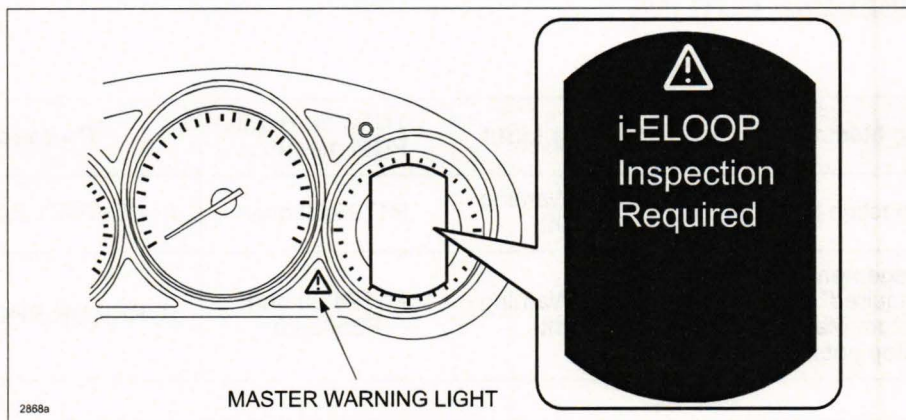
- a. Warning message "i-ELOOP Inspection Required" is displayed in the instrument cluster information display while driving.
- b. The Master warning light will be illuminated.

- c. DTC P1794:00 (Capacitor (i-ELOOP) system: Capacitor (i-ELOOP) malfunction) will be stored in PCM memory.

Customers having this concern should have their vehicle repaired using A. REPAIR PROCEDURE.

1. Verify DTC P1794:00 is stored in PCM memory.
2. Select M-MDS initial screen > "Datalogger" > "Module" > "PCM" > PID "CAP_SYS_16" and read the value.
3. Does the "CAP_SYS_16" show ON?
 - Yes - Proceed to step 4.
 - No - This service bulletin does not apply. Refer to MS3 online or Workshop Manual (section 01-02 DTC P1794:00 [SKYACTIV-G 2.5]).
4. Reboot the IDS to clear memory before reprogramming.
5. Using IDS 87.04 or later software, reprogram the PCM to the latest calibration following the "Module Reprogramming" procedure.

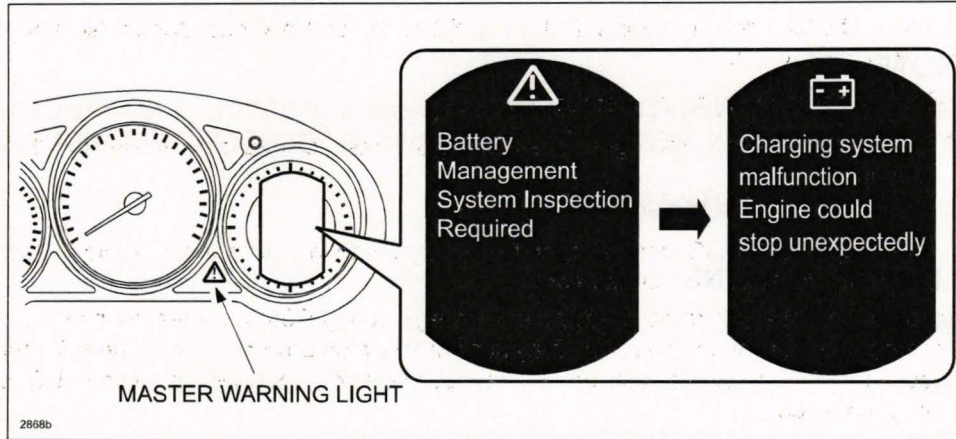
- a. Warning message "Battery Management System Inspection Required" and then "Charging System Malfunction/Engine could stop unexpectedly" is displayed in the instrument cluster information display after driving in the rain.
- b. The Master warning light will be illuminated.

- c. The following DTCs are stored in PCM memory:
 - DTC P1794:00 - Capacitor (i-ELOOP) system: Capacitor (i-ELOOP) malfunction
 - DTC P2502:00 - Generator system: Malfunction in voltage generated by generator

Customers having this concern should have their vehicle repaired using B. REPAIR PROCEDURE.

1. Verify DTC P1794:00 and P2502:00 are stored in PCM memory.
2. Select M-MDS initial screen > "Datalogger" > "Module" > "PCM" > PID "CAP_SYS_13" and read the value.
3. Does the "CAP_SYS_13" show ON?
 - Yes - Proceed to step 4.
 - No - This service bulletin does not apply. Refer to MS3 online or Workshop Manual (section 01-02 DTC P1794:00 [SKYACTIV-G 2.5]) and (section 01-02 DTC P2502:00 [SKYACTIV-G 2.5]).
4. Reboot the IDS to clear memory before reprogramming.
5. Using IDS 87.06 or later software, reprogram the PCM to the latest calibration following the "Module Reprogramming" procedure.

6. Perform battery inspection. Refer to TSB 01-016/13. Charge or replace the battery if necessary.
 7. After performing the PCM reprogramming procedure, verify the repair by starting the engine and making sure there are no MIL illumination or abnormal warning lights present.
