# STORMWATER BEST MANAGEMENT PRACTICES GREATER BALTIMORE SURVEY 2016

Prepared By Richard Klein  
Community & Environmental Defense Services  
410-654-3021 [Rklein@ceds.org](mailto:Rklein@ceds.org) [ceds.org/gbs](http://ceds.org/gbs)  
July 22, 2016

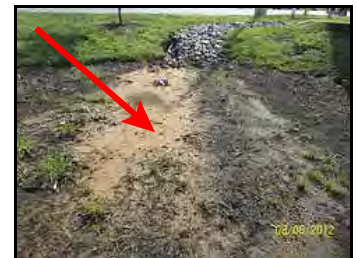
Sediment deposit in BMP

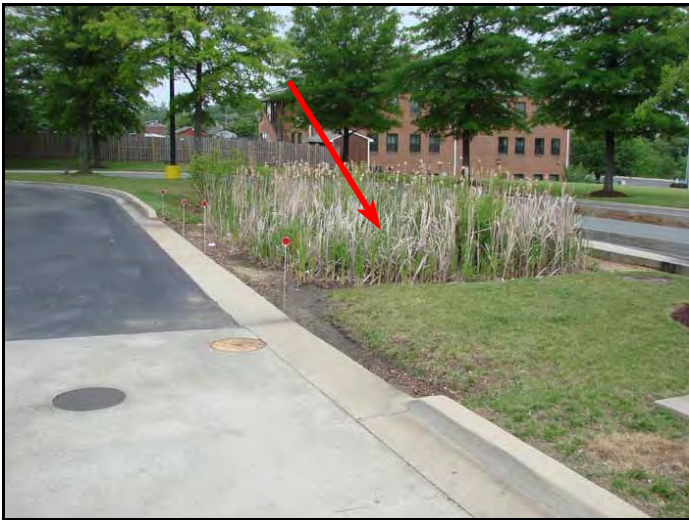
Cattails have taken over this bioretention BMP indicating the surface has been clogged for a long time.

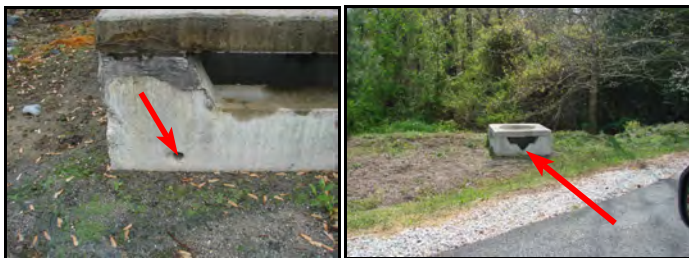
Hole drilled through inlet wall

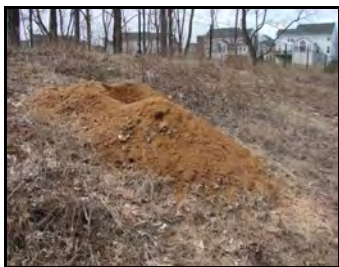
Groundhog burrow

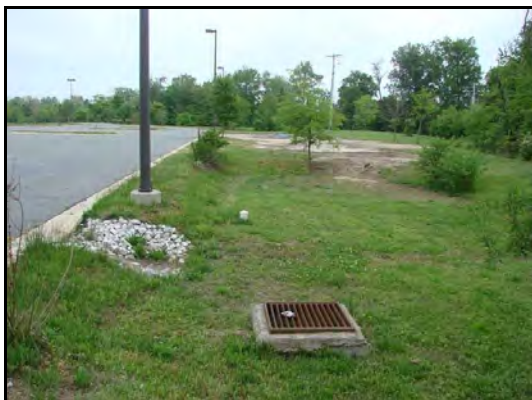
Exposed soil, like that above this bioretention BMP, can quickly kill an infiltration trench

2. If soil is exposed to erosive forces within the area draining to an infiltration trench, then the soil should be mulched-seeded as quickly as possible and runoff diverted away from the trench in the meantime.

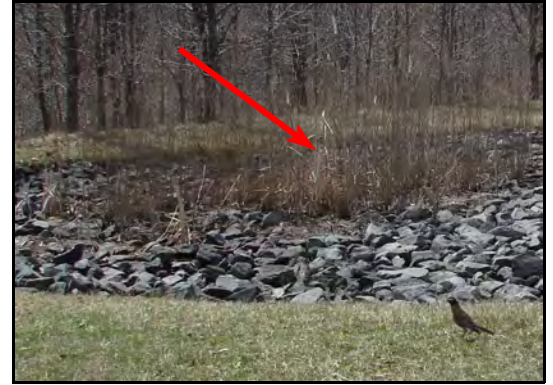
Winter view of cattails in trench indicating runoff no longer infiltrates completely within 48 hours

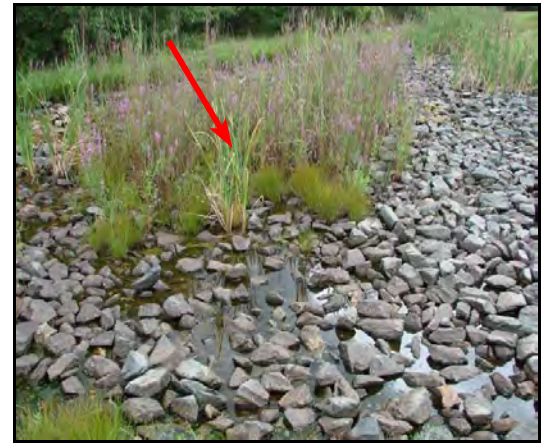
Summer view of cattails growing from trench

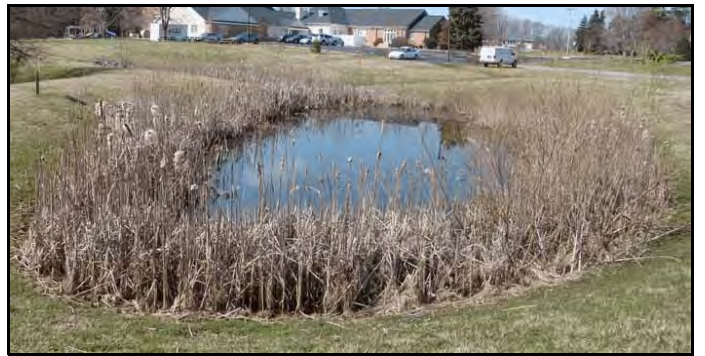
Wet Pond Partially Full With Sediment-Cattails

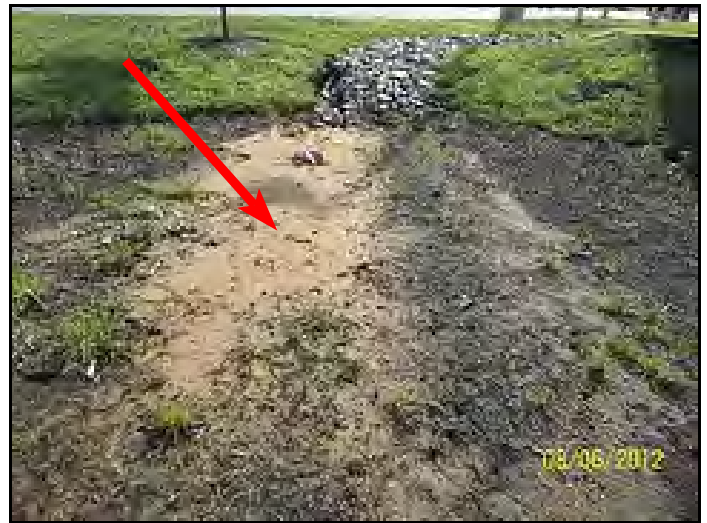
Sediment discharged into bioretention facility from Stormwater Maintenance LLC

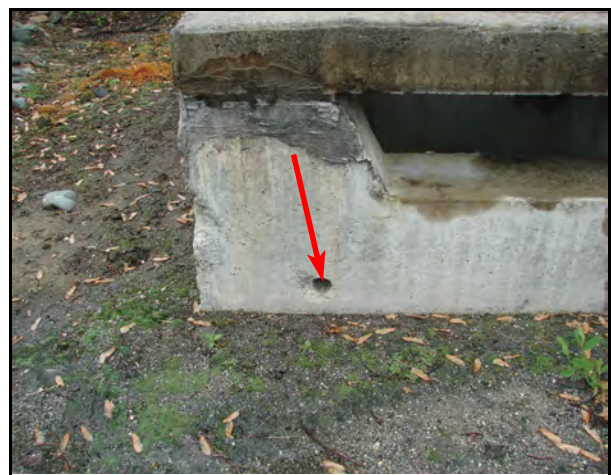
**Hole drilled through inlet wall**

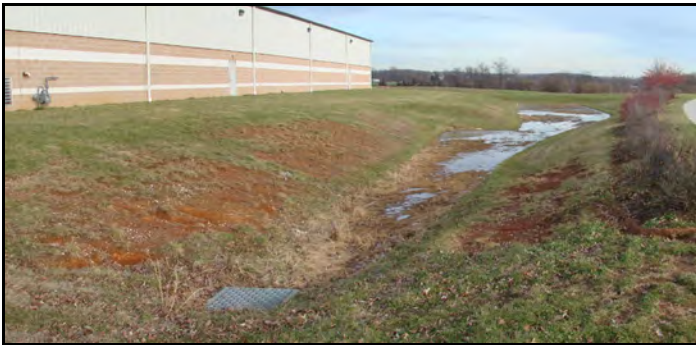
**Infiltration basin is failing if water remains on the floor or in trench when 48 hours has passed since runoff ceased entering basin.**

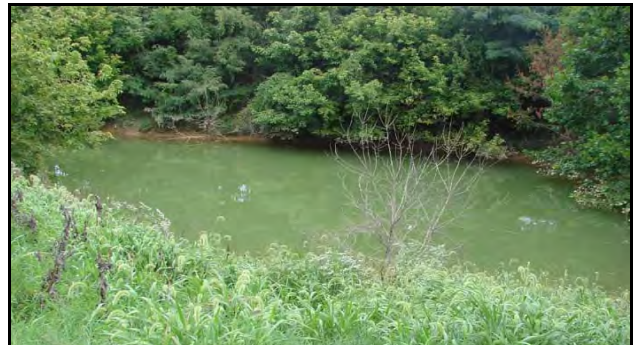
**This infiltration basin holds a permanent pool of water**

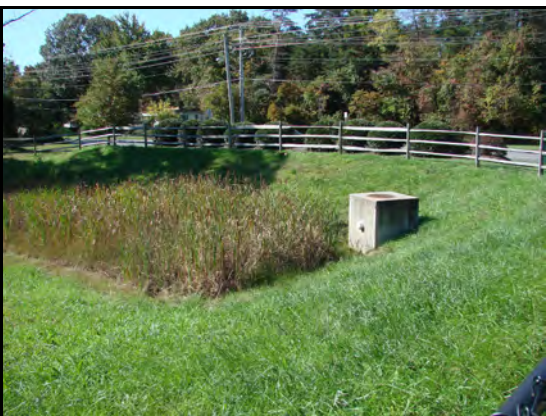
**Infiltration Basin full of cattails**

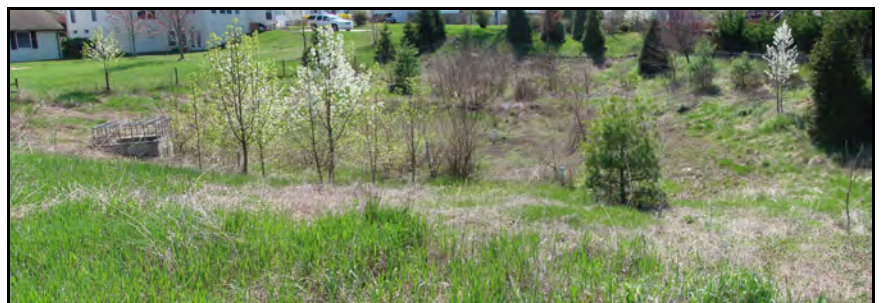
**Infiltration Basin overgrown with vegetation**

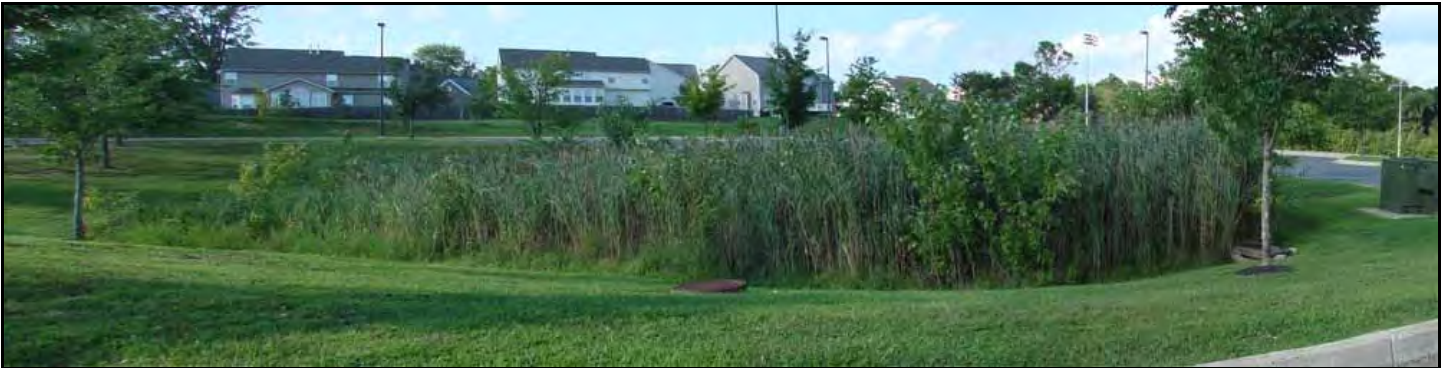
**Sand filter overgrown with Phragmites, a wetland plant indicating clogging and that runoff no longer drains completely in 72 hours**

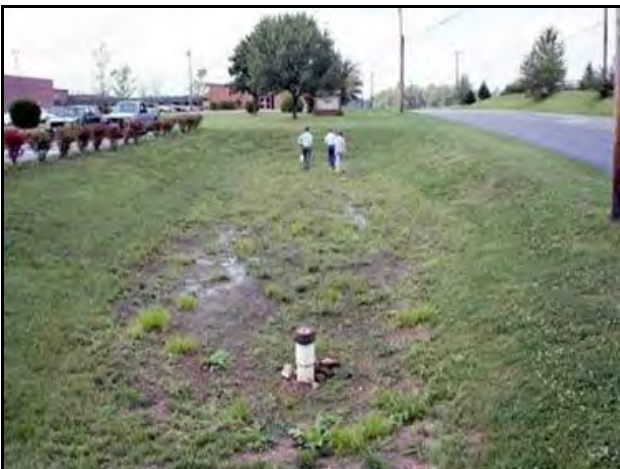
**Holding water more than 72 hours after runoff ceases indicates clogging and failure**

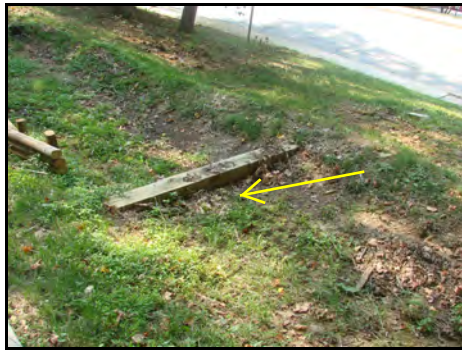
**Sediment accumulated behind check dam must be periodically removed**

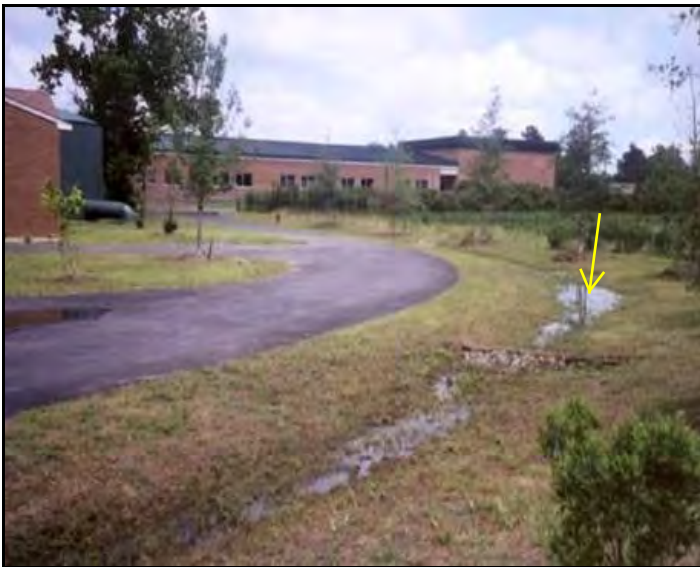
**Swale is failing if water does not drain completely within 48 hours after runoff ceases**

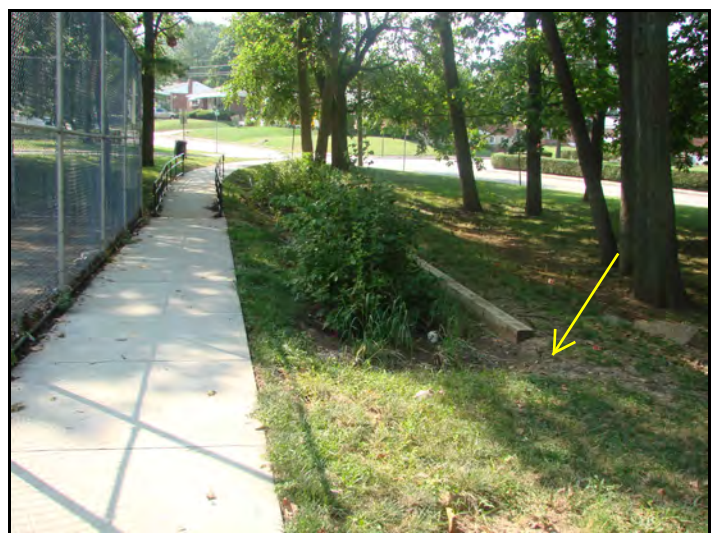
**Swale full of sediment; overgrown with vegetation with poor erosion control properties; severe erosion at outlet**
