**Traction Power Electrification System
Investigation
Washington Metropolitan Area Transit Authority
(WMATA)**

FINAL REPORT

Federal Transit Administration
U.S. Department of Transportation
1200 New Jersey Avenue, SE
Washington, DC 20590

December 9, 2016

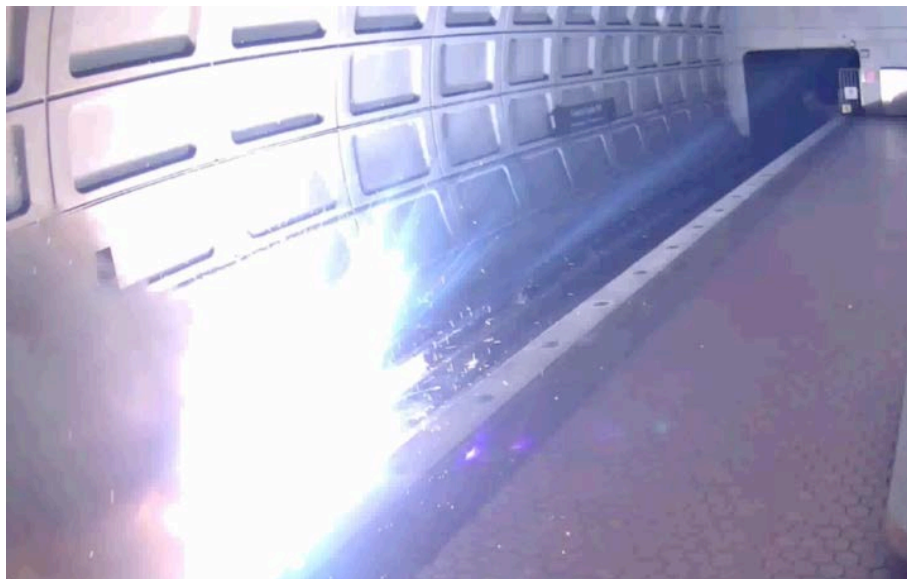
Figure 2: Electrical Arcing Event at Federal Center SW Station on May 5, 2016

On May 11, 2016, FTA issued a follow-up letter, which directed WMATA to complete repairs to TPE system components on the Red Line between Medical Center and Van Ness and on the Blue/Orange/Silver Line between Potomac Avenue and the D&G junction.⁶ In support of this activity, FWSO conducts on-going inspections of this track to assess conditions and progress, and FWSO's reports are available online.⁷

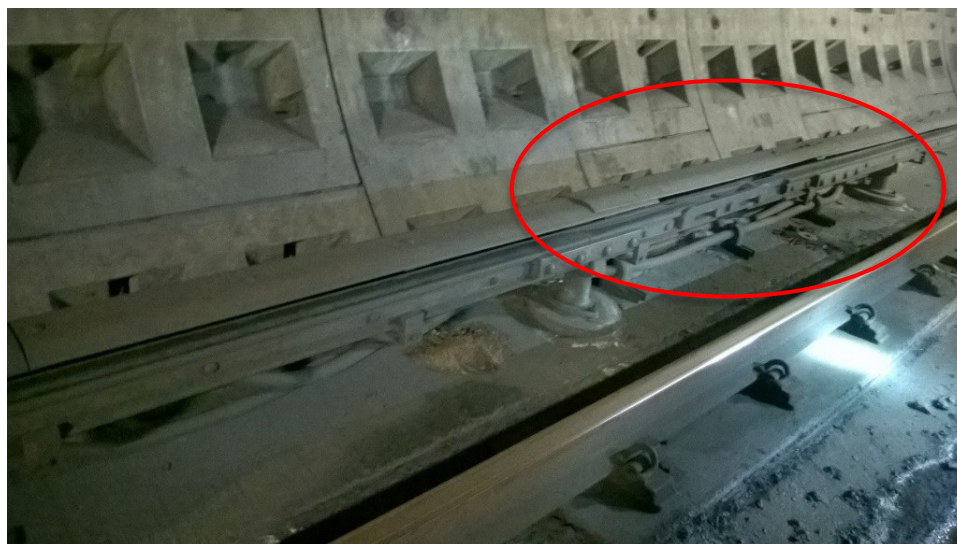
Throughout the rail system, third rail gaps exist to support interlockings, safe access to enclosures, and means of egress as well as to facilitate wayside equipment placement. Jumper cables maintain electrical continuity across these gaps, ensuring that the third rail remains energized on both sides of the gap. There are approximately 660 locations with jumper cables in the tunnels system-wide. Generally, each jumper location has four cables. Jumper locations typically include crossovers, transitions, and gaps in the contact rail. Figure 7 shows an expansion joint in the third rail, which creates a gap that must be bridged by jumper cables.

Figure 7: Third Rail Expansion Joint and Jumper Cables

improvements. For example, the FWSO technical team strongly recommended that WMATA consider reviewing the engineering requirements for third rail expansion joints in the tunnel environment, and/or consider alternate methods for installation of expansion joint cables to minimize exposure to physical damage.

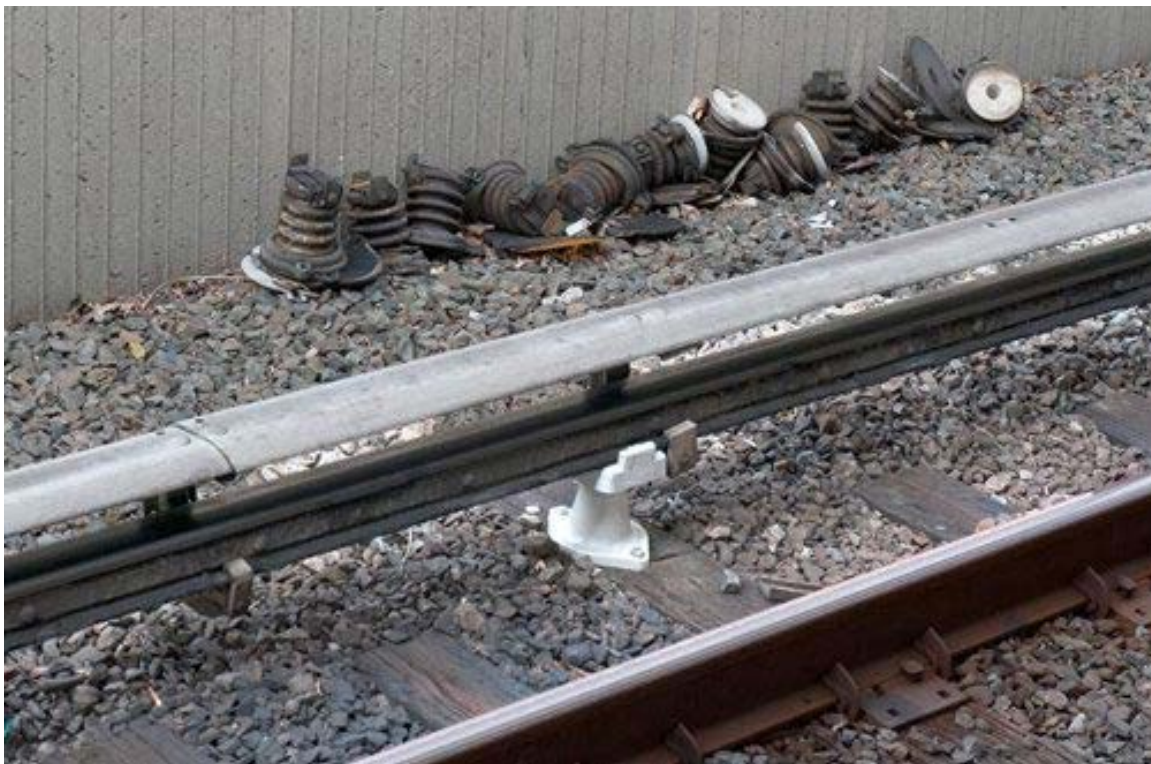
WMATA began replacing insulators and eliminating third rail expansion joints in tunnels, and issuing new work instructions to ensure that electrical cables are secured off the ground and appropriately bolted to the contact rail. WMATA is also expanding its cable replacement program, and re-instating its plans to upgrade both its positive and negative electrical return system to manage 100 percent 8-car train operation. Figure 9 shows a newly installed insulator and in the background a pile of insulators removed the third rail, contaminated with dirt, mud, dust, and other elements.

Figure 9: Newly Replaced Insulator and Old Insulators

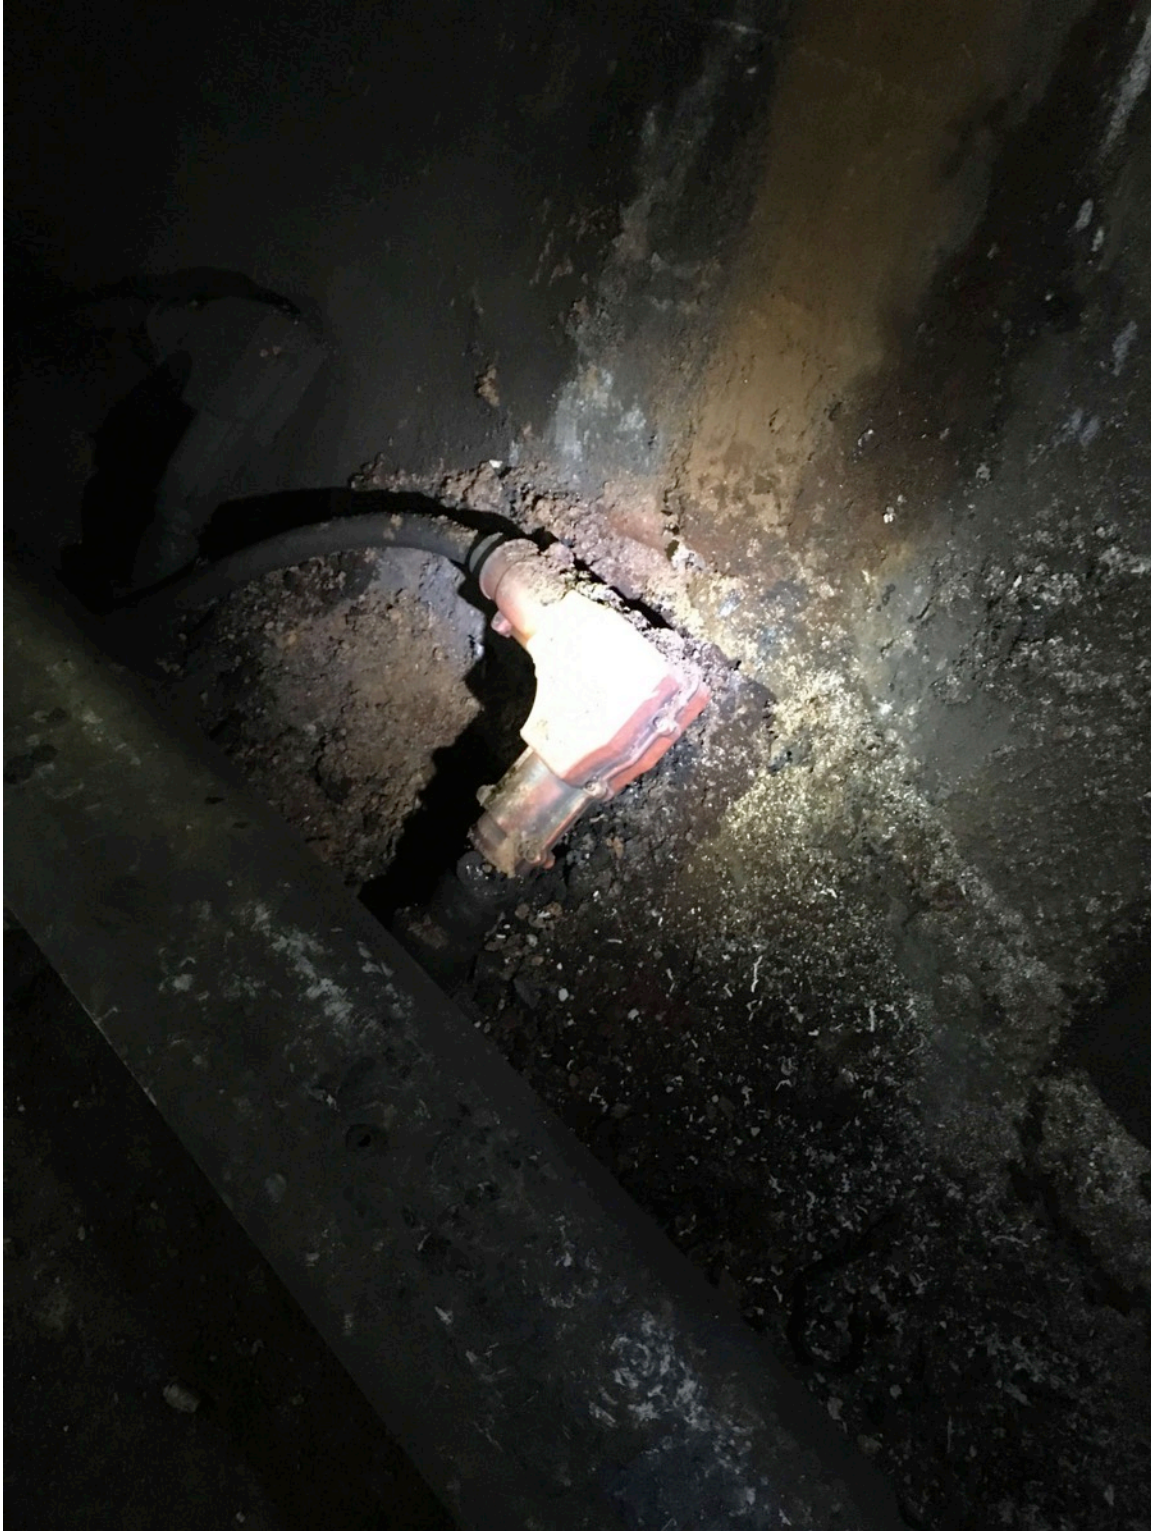
In numerous inspections and investigations regarding WMATA’s track conditions, FWSO has confirmed that track and tunnel drainage defects have not been adequately identified and prioritized for repair, allowing insulators, cables, and connectors on or near the track bed to become encased in mud, water, and other contaminants. Figures 10, 11 and 12 show examples of this condition observed by FWSO’s team.

Figure 10: Cable and Connector Assembly Coated in Mud and Water

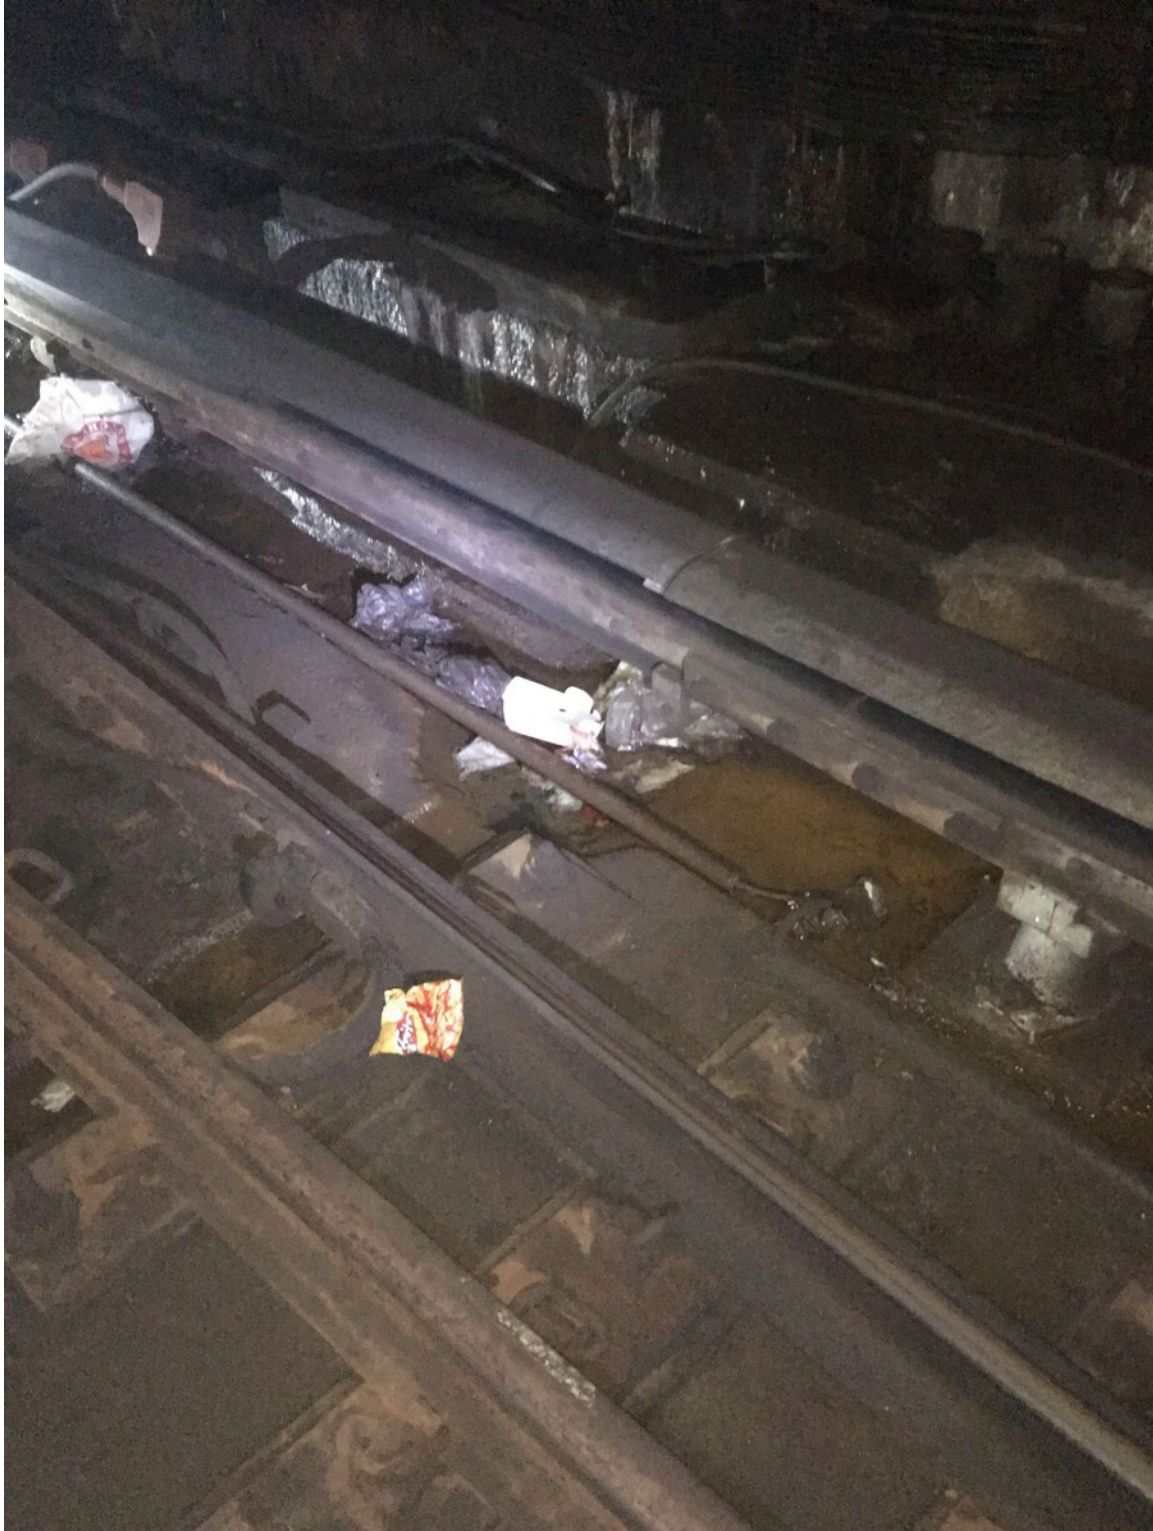
Figure 11: Water and Debris under Third Rail

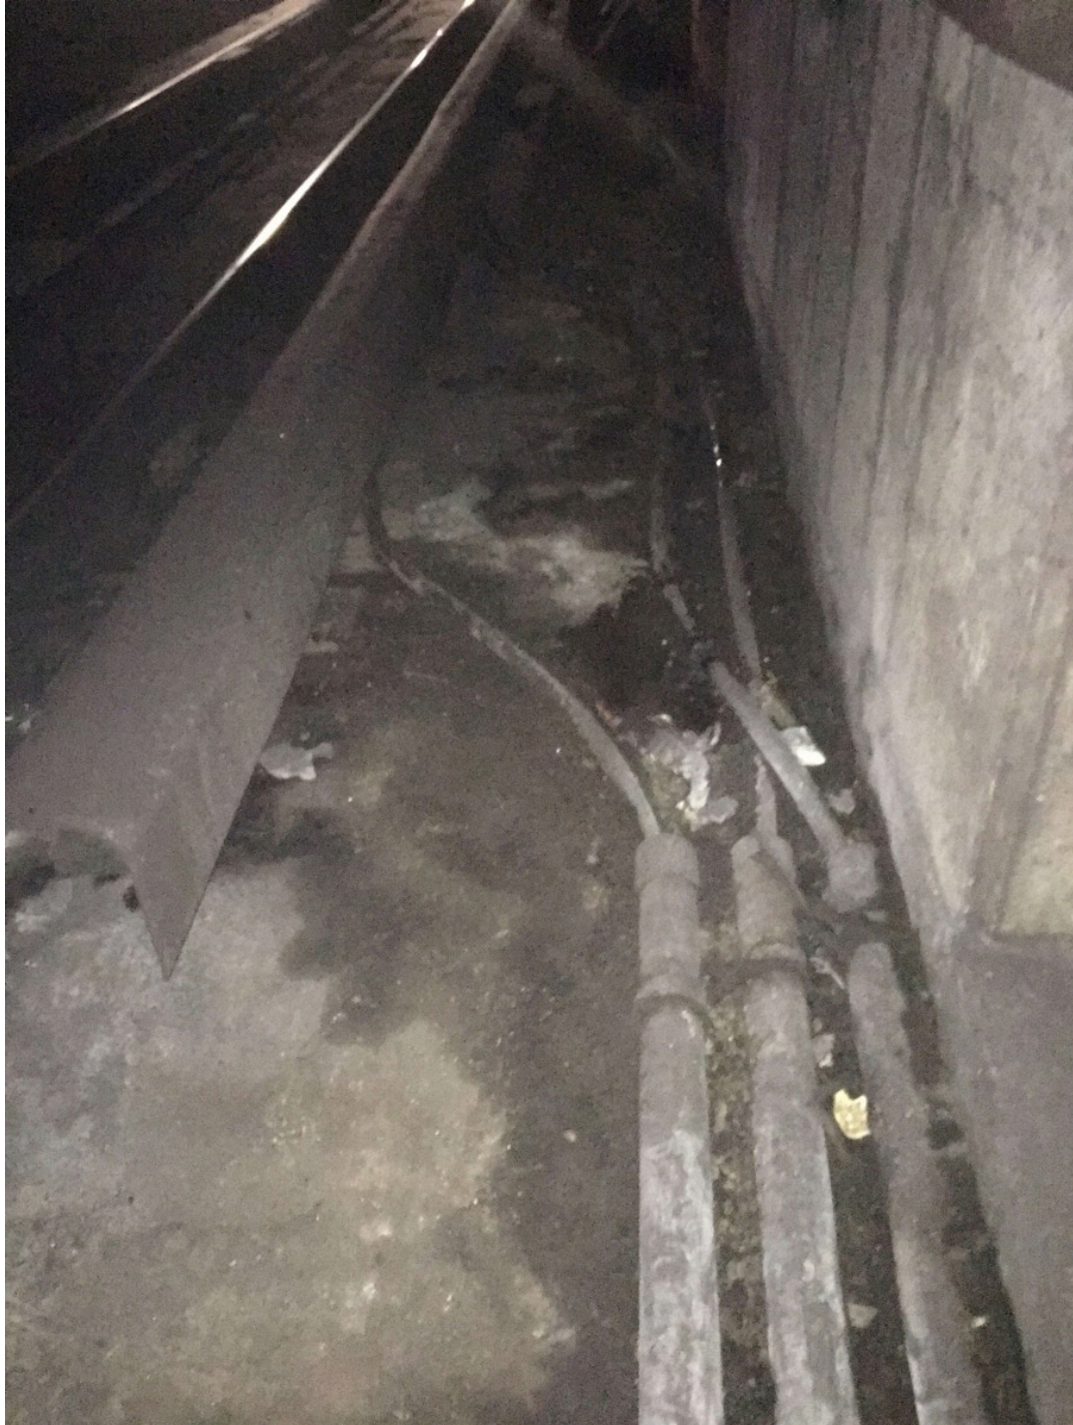
Figure 12: Power Cables on Tunnel Floor in Damp and Muddy Conditions

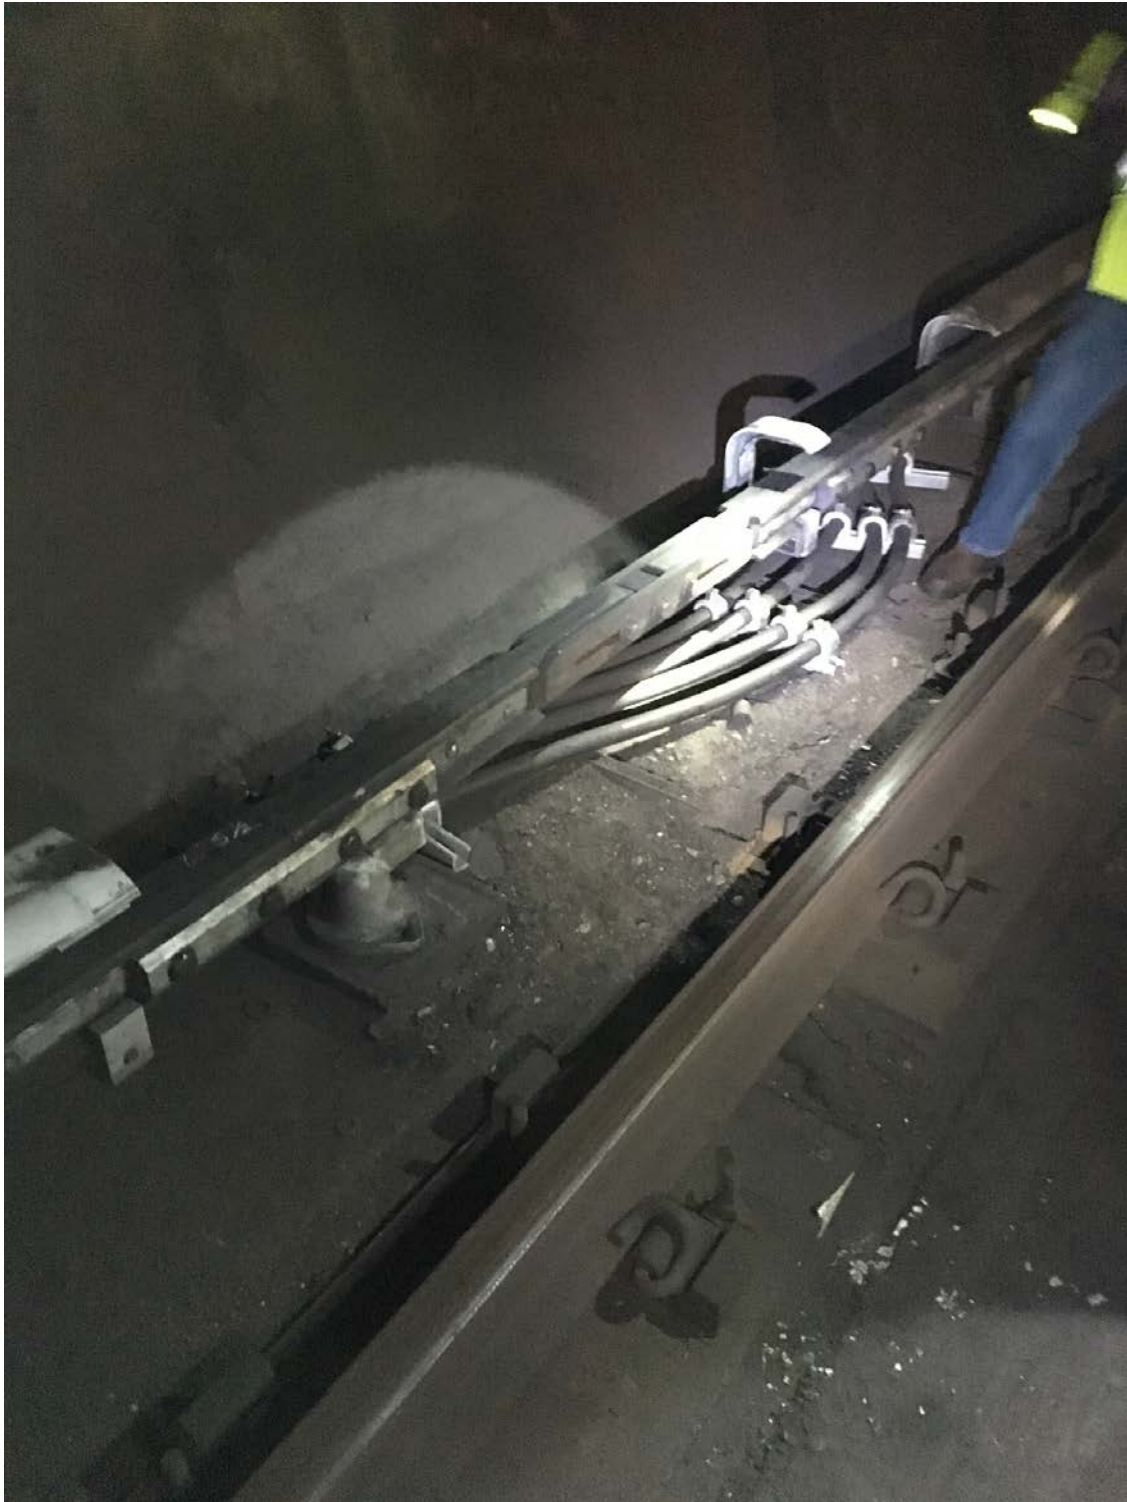
Figure 13: Typical Repair for Securing Cables Off the Ground

To date, WMATA has repaired 79 of the approximately 200 locations requiring cable securement repairs identified on March 16, 2016. These repairs require cleaning and inspection of cable, elevating cables off the ground on secured Kindorf with ceramic insulators, and replacing or adding cables as necessary. Figure 13 shows a typical repair. Through the course of their inspections, TRPM cable teams continue to find other locations where cables are loose on the ground and must be secured. Figures 14 and 15 show examples of cables on the ground or touching the tunnel wall that have been identified for repair.

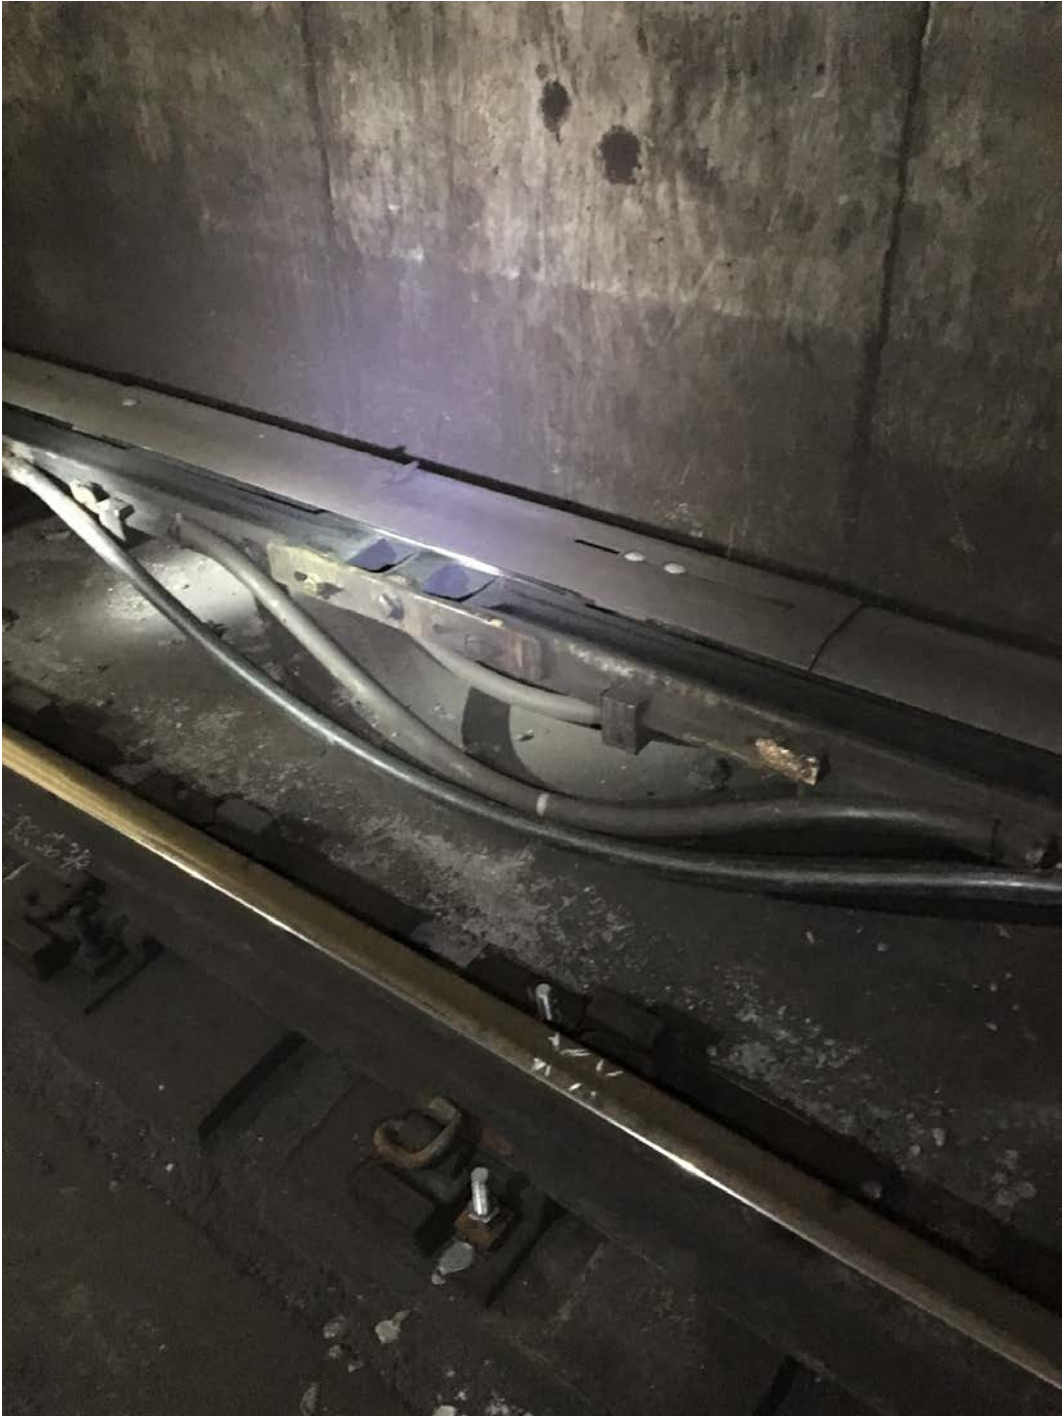
Figure 14: Cables on the Ground

TRPM continues to develop its mitigation strategy to address cables laying on the concrete tunnel surface by establishing defined criteria for the prioritization of repairs. Prioritization of repairs is based upon factors such as the cable's proximity to passenger stations (within 500 feet), insufficient quantity of cables to carry load, and environmental conditions (dry vs. wet). At the current time, this approach focuses only on positive cables.

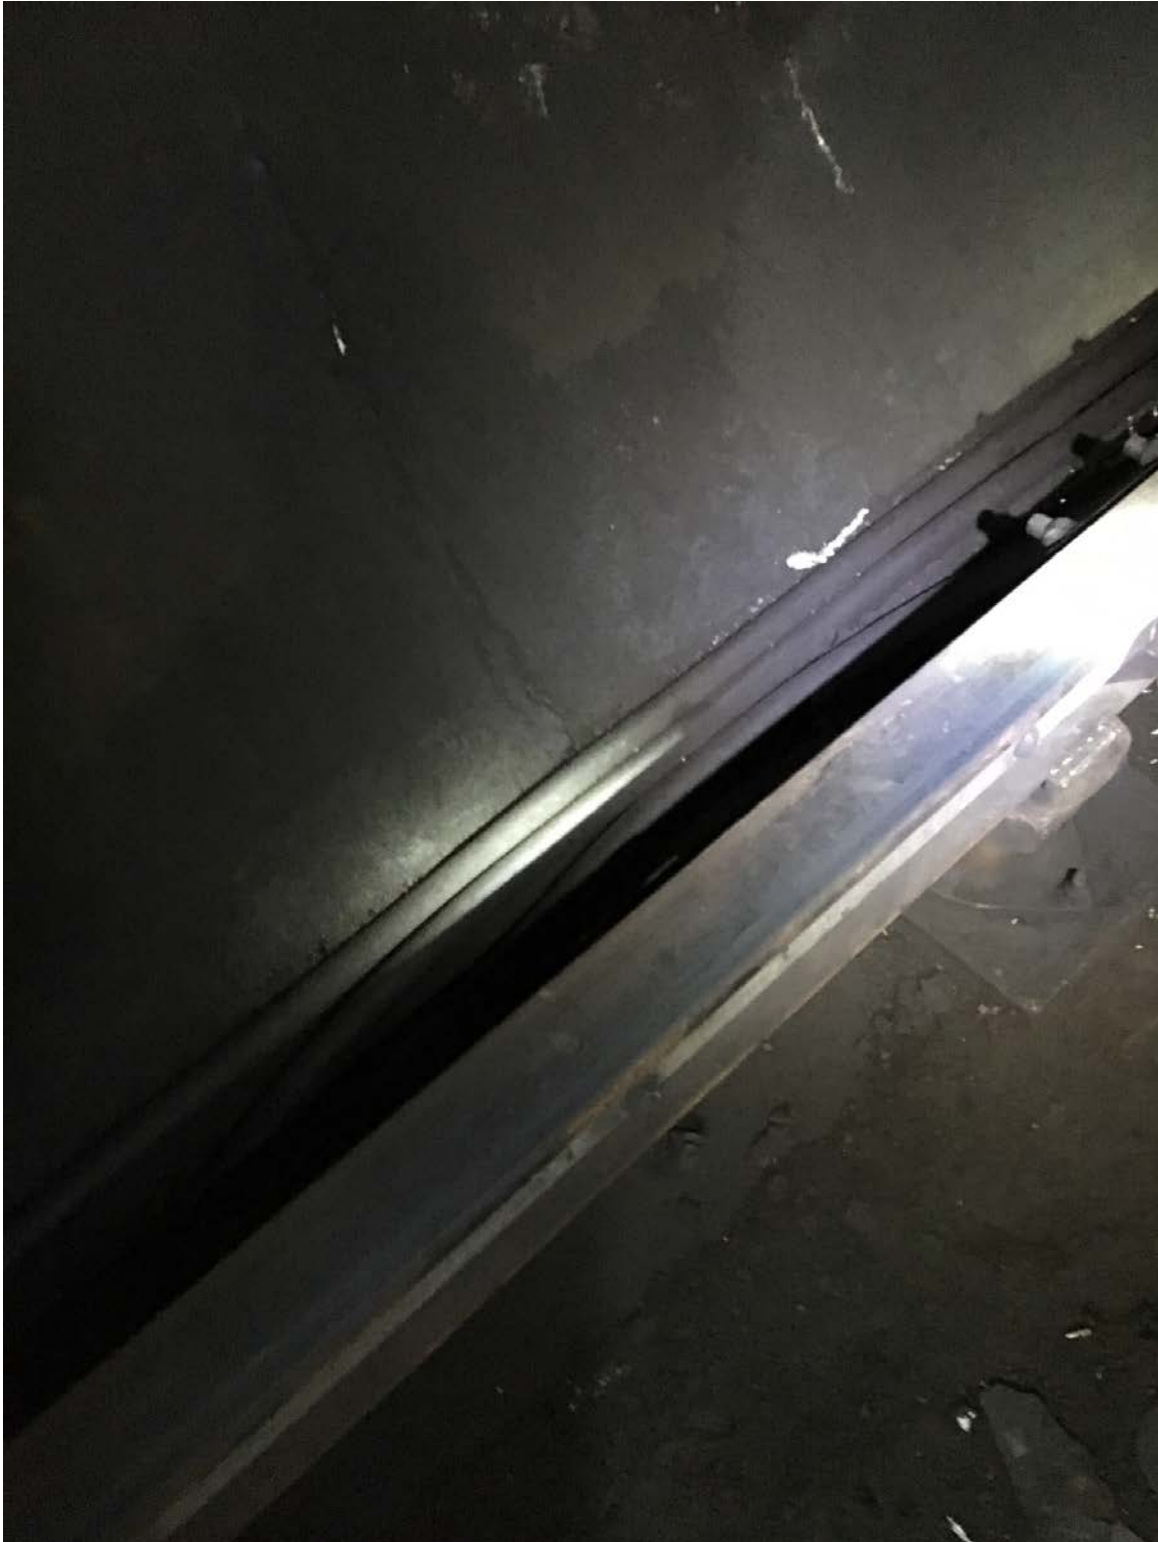
Figure 15: Power Cables Loose against Tunnel Wall

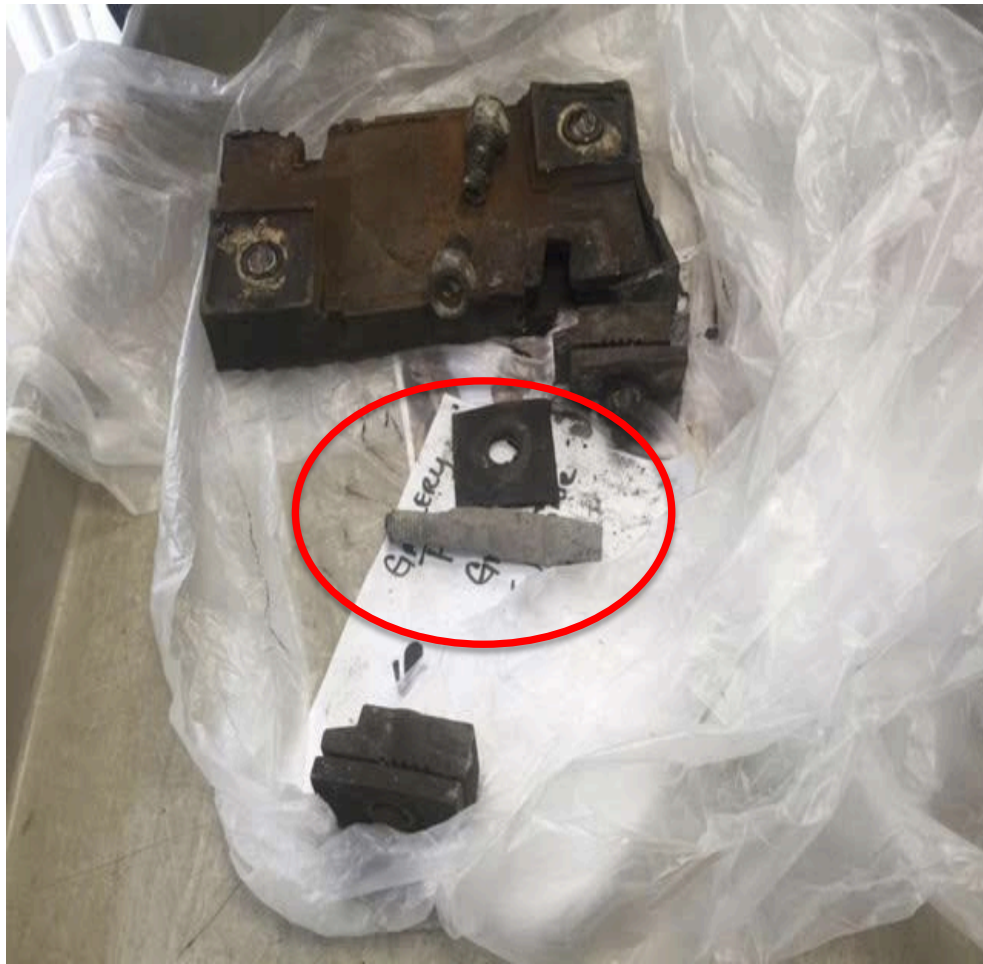
Figure 16 shows the damaged running rail fastener (tie plate) and stud mounting bolt recovered from a WMATA electrical arcing event at Gallery Place Station on June 27, 2016.

In this instance, the damaged stud bolt, circled in red, was located in the running rail farthest from the third rail, which indicates that this event was a traction power return system (negative) failure and not a flashover from the contact rail (positive). As discussed in earlier findings related to the deteriorated corrosion control features in the floating slab tunnel sections, stray current leakage is a critical concern that WMATA must investigate and resolve through its stray current corrosion control plan and enhanced attention to the inspection, maintenance, and repair of its tunnel sections, and also through increased insulation resistance in rail fasteners.

Figure 16: Track Fastener Involved in Gallery Place Electrical Arcing Incident, June 27, 2016
